30 MOHAMED SULTAN ROAD

The Phoenix Rises Again

Hong San See Temple Conservation Project

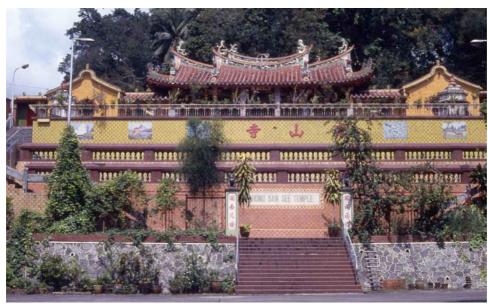
Pre 1994-1996 Restoration Entrance Hall Elevation Selected Pre-Restoration Photographic Documentation, dated early 1990s (Photo Credits: Dr Yeo Kang Shua)

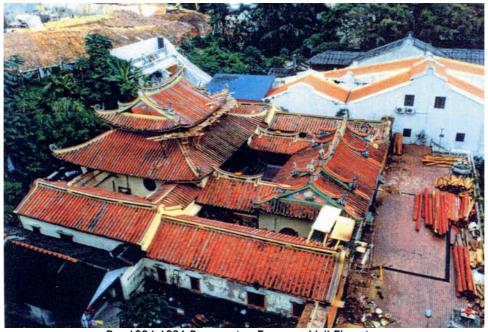
Pre 1994-1996 Restoration Entrance Hall Elevation
Selected Pre-Restoration Photographic Documentation, dated early 1990s (Note the auxiliary building on the lower left of photograph)

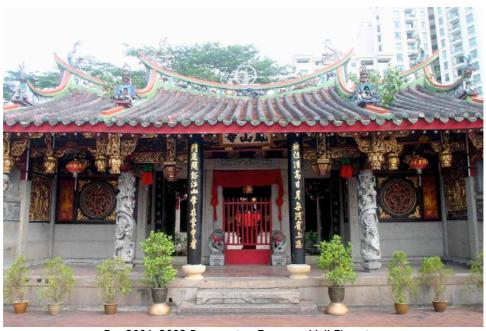
Pre 2006–2009 Restoration Entrance Hall Elevation
Selected Pre-Restoration Photographic Documentation, dated 2004
(Photo Credit: Patrick Goh)

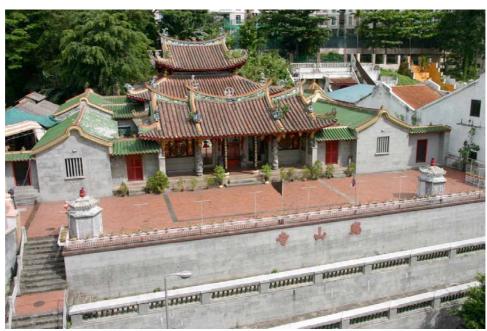
Pre 2006–2009 Restoration Overall View
Selected Pre-Restoration Photographic Documentation, dated 2004
(Photo Credit: Patrick Goh)

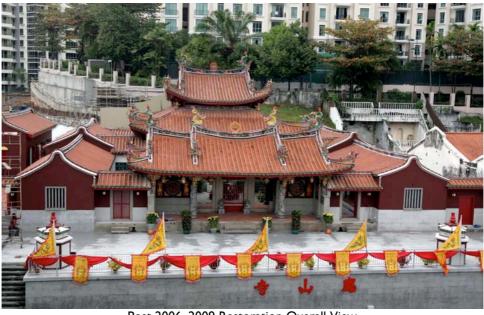
Post 2006–2009 Restoration Overall View
Post-Restoration Photographic Documentation, dated 2010
(Photo Credit: Neoh Kee Leng)
