CONSERVATION GUIDELINES
TECHNICAL SUPPLEMENT

UNDERSTANDING
THE PARTYWALLS

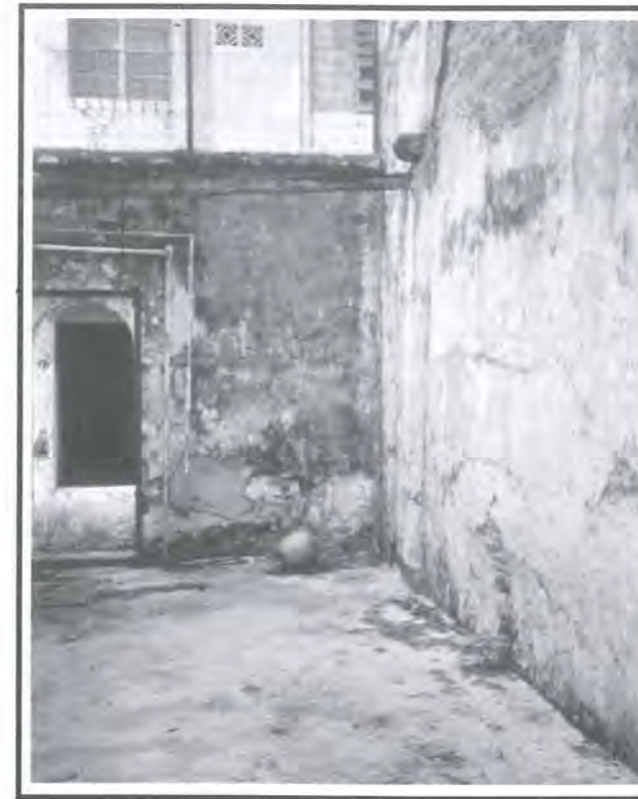
Fig 1: Cracks on the walls, due to weathering or structural settlement, require proper treatment and repair.

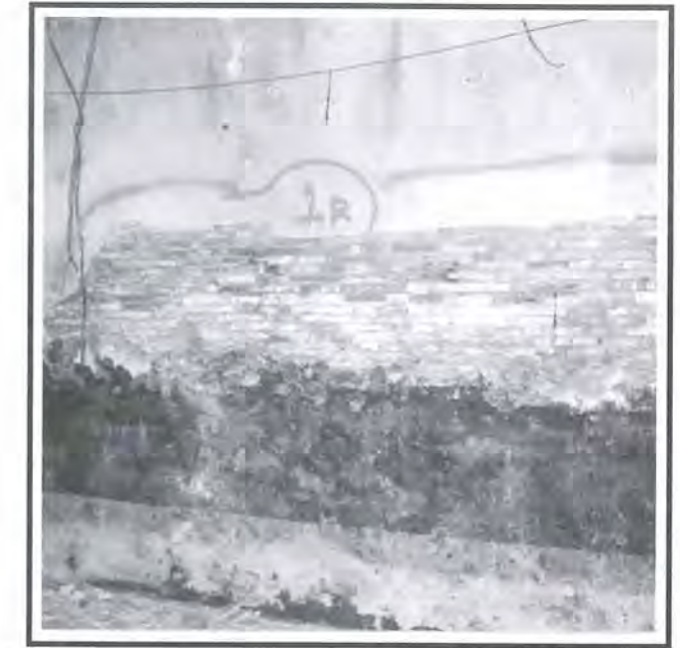
Fig 2: Organic growth on the partywall, caused by water penetration and the humid environment, requires proper treatment and cleaning.

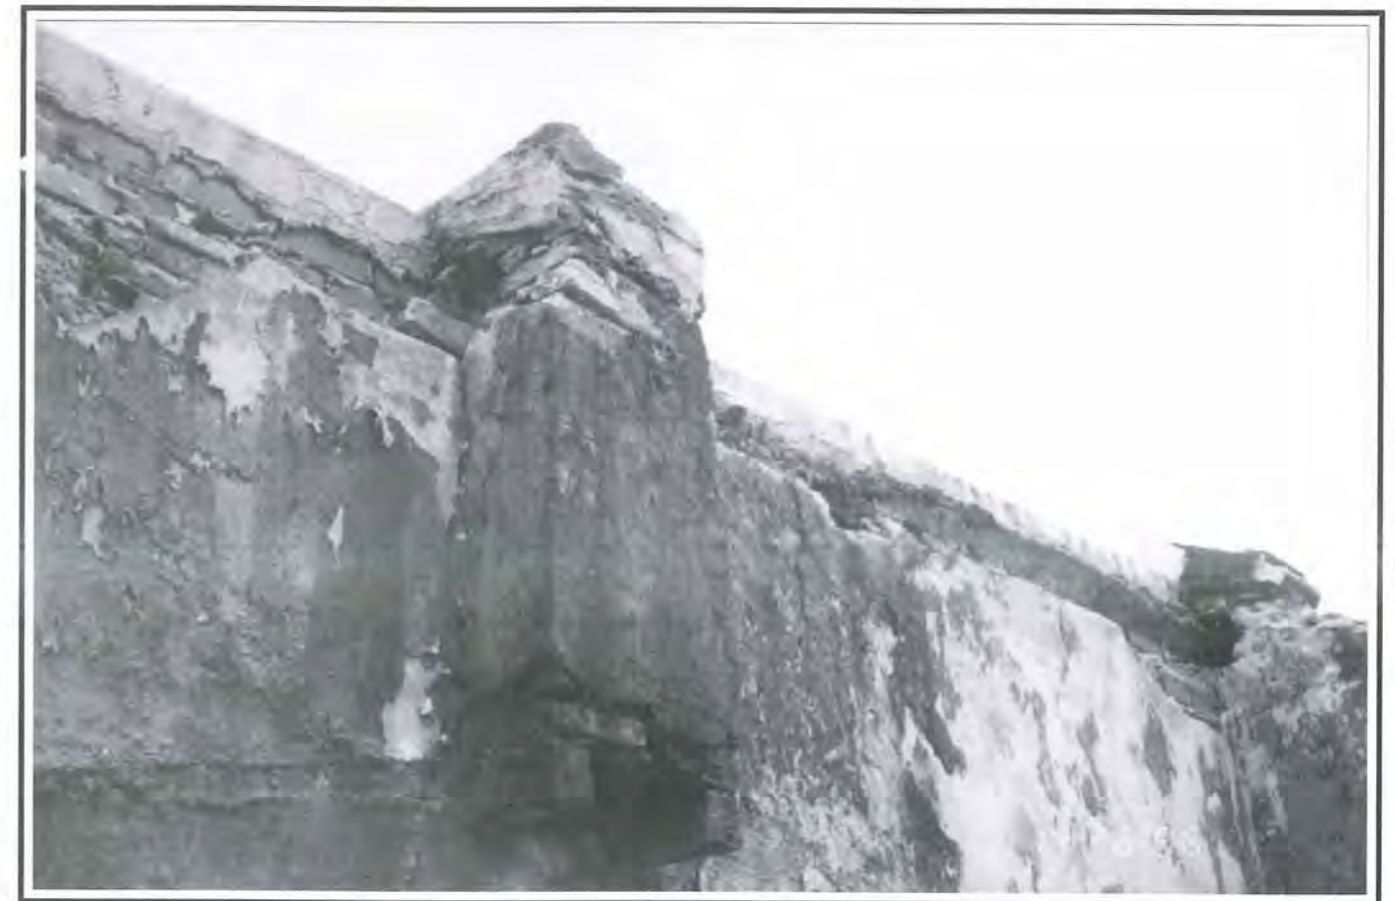
Fig 3: Deteriorated partywall, due to algae, moss and lichen growths, requires proper treatment and repair.

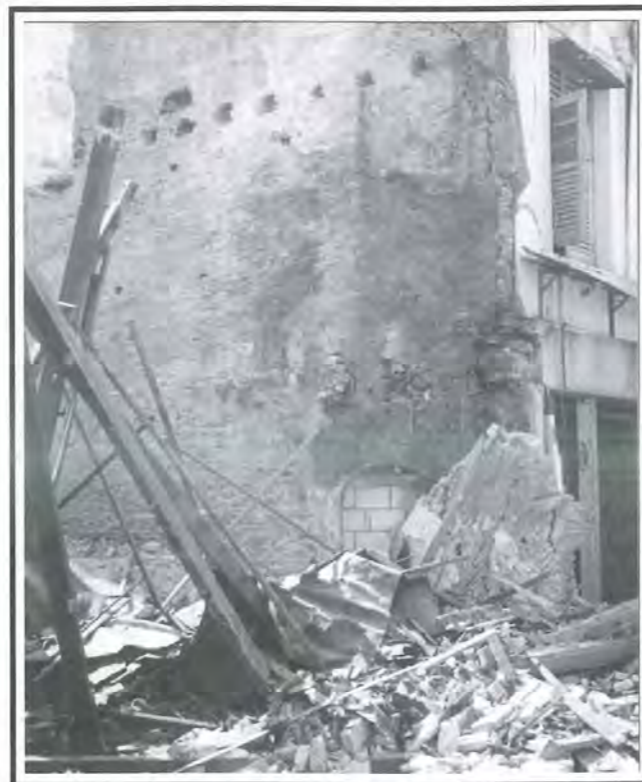
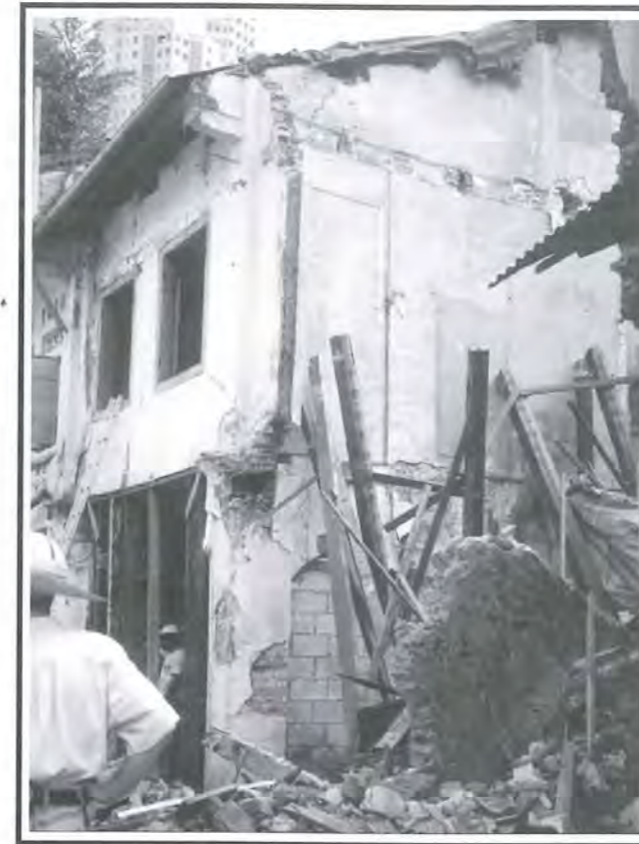
Fig 5: Partywall collapses could also be due to the structural instability of the existing partywalls which could be detected through comprehensive assessment of the existing structure.

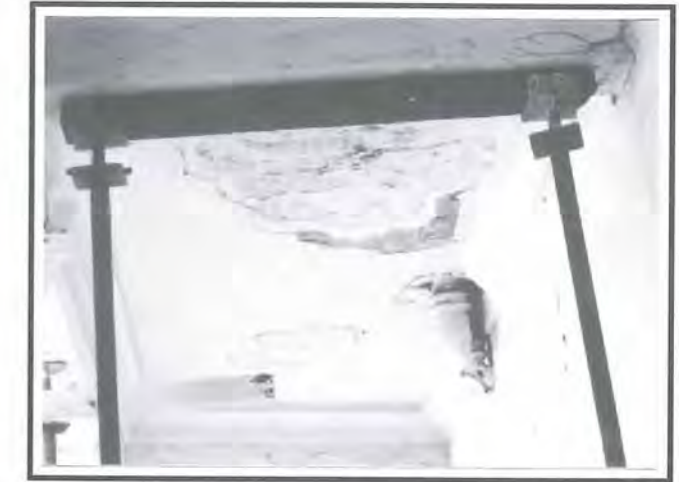
Fig 6: Propping up of the decayed timber beams during restoration is a means of providing structural stability.

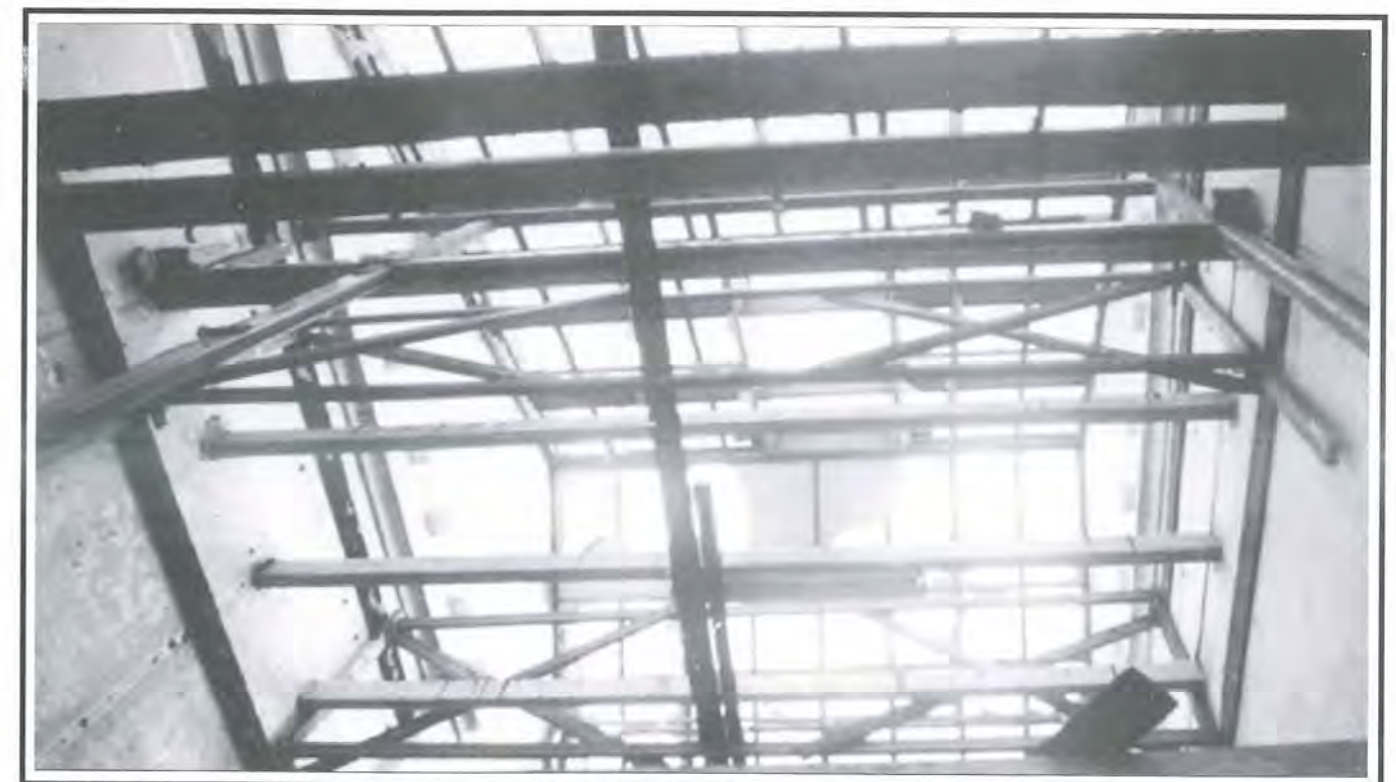
Fig 7: Adequate protection and lateral stabilisation during restoration works would prevent the collapse of the partywalls.

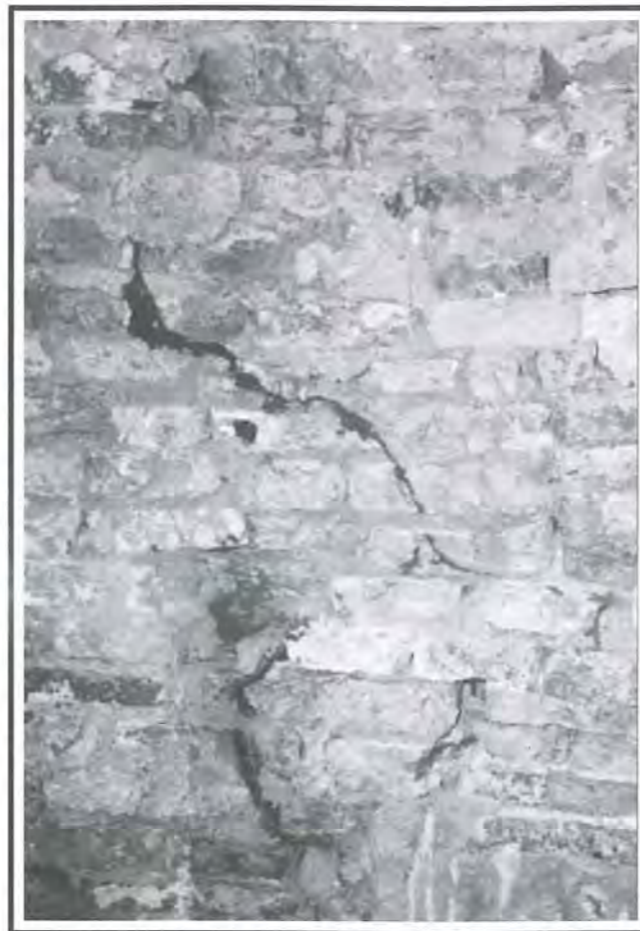
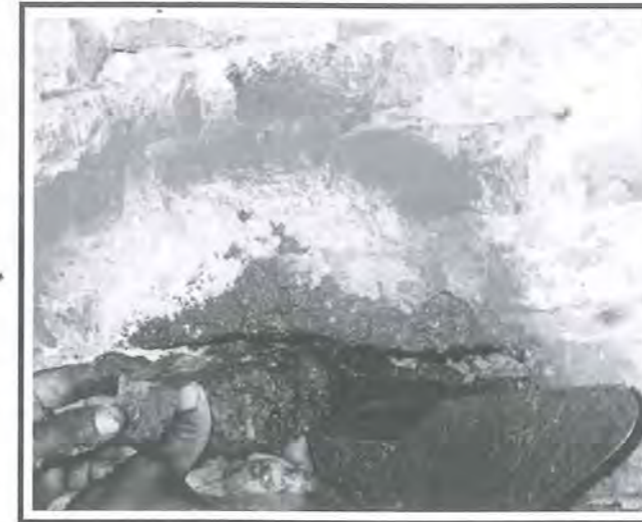
Fig 9: The process of stitching of new bricks and mortar jointing as a means of localised repair to the old brickwall.

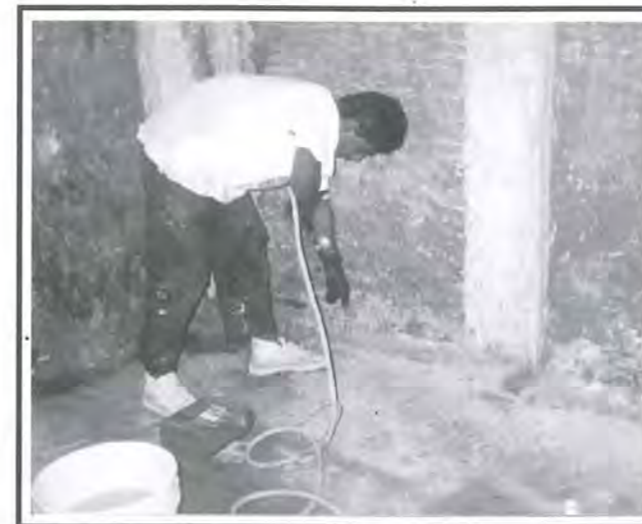
Fig 10: The process of injection of silicon into the brickwall to prevent water penetration through capillary action from the ground.

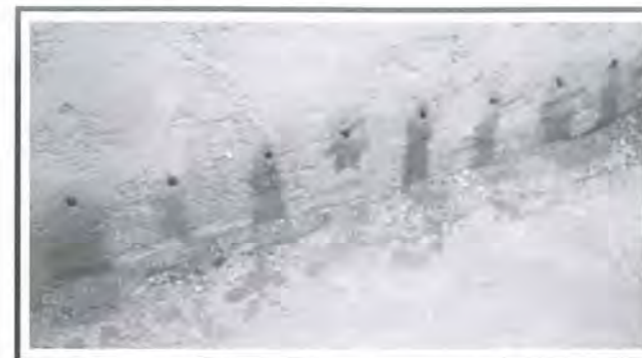
Fig 11: The holes made at about 500mm above the ground for the injection process.

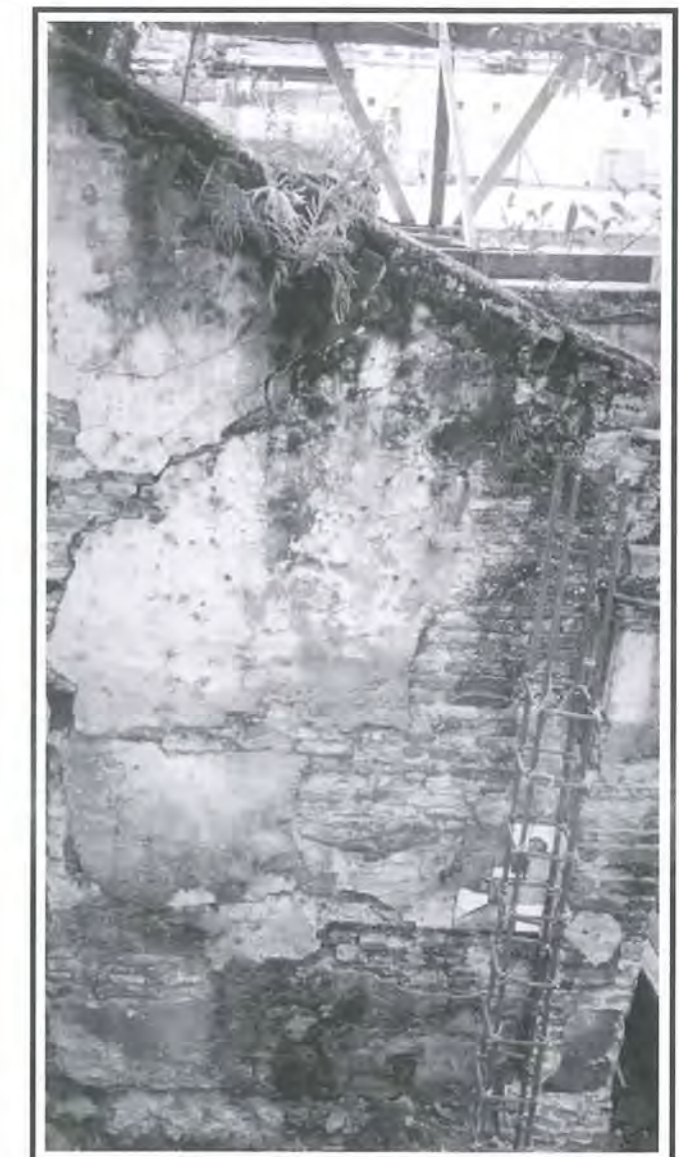
Fig 12: Cracks and areas of localised damage of the existing plaster, require proper cleaning, repair and treatment.

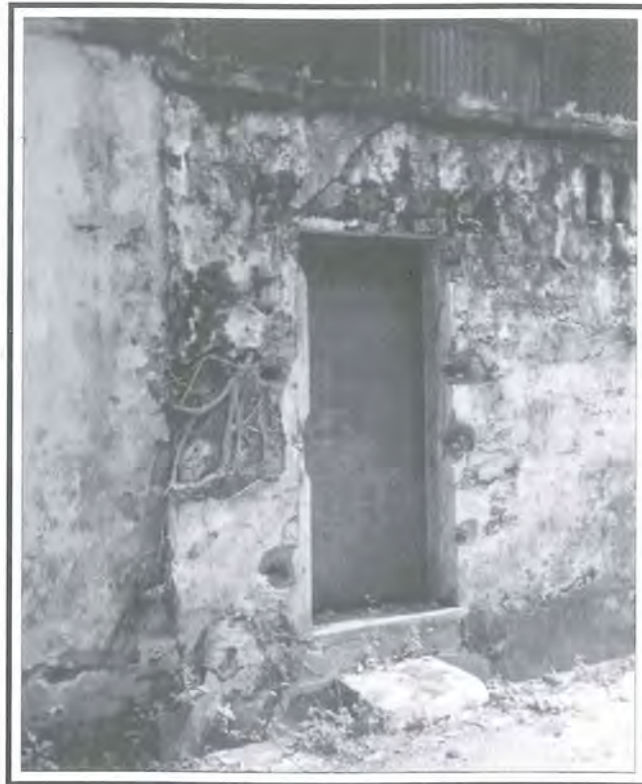
Fig 13: Damage to the plaster rendering due to vegetation growth and water penetration.

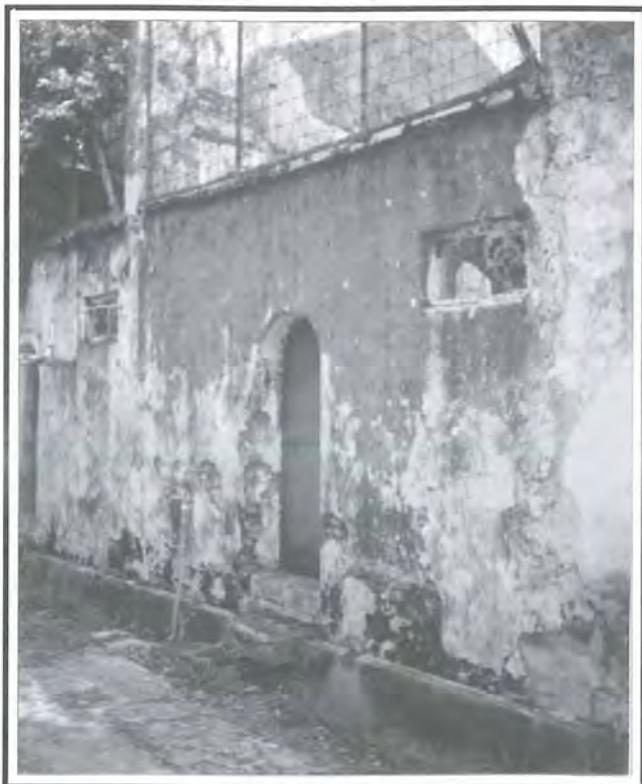
Areas of plaster, which are extensively cracked or which sound hollow, should be cut out in square edges or slightly undercut edges with sharp chisels to the backing. All dust, loosely adherent material, efflorescence and any organic growth should be thoroughly removed by bristle brushing and treatment with biocide. Surfaces to be replastered should be clean, firm and sterile. Important factors to consider when carrying out such patchwork are compatibility of materials, matching of colour and texture and adhesion of repair. (See Fig 15 - 17)

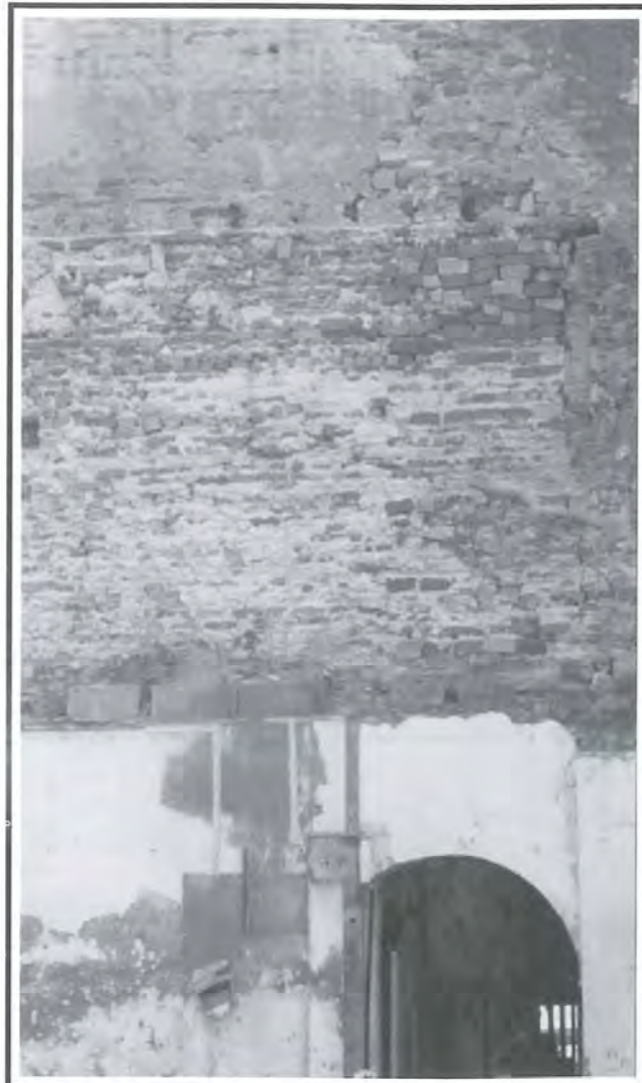
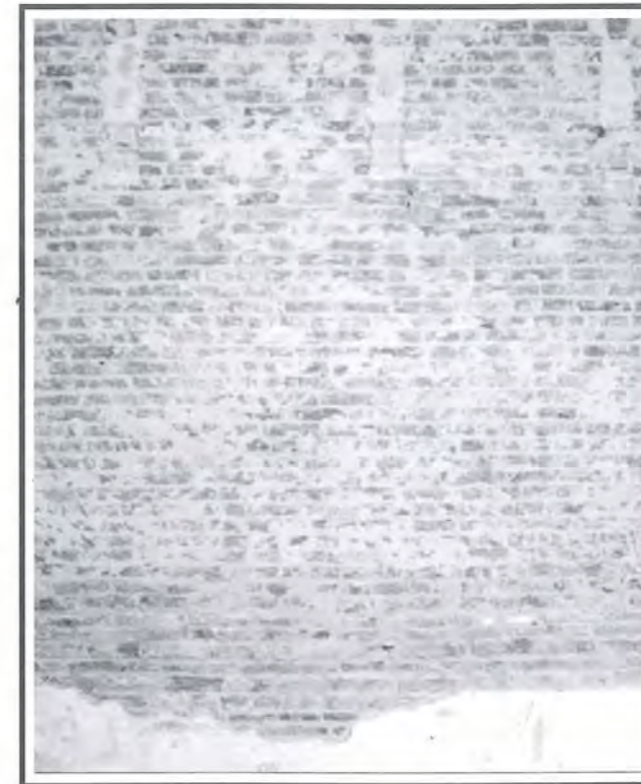
Fig 16: The surface of the brickwall, thoroughly cleaned by bristle brushing and treated with biocide, is ready for a new coat of plaster rendering.

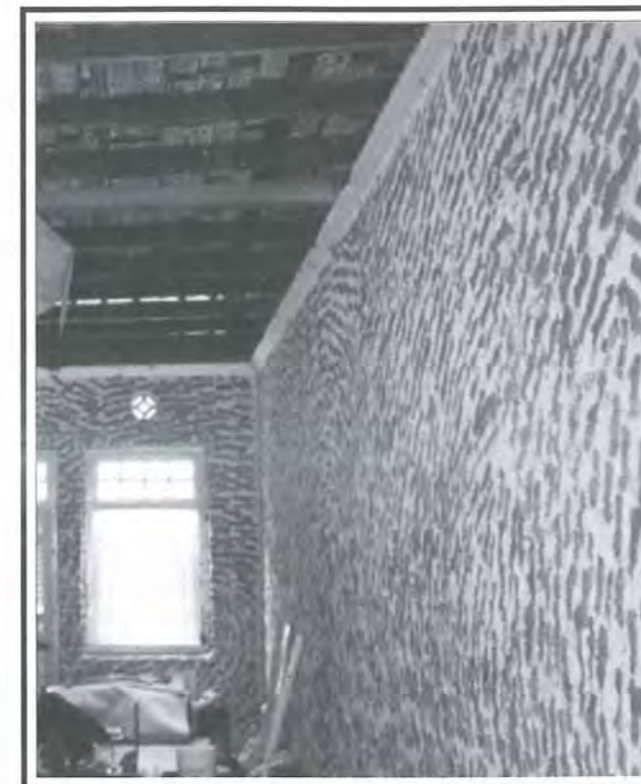
Lime-plaster is recommended for its porosity, especially useful to walls in the local hot and humid climate. This will prevent excessive moisture from being trapped within the walls, letting the walls "breathe". Trapped moisture could cause damage to the interior finishes and promote the growth of algae or moss on the walls, and the loss of adhesion of the plaster to the backing. The recommended mix for the lime plaster is 1 : 2 : 9 (cement : lime : sand). (See Fig 18)

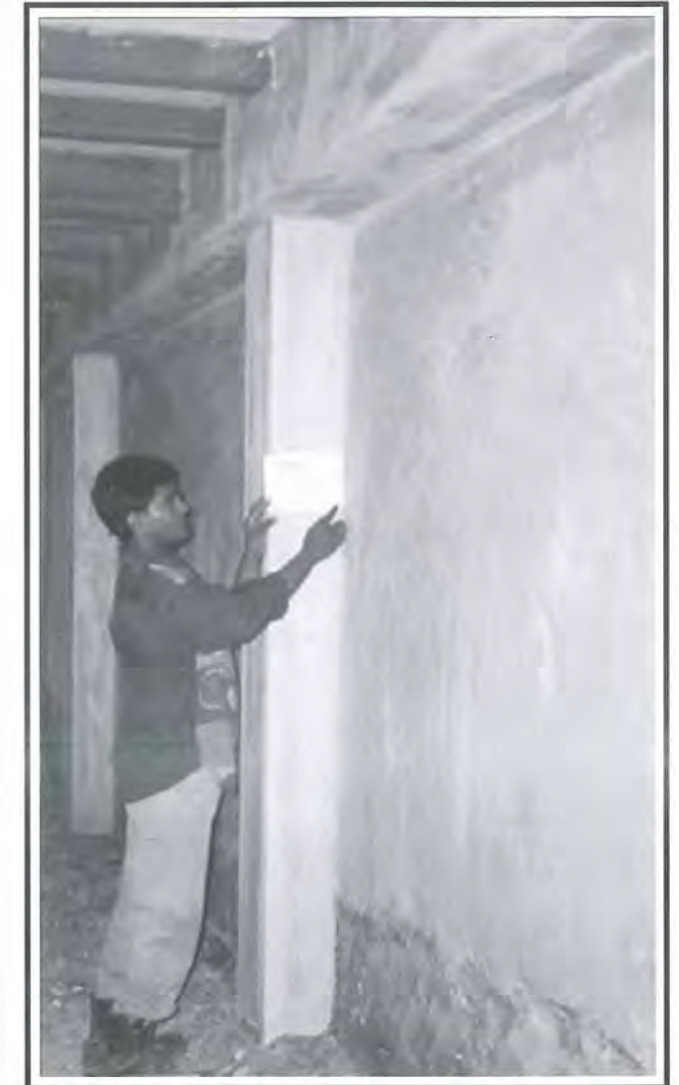
Fig 18: The new coats of plaster rendering applied to the wall

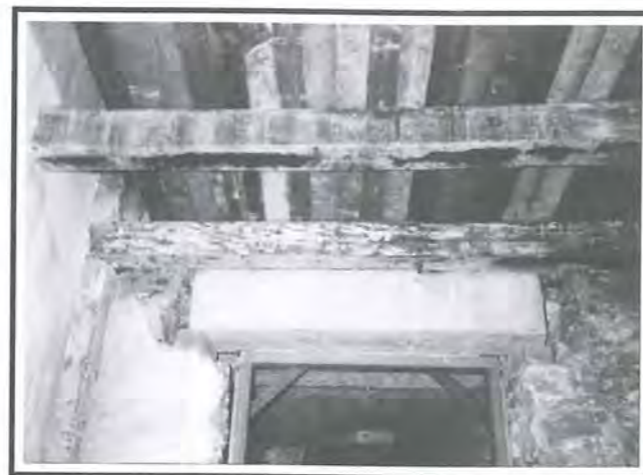
Fig 19: The use of concrete lintels for the creation of openings in the partywalls for amalgamated units.

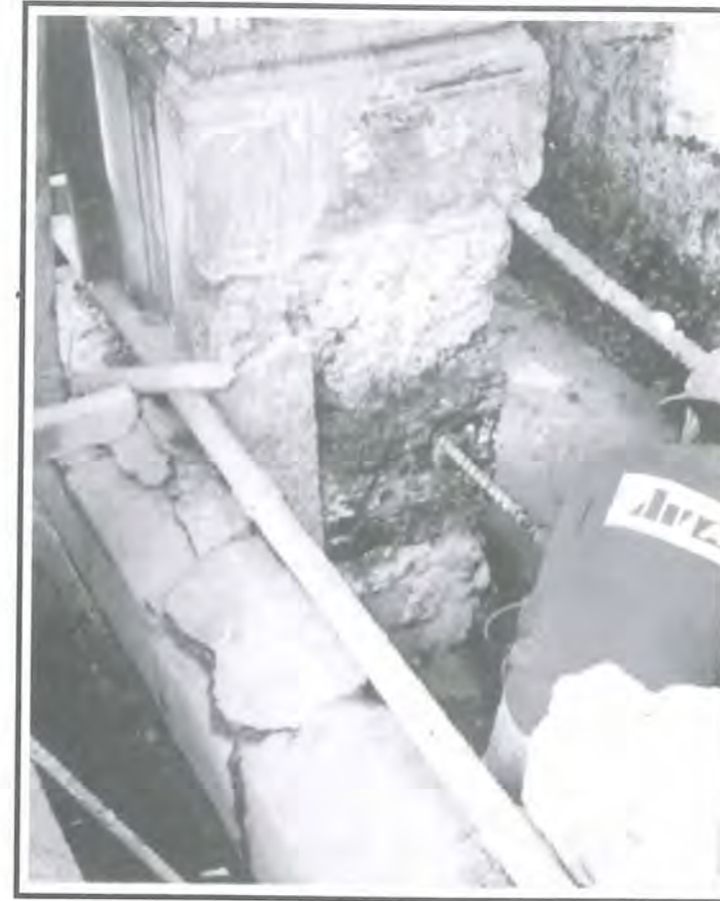
Fig 20: The strengthening of the existing foundation with reinforcement to prevent the collapse of the partywalls.

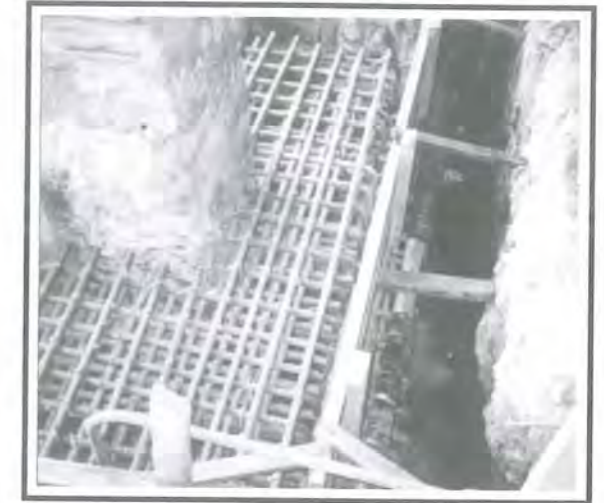
Fig 21: The addition of reinforcement to the existing reinforced concrete columns and ground structure to increase the loading capacity of the structure.

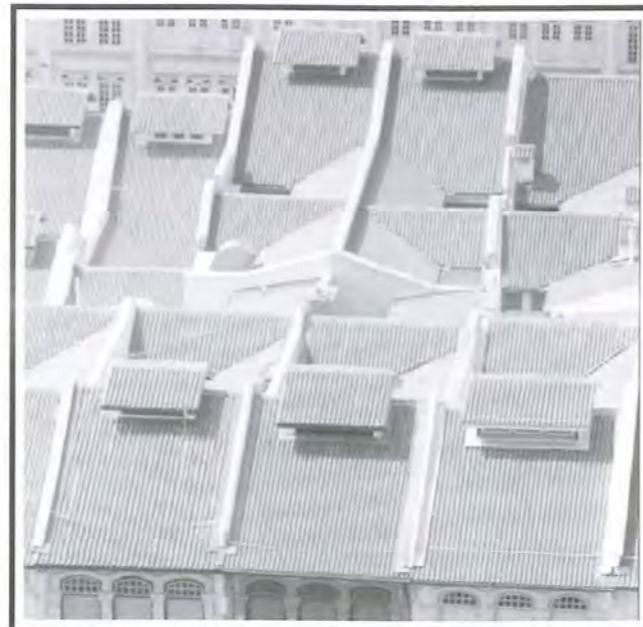
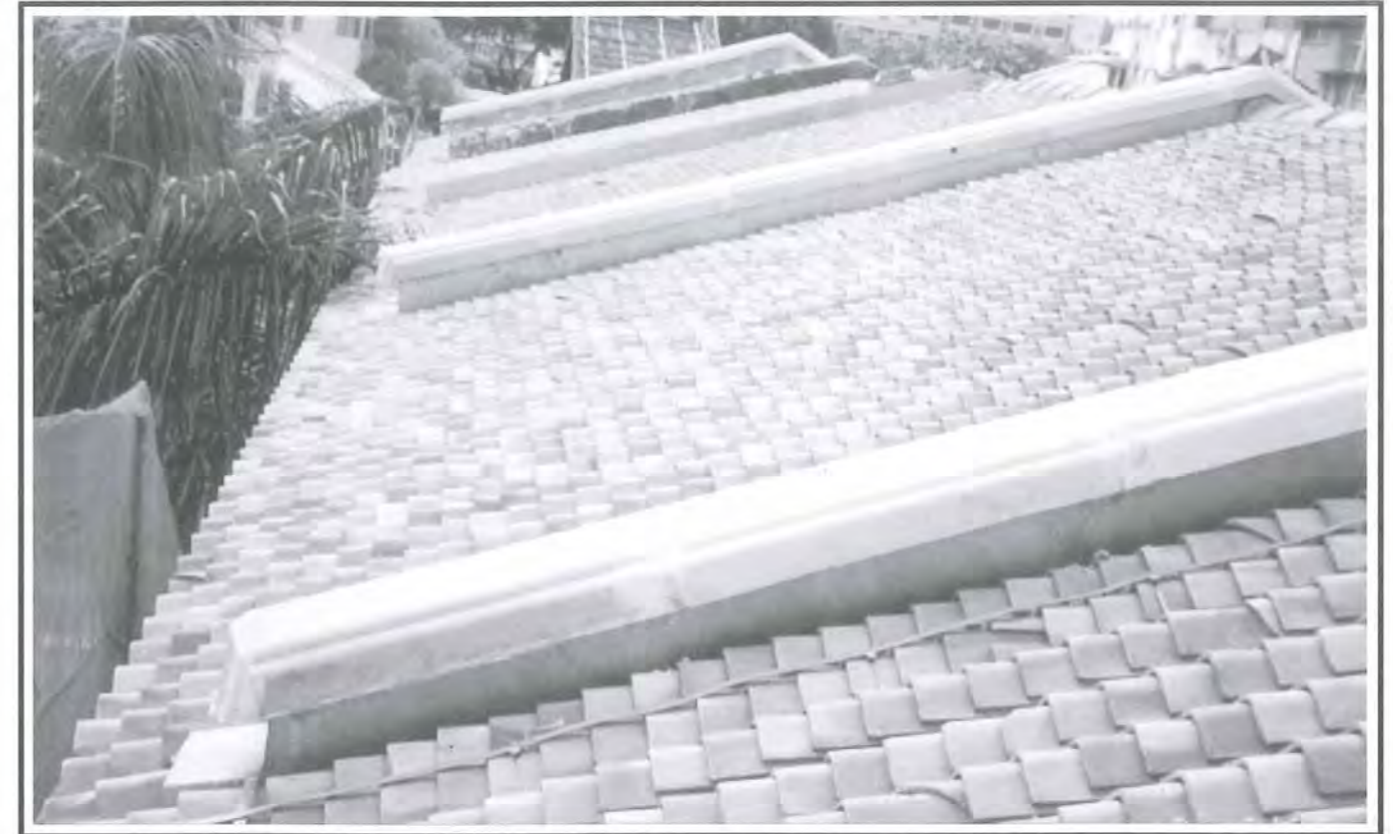
Fig 29: The use of glass reinforced concrete (GRC) coping at the partywall above the roof.

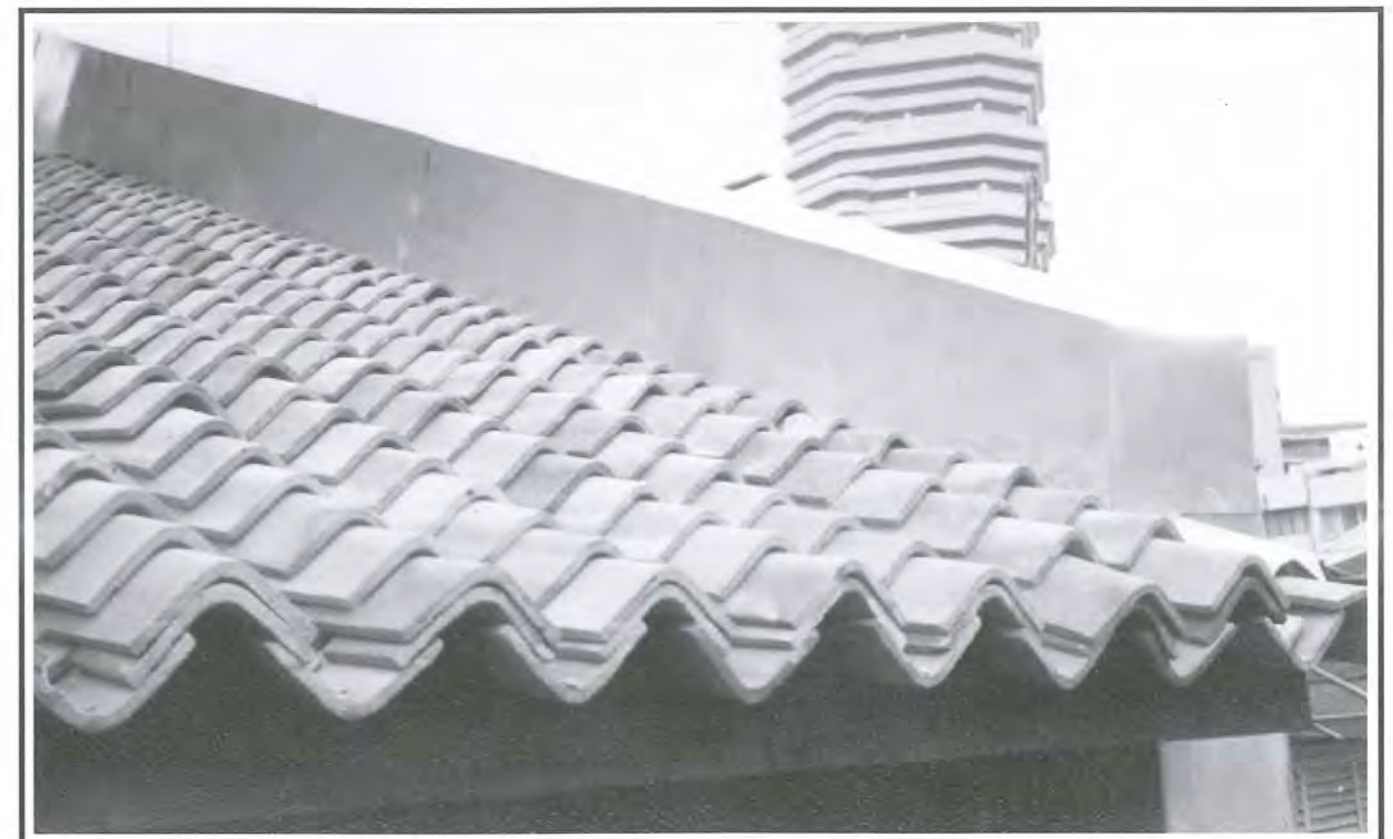
Effective protection and maintenance are the keys to preserving the historic elements of a conservation building. Deterioration can be remedied through proper restoration techniques and sensitive repair. It is important to ensure that any material used in the repairs or replacement is compatible to and integrates well with the existing structure/material. Although adaptive reuse of the old building may involve the introduction of new construction methods or repair, it is important that the structural integrity and historic character of the building should not be compromised. (See Fig 31 - 36)
