# No. 140 HILL STREET

A Breath of New Life

**2001 AWARD**

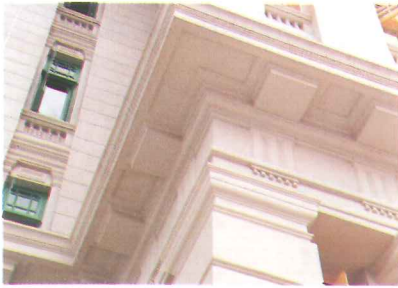
*Moulded entablature*

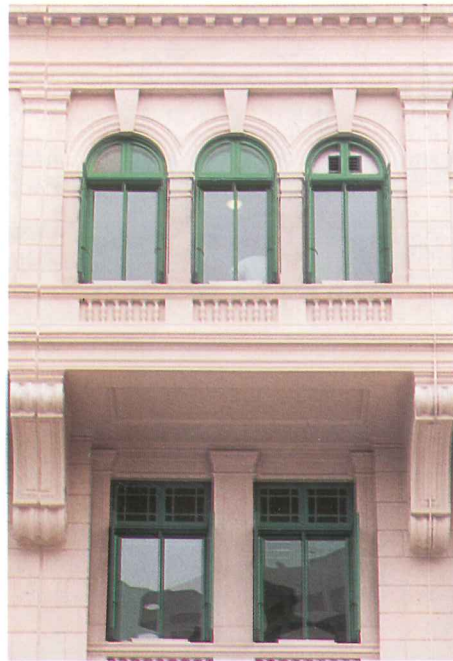
*Rusticated facade with protruding balcony and other features*

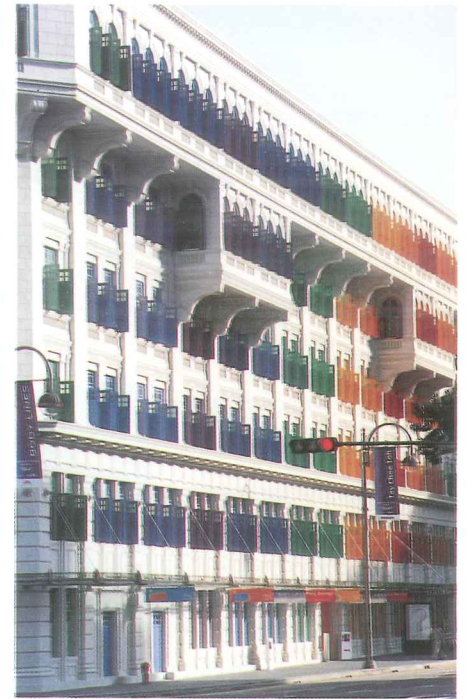
*Brightly-painted, rainbow-coloured timber windows*

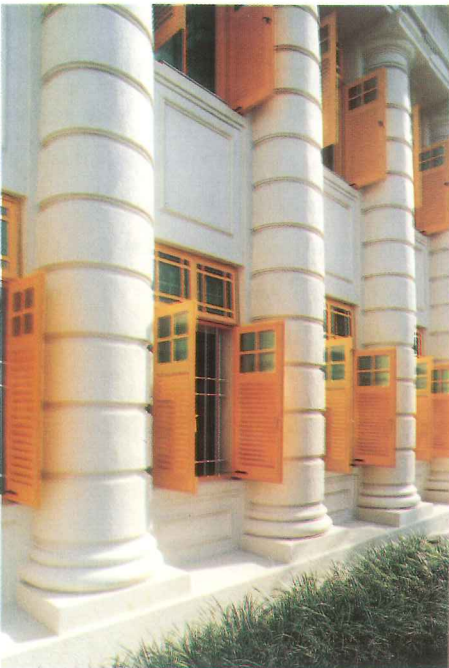
*Series of circular rusticated columns*

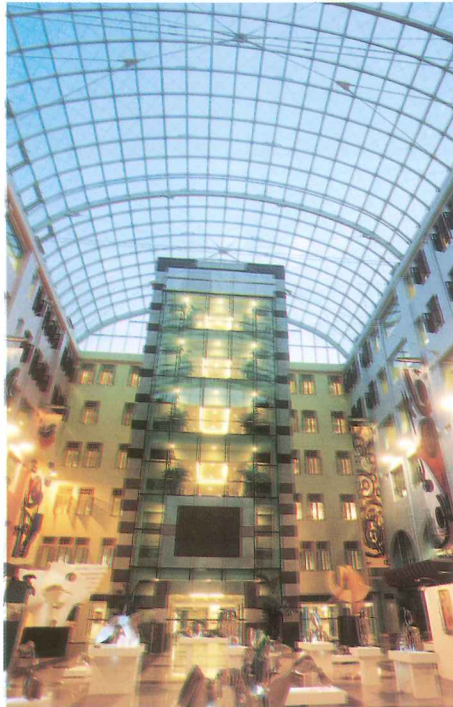
*The ARTrium - the rectangular courtyard covered with new glass roof*

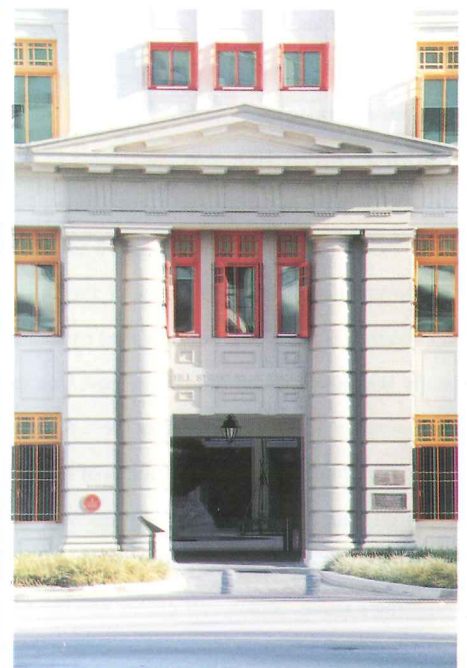
*Pedimented entrance flanked by circular and rectangular columns*
