Nos. 15 TO 23 CLUB STREET

This project comprises 5 units of two-storey shophouses with an internal courtyard and a large two-storey building at the rear. The first storey is for commercial use and the upper floors for residential purposes. The buildings are of the Early Shophouse Style and are located within the Historic District of Chinatown.

CONDITION OF THE BUILDINGS PRIOR TO CONSERVATION

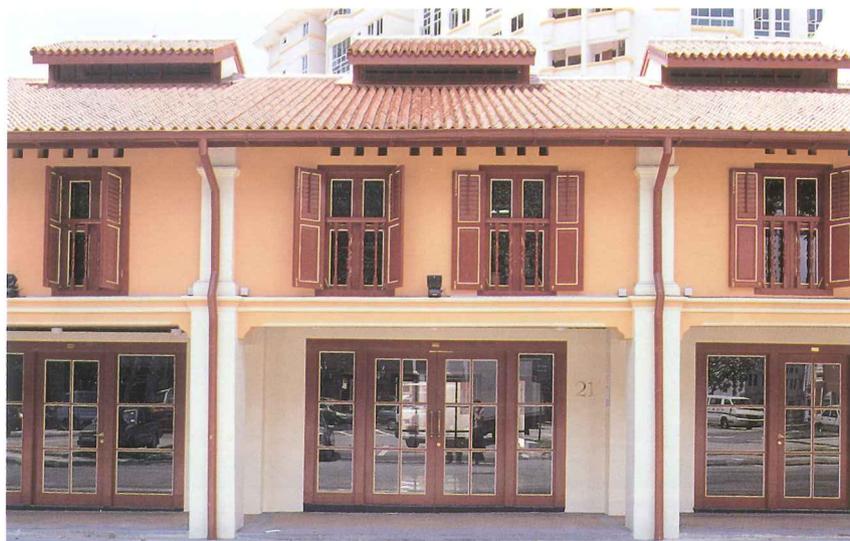
Early shophouses restored to their historic character

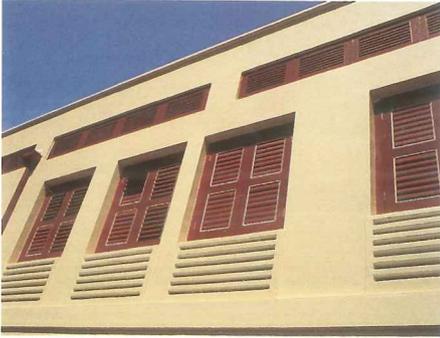
Restored rear facade of rear building

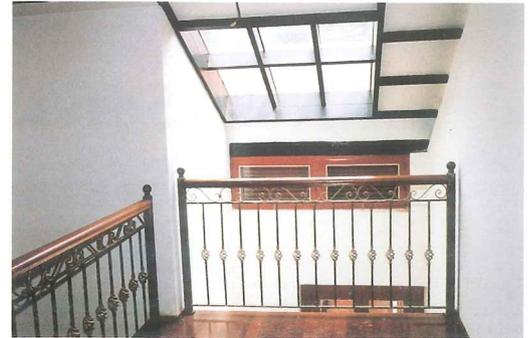
New skylight introduces natural light into the interior

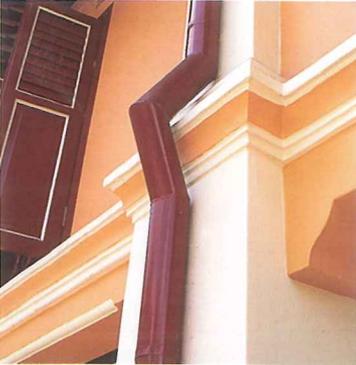
Restored moulded plaster cornice and beam

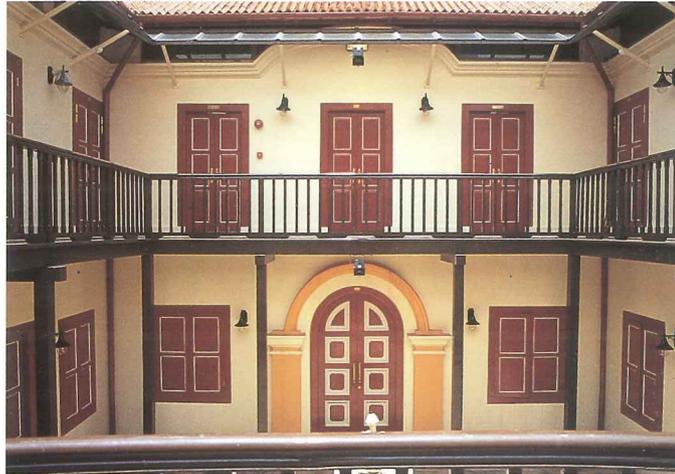
Restored main courtyard facade of the rear building

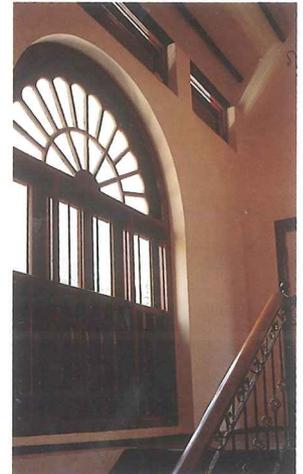
Arched window matching the original in every detail

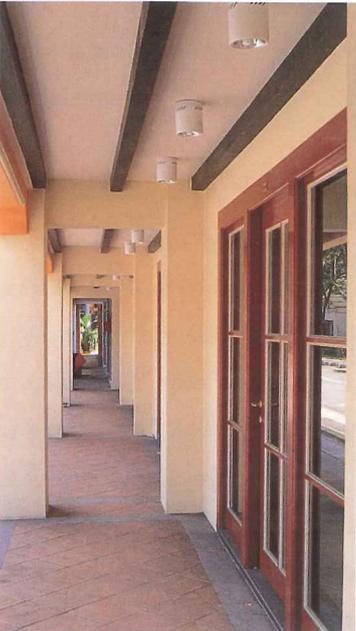
Continuous five-footway restored for uninterrupted thoroughfare

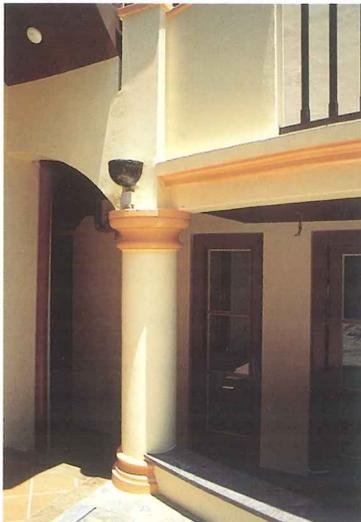
Columns with simple moulded capitals supporting the new curved balcony complement those flanking the main doors

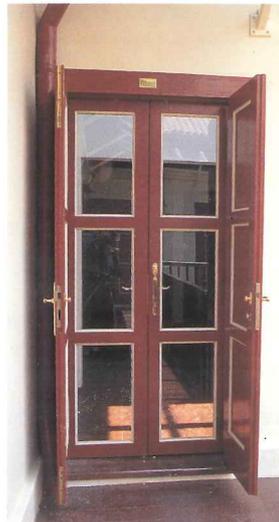
Panelled door with secondary glazed layer
