# 127, 129 & 131 SERANGOON ROAD

## 1997 AWARD

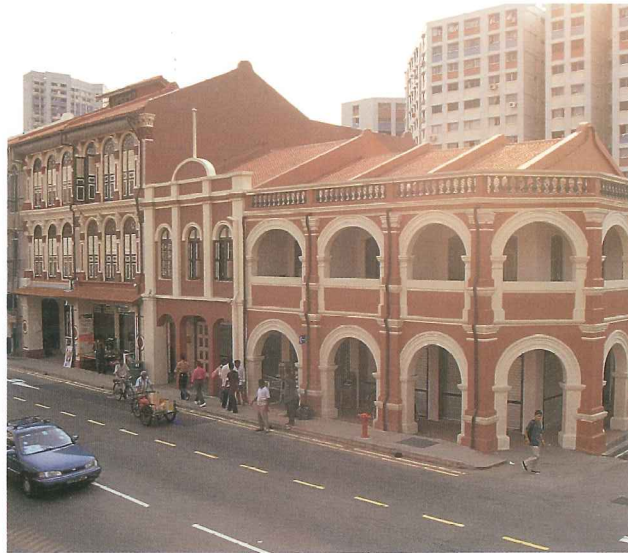
*Facades carefully restored to their original splendour*

During restoration, alternative supports were introduced to the walls to ensure the structural stability of the buildings. No more than two roof members were removed together at any one time. The same careful approach was also taken in the removal and replacement

of the timber floor joists. The arches at the second storey were reinstated with the removal of the brick infill and careful restoration of the mouldings. The roof parapet walls with ceramic bottle balustrades and moulded coping were similarly restored with the replacement of missing parts and the repair of mouldings.

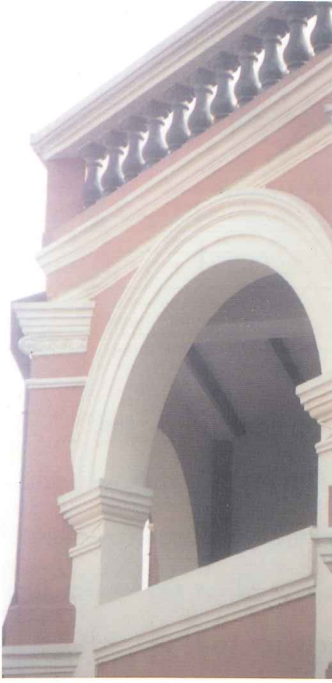
*Carefully restored architectural features on the facade*

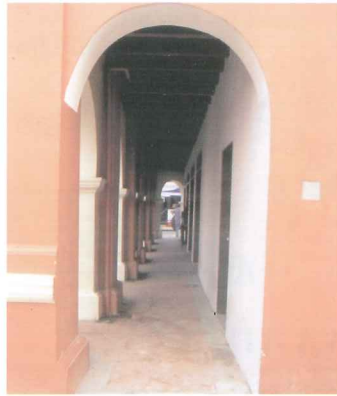
*Colonaded covered five-footway*

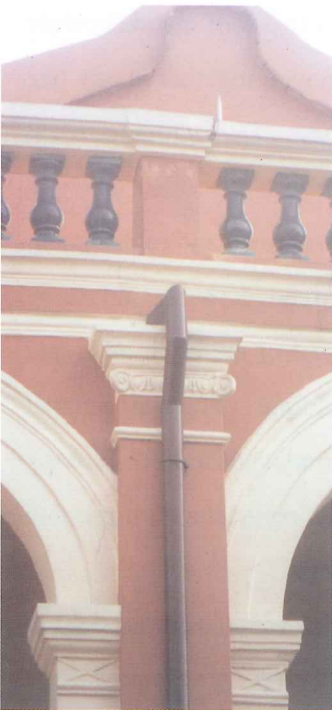
*Ionic column capital between the moulded architraves*
