# 209 SOUTH BRIDGE ROAD

## 1998 AWARD

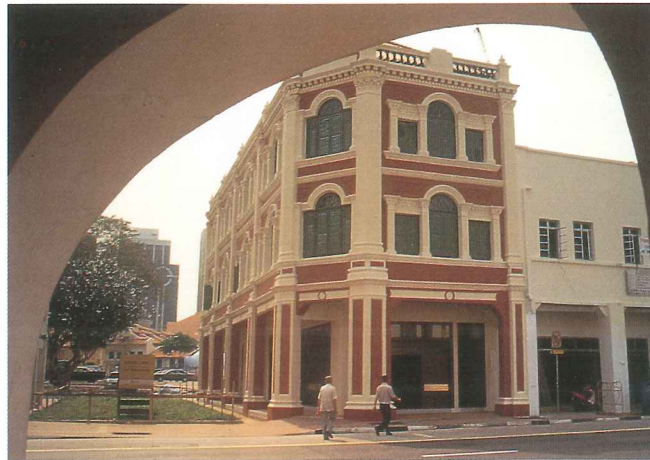
*Restored shophouse in original grandeur*

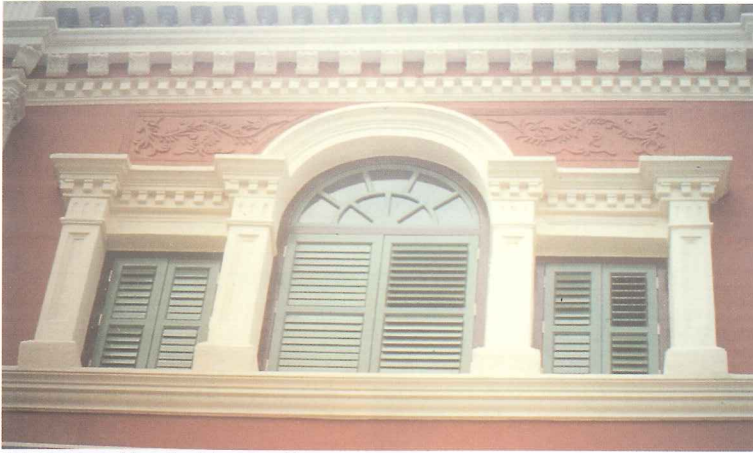
*Restored windows and decorative pilasters and mouldings*

strengthened. Timber windows and doors were retained and restored. All decorative pilasters and external ornamentations were also retained and carefully restored. The five-footway, which was previously enclosed, was reinstated to its original function. A lift and an attic with a jackroof were introduced with all precautions taken to ensure that the essence of the shophouse is not lost.

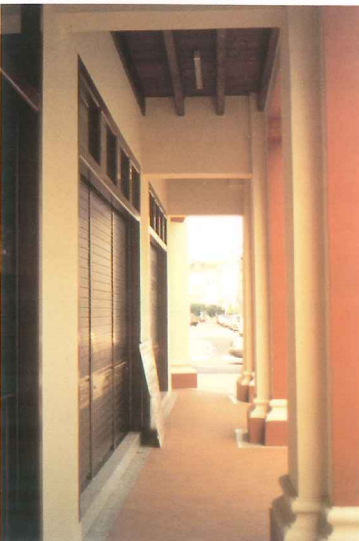
*Five-footway reinstated to original condition and function*

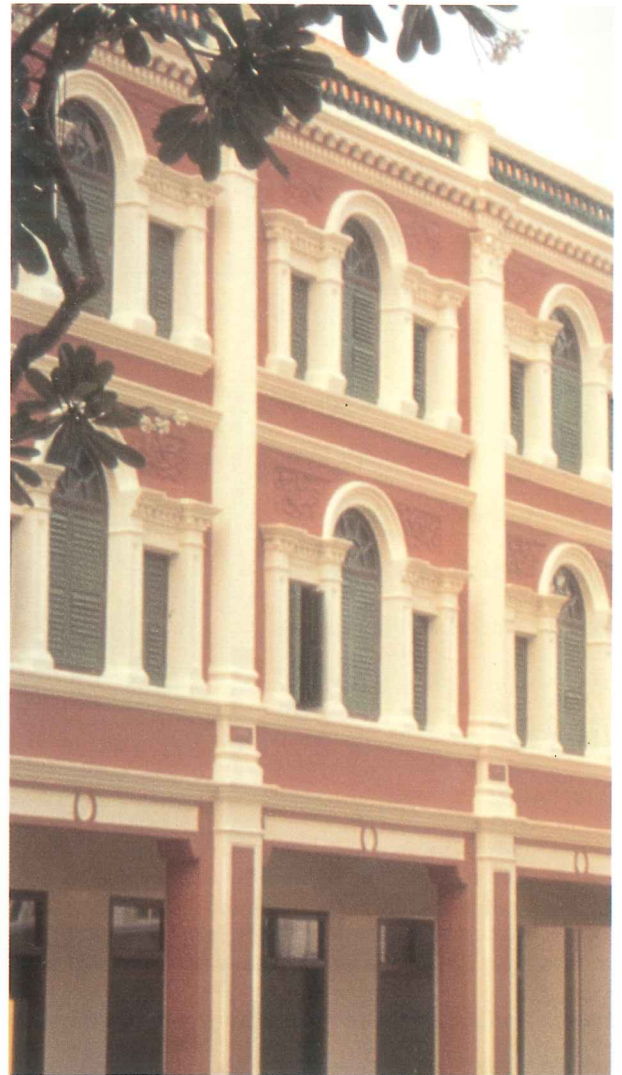
*Decorative pilasters and external ornamentations retained and sensitively restored*
