No. 1 EMPRESS PLACE

A New Lease Of Life

Owner:
National Heritage Board

Architect:
CPG Consultants Pte Ltd

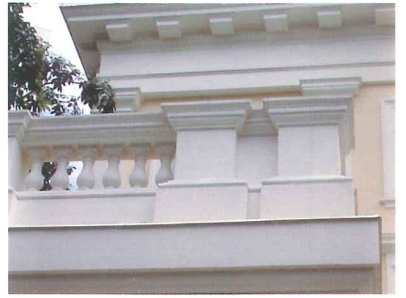
Elegant twin pilasters and dentils

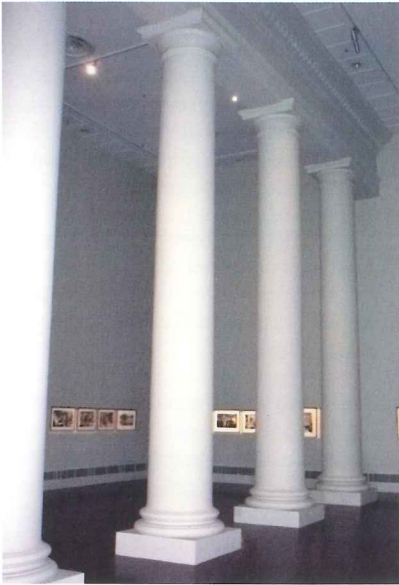
Circular masonry Doric columns

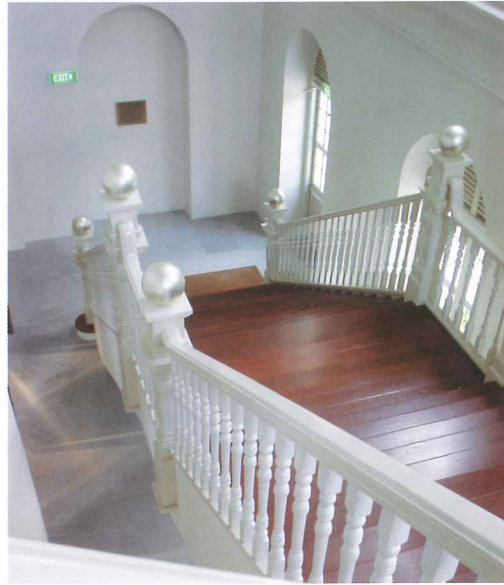
Original timber balustrade at central staircase

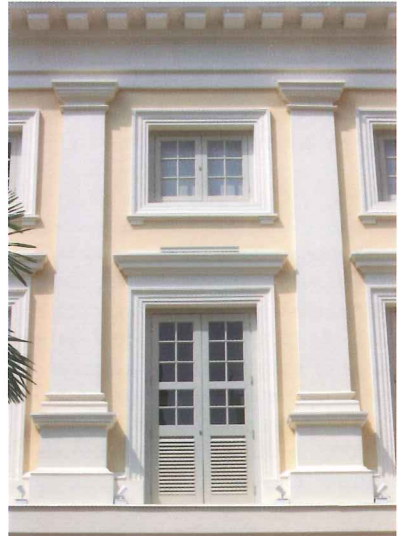
Wide rectangular windows and plastered architrave

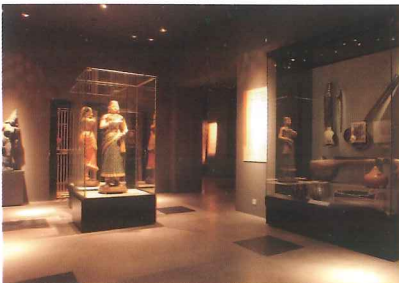
Strong Room at basement adapted to a display area

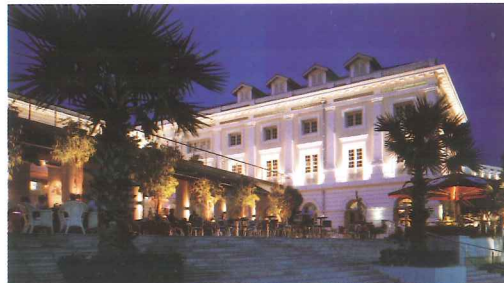
New single-storey terrace extension

In their place, a two-storey extension with a basement was added to one wing of the main building to house a function hall and a cafe. A second extension, near the Victoria Theatre, was added for a covered loading bay and upgraded M&E services. An open courtyard was created with a new basement to house,

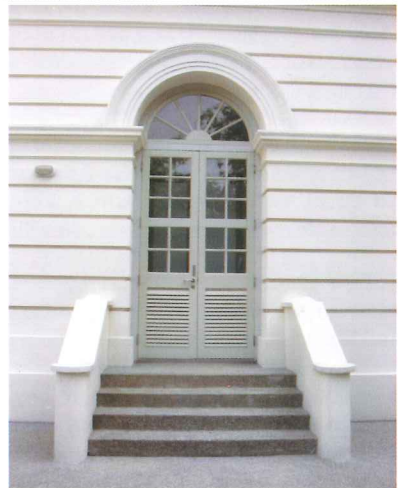
Door with arch-shaped fanlight
