No. 93 STAMFORD ROAD

Renaissance of a Grand Dame

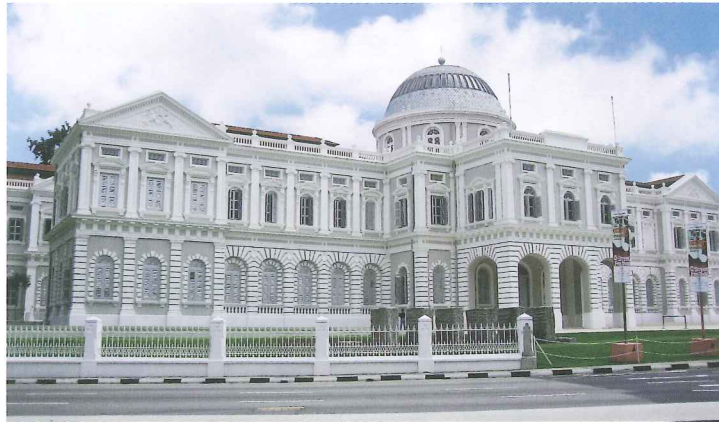
Sensitive makeover of 19th century building within a park setting

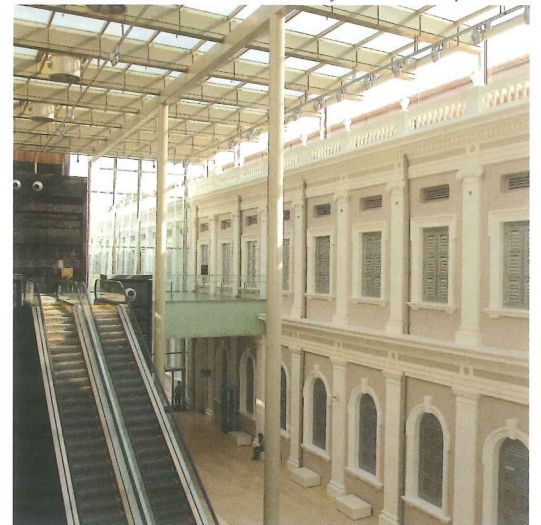
Contrast between modern and heavy masonry construction

This national monument has not only regained the grandeur of her noble past but has been invigorated to meet modern challenges. Its new rear extension, which has been intentionally set back to create an atrium, serves to complement the old dame. This contrast of modern and old heavy masonry construction embodies the spirit of the different eras.
