36 & 38 ARMENIAN STREET

SOHO Charmers

Once dilapidated and overwrought with insensitive additions and alterations, these two clusters of 1930s to 1950s Art Deco four-storey shophouses have been transformed into commercially attractive properties that still support the live-and-work functionalities of their original intent.

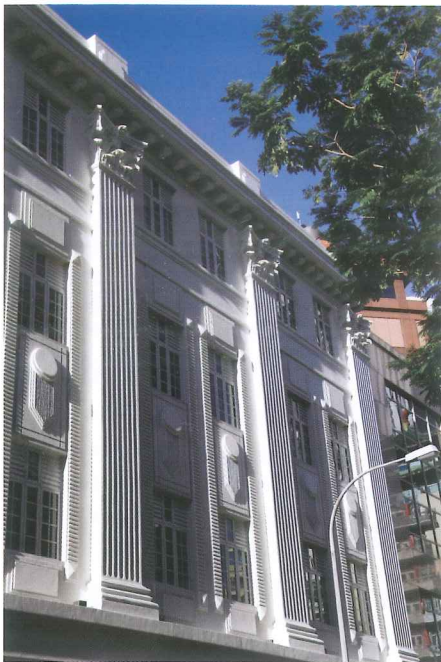
Restored façade of 36 Armenian Street

With a refurbished façade of carefully restored ornamentations, the voluntarily conserved properties now stand with renewed charm and confidence in a neighbourhood replete with heritage icons. Elaborate mouldings, chipped off motifs and ornately carved capitals have been meticulously repaired and brought back to their former glory. Algae infested walls and weathered plastering have been removed and the walls given a new coat of life.

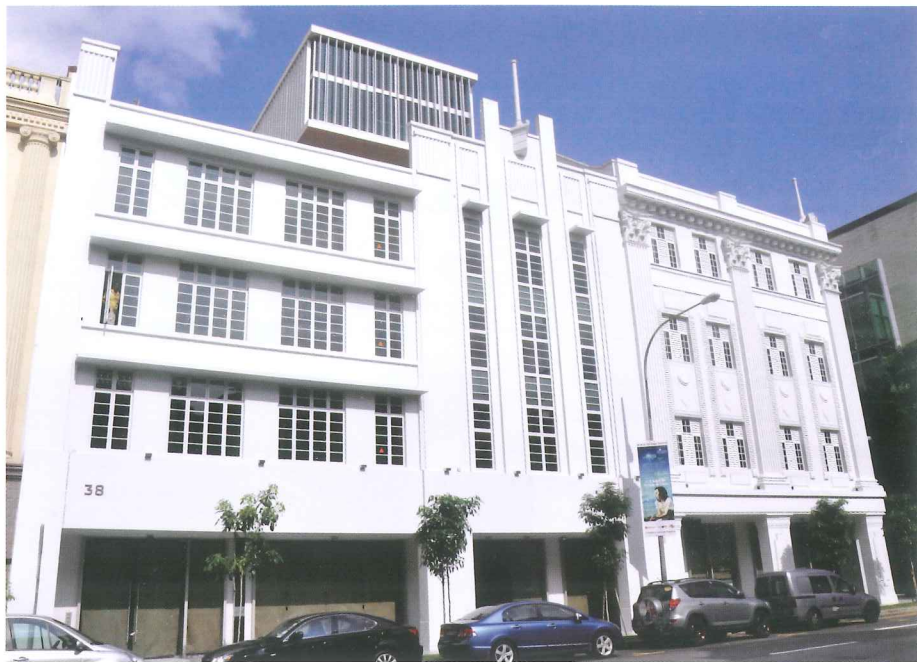
Detailed elevation of 38 Armenian Street

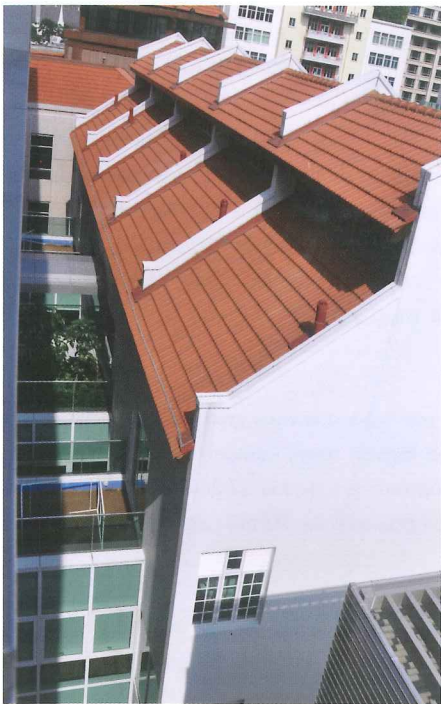
Original pitched roofs with firewall

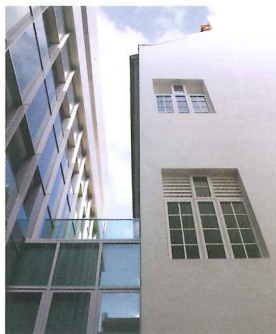
New extension complements the old

A commanding new and rear extension rises gracefully on independent support with its sixth and highest storey cantilevered over one of the conserved buildings. Purposefully designed in subtle and modern style, the new extension does not compete with the old but rather complements and accentuates its presence.

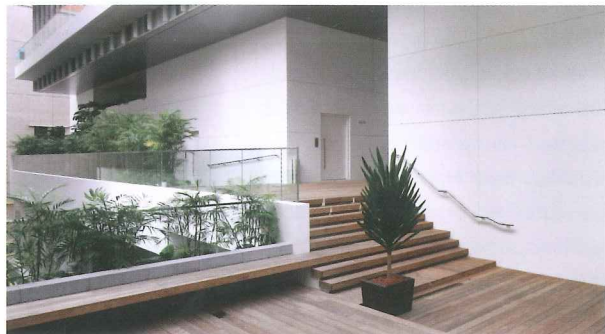
Landscaped deck at second storey

Placed between the conserved property and the extension block, these connective courtyard spaces provide a physical link between the old and new. A landscaped deck built on the second storey is a brilliant reinterpretation of the communal back lanes which are common characteristic of shophouses of old, now made relevant for contemporary usage.

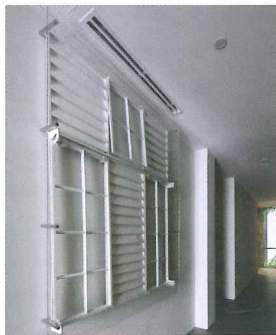
Original mild steel window on display at new lobby

Window panels and original glass which could not be salvaged were painstakingly measured for reference in making exact replicas. The project team managed to rescue and preserve an original mild steel window which is now on display at the new lobby. No. 36 Armenian Street now houses SOHO style offices on the upper floors with shops and eateries on the first and second levels. No. 38 Armenian Street has been converted into chic, interlinked spaces for private art gallery and office use.

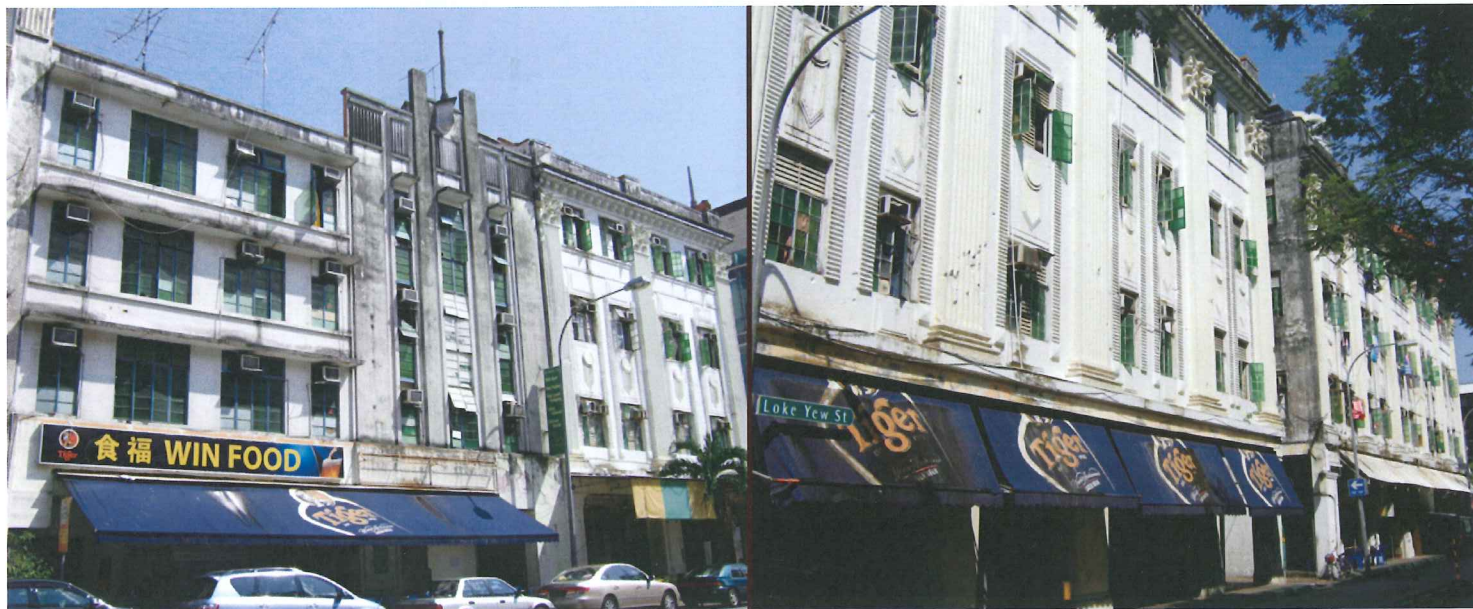
The existing buildings were in a dilapidated state. Large awnings hung outside the five-foot way damage the appearance of the shop house. The façade and the gable end walls were stained black, paint were peeling off the wall surfaces, cracks lines were also visible due to prolonged weathering. Ornaments on the façade were also visibly damaged. Pipes were seen running on the façade, cables and wires hung haphazardly across the backlane that seperated the two clusters, above the five-foot way and out from the windows. Air-conditioner condensing units were hung outside the windows, timber panels were mounted outside the louvers and the glass panels were seen with various shades of green. Tenants of the ground floor units installed zinc roof over the rear court with debris scattered over the top.

Figure 3: Condition of the existing conservation façade

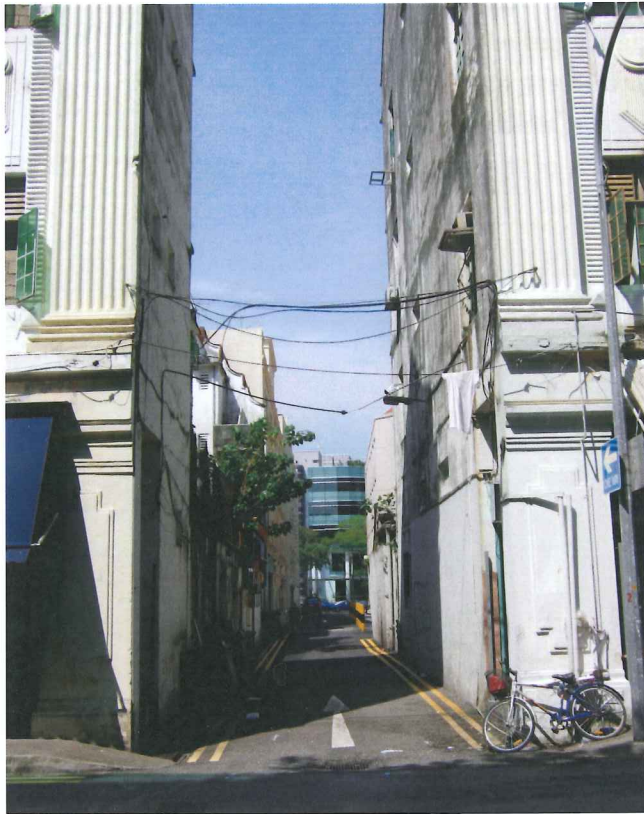
Figure 4: Existing Backlane

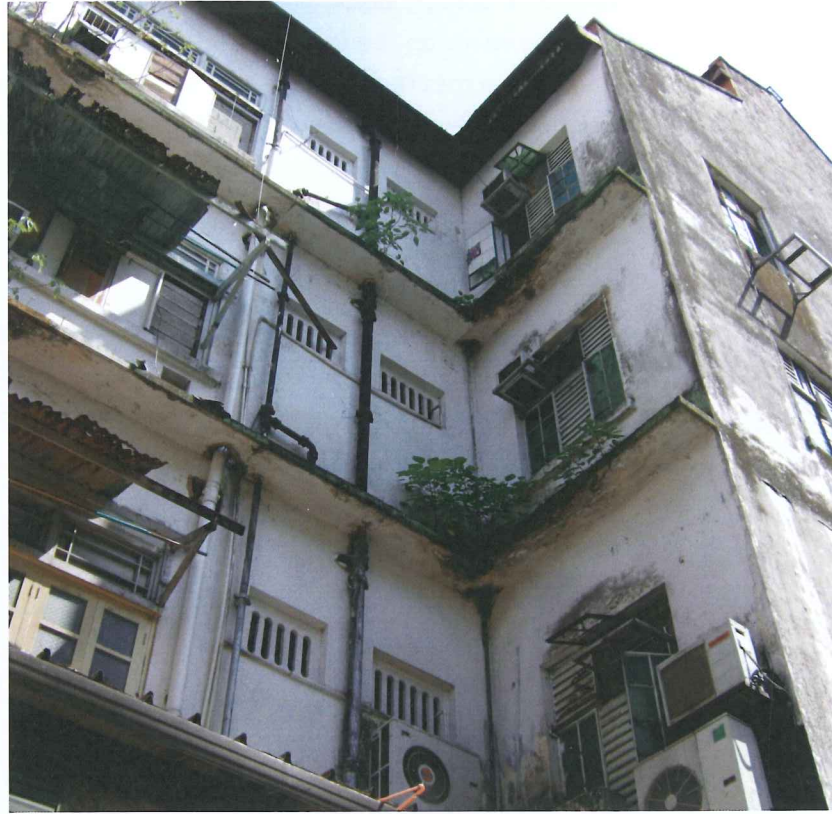
Figure 5: Existing rear of shophouse

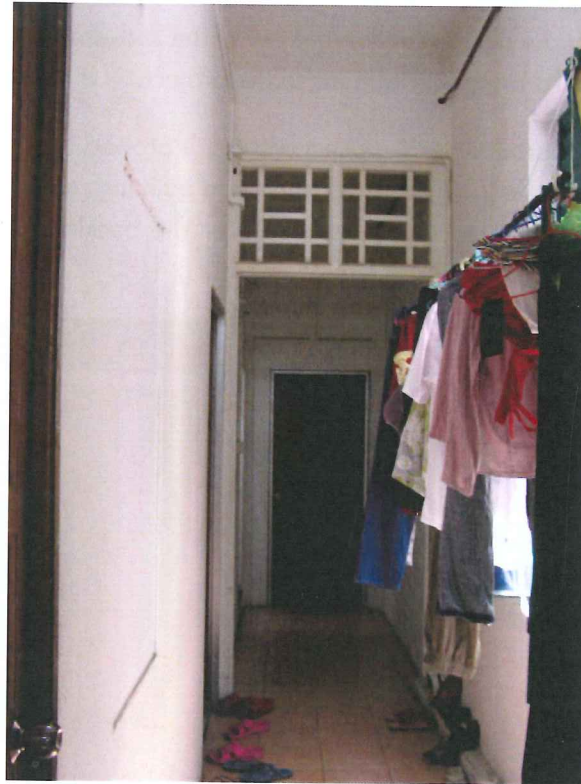
Inside, the premises above were used as lodging for foreign workers. The lack of maintenance, air circulation and poor hygiene cause foul smell to linger inside the buildings. The common areas were dark and stuffy. Partition walls and ceiling boards were in a state of deterioration.

After the removal of ceiling and plaster, detailed visual inspection disclosed minor cracks at the columns. Spalling concrete to the beams and slabs were also observed. Defective columns, corroded reinforcement and spalling concrete had to be repaired to ensure long term durability and stability. Apart from these, the building structures were generally in good condition. (Refer to Appendix 1 – Existing Building Survey Drawings)

Figure 6: Internal corridor
