CONSERVATION TECHNICAL HANDBOOK

Volume 8 | Managing Change

URBAN REDEVELOPMENT AUTHORITY

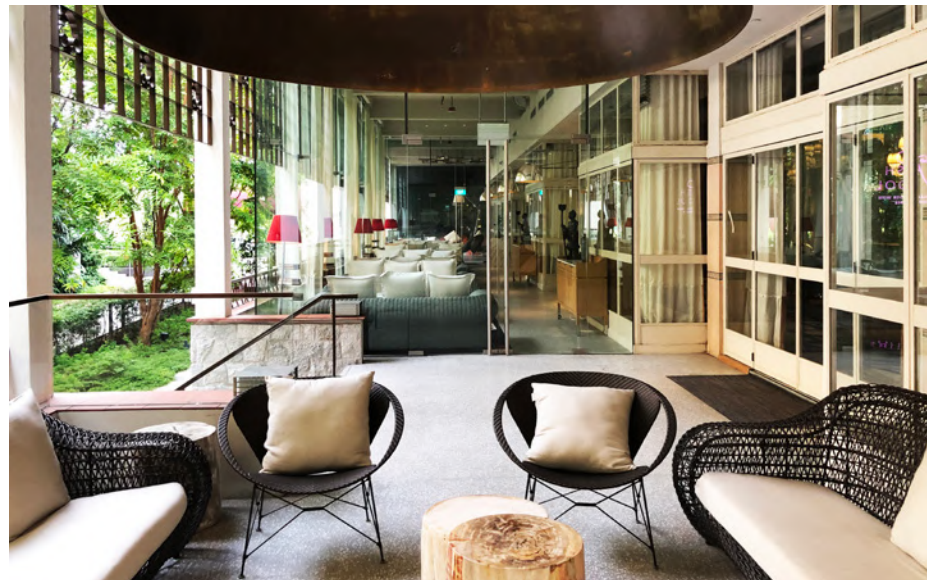
Restored verandah with design modifications and additions to railings to meet building codes for safety.

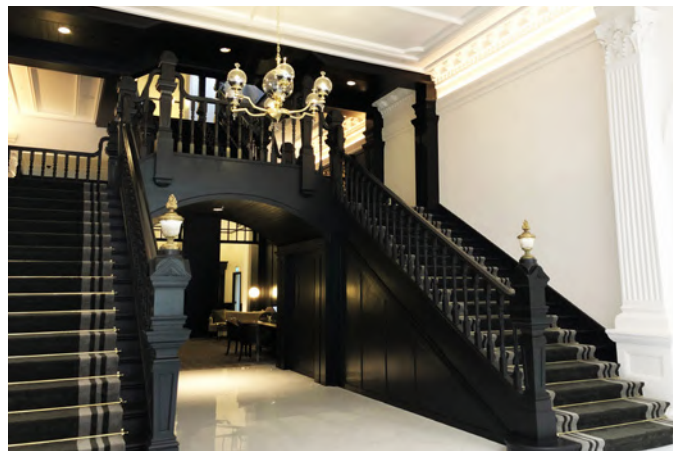
The grand staircase in the Raffles Hotel main lobby, a key heritage feature, remains in its historic configuration thanks to new fire escape staircases located elsewhere.

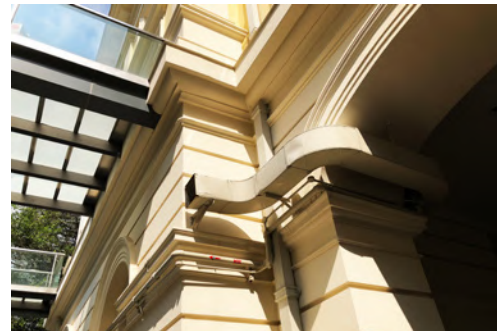
Below right: Adverse visual impact of surface-mounted M&E services on historic facade.

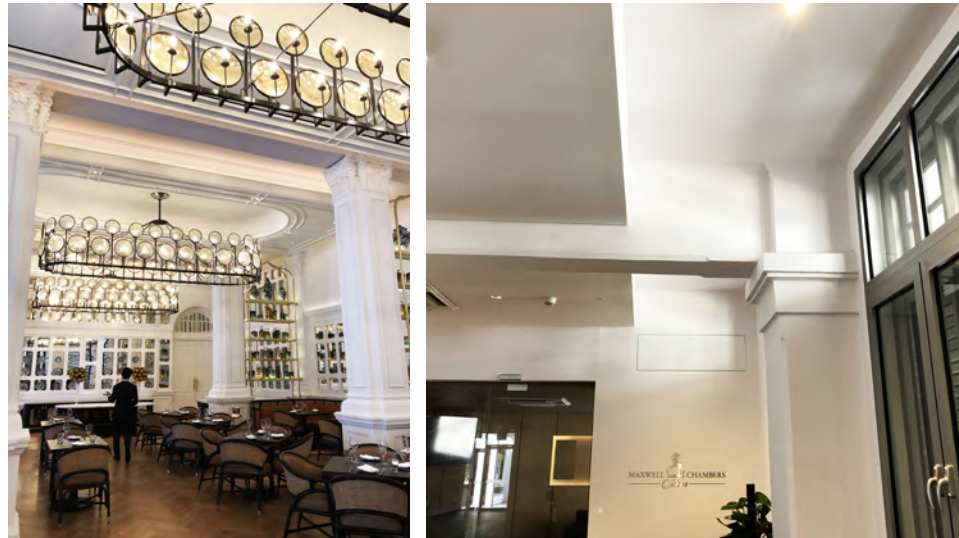
Where low dropped ceilings are unavoidable, careful routing of the M&E services concealed within the plenum and sufficient setback of the ceilings from key architectural elements such as column capitals and fenestration, allow these to be clearly expressed while mitigating the impact of the new intervention.

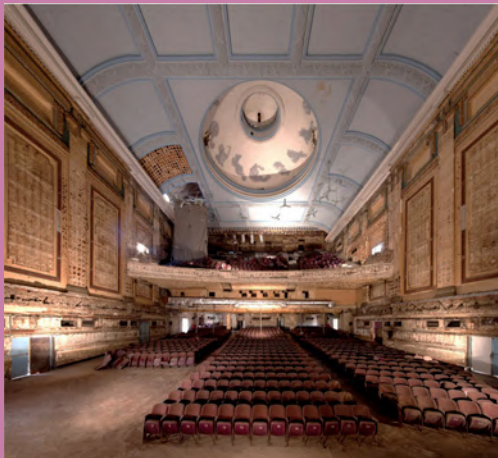
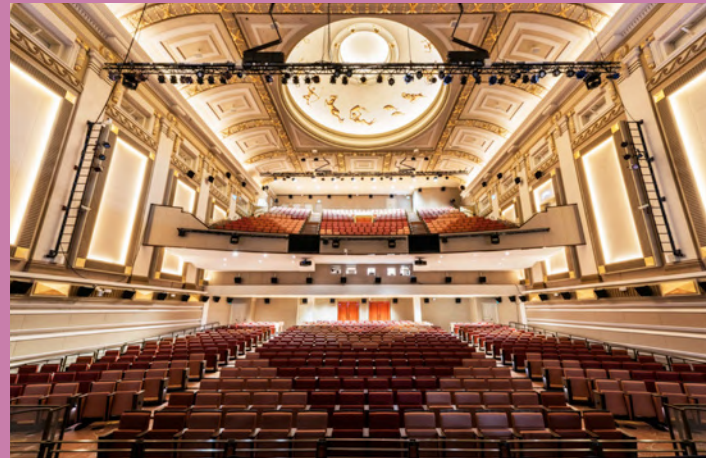
Before (left) and after (right) careful restoration of the richly ornamented interiors of Capitol Theatre.

Left and right: Missing architectural features such as the ceiling coffers were reinstated using acoustic panelling whose design matched the historic details.

Sometimes, as in the case of the Capitol Theatre, lost or missing ceiling ornamentation provided an opportunity to replicate these features in new, acoustically superior materials in order to offset the need to clad over other surfaces that are relatively intact.

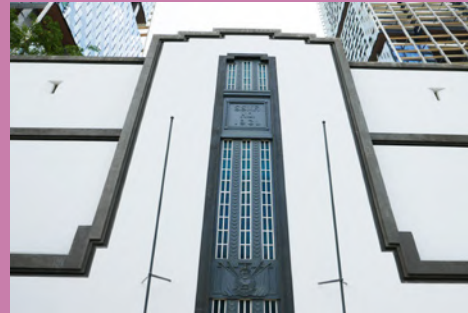
Top: The historic coloured glass in the lofty cast iron feature window of the former Straits Settlement Volunteer Corps Drill Hall has been retained, as the glazing type is not under the Safety Code's high-risk categories.

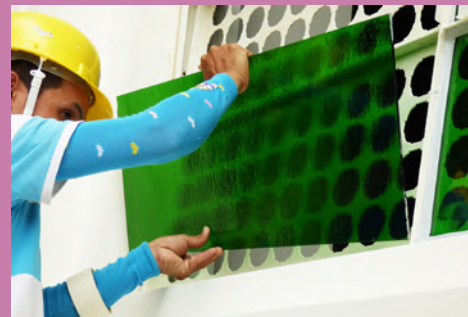
Above: Historic green tinted glazing being reinstalled after the mild steel window frames are restored.

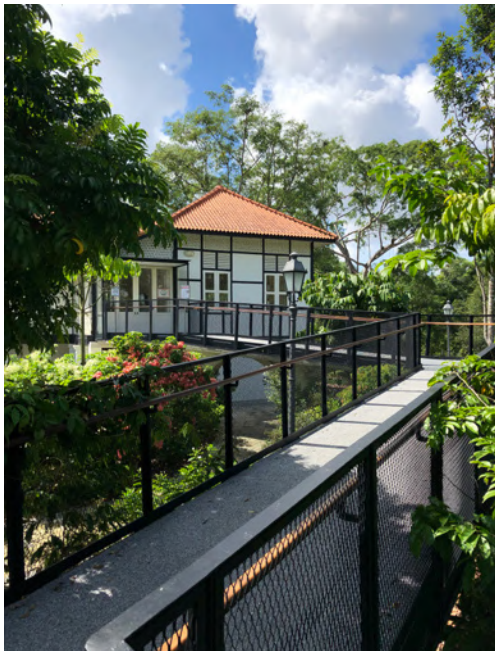
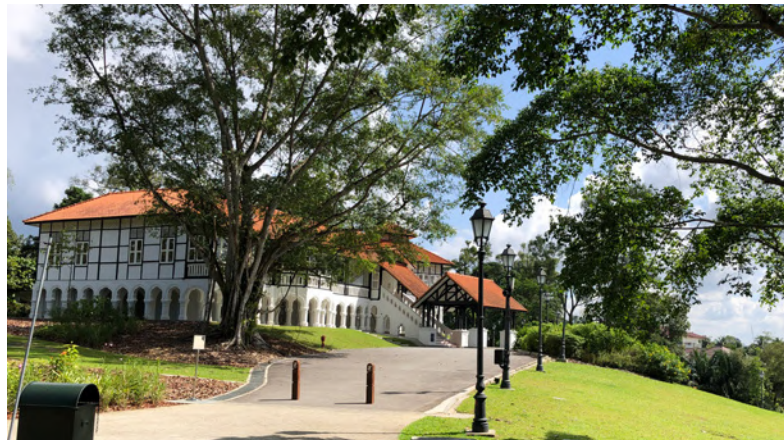
During the refurbishment of Atbara, a 19th century house, as a gallery, a new access ramp to the interiors, raised one storey above ground level, was added. The sizeable new element was discreetly located at the rear, and well-integrated with the lush landscape design (left). The ramp is thus not visible from the main approach (right), providing universal access without detracting from the heritage presentation of the historic house.

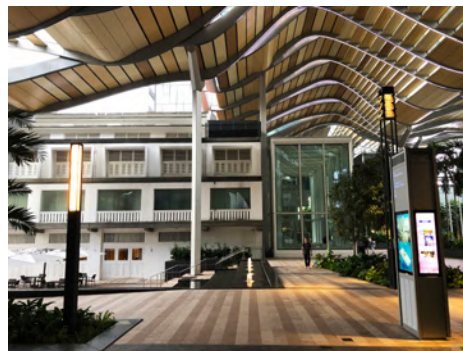
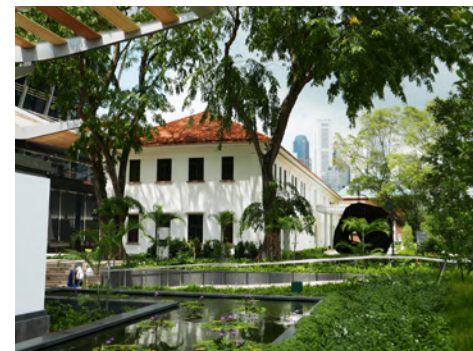
Different platform levels between new built and historic parts of South Beach development are navigated via a system of stairs and ramps integrated into the urban landscape design.

Ramps mitigating undulating terrain or varying platform levels could also be sensitively integrated with the site's landscape and public circulation design, keeping to or even enhancing the historic character and heritage presentation of the place while ensuring inclusivity.

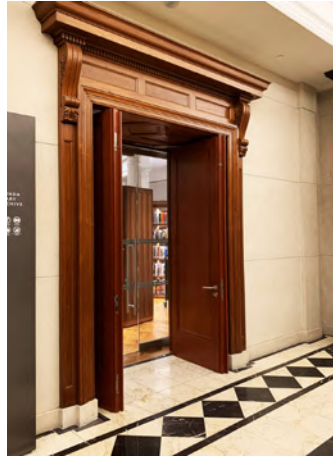
Fire-rated metal doors with timber panelling and trim detailing to ensure that the historic design of the original doorway is maintained.

Historic doors of significance should be retained with minimal modifications as far as possible. For timber panelled doors, the fire resistance rating could be upgraded using flame-retardant treatment without altering their external appearance. In cases where there are no alternative strategies to meet fire protection requirements, and existing timber panelled doors have to be replaced, new fire-rated metal composite doors with timber cladding customised to the historic design could be considered.

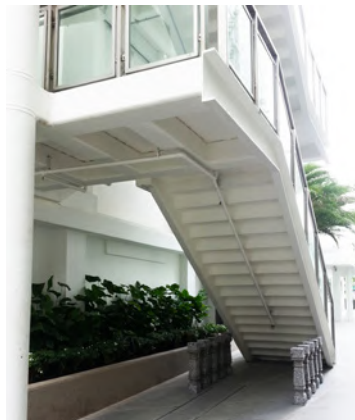
Steel escape staircase finished in intumescent paint, with fire sprinkler running below the treads.

Treatments of **exposed steel structural members** are mainly through the use of intumescent paint so that these can be left exposed instead of being clad over.

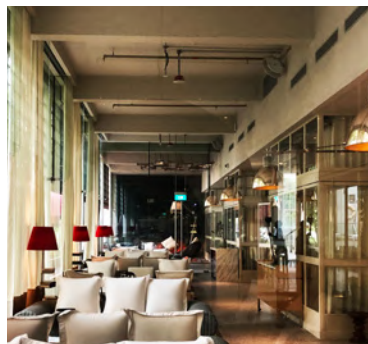
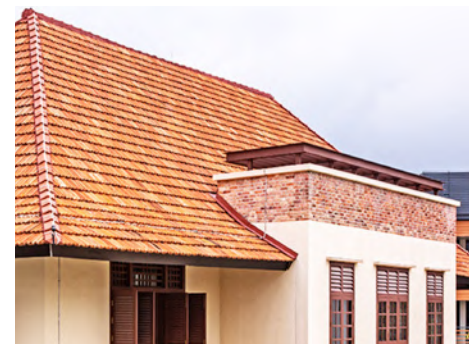
Left: The lofty ground floor verandahs of Raffles Hotel has been maintained for more than a century as a historic tropical design feature. **Middle:** Careful integration of M&E services to minimise ceiling-mounted fixtures helps to retain the heritage character of the high-ceilinged verandah - such as the use of side-throw cool air supply and task lighting. **Right:** M&E equipment is consolidated at the rear roof deck and screened by a low-key pergola. Lightning tape is laid on the pitched roof with sightline considerations to avoid becoming a detractive element.

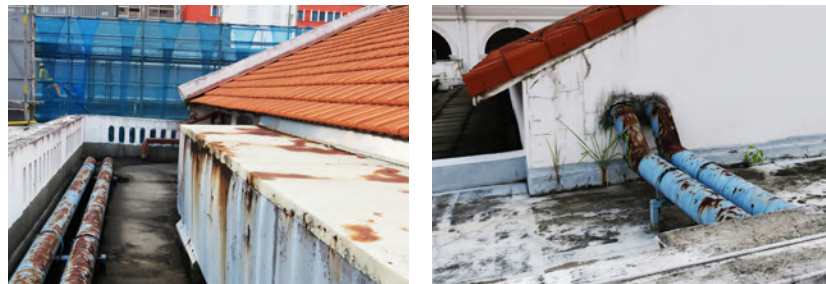
Corrosion of mechanical systems located outdoors.

Access to equipment, ducting and conduits is essential to minimise damage to fabric for maintenance and future addition. It is very important that **adequate protection** and **regular maintenance** be provided. Mechanical equipment and plant are sometimes placed externally due to the lack of a properly designed space, and often left exposed to the harsh tropical environment. These may include water/ sprinkler tanks, genset, pumps and VRV equipment. Inadequate protection results in corrosion, condensation and water seepage.

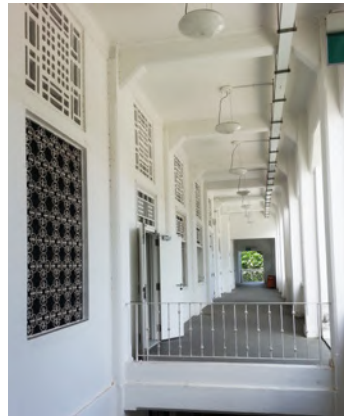
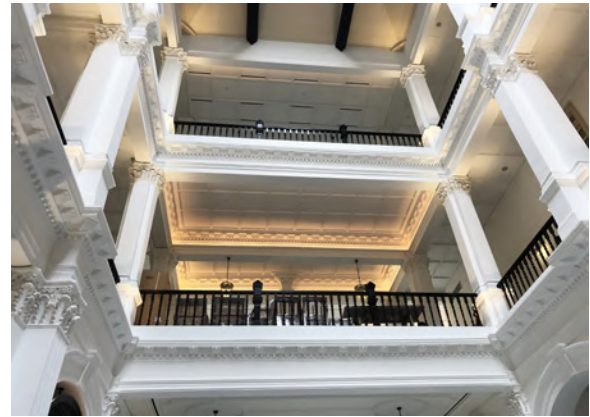
Left: Naturally ventilated open verandah is retained, with original high ceiling, lofty door openings and structural elements fully expressed, minimally enhanced with pendant lights serviced by exposed cable tray running below the beams.

Right: Careful M&E service integration within the interior spaces ensures that the original architectural features and spatial proportions are preserved while providing modern amenities and comforts.

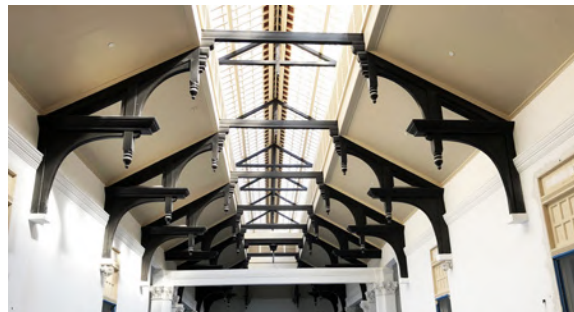
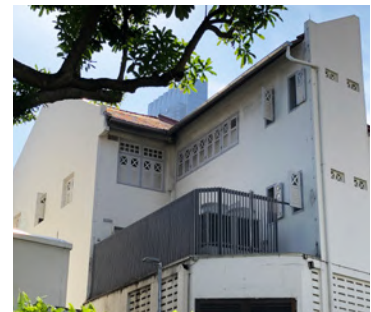
Left: Natural daylight is introduced into the Raffles Hotel atrium by replacing the jackroof tiles with glazed ones. Air-conditioning supply is introduced along the two sides of the clerestory so as not to visually clutter up the ornate timber trusses. **Right:** ACMV equipment is neatly arranged on a new deck, discreetly screened off.

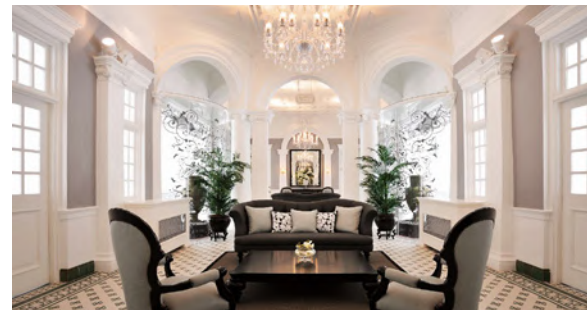
Left: M&E services are designed and laid out in two layers, such that they are able to compactly fit within the ceiling space without obstructing the historic top vents. **Right:** FCUs are concealed in low cabinets, allowing the high ceilings to be retained.

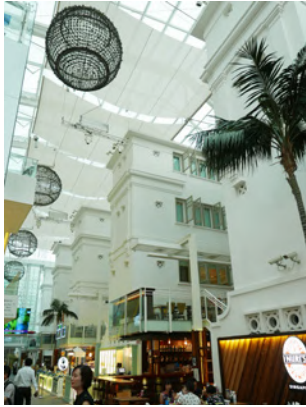
Daylight and solar heat in the air-conditioned back lanes of the Capitol development are attenuated through low-emissivity glass and fabric shades below. At the street level, air-conditioning supply air is integrated with the historic ventilation blocks along the retained rear boundary walls of the 'finger' rear blocks.

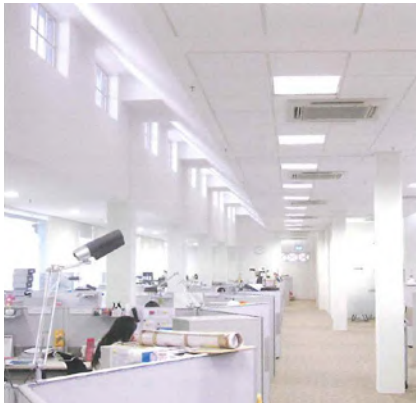
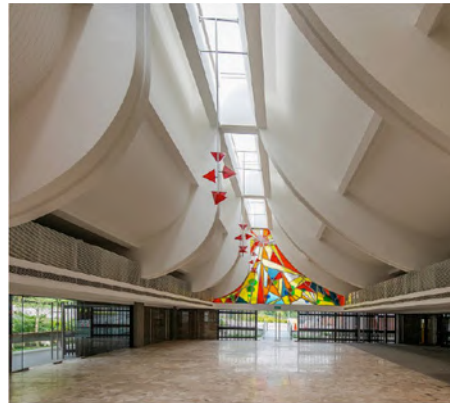
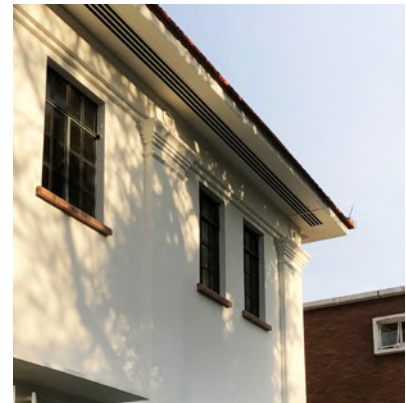
Left: The original high-ceilinged classroom of the former Victoria School features clerestory lights, which have been revealed by introducing an inclined ceiling that slopes away from the wall surface. This creates an interesting light scoop effect and lets ample daylight into the deep plan office. **Middle:** To preserve the spatial character and unique ceiling and skylight design, M&E services are discreetly placed along the edges of the enclosure walls. **Right:** Air intake and exhaust vents are integrated into the roof eave soffits of the conserved building, reminiscent of the original roof vent design.

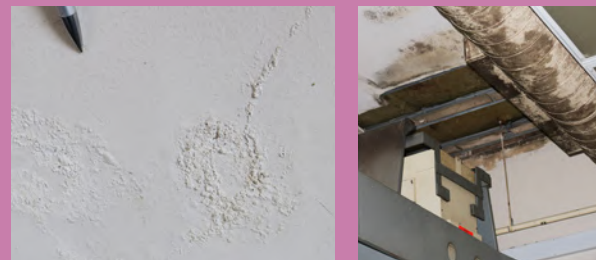
Moisture presence resulting in salt attack (left), mould growth (right) and poor indoor air quality.

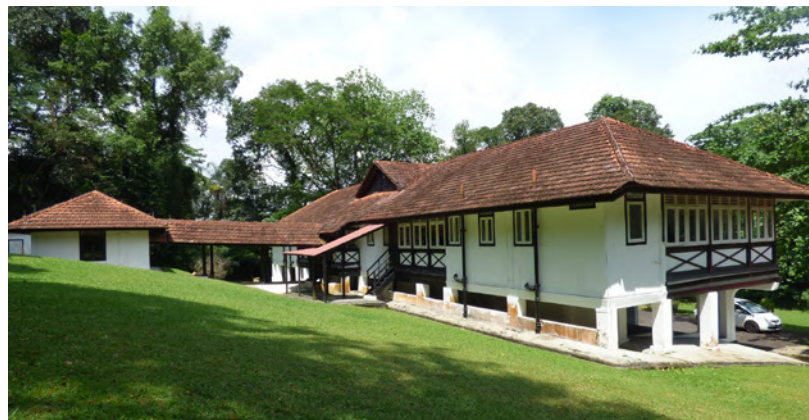
Solid walls and exposed sanitary pipes at the rear of this colonial government staff quarters indicate the location of bathrooms. Most of these historic houses were constructed with timber joist-and-board flooring. The exceptions were wet areas such as bathrooms and kitchens where ferro-concrete slabs were used instead, for their better resistance to water damage.

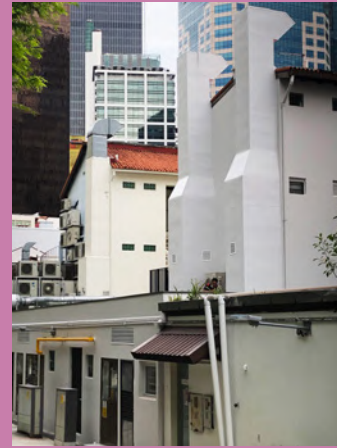
Neatly integrated kitchen exhaust flues on the rear service blocks of shophouses.

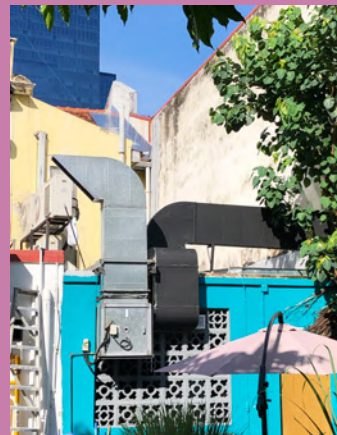
Uncoordinated kitchen exhaust flues penetrating rear facade elements and causing visual clutter.

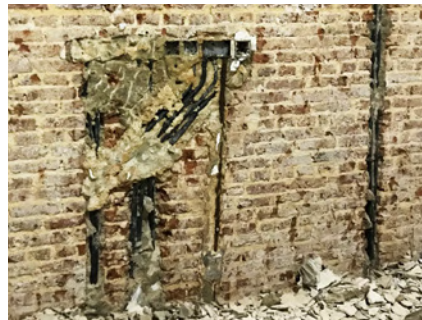
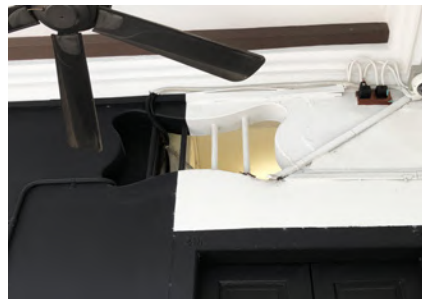
Top: Chasing in M&E conduits and pipework causes irreversible damage to historic structure and fabric.

Bottom: Insensitive installation of electrical wiring and conduits often result in adverse impact to heritage features. In this case the CCTV conduit is inappropriately routed through the historic decorative top vent.

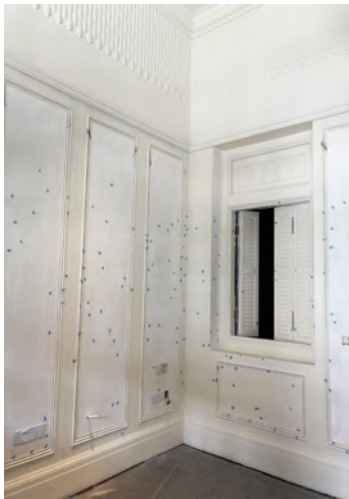
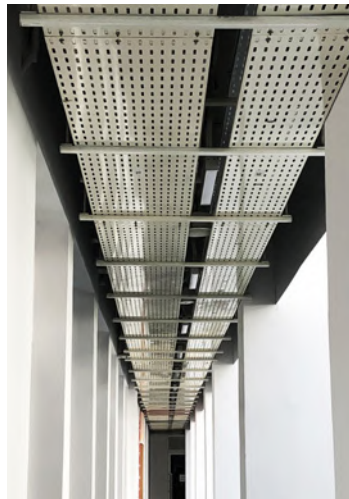
Left: New wall dadoes are introduced as an integral part of a major interior design refurbishment of a historic monument to conceal electrical and other M&E conduits, so as to avoid chasing these into the load-bearing masonry walls. **Middle:** M&E services are tightly coordinated to allow these to be efficiently packed within a narrow ceiling space. **Right:** New recessed downlights are carefully integrated within the historic teak ceiling panels at the former Supreme Court (now National Gallery of Singapore), within the smaller square panels. The octagonal feature panels were left intact and restored. New M&E services are designed to run above the panels, with dedicated access panels for servicing.

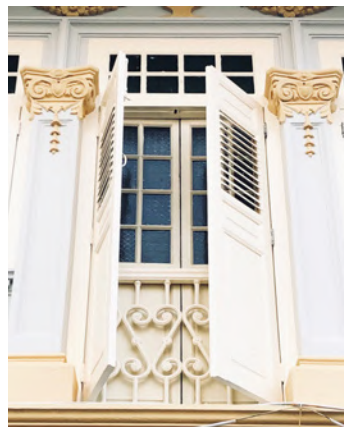
Historic French window with louvred shutters and secondary glazed lattice casement windows on the inside behind decorative railings. Interventions on historic fenestrations such as these should be minimised to avoid irreversible loss of heritage character. Modifications, if needed, should be additive, reversible and localised.

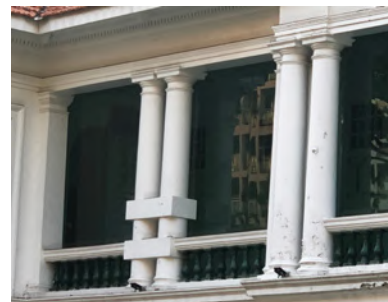
New glazing enclosure in heavily tinted solar glass resulted in the loss of legibility of the historic verandah, and adversely altering the heritage presentation of the main facade.

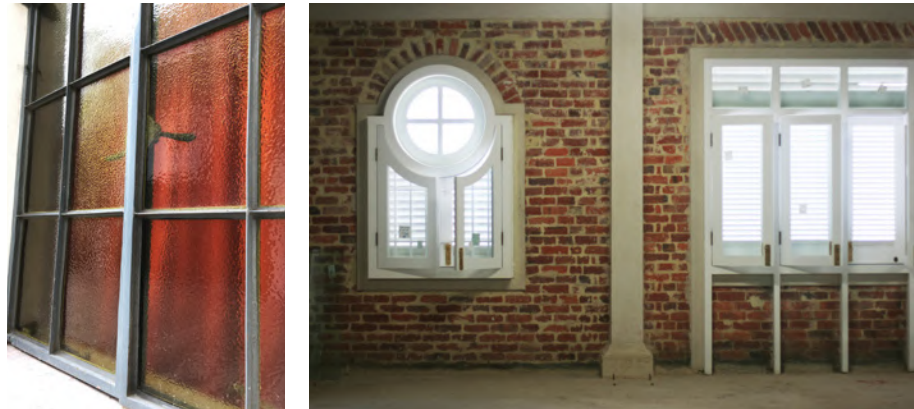
Right: Restored mild steel window with historic tinted glazing retained.

Far right: Customised timber-framed secondary windows that are compatible with the historic windows, with added acoustic seals for additional sound insulation.

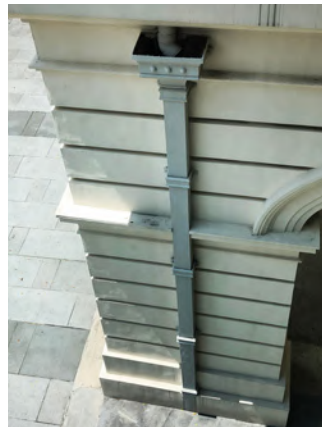
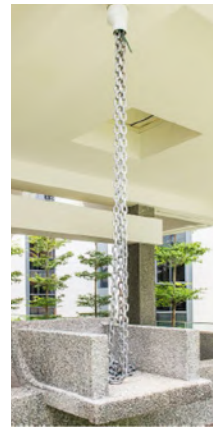
Left: Restored rainwater chain and receptacle at the former Trinity Theological College Chapel, a character-defining element.

Far left: Historic cast iron rainwater downpipe that is retained and continues to serve its original function.

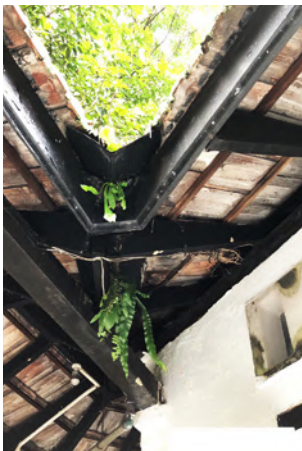
Plant growth on roofs and rainwater goods is an indication of compromised drainage, usually resulting from trapped environmental dirt/contaminants and water stagnation. This can be avoided through regular, appropriate maintenance.

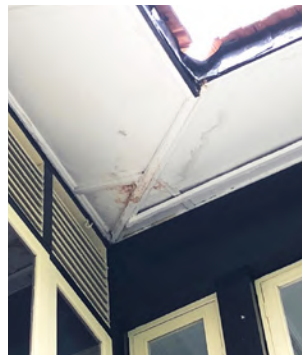
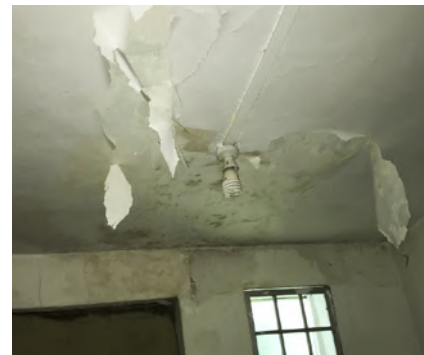
Prolonged poor drainage may lead to water leakage from the roof causing brownish water stain marks and deterioration of the eave soffit, ceiling board and paint.

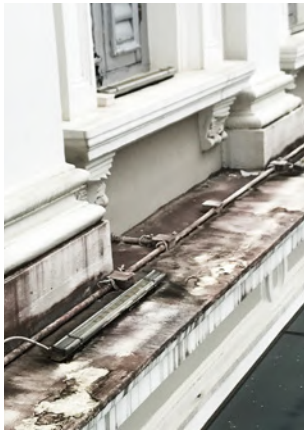
Eroded projecting ledge resulting in water ponding and staining of the facade. If left untreated, there will be increased risk of rainwater seepage into the interior.

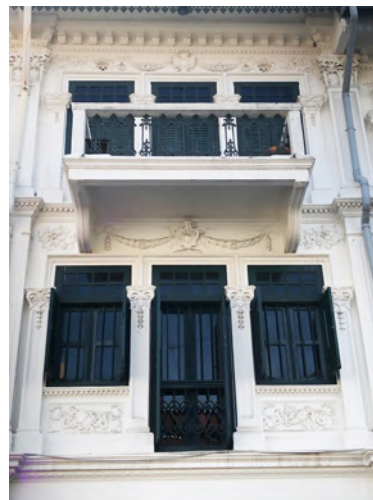
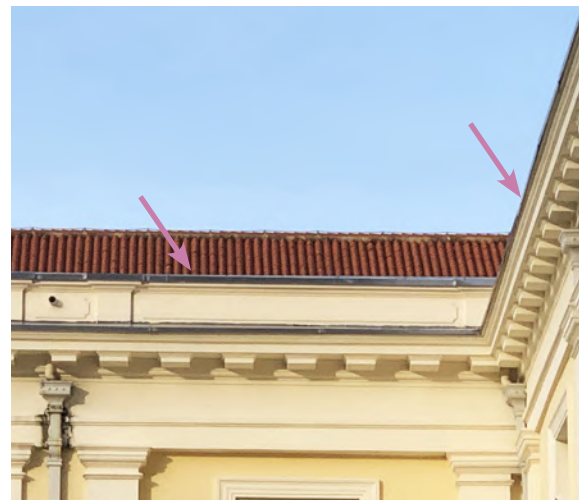
Left: Historic architectural elements such as projecting ledges, cornices, string courses and windowsills are part of a sophisticated facade water shedding system, facilitating rapid rainwater runoff as well as helping to prevent dirt staining due to ponding water.

Right: Stainless steel flashing installed as enhancement detail on the projecting cornices and copings of a historic facade.

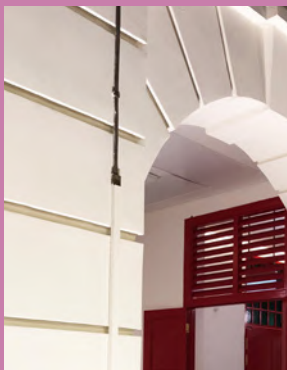
Lightning tape running across facade rustication disrupts its legibility – more inconspicuous locations, such as at the side walls, should be explored.

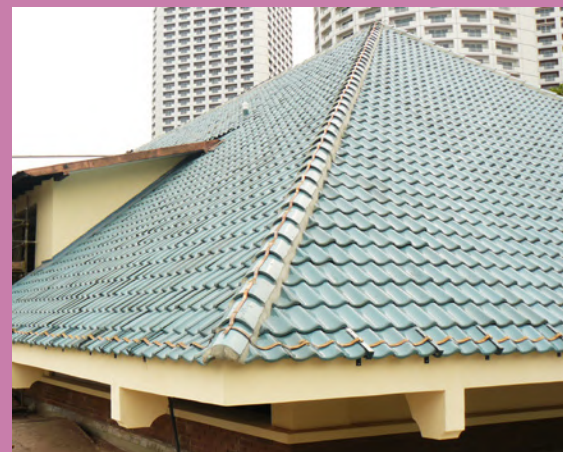
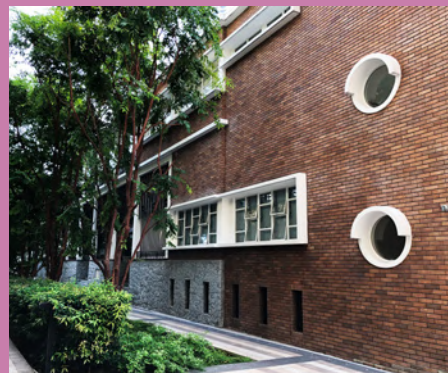
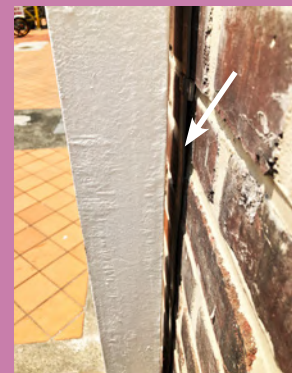
Right top: Copper lightning tape is used to better complement the copper shed dormer roof, and the aquamarine blue glaze and profile of the pantile roof tiles.

Right: Down lightning tape should be avoided on high key facade finishes such as fairfaced brick tile and granite. These may be concealed within interior structural elements and clad over.

Far right: Surface-mounted lightning tape on fairfaced brick facade, concealed behind retained rainwater downpipe.

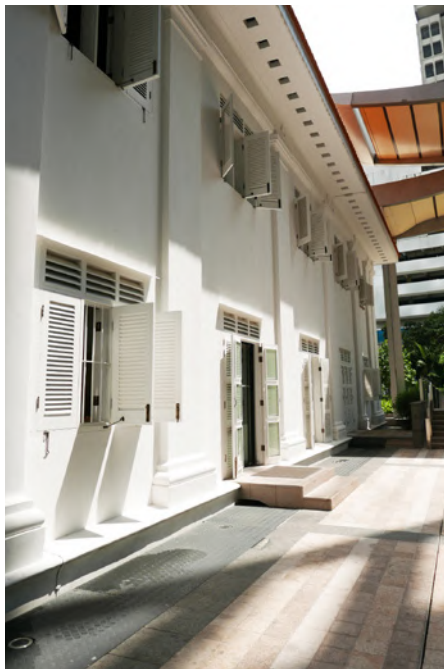
Above: Due to higher incidents of torrential rainfall trend, there is a need to provide wider and deeper perimeter drains, that should form part of the development's hardscape design.

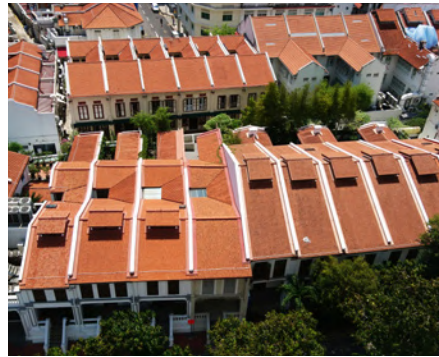
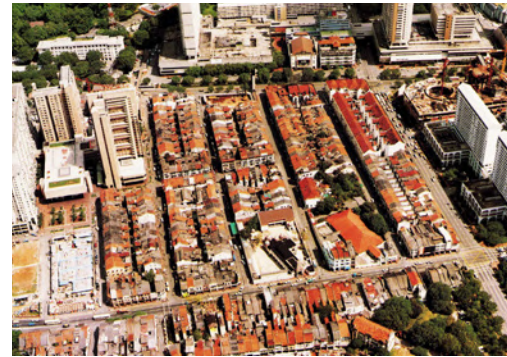
Right: Shophouse roofscape showing party walls demarcating long, narrow plans, punctuated by air/light wells.

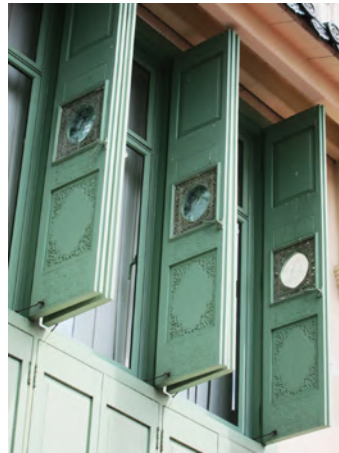
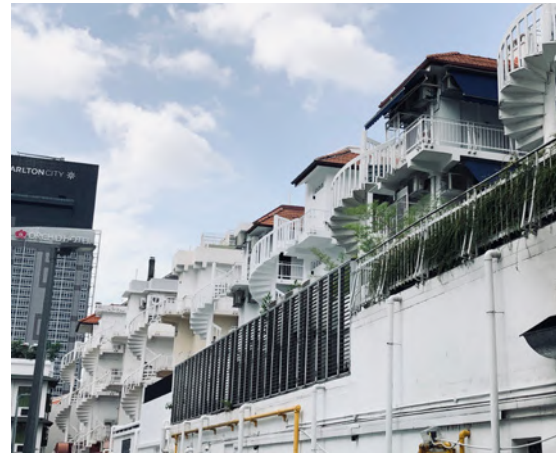
Right: Restored carved timber windows with new aluminium secondary windows behind.

Far right: Historic spiral fire escape staircases should be retained and restored as significant character-defining elements of shophouses and heritage streetscape. M&E equipment located on new flat roof at the back, can be neatly concealed with screen.

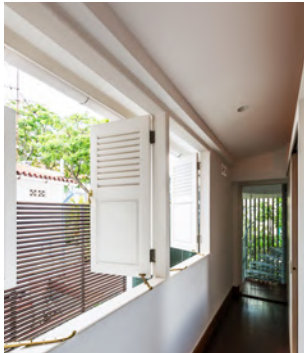
Services could be integrated during the reconstruction (**above**) of the service wing, and concealed above false ceilings (**top**).

A connecting wing that serves both the main house and the new extension, the **reconstructed service block** houses the **kitchen** on the first storey and **master bathroom** above. Although the original masonry structure was rebuilt in RC to enable a larger ground floor opening, this allowed for consolidation and discreet integration of new services. The relocated distribution board, main air-con ducting, sewer and drainage piping could be laid and concealed during its reconstruction. In mitigation, the old timber windows and roof tiles were salvaged and reinstated on the rebuilt service wing.

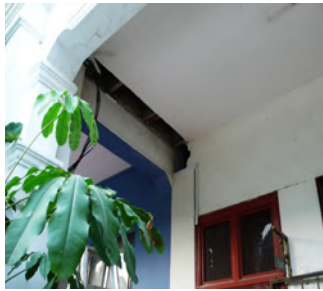
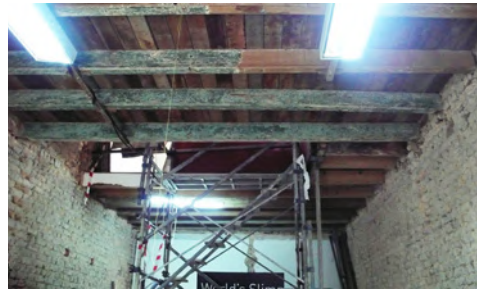
Above left: Originally exposed timber floor concealed at the five-foot way.
Above right: Restoring timber joists found intact above false ceilings.

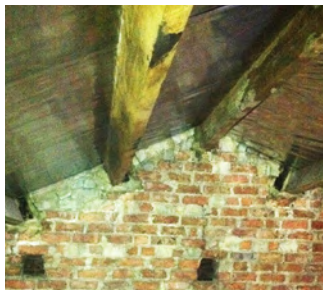
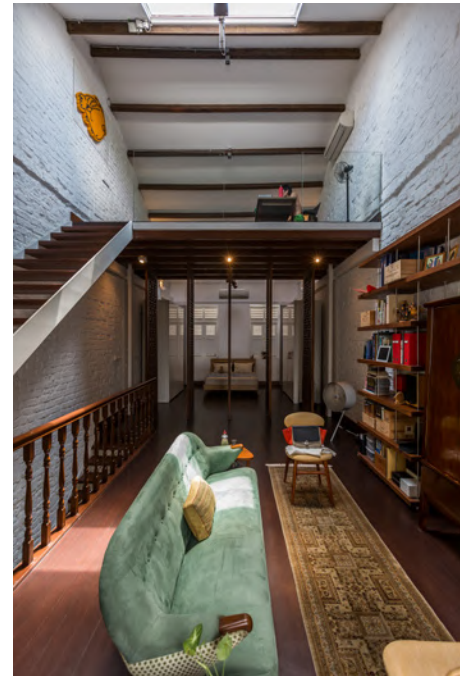
New attic structure

Left: Historic timber roof purlins being restored in situ as interior features. **Middle:** A new lightweight steel frame of beams, joists and slender columns extending to the first storey being installed for the new attic. **Right:** Completed new attic deck and restored historic timber purlins, exposed by installing roof insulation and ceiling board between members.

Services are discreetly routed along the new steel beams on the second storey, as well as concealed within slim box beams tucked under the timber floor joists and hugging the party wall at the first storey. Instead of concealing the entire extent of the roof underside, a false ceiling is added between roof purlins, which, like the floor joists, are revealed as an interior heritage feature.

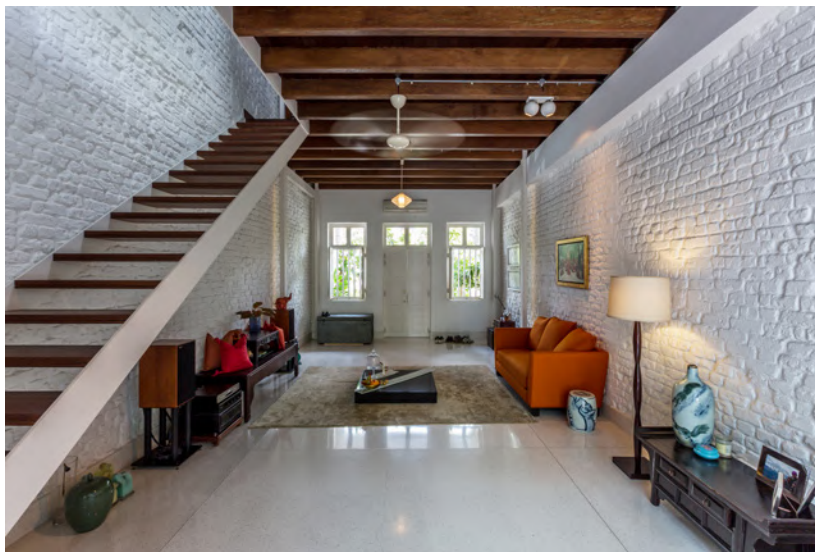
Left: View of living area showing restored historic joists as interior features, and the discreet new steel columns. Services are routed via discreet box beams to minimise visual clutter.

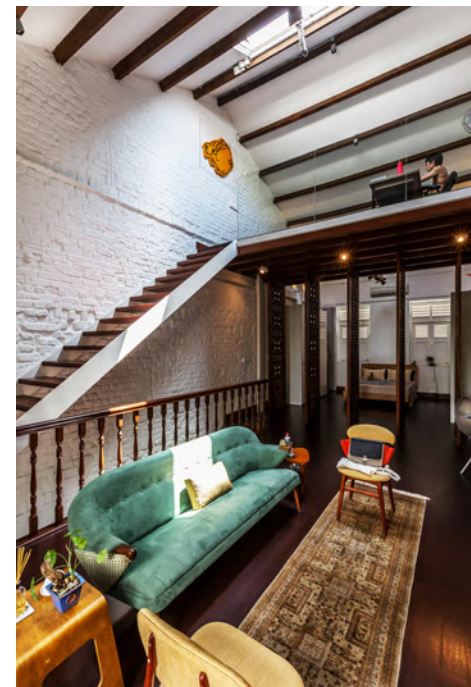
Right: View of second storey lounge area and master bedroom lit by natural daylight from the new skylight. The interior heritage character of the townhouse can be fully appreciated with the restored timber floor and purlins.

The number of air-conditioning fan coil units was reduced, along with the amount of trunking needed, by providing **options for mechanical and natural ventilation**, such as the use of **fans** and the introduction of an **openable skylight** at the rear of the main roof.

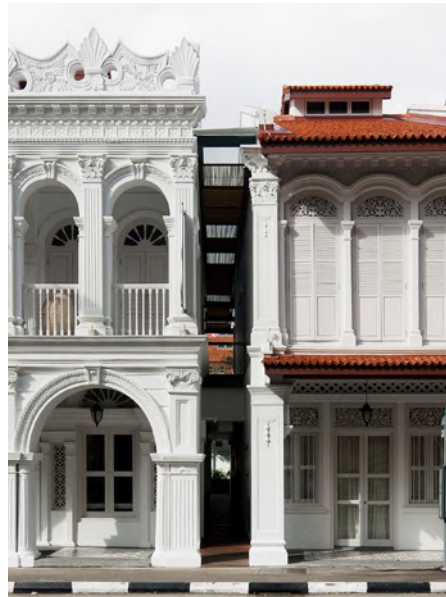
Right: The covered link bridge is designed to be visually light and set back from the facade, so that the side alley is still perceivable.
Far right: Section of new covered link bridge showing design integration of services: refrigerant and sprinkler pipes run between the bamboo ceiling and glass roof, while the M&E service tray is accommodated below the slab.

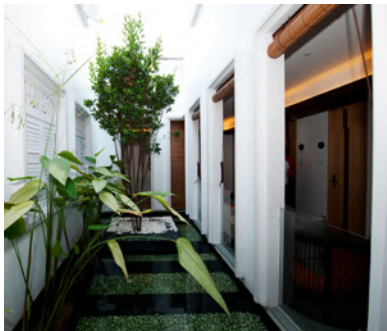
Air movement through the hotel is facilitated by the new courtyards and natural ventilation.

Common circulation areas are designed to be **naturally ventilated** to recall shophouse interiors of the past. This significantly lessens the ACMV load and reduces heritage impact by minimising the amount of equipment and trunking needed. While the open backyards are roofed over and enclosed, four new landscaped **courtyards** have been created across the development serving as light and air wells punctuating the common circulation spaces. This introduces air movement and diffused daylight for environmental comfort.

Exhaust ducting is decentralised such that foul air is channelled through a few outlets, via the second storey and new jackroofs, rather than a singular location that would have required a sizeable duct running through the historic interiors.

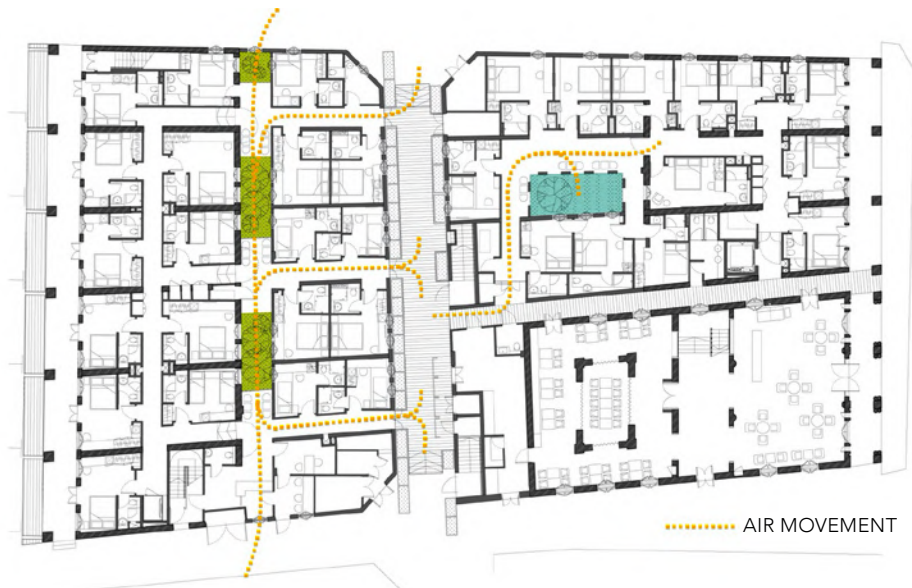
Jackroofs and **skylights** are introduced as useful design devices that are also in keeping with the historic architectural vocabulary of townhouses/shophouses. The new jackroof and skylight added to each unit serve to channel natural daylight into the deep plan and double-up as ventilation inlets/outlets.

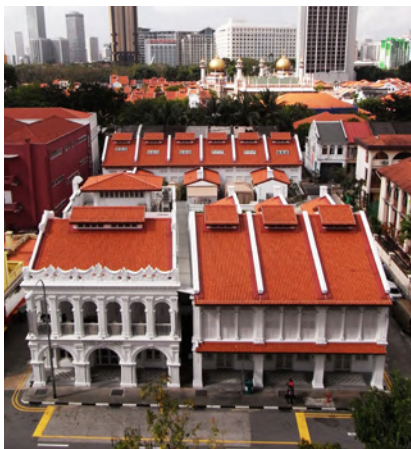
New jackroofs are introduced, in keeping with the architectural vocabulary of townhouses/shophouses.

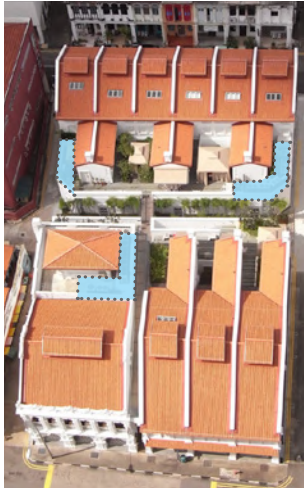
Discreet placement of M&E equipment on the roof terraces.

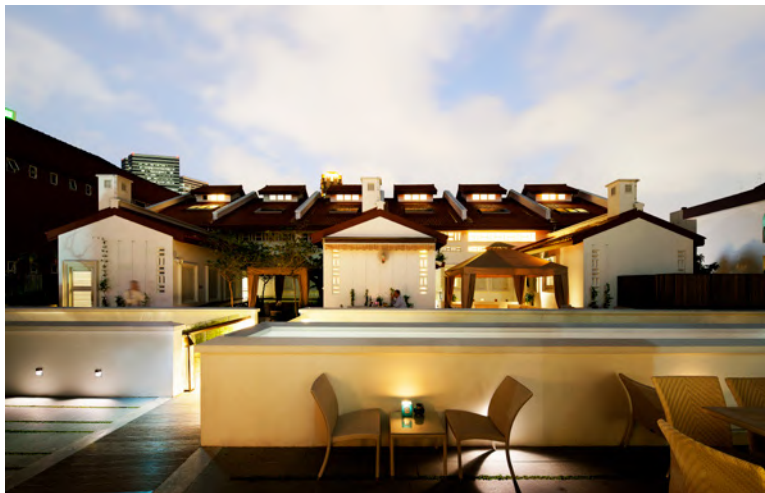
Above: New roof terraces connect the two wings while serving as a dining patio and open-air lounge.

Right: Open-air fire escape stairs leading from the roof terrace to the back lane

Fire safety provisions, including sprinkler systems and escape route planning, present some of the most challenging aspects of design integration for historic buildings. At The Sultan, the sprinkler networks servicing unit 101 and the two wings could be connected via the roof terraces and link bridge into a single system, with only one set of tank and pumps to be accommodated. A new basement was excavated at one of the corner units to house this equipment, so it would not take up prime interior space.

Fire escape staircases are a regulatory requirement that often cause adverse heritage impact especially if they are located indoors, due to the need for enclosures to achieve **fire compartmentalisation**. To reduce such impact, two fire escape staircases serving unit 101 and the Jalan Sultan wing have been diverted to the exterior, accessed via the new roof terrace. The open-air stairways along the back boundary wall serve as landscaped vertical connections from street level to the terrace, as well as fire escape routes discharging into the back lane.

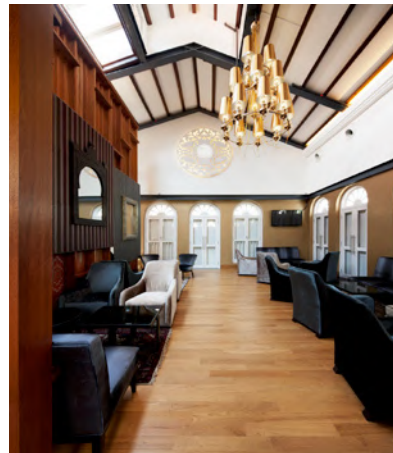
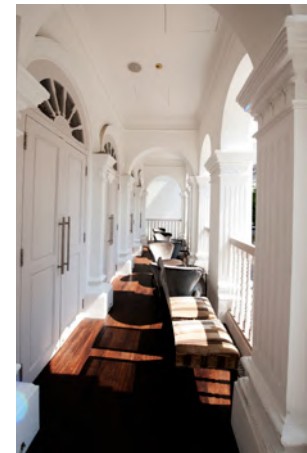
Left and middle: Second storey dining hall with air-con units, service pipes and trunking decanted outside. Outlet penetrations are discreet and carefully coordinated with the interior historic elements. **Right:** Verandah outside the dining hall, with a false ceiling concealing the FCUs.

Design parameters are put in place to ensure that as far as possible, **services are confined to the margins and less visible areas, or integrated within new design features**. For example, the new roof terraces and link bridges provide cover to discreetly run services on the side and back elevations, **minimising intrusion within** the historic buildings. At the second storey dining hall of unit 101, air-con equipment is kept on the exterior: fan coil units are concealed within the verandah ceiling space in front, and outdoor units are parked behind flat roof parapets at the back, with refrigerant pipes running along the gable wall, housed together with sprinkler pipes within the link bridge shelter structure. **Air-con outlet penetrations** are carefully located to avoid ornamental plasterwork such as cornices, and synchronised with existing French windows.

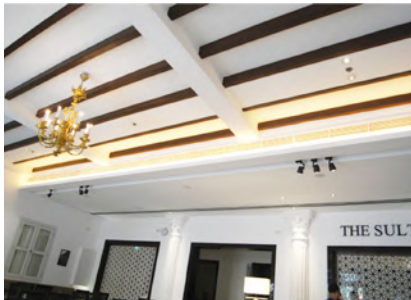
Main lobby with exposed timber ceiling joists. Drop ceiling is kept to one end, with false ceiling selectively installed between joists where needed to accommodate services and lighting.

At the main lobby, where the air-con equipment and trunking could not be completely kept outside, the **drop ceiling** created to accommodate them is **confined** to one end of the space. Where necessary, **discreet box beams** and **false ceilings between joists** are selectively introduced to conceal sprinkler pipes, conduits and light fittings.

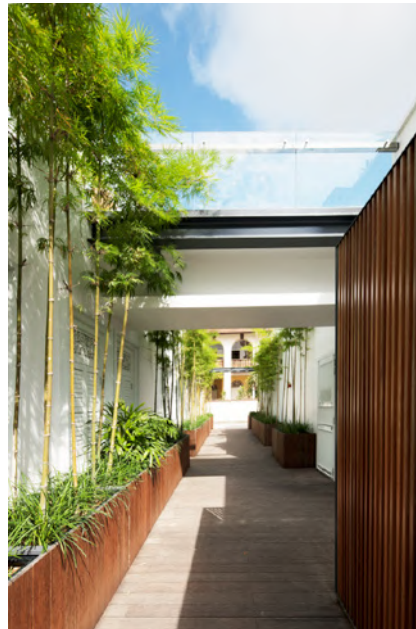
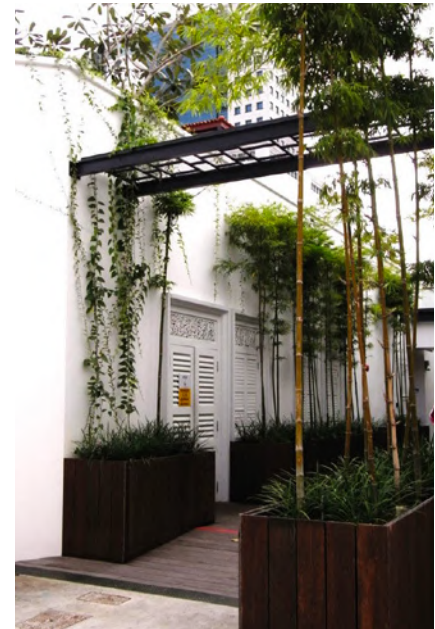
Special permission was sought to cover the back lane with timber deck to enable universal access.

Removable timber decks are laid over the open drains along Aliwal Street, interspersed with planter seats, for a safer and more welcoming street frontage. Timber decks are also laid across the back lane matching the floor level within the hotel compound, and ramped at both ends for barrier-free access to and from the main streets.

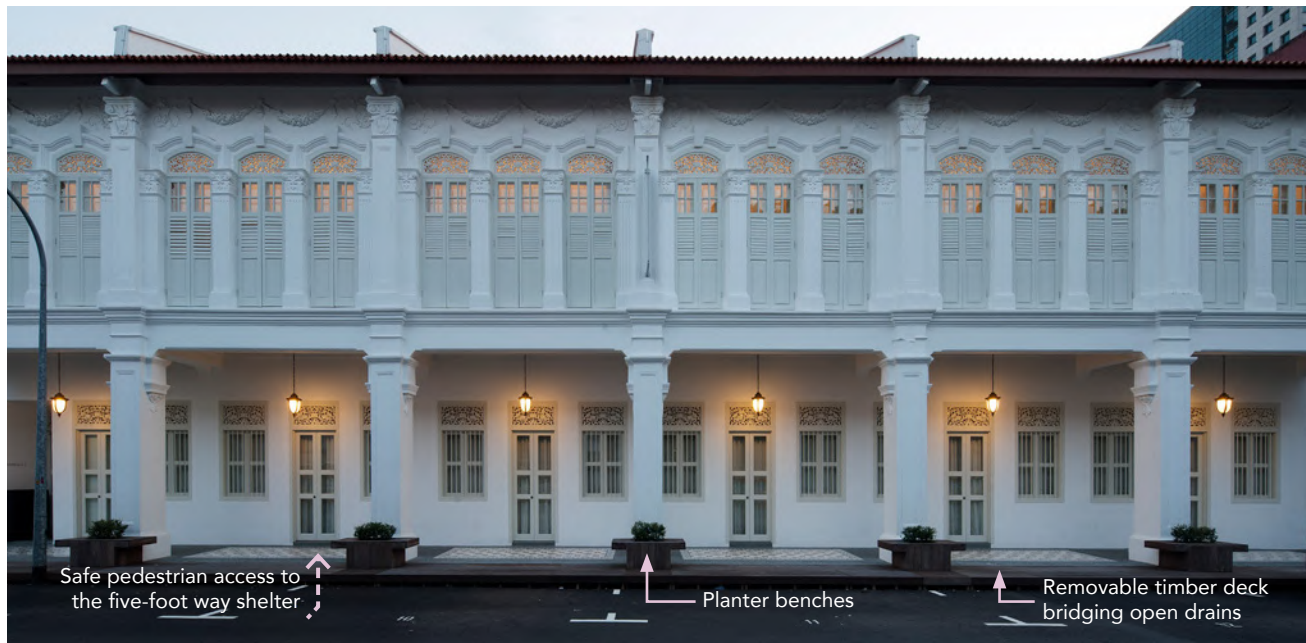
Timber deck and planters were introduced along the front of the Aliwal Street wing.

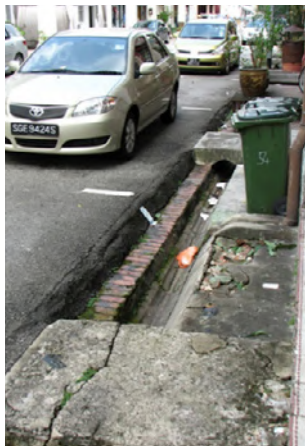
Prior condition of street interface with uncovered drain and uneven pavement levels.

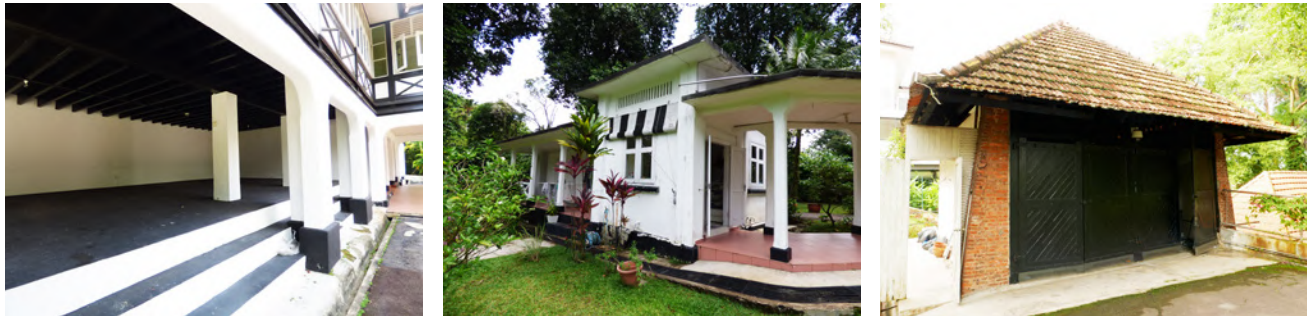
Ancillary spaces and structures are integral elements of the historic bungalow compound – **from top:** spacious undercroft may be used for storage, animal rearing, as workspace or play area; servants' quarters in the outhouse connected by linkway; garage designed as a miniature of the main house.

For houses on storey-high piers, the **undercroft spaces** could be put to ancillary use such as storage, animal rearing or play area. As flood incidents subsided with drainage improvements over the years, it was not uncommon for owners to subsequently enclose such undercroft spaces and convert them to more usable and rentable dwelling areas.

Prior to the widespread adoption of modern sanitary systems, toilets were located outside the main house, often linked by a covered **linkway**. Other functions accommodated in **ancillary structures**, or outhouses, included kitchens and quarters for servants, nannies, cooks or syces (drivers). The well-heeled might even have several **outhouses, tennis courts** and even **garages** within the bungalow's expansive compound.

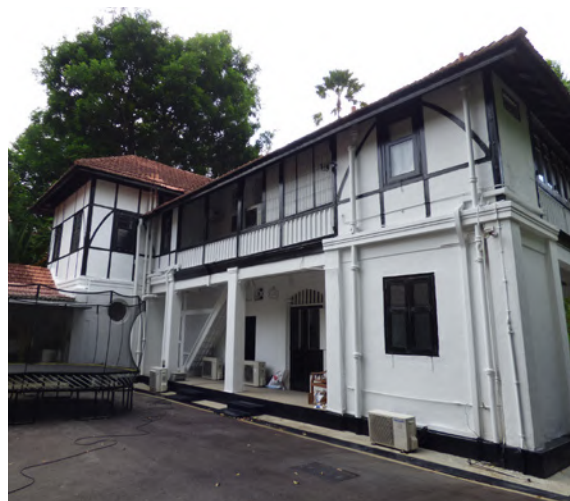
Most historic bungalows are hybrid construction. Bungalows such as this typically feature loadbearing masonry, half-timbered walls on the upper storey and timber roof structure, as well as ferro-concrete bathroom floors.

Planter's bungalow.

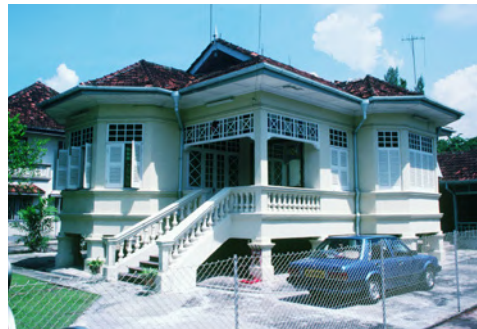
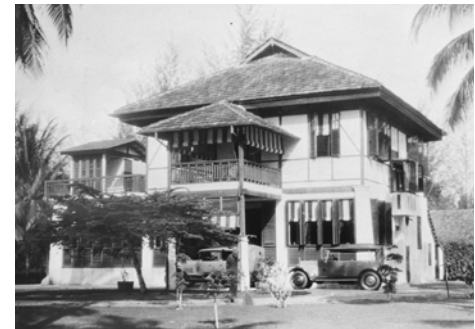
*Right: Anglo-Malay bungalow.
Far right: Black and white half-timbered house.*

- **Planter's villa** generally refers to a typology that was originally designed for surveillance – usually located on elevated ground and raised on high piers to provide strategic vantage points (e.g., a planter's villa that facilitated surveillance of a plantation, or the harbour master's house that had a view of the coastline and approaching vessels)
- **Anglo-Malay bungalow:** single-storey house raised on low piers and relatively modest in scale, and often featuring an ornamented entrance stairway and porch
- **Black and white half-timbered house:** single- or double-storey bungalow characterised by articulated black timber structural main frame with white stucco infill walls, commonly associated with colonial government quarters
