CONSERVATION TECHNICAL HANDBOOK

Volume 8 | Managing Change

URBAN REDEVELOPMENT AUTHORITY

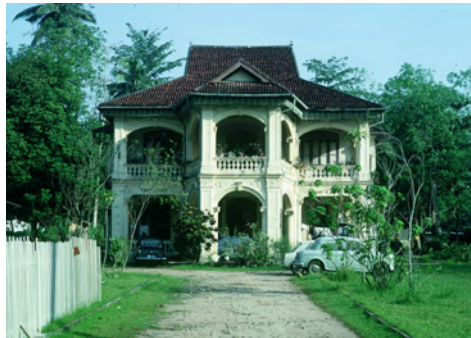
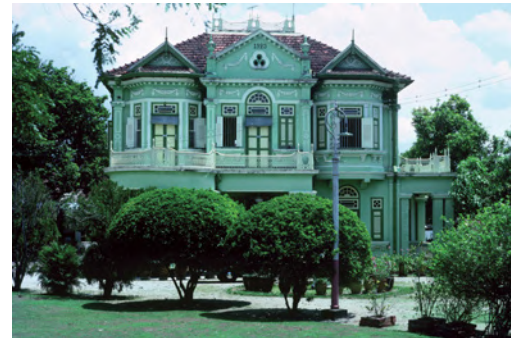
Left: Bungalow with classical revival influence. Right: Eclectic bungalow design

- **Classical revival/eclectic bungalows** are usually two-storey and ornamented with stuccowork in adaptive revivalist styles including Neoclassical, neo-Gothic, Tudor and so on
- **Art Deco** bungalows are usually two-storey, feature simple geometric form and sparse stylised ornamentation and often sport nautical design elements such as porthole windows, mild steel railings, curved corners and streamlines.
- **Arts and Crafts** bungalows are usually two-storey, often found with a domineering pitched roof, geometric fenestration grille design, coupled with expressive use of materials as a form of decoration, such as textured plaster, fairfaced bricks, articulated timber frame, exposed stone chipping finish and so on.

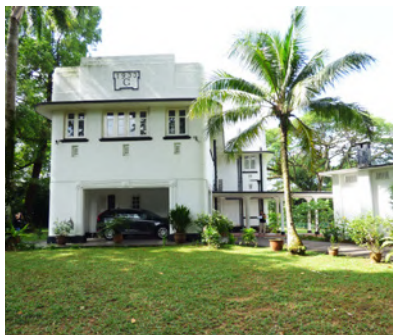
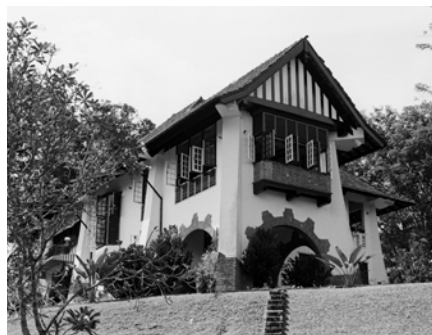
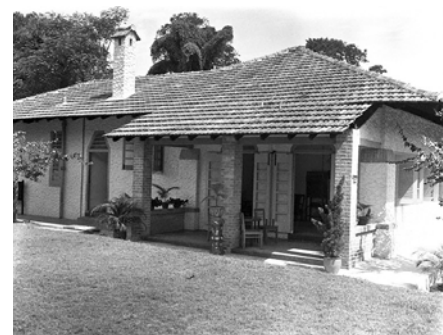
Left: Bungalow with Art Deco design. Middle to right: Prewar and post-war bungalows with Arts and Crafts influence.

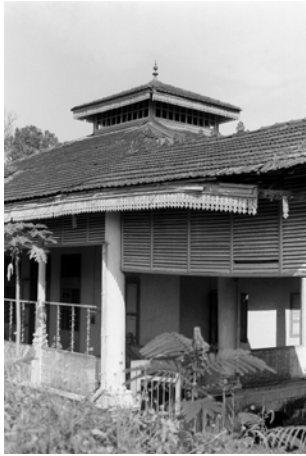
Top: A house with a jackroof, deep eaves, and a verandah protected by louvred screens.

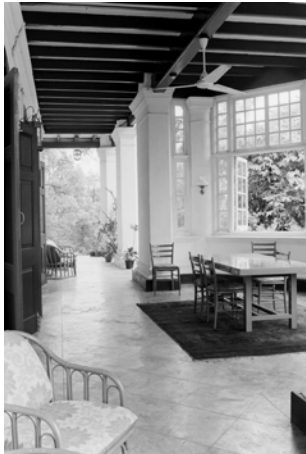
Above: A generous verandah with high ceilings at the ground floor of a bungalow.

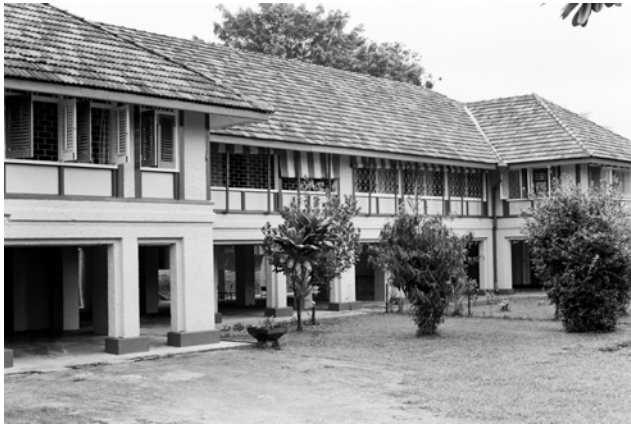
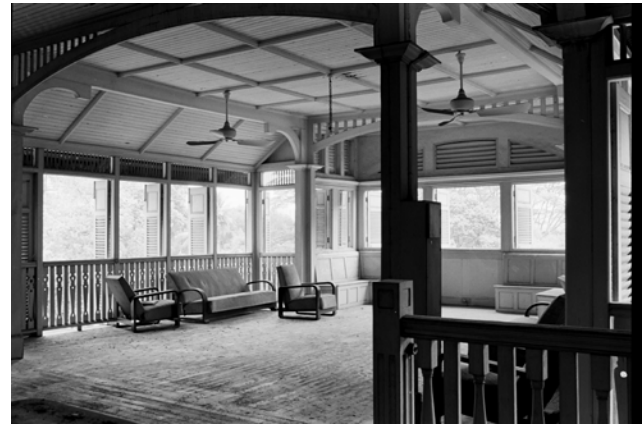
Left: Raising houses on high piers also aided ventilation. **Right:** A breezy upper floor verandah sitting room decked out in carved timber elements, with a porous enclosure of louvered French windows, balustrade and top vents.

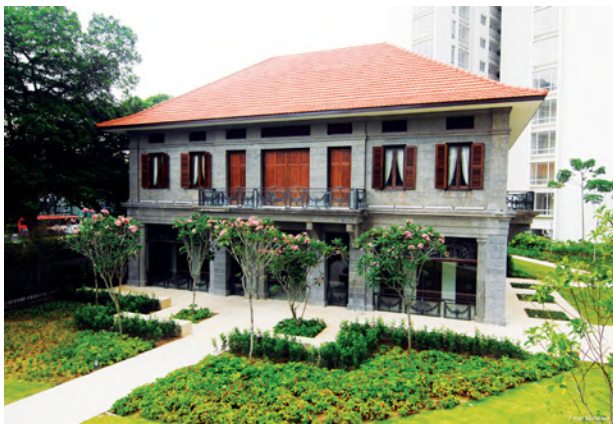
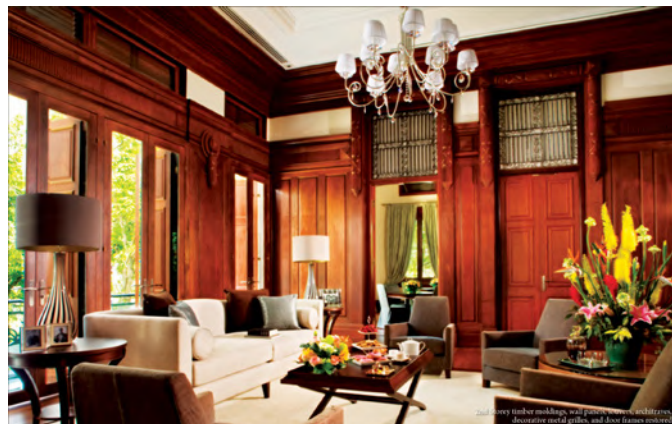
A historic house with a large compound may be conserved and adapted as a condominium clubhouse when the site is redeveloped and intensified. At The Seaview Clubhouse, formerly a residence, the sitting room with restored carved timber panelling has been sensitively fitted with a VRV air-conditioning system.

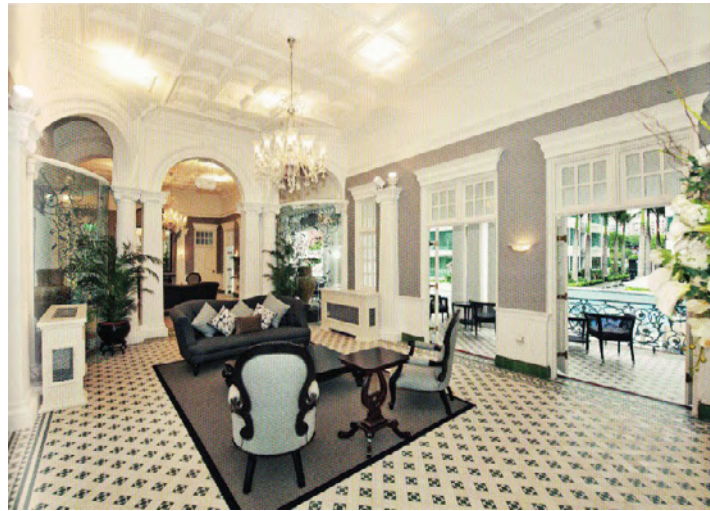
In this bungalow-turned-clubhouse at 124 St. Patrick's Road, air conditioning is channelled through a floor unit concealed in timber cabinetry on the left, devised to complement the historic interior design and proportions.

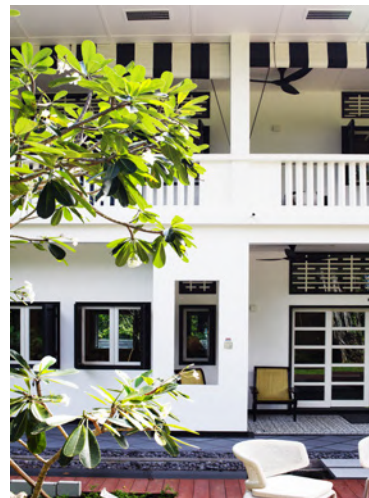
Left: Constructed in reinforced concrete, the bungalows feature character-defining elements such as ventilated soffits, verandahs with ventilated balustrade, and clerestories with Art Deco grill design.

This project comprises three **Art Deco colonial bungalows** and their **outhouses** in Rochester Park, a military housing estate likely built in the 1950s. The main houses are in reinforced concrete (RC) column, beam and slab structure with masonry infill walls, and timber roof frame with clay tile finish. The outhouses are in RC frame construction with RC flat roofs.

Investigated and found to be in sound condition, the **main RC and timber structures** of the houses were repaired and restored. **Character-defining historic elements** that were restored or reinstated like-for-like included timber eave brackets, ventilated eave soffits, precast RC canopies, timber fenestrations with Art Deco grille design, and front verandahs with ventilated balustrade.

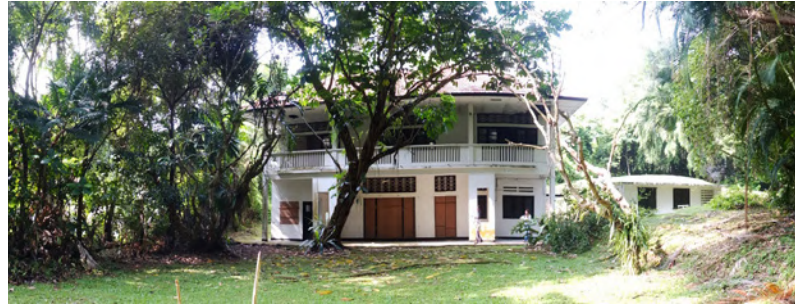
Below: A trellised sheltered linkway of footpaths, ramps and steps weaves through the semi-wild undulating terrain, providing barrier-free access.

Instead of levelling or decking over the terrain, the undulating contours are retained as a historic landscape feature and negotiated using **footpaths, ramps, steps** and **platform lifts**, modified only where needed to accommodate the 1:12 ramp gradient for **barrier-free access**.

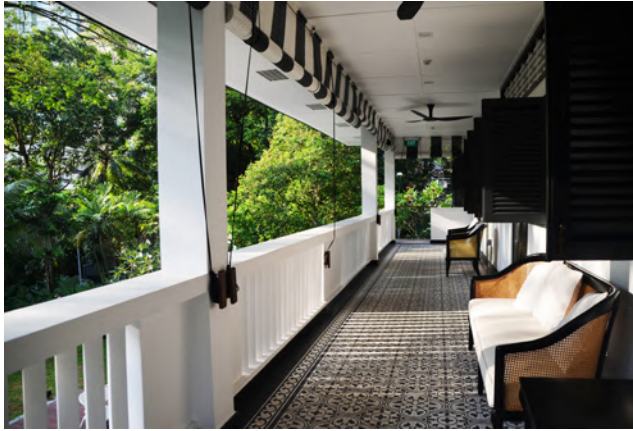
Left: Front verandah restored as tropical sitting lounge with a view, also serving as an environmental buffer for the air-conditioned interiors.

Rather than being glassed in, the bungalows' **front verandahs** have been restored to their original historic design as open, breezy lounges with immersive views of the greenery. The verandahs also serve as an **environment buffer** between the warm, humid outdoors and air-conditioned building core spaces.

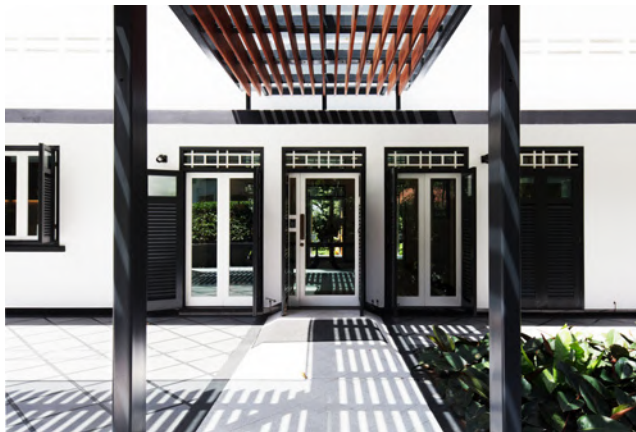
Left: Incorporation of Low-E glazing and security card reader on the secondary layer of like-for-like replacement fenestrations.

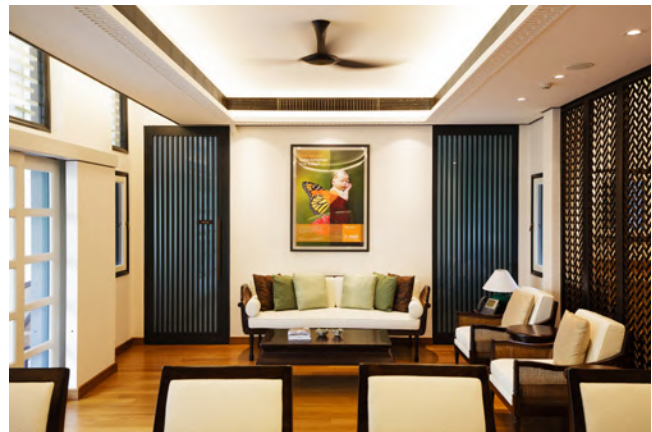
Right: Discreet AC outlet grille integrated in drop ceiling that is set back from the feature clerestories.

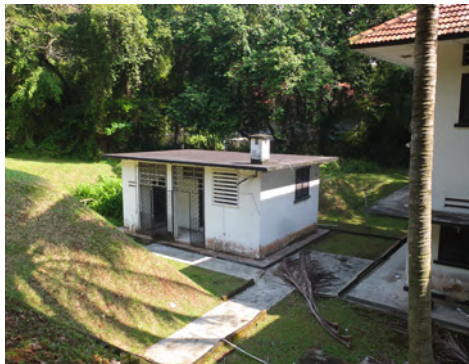
Historic ancillary structures such as outhouses are an integral part of the heritage compound (**above**). These are retained here and adapted as washroom blocks (**right**). Condenser units are parked right behind, concealed by a timber screen.

Although not mandated for conservation, the **outhouses**, found to be in good condition, were retained as **integral historic components** of the colonial house compound. Originally used as kitchens and servants' quarters, these were adapted to accommodate the increased quantum of washrooms required for the change to institutional use. **Sanitary piping** existing on site was damaged by invasive tree roots and deteriorated beyond repair; new lines had to be laid and connected to the sanitary inspection chamber. The **routing** is carefully **coordinated with the tree plan** to avoid affecting the roots of retained trees.

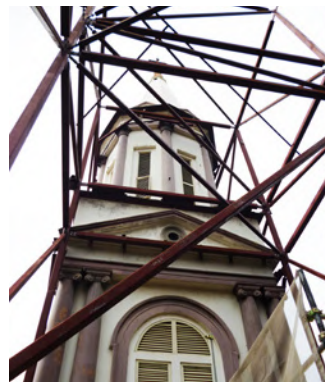
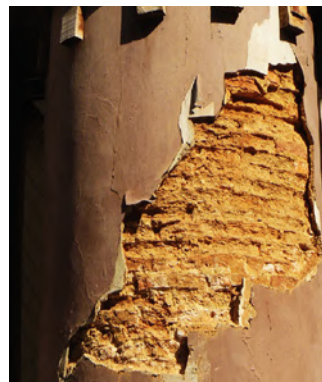
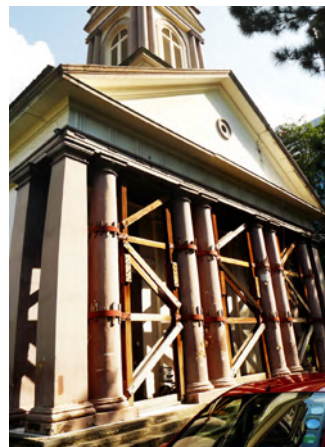
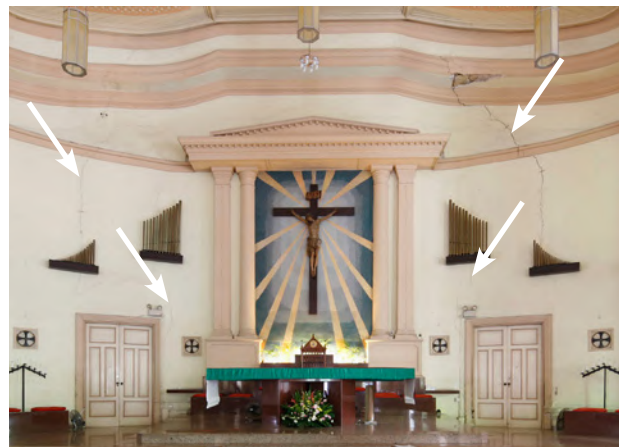
The east facade with the bell tower suffered the most extensive structural damage. Massive timber shoring was installed to prop up this area. On the interior (bottom far right), extensive cracks appeared on the altar wall below the bell tower.

The early 2000s saw unprecedented underground construction works in the cathedral's vicinity, such as the Circle Line MRT stations and tunnels, and basement areas of Singapore Management University. The cathedral's original foundation of compacted earth and boulders was affected, leading to **uneven settlement** of the building. This resulted in large and **extensive cracks** in the floor slab, walls and columns. By 2009, the bell tower at the east facade had tilted, and the portico columns had to be propped up by massive timber struts. Horizontal elements such as door lintels, window frames and cornices also showed visible shearing. The interiors were not spared either, with large cracks and delaminated finishes observed at the front altar wall, and multiple cracks had also propagated across the mosaic floor. At the north and south transepts, continuously growing cracks in the window frames prompted the church to dismantle two valuable **stained glass panels** for safekeeping in 2010.

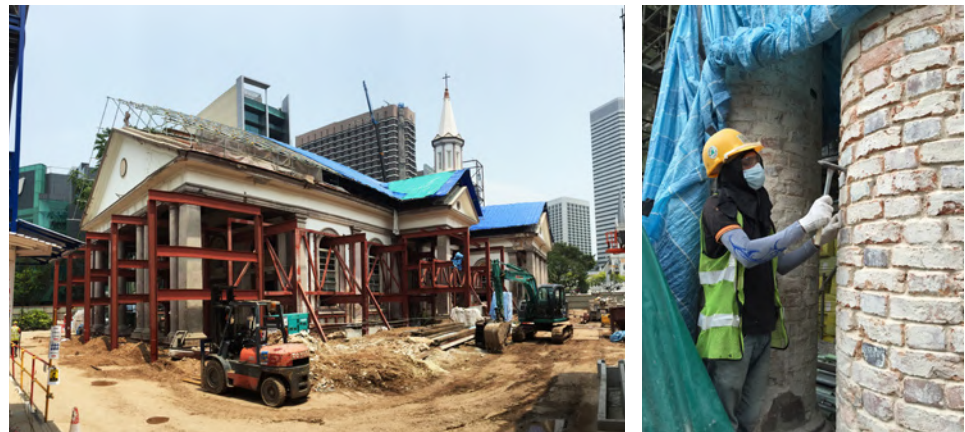
Left: Underpinning works in progress, with massive shoring in place to ensure the structural stability of the cathedral during the rehabilitation works.

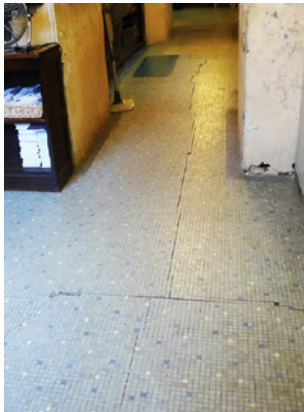
Above: Large cracks on the floor slab prior to restoration works.

The restoration and enhancement works were governed by the philosophy of maximising what could be retained, and minimising invasive interventions. Due to the heaving and extensive cracking of the **cathedral's floor**, it had to be entirely **reconstructed**, while the structurally compromised **foundations** had to be fully **underpinned**.

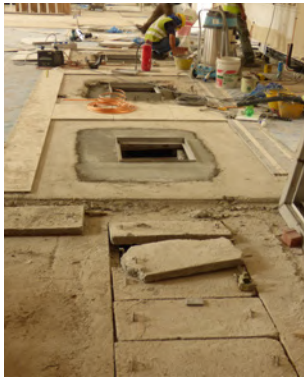
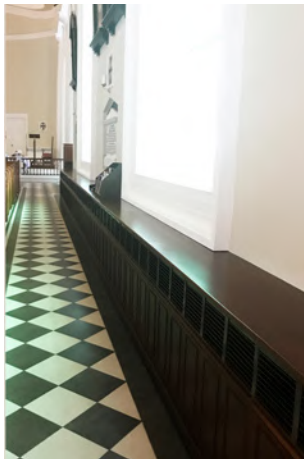
Top: New M&E trenches were cast together with the new floor slab to house ducts, cables and conduits. Panels at regular intervals provide maintenance access. **Above:** Air-conditioning FCUs housed within custom-made timber cabinets on both sides of the nave.

Two banks of **floor-mounted air-conditioning fan coil units** run alongside these trenches along both side walls of the nave, neatly tucked under the massive window architraves. The equipment is housed in **timber cabinetry** with cleverly disguised diffuser grilles, giving the appearance of wall dadoes within the voluminous hall. This design treatment freed up the cathedral walls and ceiling from unsightly M&E conduits and ductwork, while enhancing the heritage character of its interiors.

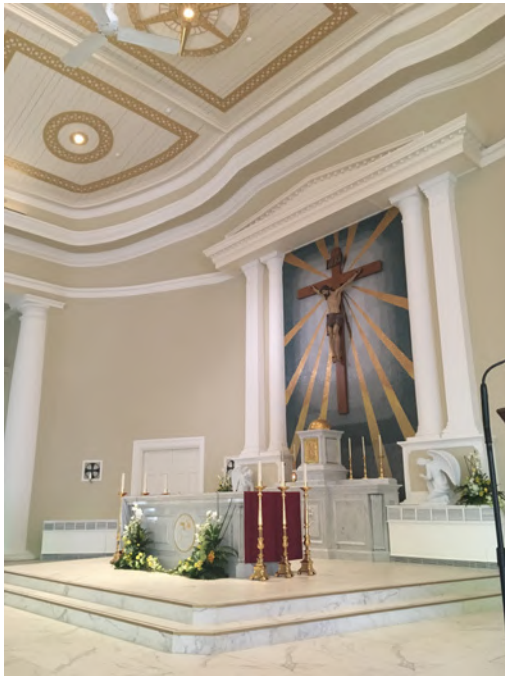
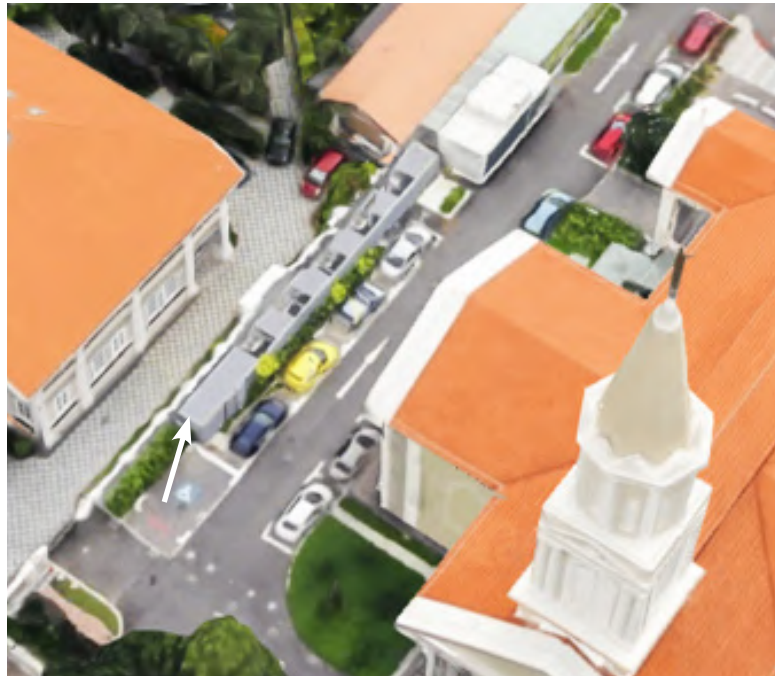
Left: Matching white air-conditioning FCU cabinets sensitively placed at the altar to reduce visual impact.

Right: Condenser units housed away from the cathedral, screened with metal louvre casing and camouflaged with dense planting.

Having a consolidated underfloor ducting and cabling trench also meant much **less M&E penetration** on the historic brick masonry walls. In a conventional scenario, floor-mounted ACMV fan coil units (FCUs) would necessitate refrigerant and condensate piping to puncture through the wall enclosure to a row of outdoor condenser units, which would clutter up the historic facades. The alternative strategy adopted ensured that these were routed to a **consolidated bank of condenser units** housed a distance away – at the boundary wall between the cathedral and the archbishop’s residence. The condenser units are concealed within metal louvred screens and landscaping, separated from the cathedral by a driveway and parking spaces.

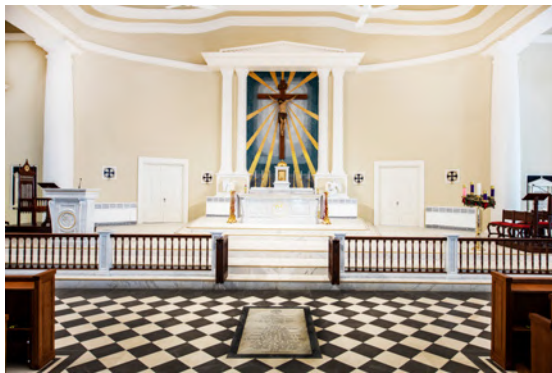
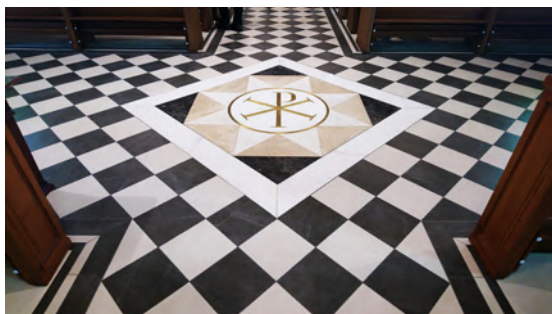
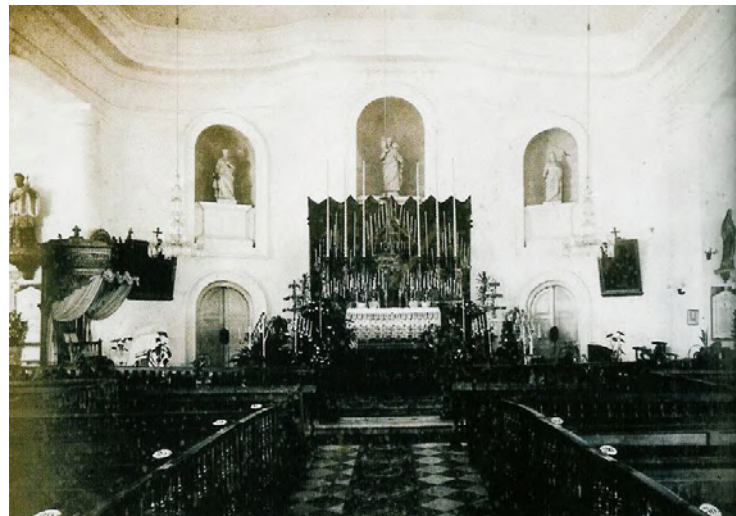
Left top and bottom: Reinstated flooring drawing inspiration from the historic design.

Above: Archival photo of cathedral interior showing original chequerboard flooring pattern.

Finally, the new floor slab also provided the opportunity to install a **flooring design** that draws inspiration from archival photographs showing historic cathedral interiors with marble tiles laid in a black and white diagonal 'chequerboard' pattern. Rather than attempting a literal replica of the historic flooring, of which there are no design records, new large ceramic tiles in two contrasting tones were used to reinterpret the chequered pattern. The new design takes into account BCA's safety requirements for slip-resistant tiling, as well as the required size and distribution for floor access panel.

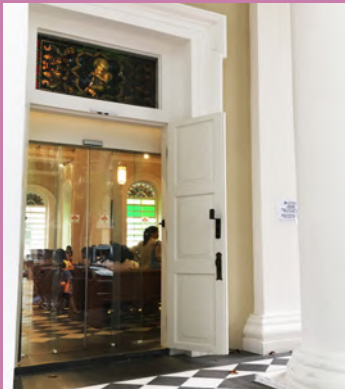
Secondary frameless glass automated sliding doors are added behind the restored historic doors, which are held open during operating hours.

New **frameless glass sliding doors** were added behind the historic timber doors, which are kept open at all times. Ceiling **smoke detectors** are installed and painted to match the colour of the timber feature ceiling. **Exhaust fans** are installed over the drop ceiling panels, and discharge is channelled through the historic **jackroof vents**.

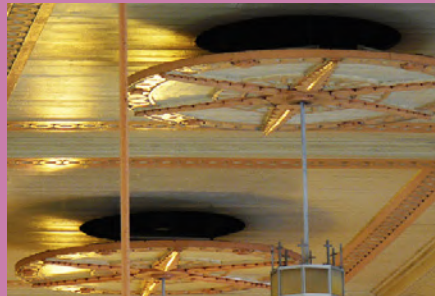
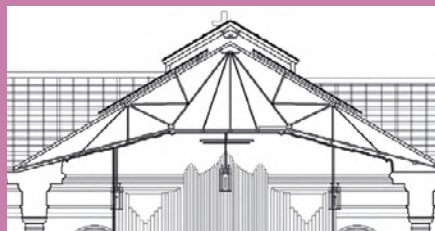
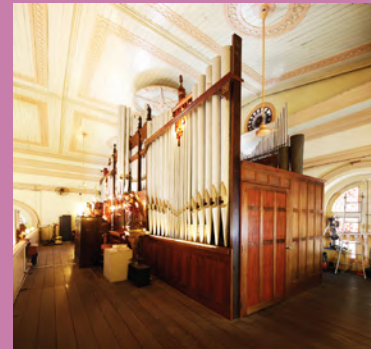
Above: Alternative means of fire escape for the choir loft were explored

Left: Existing ventilated ceiling features were adapted as smoke extractor vents, with discharge through the historic jack roof.

A key issue was the **choir loft** that is supported on massive timber joists and steel beams, which is only accessible via two 1912 cast iron staircases. To avoid replacing these historic stairs with code-compliant dog-leg staircases, **alternative means of fire escape** were explored.

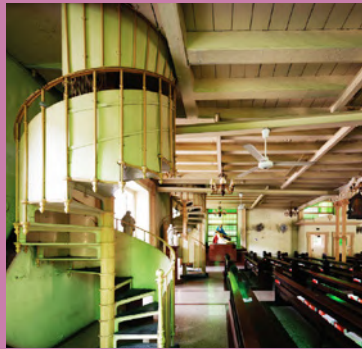
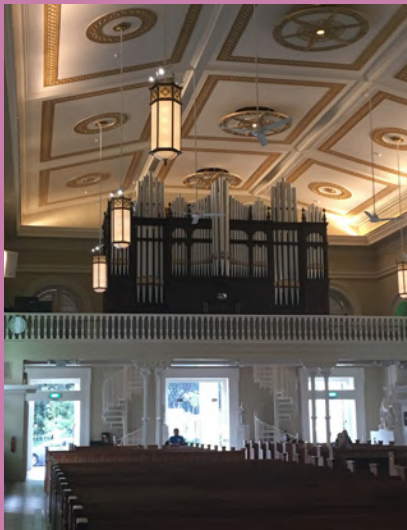
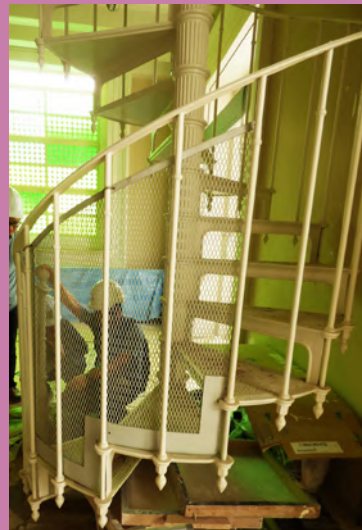
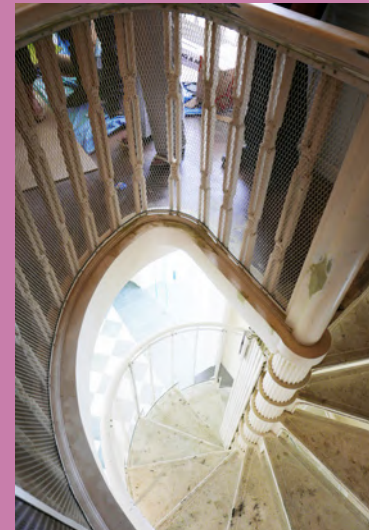
Top row: The wide non-compliant gaps of historic railings and balustrades were once sealed up with plywood boards, altering the character of these historic elements.

Bottom row: Metal mesh is now used instead, reinstating the visually light historic design character. Designed for reversibility, the mesh is attached using metal hooks and clamps.

Safety requirements were met by installing visually unobtrusive lightweight metal mesh barriers behind the historic metal balustrades of the cast iron staircases, as well as timber railings on the loft.

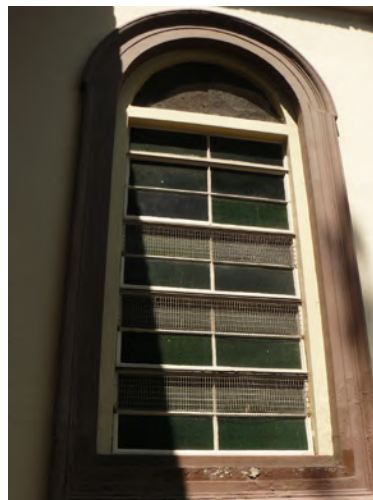
Original condition of louvred mild steel window with glass panels and wire mesh, in various green tints and textures.

One such example that best exemplifies the aforementioned ethos is the cathedral's **mild steel windows**, which replaced their timber louvred predecessor in the 1940s. The large, expansive pivoted mild-steel framed windows originally featured dark green tinted hand-rolled glass that was believed to reduce glare and heat from the tropical sun. They also allowed the interiors to be well ventilated, being fully openable. Over the decades, wear and tear, as well as localised replacement with clear glass, has resulted in a distinctive patchwork of differing shades, hues and textures of glazing, illuminating the cathedral's interiors with an uncommon light quality.

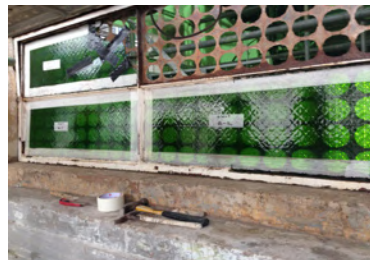
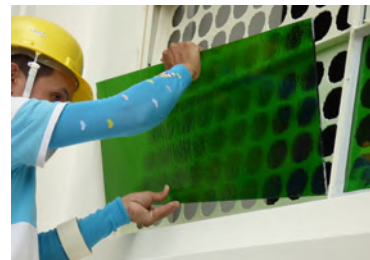
Above left: Tagging and removal of glass to repair corroded mild steel window casements.

Above right: Reinstallation of glass into restored casements.

It was decided to **retain** as many **variations of the glazing** as possible, as they serve to highlight the past contributions of the church community. To do so, each panel of glass was tagged and labelled to ensure it was returned to its specific position. Broken panels were replaced with matching like-for-like pieces.

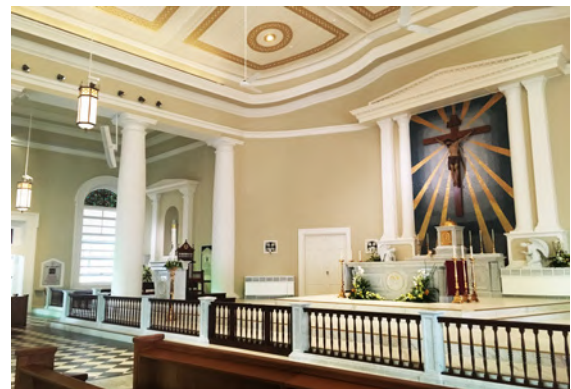
Right: Latter-day clear glass panels are retained at the north and south transepts to allow ample daylighting for the sanctuary and altar area. Additional track lights mounted on the lower cornice provide extra illumination during religious services.

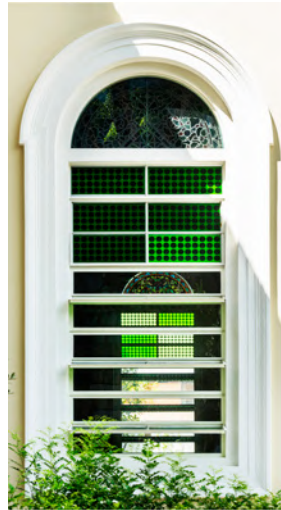
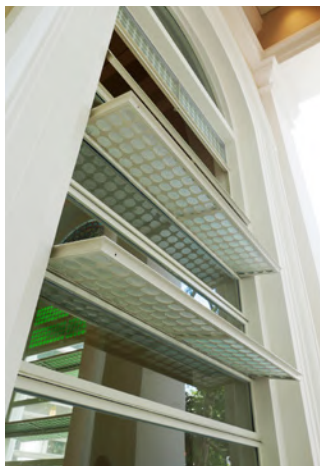
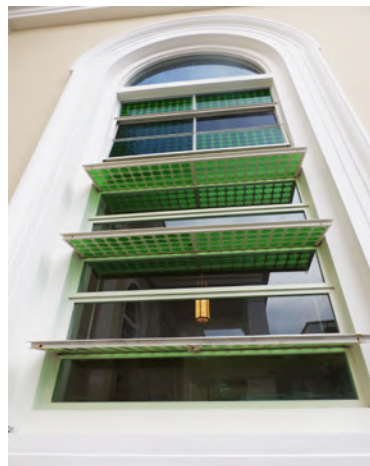
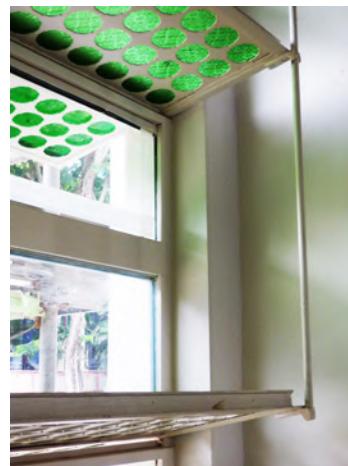
Top row: The green glass panels at the top are closed to reduce glare, while those at the bottom section are opened into a horizontal position to allow daylight to enter.

Bottom row: Adaptation of louvred mild-steel windows for the air-conditioned interiors, with clear glass panels added in between, using reversible fixing methods.

In order to optimise natural daylight streaming into the cathedral, whilst regulating the interior thermal comfort, several decisions were made. Drawing functional inspiration from the dark tinted stained glass lunettes, the top three green glazed panels were shut to **mitigate glare** and **provide shade**. To let in **natural light** without the green tinge, the bottom six panels were pivoted to the open, horizontal position and held in place with clamps and screws, allowing them to function as **sun-shading devices** at the same time. **Secondary clear glass panels** were introduced to keep out the elements and maintain the interior air conditioning. These interventions are **reversible** if there is intention to reinstate the windows' operability in the future.

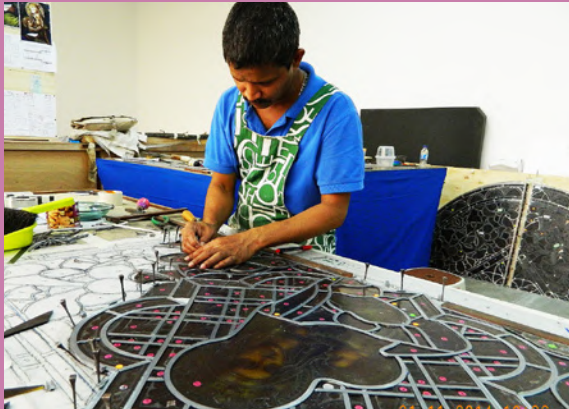
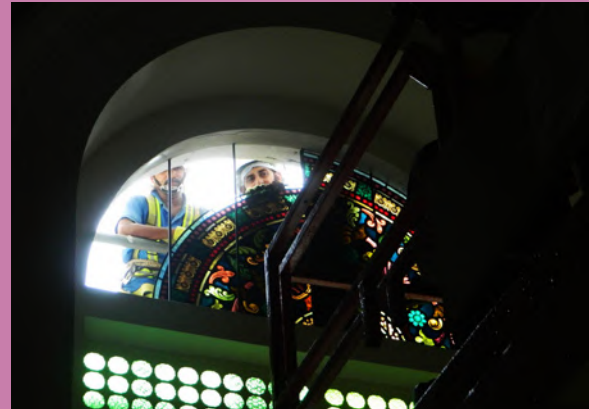
An important part of the cathedral restoration was the conservation repairs to its stained glass, which included installation of new protective external glazing (bottom left).

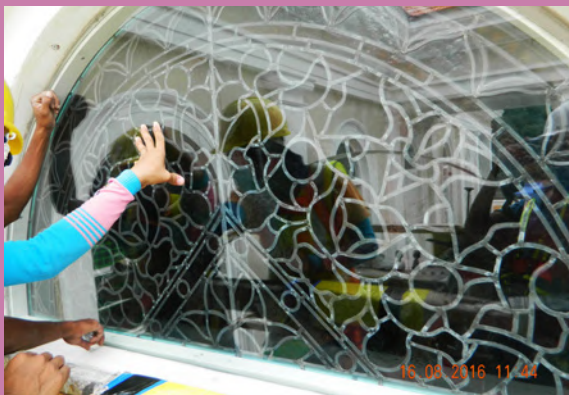
STAINED GLASS RESTORATION

A gap is maintained at the top or bottom of the stained glass to ventilate the interstitial space, and to reduce condensation risk.

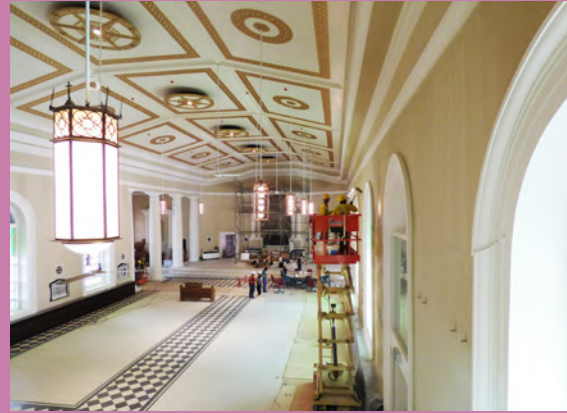
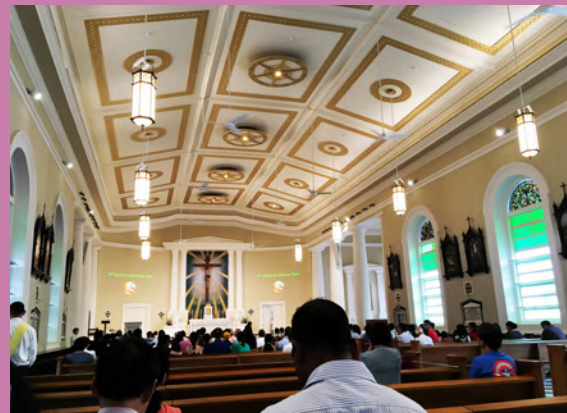
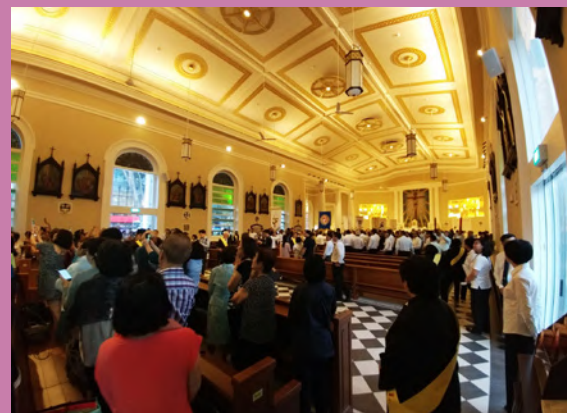
Middle: The interior lighting levels can be adjusted to accommodate projection of images onto the sanctuary walls flanking the altarpiece. This was a conscious decision to not mount new projection screens or LED TVs that would otherwise detract from the historic character of this important space.

Bottom: During evening services, the cathedral interiors are lit using a combination of track lights that illuminate the timber ceiling, recessed downlights, and refurbished historic pendant lights.

Given the friable nature of the brick masonry, and the thin plaster layer, all new electrical conduits are either **surface-mounted** or **concealed** in lightweight panel **box-ups**. To light up the restored timber ceiling, new track lights with exposed electrical trunking were installed out of sight above the highest cornice line. The **historic pendant lamps** dating to the 1950s were retained, with their tungsten filament luminaires replaced with LED lights. Originally, it was intended to install additional uplights directly below the restored Stations of the Cross paintings that line both sides of the nave. However, this would mean unsightly exposed conduits at regular intervals. To overcome this, new **spotlights** mounted on top of the pendant lights were used instead. Latter-day pendant lamps along the centre bay of the timber ceiling were removed and replaced by **recessed downlights** that are integrated into the centre of the ceiling 'starburst' motif, reinstating the historic character.

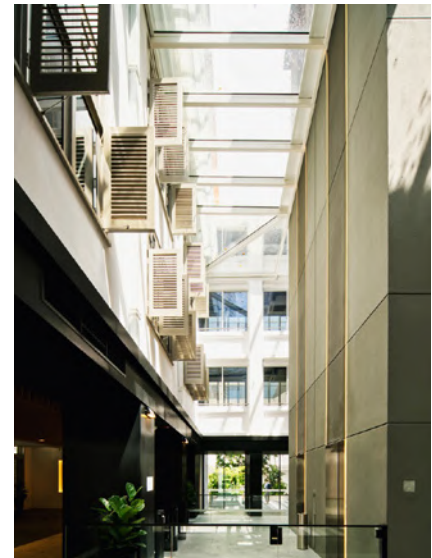
Above: A schematic diagram of the building layout. There were originally five courtyards (highlighted in light green), which were subdivided during later rounds of works.

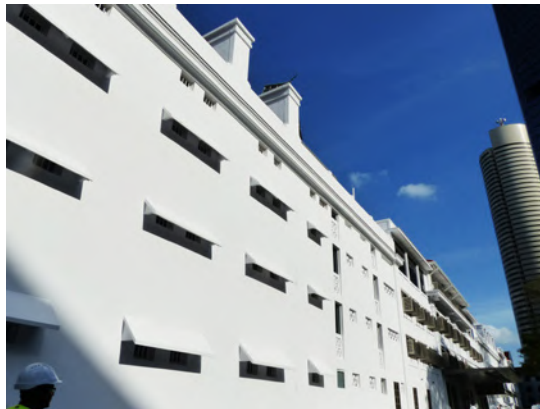
Above left: The austere rear facade of the building, with retained and restored hooded windows and chimneys, which hark back to the days when the rear wing housed the police barracks.

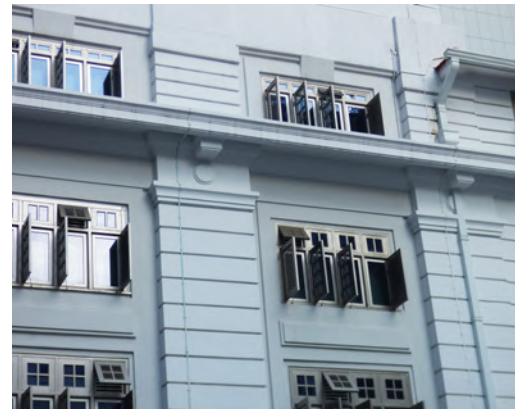
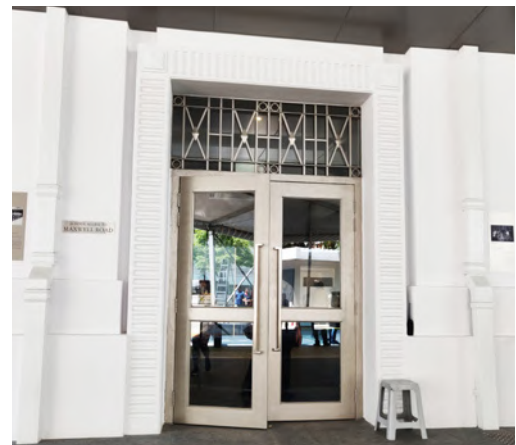
Above right: New secondary fixed glass panels were installed to accommodate air conditioning and meet the stringent acoustic rating required for the new office suites.

Right: Reinstated metal grilles and ornamented architraves are some of the building elements that underwent conservation works.

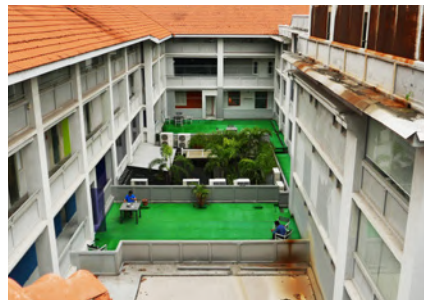
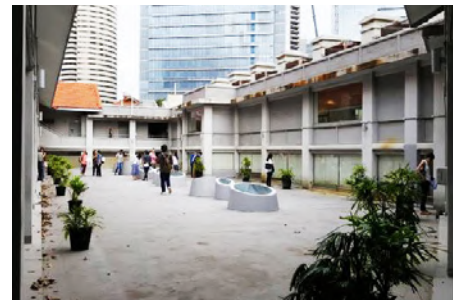
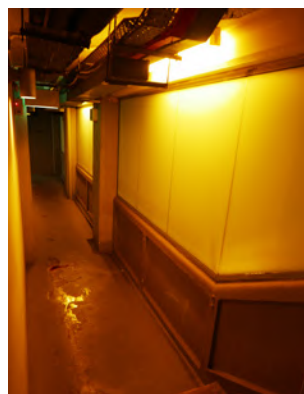
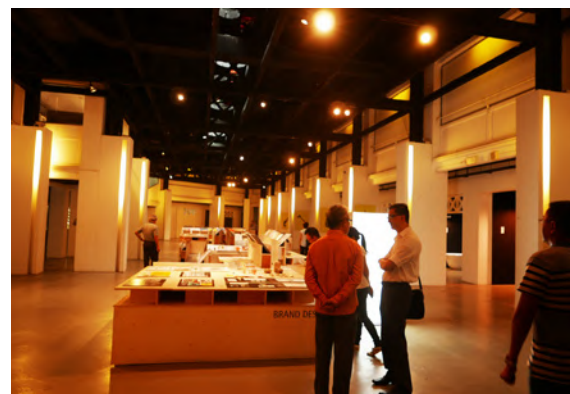
Right top and bottom: Some of the existing corridors were enclosed with a latter-day opaque cladding, creating rather dark and unpleasant spaces within.

Far right top and bottom: Latter-day flat roofs enclosed original courtyards to create more usable floor area, including the exhibition hall of the Red Dot Museum. However existing interior spaces on the first and second storeys were also deprived of natural daylight.

The main conservation strategy aimed to restore the original courtyards, considered key character-defining elements of the building, in order to serve as effective orientation points within the complex, as well as optimise daylight entry.

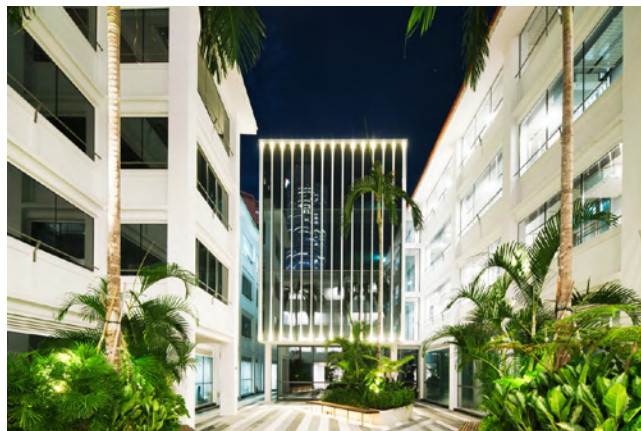
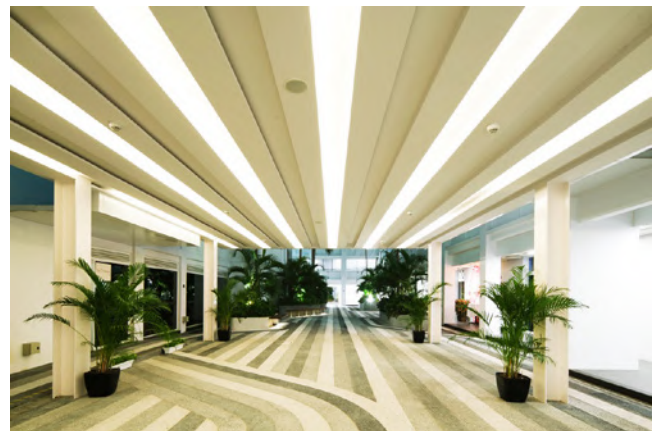
Bottom left: New annex blocks are discreetly inserted on one end of the courtyards.

Bottom right: The open ground floor and landscape design aim to enhance spatial porosity and to create pleasant informal spaces.

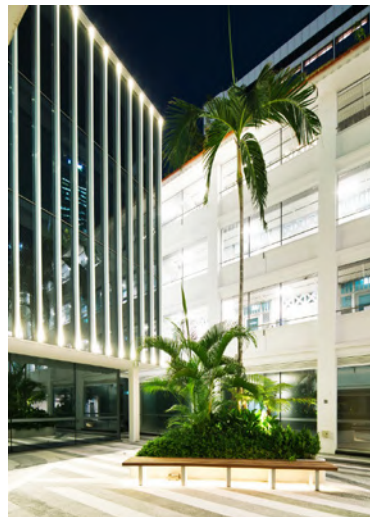
View from the courtyard of the glazed corridors and its neatly integrated exposed ceiling M&E conduit trays.

From the early design stage, the architect eschewed the use of extravagant new finishes in the upgrading works, being cognisant of the associative value of the historic architectural finishes of plainfaced plaster and cement screed to the original function of the building. A **restrained material palette** in a monochromatic colour scheme was introduced through various materials such as dark grey floor tiles for public circulation corridors, pebble-wash for the open courtyards, white perforated aluminium screens and grey-tinted infill glazing. These carefully curated finishes not only suited the historic architectural expression but also complemented the exposed design of the M&E services.

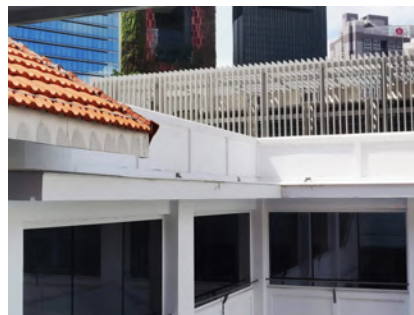
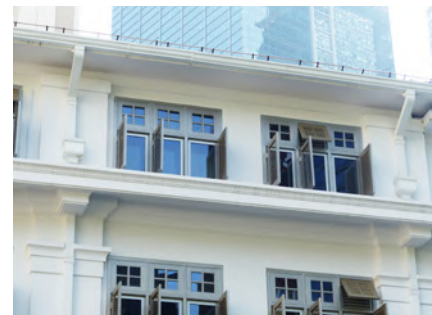
Right: ACMV equipment is located on the flat roof, discreetly screened by aluminium trellises.

Far right: Fresh air intake ducts are located on the facade, designed to be integrated with historic fenestrations so that no extra wall openings are needed.

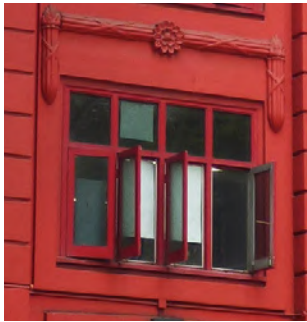
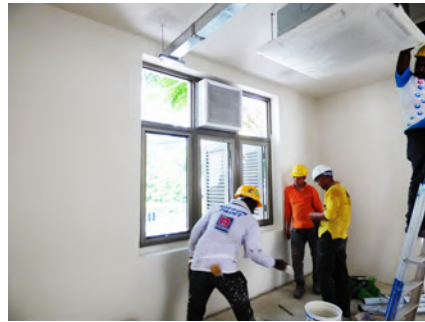
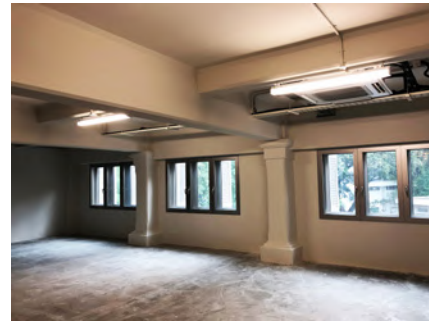
Left: Insensitively modified windows, many of which had their characteristic louvres and vents removed, were slated for restoration to their historic design.

Middle and right: Fresh air intake grille being installed behind a selected top light, connected to FCUs within the office units.

It was found that many windows had undergone ad hoc alterations. In particular, the original window toplights had mostly been replaced with latter-day ones of incompatible design. These were recommended for reinstatement to recover the legibility of the historic facade design – this presented an opportunity to **integrate fresh air intake with the reinstated toplights**. An aluminium grille was installed behind each selected reinstated top hung panel. The latter would be kept permanently half-open for fresh air intake to the ACMV ductwork, concealed within the plenum behind the toplights. The final design is unobtrusive; at the same time, the selection of top lights for modification was randomised across the building elevation, enlivening the otherwise regimented facades.

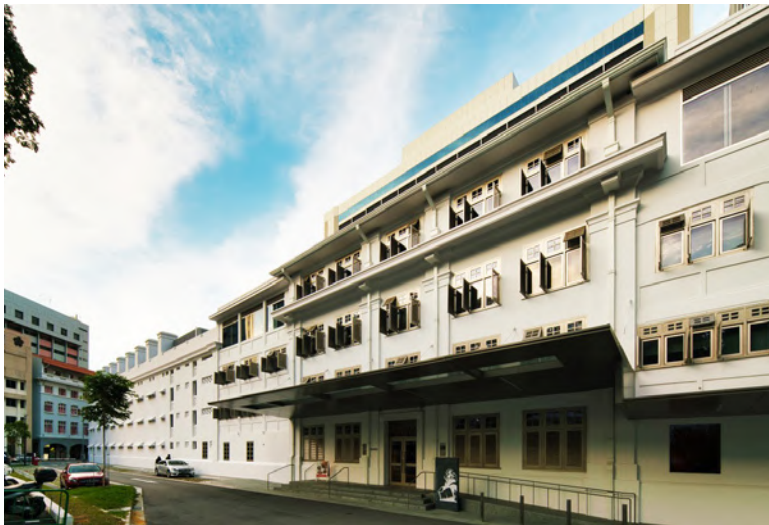
Above: The intake ducts are camouflaged by being located at randomly open top lights, creating visual interest on the facade.

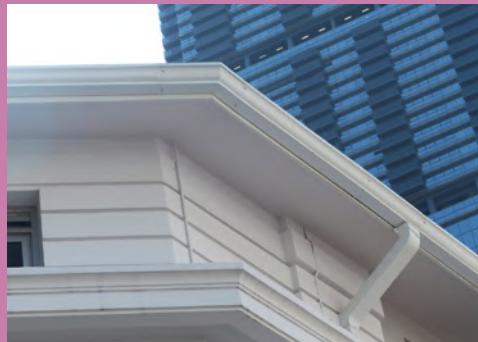
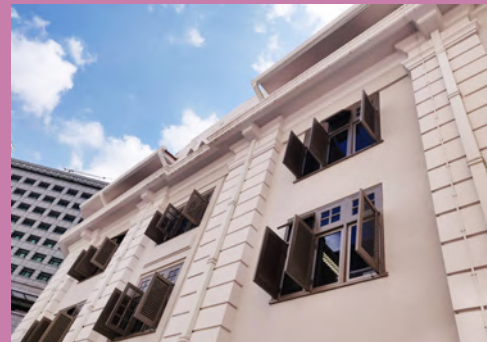
Left: **Badly deteriorated historic cast iron rainwater goods**. Middle and right: **Restored historic rainwater gutter and rainwater downpipes along all facades and internal courtyards of the building**.

Instead, the historic cast iron rainwater goods were **restored for continued use**. The rainwater goods were found to be badly deteriorated, with signs of corrosion, breakage and loss of components. A number of historic gutters had also been inappropriately replaced with galvanised steel parts in the previous refurbishment, resulting in the need for extensive **new fabrication**. **Localised repair and partial replacement** were prioritised over complete replacement of the rainwater goods where possible.

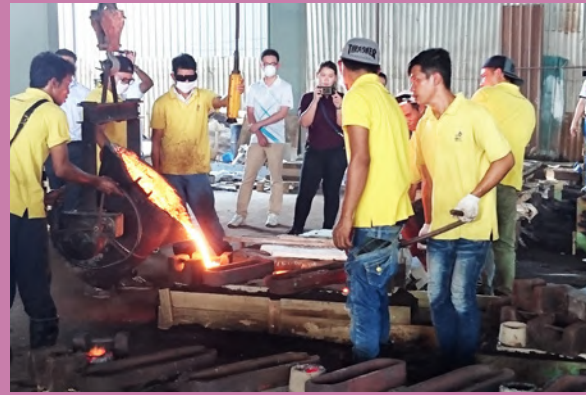
Molten iron being poured into a mould to recast rainwater gutters.

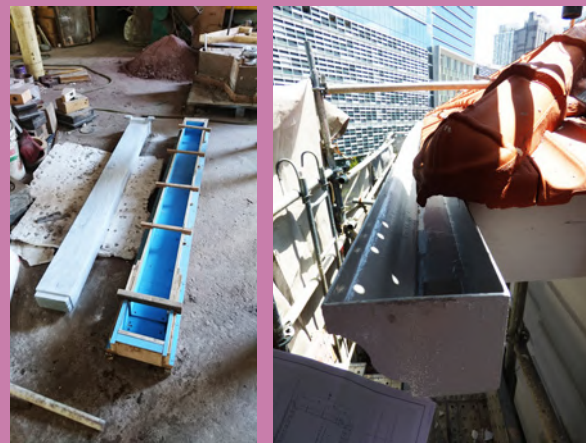
Left: A newly cast segment of rainwater downpipe. Right: Newly installed gutter. The repaired and replaced cast iron goods are treated with anti-rust coating and paint to protect them from deterioration.

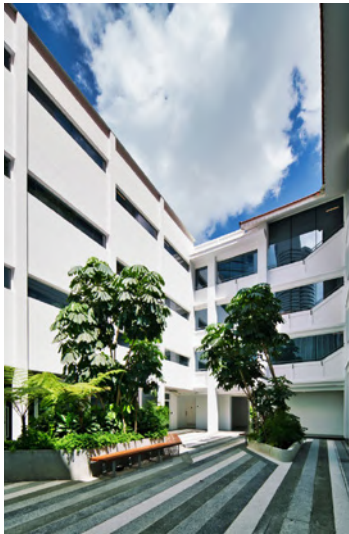
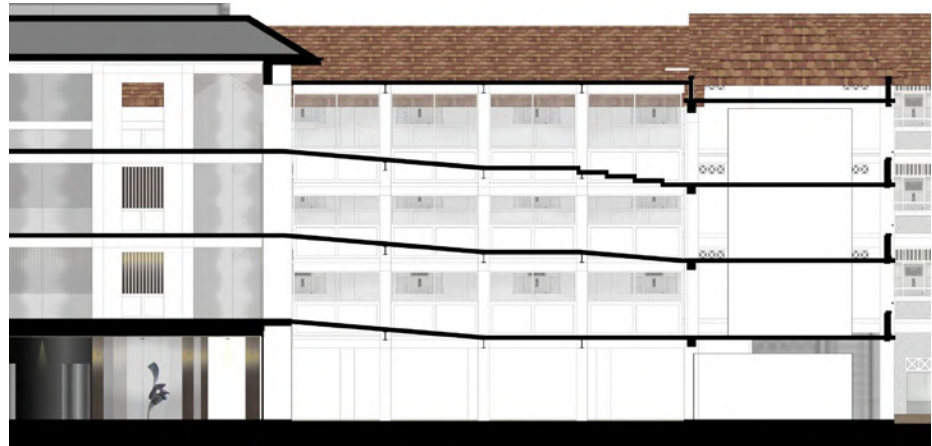
Left: Elevation outside the newly added corridors (on the left) subtly contrasts with the adjacent and opposite historic corridors. Right: Schematic section depicts introduction of accessibility-compliant ramps to offset level differences.

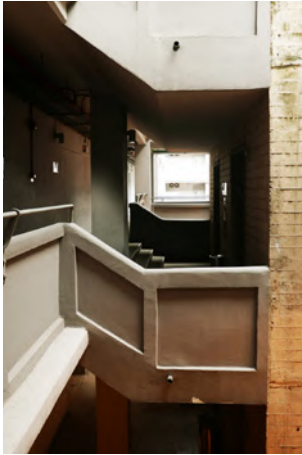
Above: Prior to this round of restoration in 2016, a small flight of steps was required to access the elevator lobby on every level, presenting challenges in accessibility.

Right: Section demonstrating existing accessibility barrier (dotted lines) and the enhanced design.

Another key universal access design issue involved **vertical circulation planning**. There was an existing bank of elevators in the central courtyard, which needed to be upgraded. The old elevator landings were a few steps out of alignment with the historic floor slab levels.

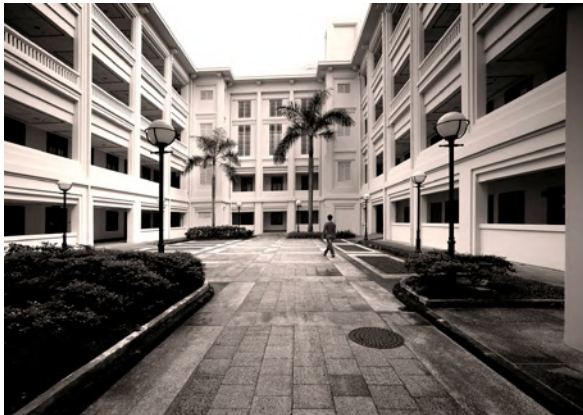
Above: The old City Hall courtyard prior to restoration.
Right: New atrium converted from the City Hall courtyard, with glazed roof that incorporates fire protection systems such as sprinklers and smoke extractors.

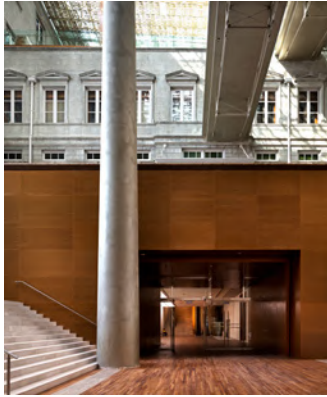
Aside from serving as a physical connector and new entrance point to the NGS, the new basement serves as a back-of-house and M&E spine between the two historic buildings.

Besides the glazed roof canopy and common atrium, another major design intervention that serve to unite two very different buildings as a single art institution was the new **three-storey basement concourse**. Due to the deep pile foundation of the Supreme Court, the basement was mostly located under the City Hall which had a raft foundation. However this still called for extensive structural remodelling and rebuilding, causing significant impact to the historic fabric.

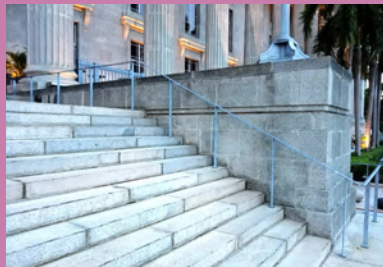
New mild steel safety railings in low-key design were added to the grand staircase at the old City Hall podium.
