CONSERVATION TECHNICAL HANDBOOK

Volume 8 | Managing Change

URBAN REDEVELOPMENT AUTHORITY

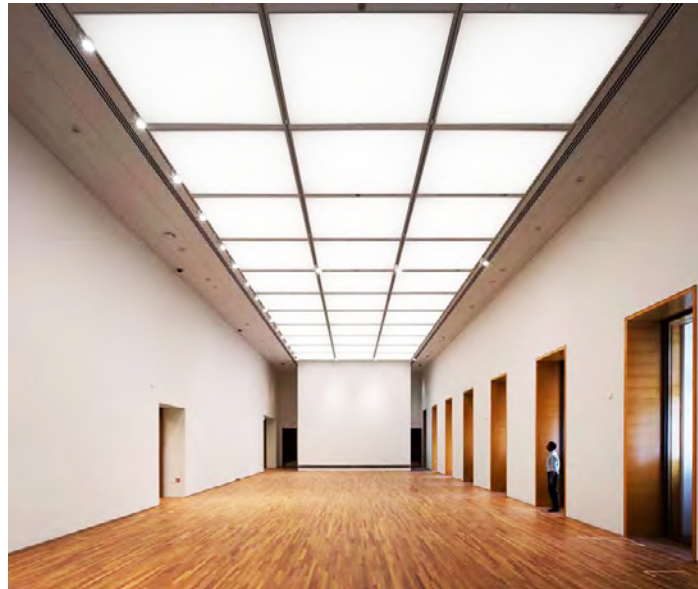
The introduction of dry partition 'fat walls' hugging the interior side of the historic facade walls was intended for the design integration of extensive services without obscuring existing openings or drastically changing spatial proportions.

Sectional details of the 'fat walls' at old City Hall (*left*) and Supreme Court (*right*).

The 'fat walls' of NGS – a new **secondary peripheral drywall** installed behind the historic facades – cleverly integrate this modern HVAC equipment while leaving original openings intact. Although the wall thickness takes up some usable floor area, several **critical building performance upgrades** – structural strengthening, M&E conduits, exterior lighting, daylight control, new secondary doors and windows with thermal, acoustic, anti-blast requirements – could be integrated within this single architectural gesture.

The 'fat walls' serve to attenuate the harsh tropical sunlight and maintain a stable internal environment, through incorporating new **secondary windows** with high-performance glazing to cut down on solar heat gain. The majority of the existing timber and steel framed windows and green-tinted glazing were retained as a result. This strategy thus ensured that the original scale and spatial quality of the historic architecture is maintained, while stringent performance requirements for a modern gallery are met.

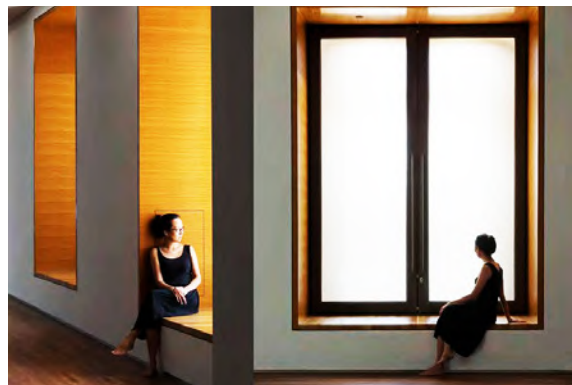
Translucent secondary glazing allows details of the restored historic windows to be appreciated from the inside while fulfilling climatic and security performance.

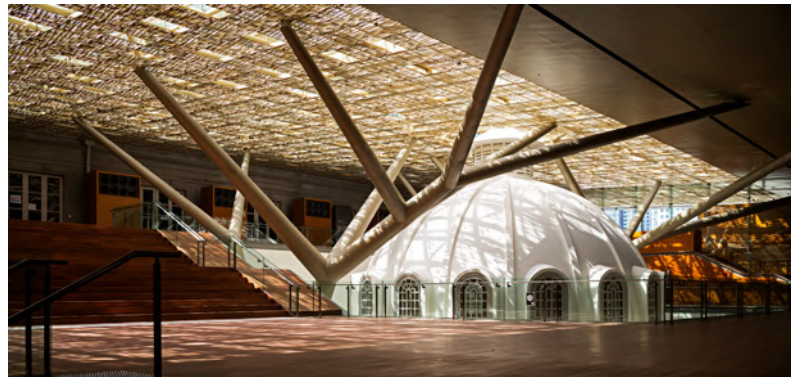
Right: The Rotunda dome restored in plaster and paint finish. The new roof terrace allows visitors to view the dome up close. Attractive shadow patterns reminiscent of traditional rattan weaving craft are cast.

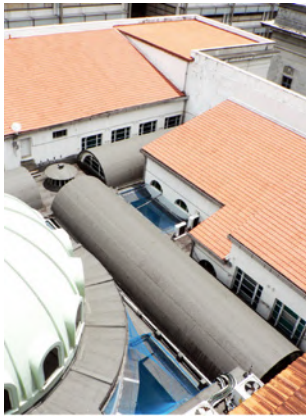
The historic roofscape – hidden from public view – originally comprised a series of barrel vaults, circular jackroofs and pitched roofs over the courtrooms.

The introduction of a new terrace above this historic roofscape was the **'best compromise' solution**, providing permanent weather protection. With the added roof plane, the second-storey hallways were no longer lit by daylight entering through the clerestories and skylights, with their historic ambience and spatial character somewhat diminished. Although there was still some diffused daylight through the restored corridor windows, the dramatic illumination highlighting the vaults and hallway junctions has largely been replaced by artificial lighting.

Nevertheless, the roof terrace and glazed canopy extension critically restored the **watertightness** of the old Supreme Court's building envelope, resolving the inherent design flaws of the original fragmented roof design. The airspace between the old and new roof planes could also be utilised as a continuous **building services plenum** where the thick swath of conduits such as ACMV ducting could be neatly accommodated and routed. These served the **heavily serviced new permanent collection galleries** converted from the **old court rooms**, routed through existing clerestories that opened into the rooftop service plenum space.

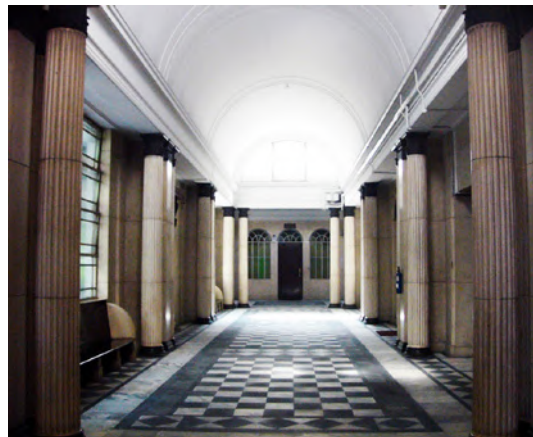
The clerestory lights facilitate daylighting and natural ventilation of the deep plan interiors, with dramatic illumination highlighting the corridor junctions, vaults and reflecting off the mother-of-pearl terrazzo finishes.

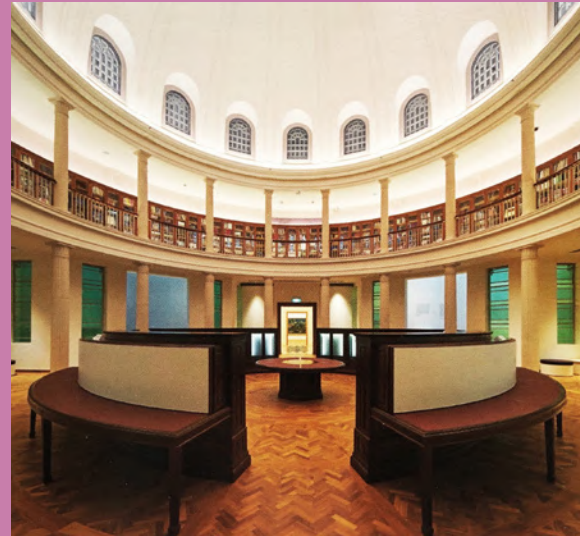
The restored Rotunda Library. New secondary anti-blast windows that match the historic design are installed at the clerestory lights of this space.

For high-security buildings, **apertures** in the building fabric present additional considerations. For this reason, some early building retrofits took the approach of sealing up original fenestration deemed to pose high security risks. Restored at a time when the threat of global terrorism was on the rise, an **enhanced security classification** on the National Gallery resulted in stringent requirements. **Anti-blast glass** is used for new enclosures such as the new roof canopies, and added to historic fenestrations via new **secondary windows**. A coordinated design can effectively conserve historic apertures while fulfilling security requirements.

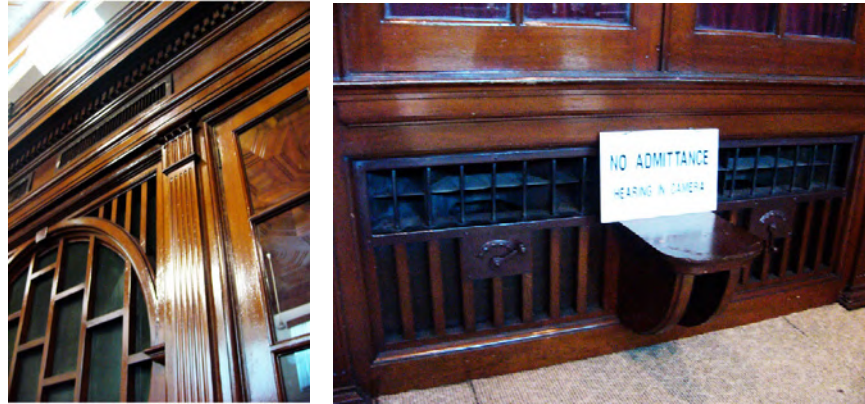
The historic Solo-Air cooled air system was cleverly integrated within the original timber shelves and dadoes of the courtrooms. These cavities and flues were partially reused in the NGS, and provided inspiration for similar treatment to conceal new M&E services within the architecturally important courtrooms.

As far as possible, the design team capitalised on and expanded **existing service interstitial spaces** to accommodate the new, much increased M&E provision. This included the **Solo-Air** cooled air ventilation ducting and flues cleverly integrated within timber panelling, cabinetry and furniture – one of the unusual historic design features in the old Supreme Court and an innovation of its times. A dense network of wiring and ducting was also integrated in the **existing ceiling space** above the restored timber ceilings. The result of this rigorous coordination is the elegantly restored courtrooms, adapted as the Permanent Galleries of the NGS.

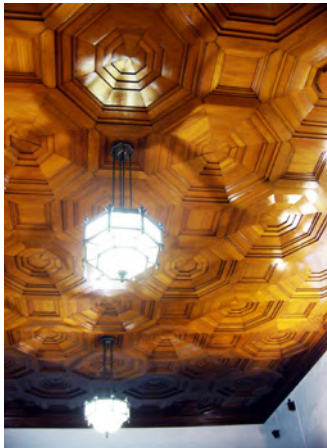
Left: The teak ornamented ceilings with historic bronze light fixtures before restoration. **Right:** The restored ceiling with new recessed downlights and fire protection sensors sensitively incorporated in a visually non-obtrusive way.

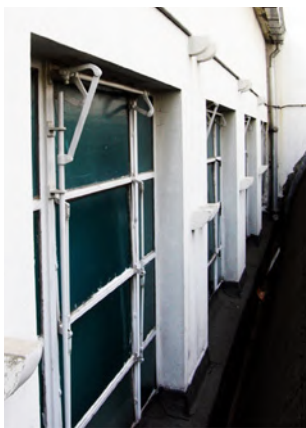
Exterior view of mild steel windows at the courtroom mezzanine, prior to restoration.

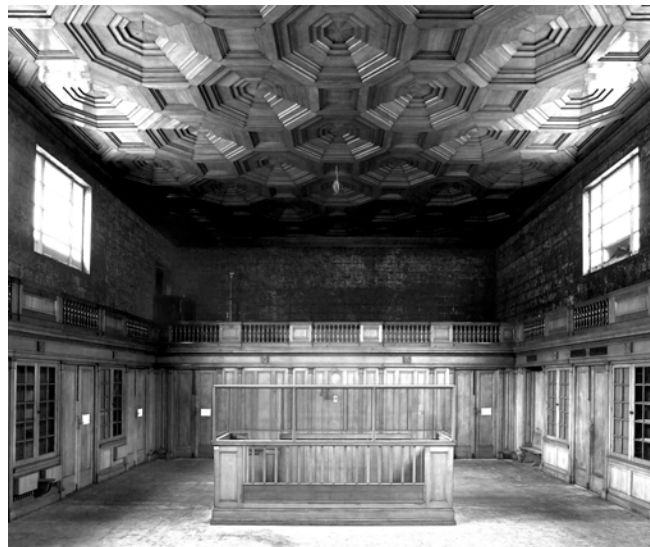
Left top: One of the courtrooms undergoing restoration. The mezzanine was originally lined with pivoted mild steel windows providing the interiors with daylight illumination.

Left bottom: A fully restored courtroom with original fittings, and new mezzanine dry walls installed over the mild steel windows. New services to control the room’s environment are discreetly concealed within the dry walls and ceiling.

Existing service spaces were still insufficient given the extensive servicing needed, and other areas of secondary significance were judiciously selected for intervention using the ‘best compromise’ approach. New secondary dry walls concealing air-conditioning ducts were installed along the length of the **courtroom mezzanine gallery walls**. These also covered up the mezzanine clerestories, now used as M&E entry points from the rooftop service plenum. While the historic mezzanine internal elevation and **mild steel clerestories** are obscured, and daylighting is sacrificed, the changes enabled the air-conditioning and strict interior lighting and humidity control requisite for gallery use.

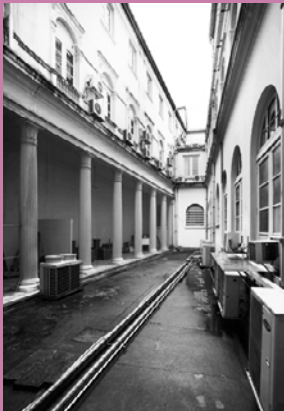
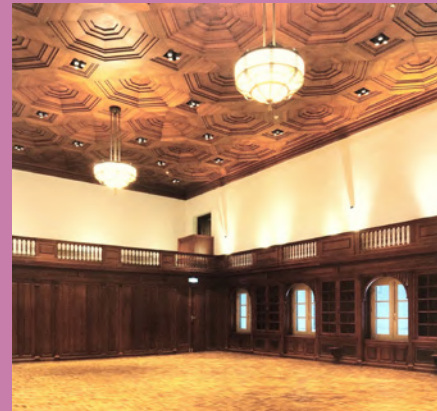
Window design enhancement for fire-compartmentation requirements.

Left and middle: The open-air courtyard before and after restoration; windows requiring fire protection are on the right side upper storey. Right: View of enhanced historic windows from within restored interiors.
