# CONSERVATION TECHNICAL HANDBOOK

A GUIDE FOR BEST PRACTICES

## Volume 2 | Roofs

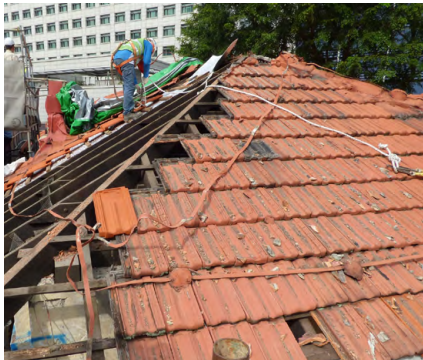
TIMBER BATTENS WITH INTERLOCKING CLAY TILES

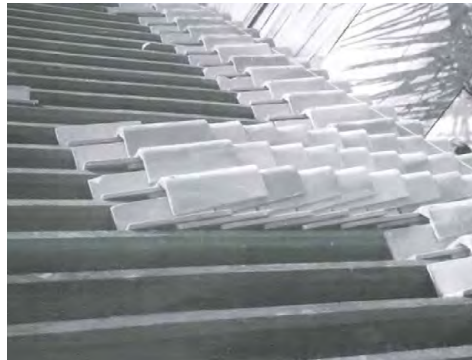
INCLINED TIMBER BATTENS WITH V-PROFILE TILES

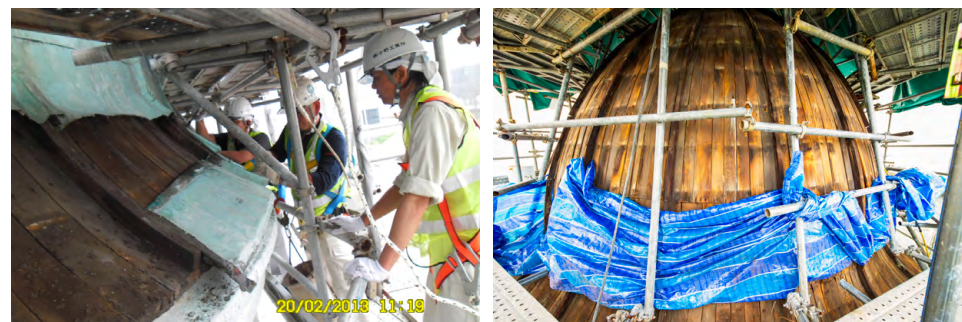
*Timber substrate for securing and shaping copper sheet roofing into a dome form.*

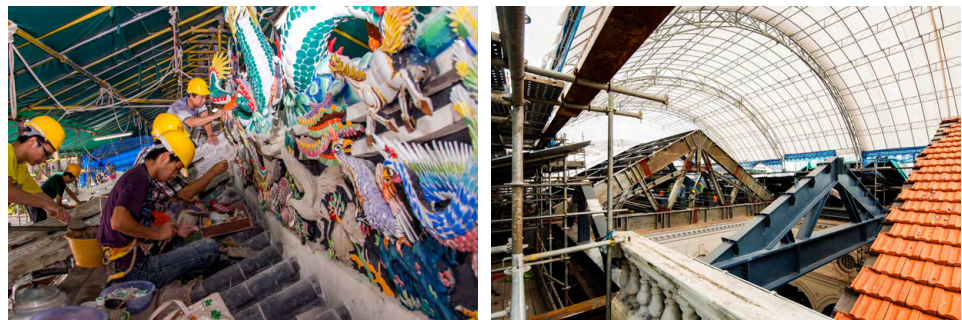
*Left: A simple pole-and-canvas temporary roof for restoration of delicate temple ceramic shardwork at Wak Hai Cheng Bio. Right: Mobile temporary roof mounted on tracks that can be moved according to the roof section undergoing works, at the Victoria Concert Hall.*

During major roof structural rehabilitation, roof cover restoration or replacement, a **temporary shelter** should be erected above the existing roof level to protect vulnerable interior elements such as timber finishes, wall ends and building components not intended for exposure to the climate. A temporary shelter is also critical to ensure an all-weather environment that allows for conservation work whether on the roof or at the exposed interiors.

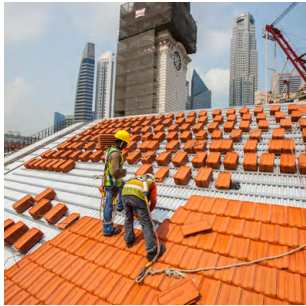
*Interlocking clay tiles laid on metal battens atop secondary metal roof.*

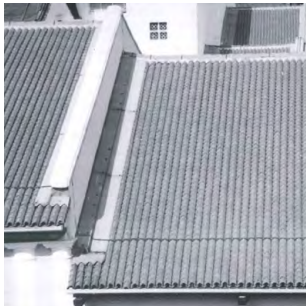
*New flashing lining the junction between roof covering and partywall.*

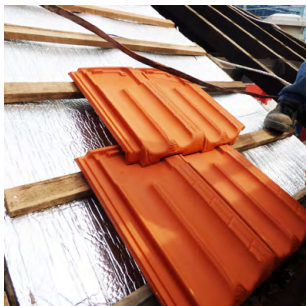
*The new sisalation foil is secured to the rafters together with the battens above. Tiles are then laid on top as the final roof layer. Pads of rockwool would usually be added below, between rafters.*

An added metal decking may lead to increased heat gain to the building interiors - this should be mitigated by sufficient roof insulation and ventilation of the roof space. During major roof conservation works, sisalation and rock wool layers are often added to the roof build-up to improve thermal and acoustic insulation for better interior comfort, as well as energy-efficiency, especially where air-conditioning is introduced to the historic building. Sisalation foil sheets also act as an added waterproof layer.

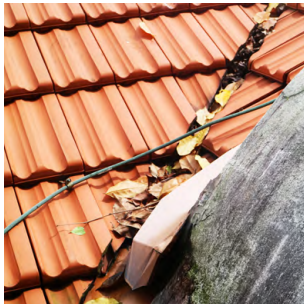
*Leaf litter choking up roof valley gutter – unreachable areas such as this may only be detected with elevated access or via a drone recording.*

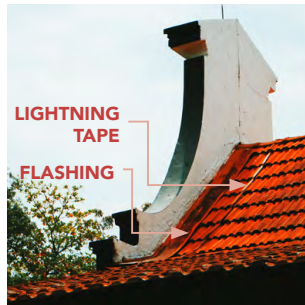
Roof accessory elements to check during maintenance inspection.

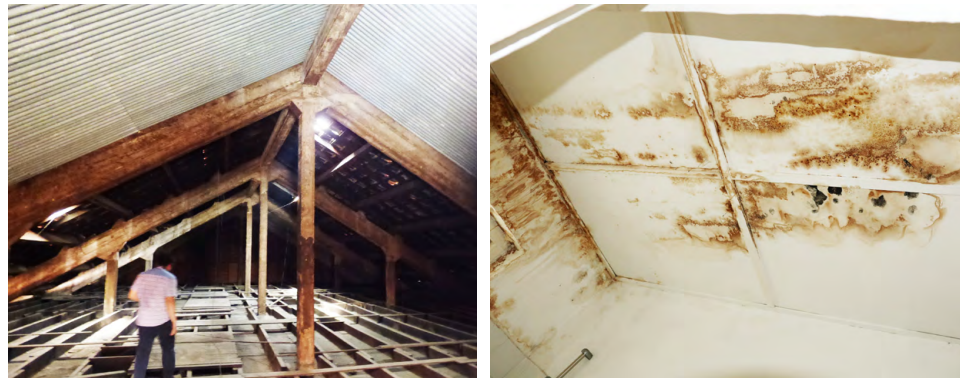
*Left: Inspection of roof space between ceiling and roof covering. Right: Water ingress through defective roof causing ceiling stains and deterioration.*

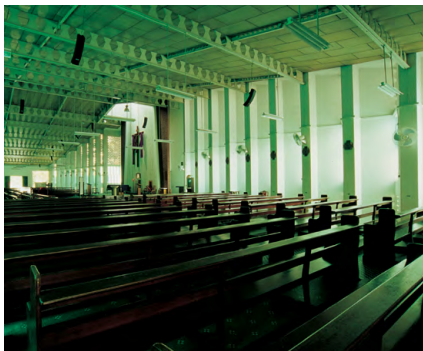
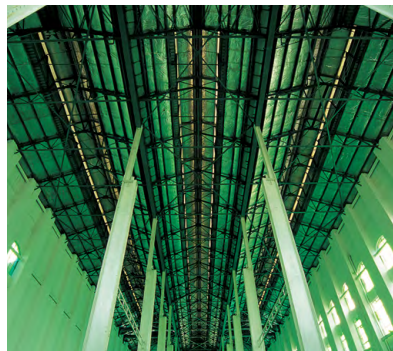
*Left: Castellated steel roof beams span the interiors of Church of St Bernadette (1959) by local architect Alfred Wong. Middle: The lightweight steel-framed roof of the St James Electric Station (1927) was brought to site in pre-fabricated components and assembled together using rivets. Right: Telok Ayer Market (also known as Lau Pa Sat, 1894) features cast iron pillars and roof trusses.*

The subsequent development of castellated steel beams, with perforated web-plates and increased depth, created stronger structural members without additional material or weight.

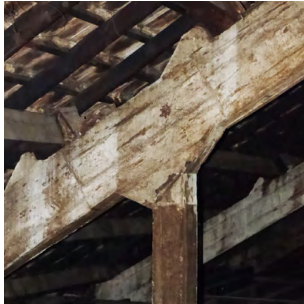
RC roof truss details of Ellison building (1924) - cast with notches for receiving timber battens and monolithic joints.

Some of the shophouses of the early 1920s, such as Ellison Building, featured the traditional triangular-truss roof but constructed in RC. A more expressive example can be found in Clifford Pier (1933). The Church of St Teresa (1929) features RC portal frame roof, constructed by Brossard and Mopin.

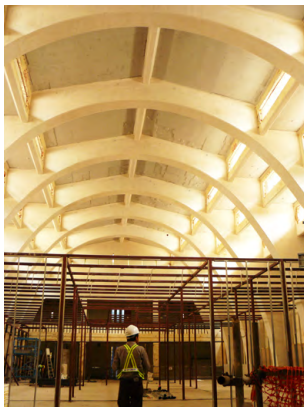
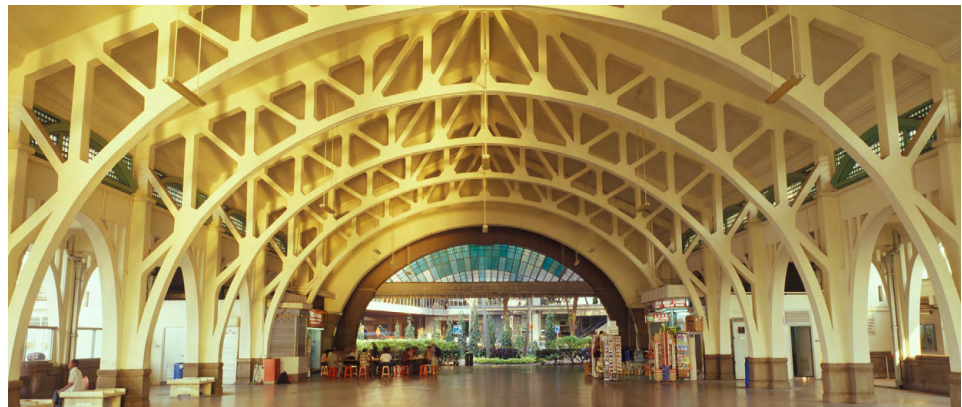
**Left:** The series of two-storey parabolic arch frames at SSVF Drill Hall (1934) springs from the ground level and frames the lofty upper floor hall space, supporting a stepped profile roof with integrated clerestories. **Right:** RC arched trusses of Clifford Pier (1933) function as both the structure and the roof, providing an expanse of column free space, while the exposed trusses define the quality of the space below.

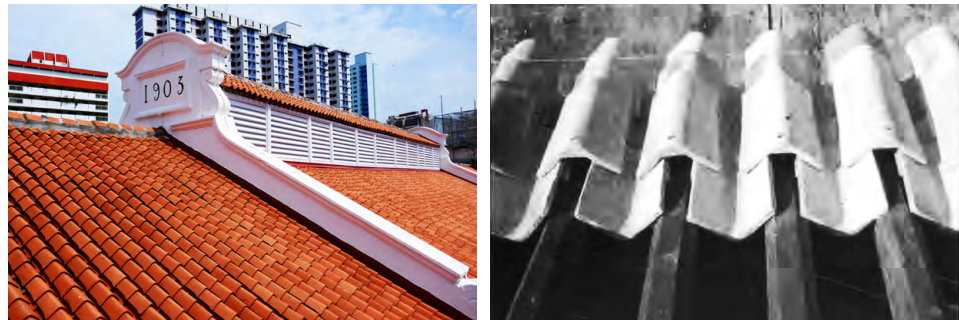
*V-profile tiles are laid by nestling rows of upturned tiles between closely spaced inclined battens forming 'valleys', and overlapped with alternating rows of upright tiles forming 'ridges'. The tiles could also be layered on in twos or threes for added water-tightness.*

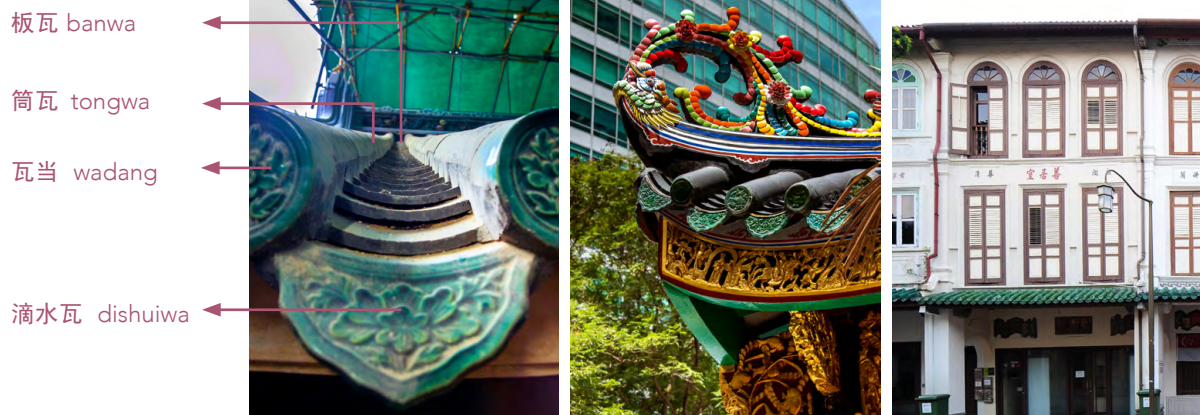
*Left: Different tile types in the Chinese roof tiling system as seen at Wak Hai Cheng Bio. Right: First storey awning with green glazed Chinese tiles and granite bracket at a shophouse along Telok Ayer Street.*

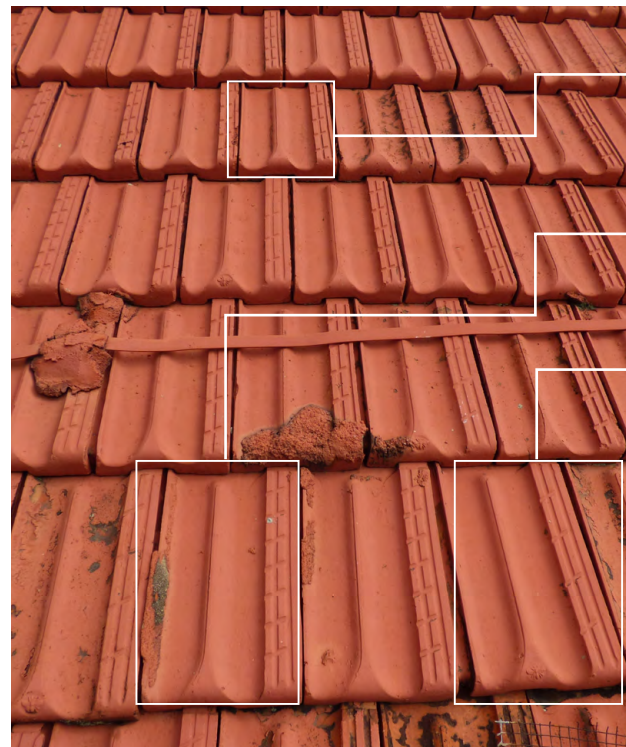
Three different brands of Marseille found on the same roof plane, identified by the different imprinted brand logos.

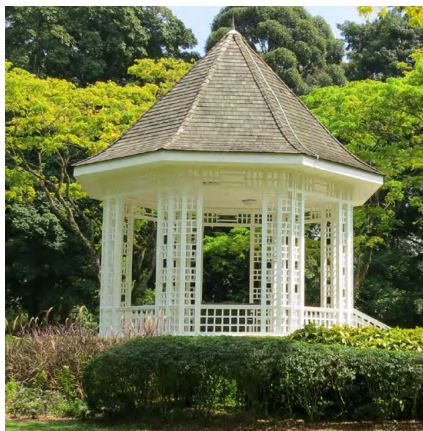
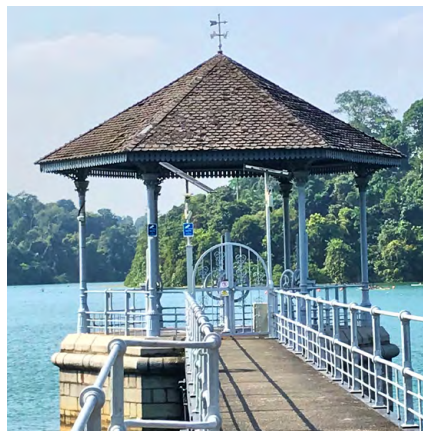
*Left:* Bandstand with timber shingle roof covering, Singapore Botanic Gardens. *Middle:* Gazebo at the MacRitchie Reservoir with slate roof covering (stone shingle). *Right:* Pressed metal shingle at National Museum of Singapore.

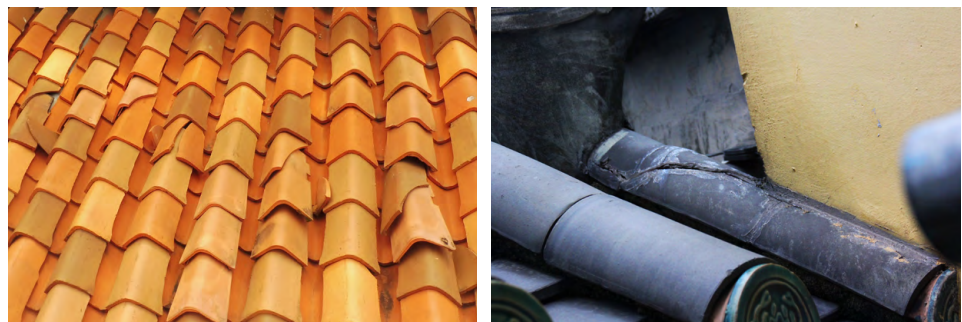
*Roof tile breakage*

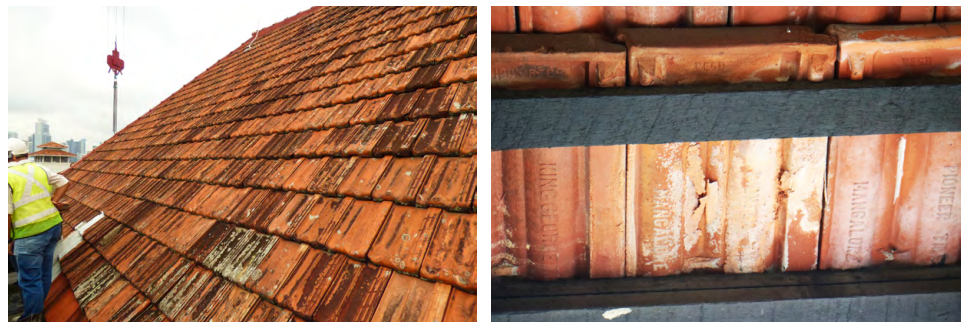
*Left: Eroded tile surface and biological growth. Right: Efflorescence, or salt crystallization on roof tile – due to the clay tile body containing high salt content.*

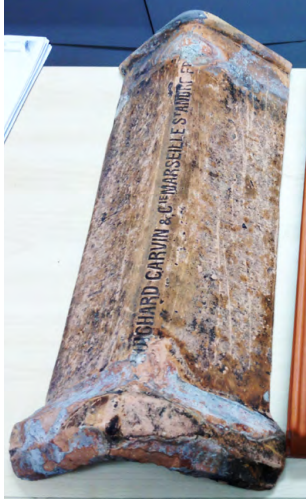
*Weathered ridge tile showing surface erosion, chipping, cracks and flaking.*

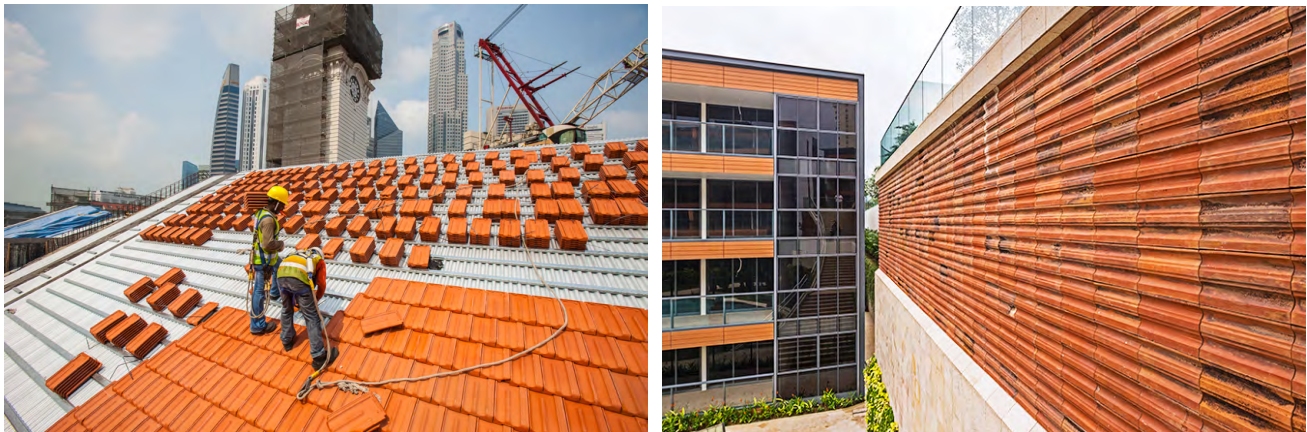
**Left:** Corrugated metal deck as secondary roof receiving galvanised steel battens and Marseille tile finish, at the Victoria Concert Hall. **Right:** Salvaged historic Marseille roof tiles upcycled as landscape feature wall in the adaptive reuse development Sophia Hills.

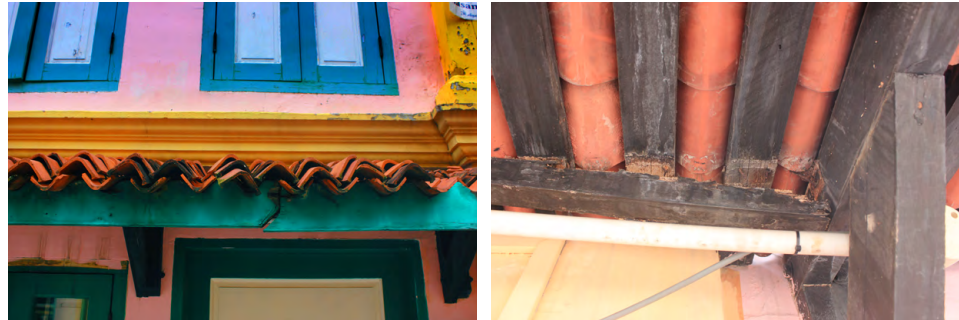
*Deterioration and dislocation of v-profile tiles, disjointed roof timber members suffering from wet rot and structural risk – defects that should have been detected and addressed in their early stages by regular maintenance were instead left to worsen.*

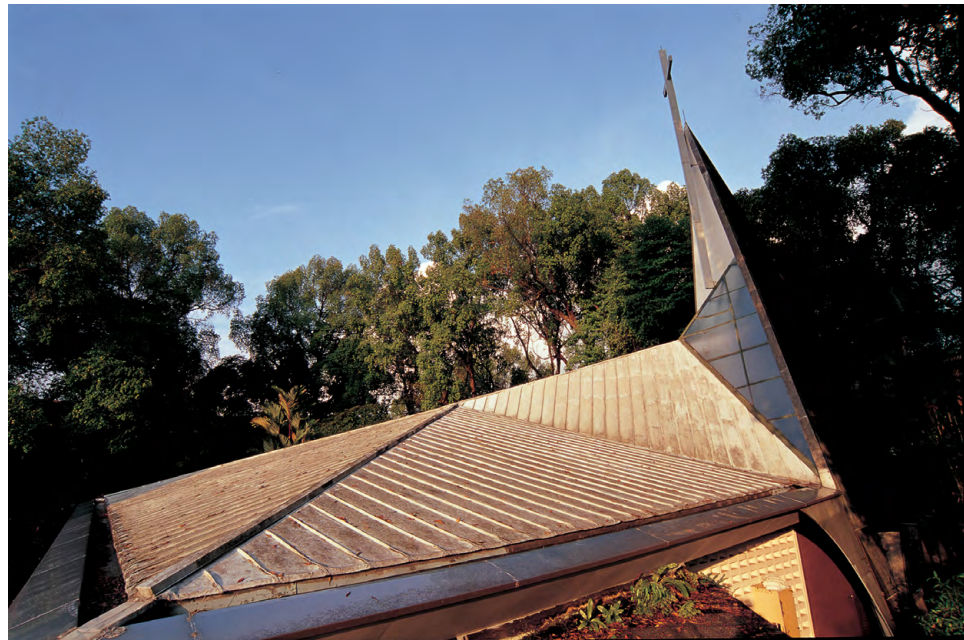
*Maris Stella Chapel features an expressive roof composed of a few simple pitched roof planes with sheet metal roofing, constructed in situ with hand-crimped standing seams that are folded flat at the edges. A skylight is incorporated as part of the roof design.*

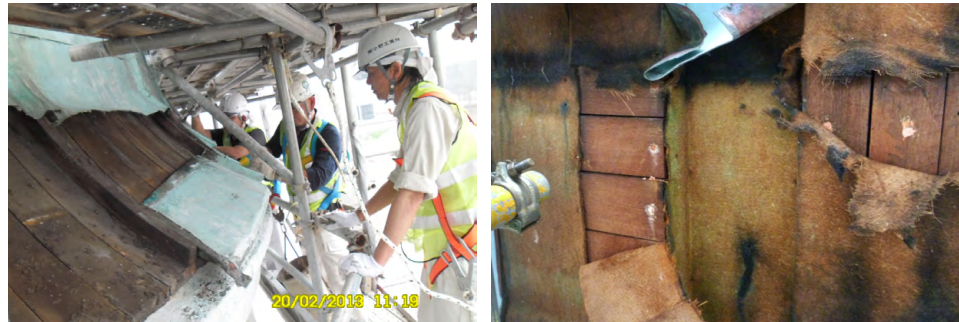
Alternatively, regular size metal roof sheets were laid over the timber substrate, often with an added layer of insulation fabric or felt in between, painstakingly worked by hand on site. Single- and double-lock seams are used to join the sheets and form the roof covering. In some cases there are no seams and the metal sheets are nailed directly onto the timber backing. At the Victoria Theatre and Concert Hall (1905), the dome roof atop the clock tower is built using small copper sheets wrapped around a 'barrel' substrate supported on timber ribs.

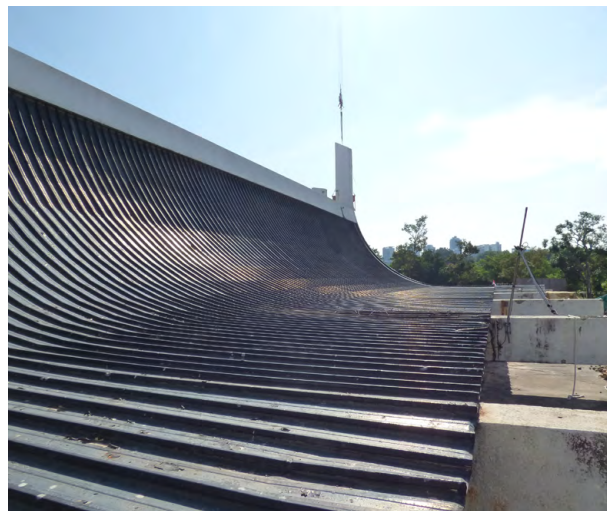
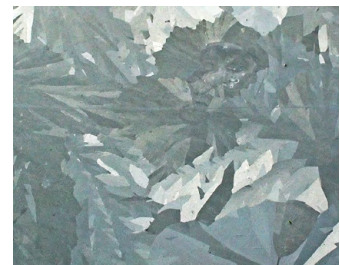
**Right:** Corrugated galvanised steel sheets used for a distinctive roof form with sweeping curve profile of the former Trinity Theological College Chapel (1960s). **Far right top:** Close-up view of galvanised steel. **Far right bottom:** Channels of the profiled sheet run from ridge to eave facilitating drainage, with the edge of the metal sheet folded down slightly as a drip detail at the eave.

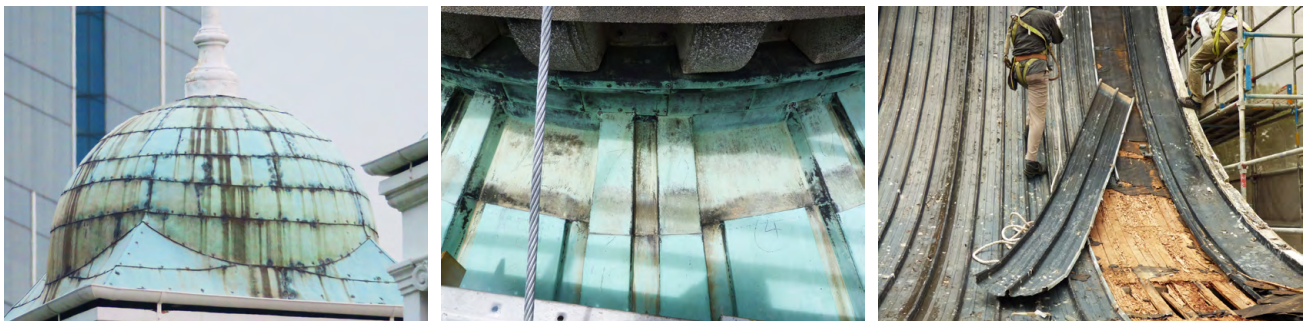
*Left: Iron rust run-off on copper roof. Middle: Inconsistent erosion of patina layer and stain accumulation due to different exposure, run-off of water and effect of pollution. Right: Termite attack in the timber backing below the galvanised steel roof sheets and insulation felt/fabric.*

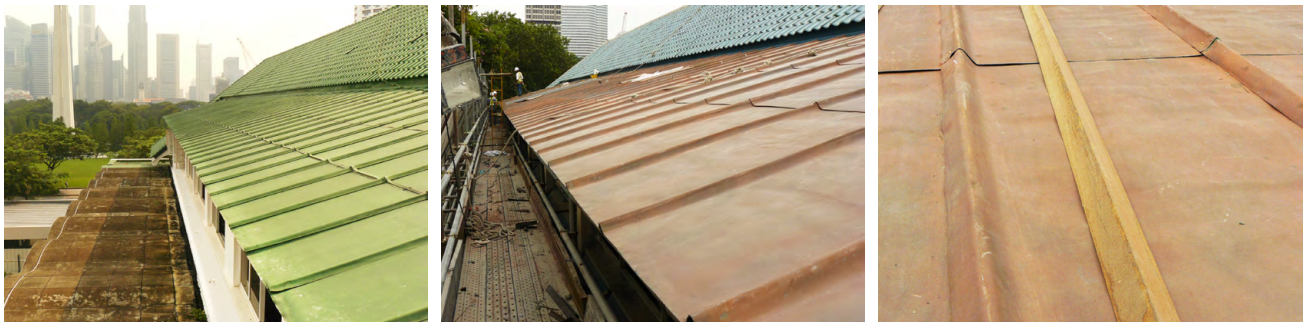
*Left & middle: Inappropriately painted copper pitch roof – before and after paint removal. Right: Deteriorated roof sheets were selectively replaced – photo shows timber strip used for manually forming the triangular profile standing seams.*

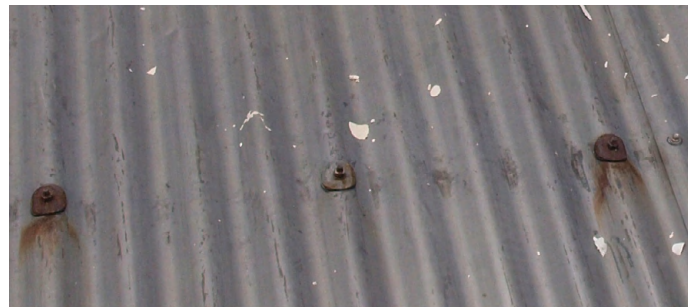
**Right:** Due to long term maintenance concerns, powder-coated steel sheet was used when replacing the badly deteriorated painted galvanised steel roofing at the Cathedral of Good Shepherd spire. Nonetheless it has the same base metal - iron.  
**Far right:** In corrugated galvanised iron sheets, there is tendency to rust around fixings, in the form of crevice corrosion.

Rust on galvanized iron may be removed and the roofing sheet recoated with zinc through galvanizing processes (hot-dip galvanizing, electro galvanizing, sherardizing and metallic spraying). In corrugated galvanized iron sheets, there is tendency to rust around fixings, in the form of crevice corrosion. This may be repaired by inserting a slip-sheet with matching profiled corrugated sheets with provision for sufficient overlap and proper fastening.

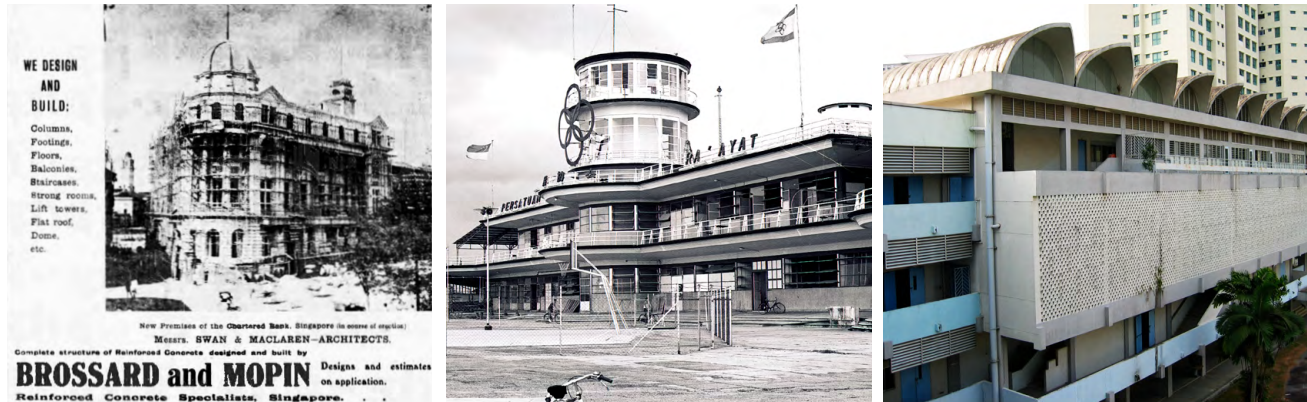
*Left: Advertisement showing Chartered Bank with its RC dome roof, under construction in 1916. Middle: Kallang Aerodrome (1937) with generous flat roof decks where people could watch planes land or take off. Right: Expressive RC pointed vaults with clerestoreys incorporated at Nan Chiau High School (1965).*

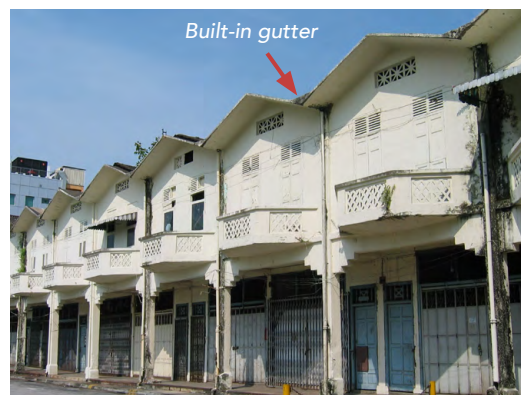
*Jellicoe Road warehouses (1920s) feature a series of thin shell RC pitch roofs with built-in gutter at the valleys.*

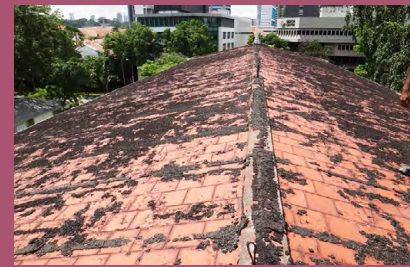
*The topmost bituminous waterproofing membrane of the RC roof slab has badly deteriorated, revealing the underlying terracotta tile layer.*

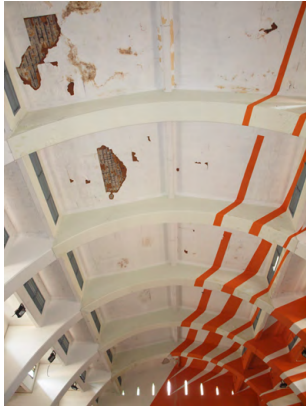
*Prolonged rainwater infiltration through compromised RC roof cover can result in complete carbonation of the concrete, resulting in extensive corrosion of rebars and concrete spalling.*

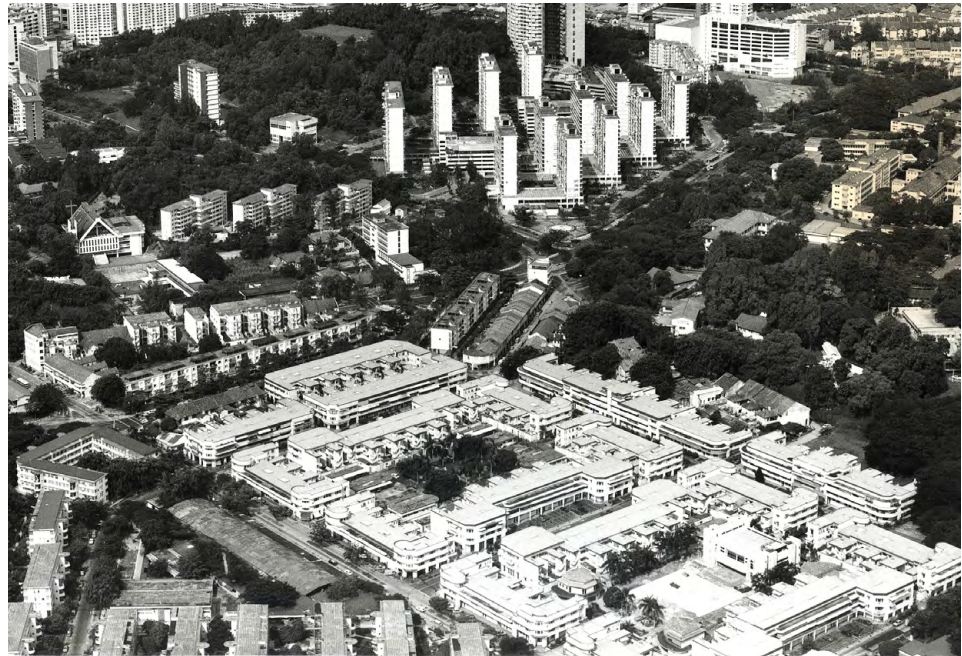
*The top floor units of early public housing flats with RC flat roof experience high heat gain.*

The builders and designers of some early flat roofs have not catered sufficiently for the tropical climate thermal heat gain, resulting in overly warm interiors. Particularly for residential buildings, it may be necessary to introduce a secondary roof over the RC roof to improve thermal comfort.

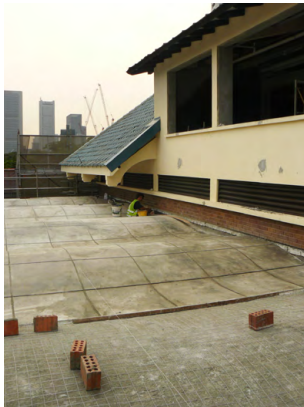
*Applying finishing screed to restored thin shell RC vaulted canopy. The original roofing did not have a waterproofing layer, and adding one would have changed the thin-shell roof aesthetics – instead a waterproofing additive was added to the finishing screed.*

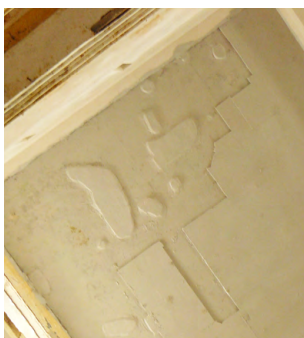
*Concrete rehabilitation by integration repair—white patches of fiber-reinforced mortar applied on badly spalled RC roof slab to return strength and integrity to the concrete cover.*

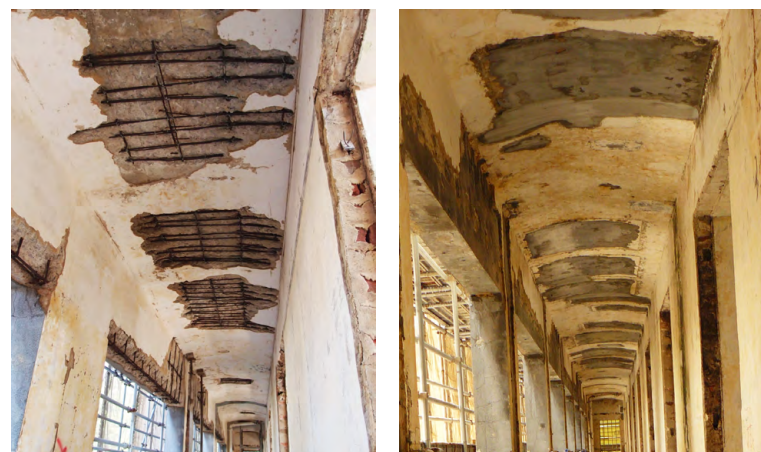
*Repair of RC roof concrete spalling – removal of deteriorated concrete and rust, replacement of rebar if necessary, treat with anti-rust coating, and patching with compatible mortar.*

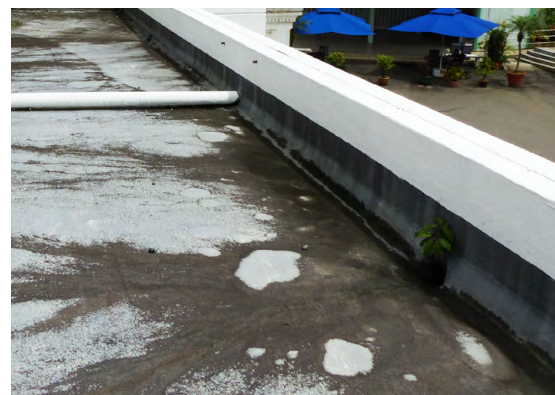
*Exposed waterproofing membrane with blistering and other defects should be replaced.*

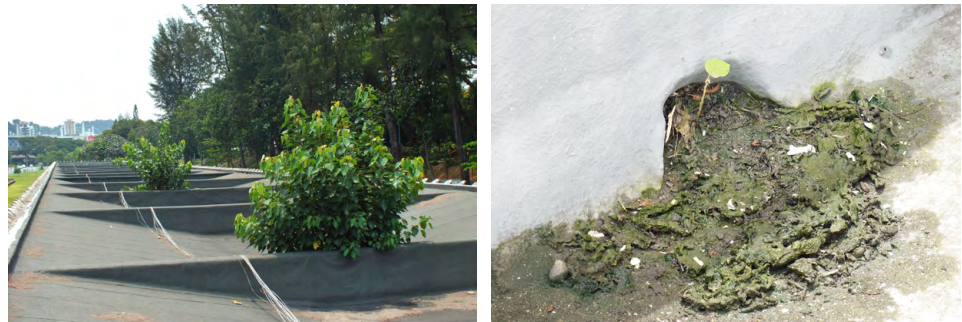
**Left:** Plant growth on RC roof canopy where the drainage holes are located suggests that there is chokage – any debris should be cleaned, and vegetation growth carefully removed and treated with herbicide. **Right:** Accumulation of dirt, debris and plant growth at the drainage holes of an under-maintained flat roof.

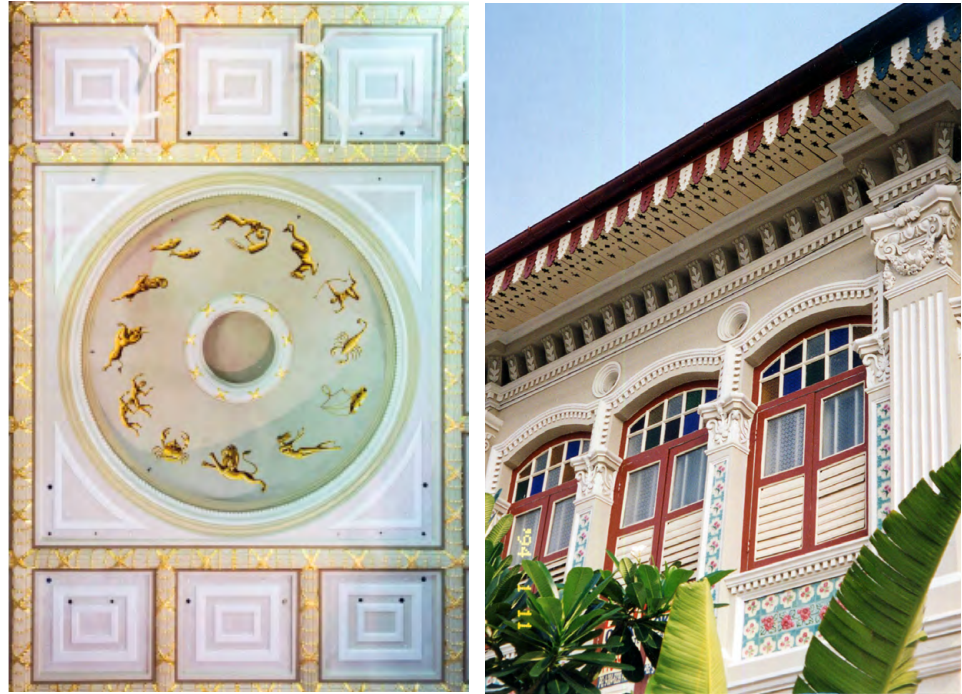
*Right: Capitol Theatre is famed for its massive ornamented ceiling that featured precast elements in a stylised reed bunch design, with cornices made of in-situ render on lath.*  
*Far right: timber strip eave soffit with decorative fretwork that also serve as vents, at a Koon Seng Road townhouse.*

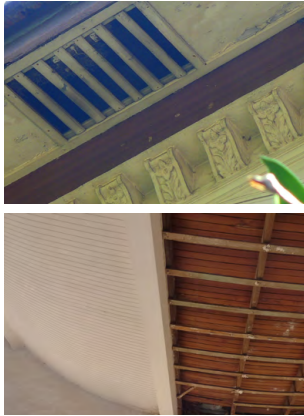
**Top:** Timber board eave soffit with a ventilation panel. **Above:** Exposed timber ceiling joists on which the timber strip ceiling (as seen on the left) was secured.

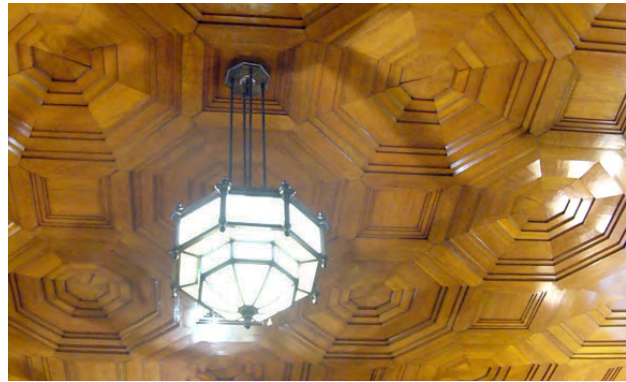
*Top: Timber strip ceiling overlaid with decorative fretwork at the Cathedral of Good Shepherd. The centre row of dropped circular ceiling panels allows for the escape of rising warm air through the roof space and jack roof above. Top right: Teak coffered ceilings convey a sense of formality and understated opulence in an otherwise restrained, monochromatic material palette at the former Supreme Court.*

The original simple plastered ceiling of the Cathedral of the Good Shepherd gave way to an elaborate timber strip ceiling in the 1910s, when it underwent re-roofing works. The use of timber for ceilings are, not surprisingly, reserved for buildings of stature – due to its much higher material and labour cost. Given their heft compared to plaster ceilings, timber ceilings also require the use of heavy gauge timber, or mild steel framing. The Cathedral timber ceiling incorporated a row of dropped panels, allowing hot air to move through the roof space and escape via louvred openings of the jacked roof above the ceiling.

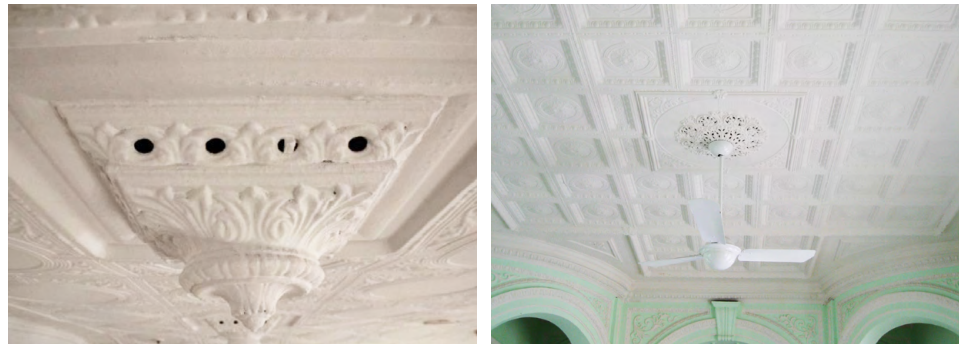
**Top:** Dislodged soffit plasterboard panel. **Above:** If ceiling water ingress is left untreated, the damage may worsen to paint peeling, staining, timber joist wet rot, termite infestation, and may even affect adjacent structures or elements.

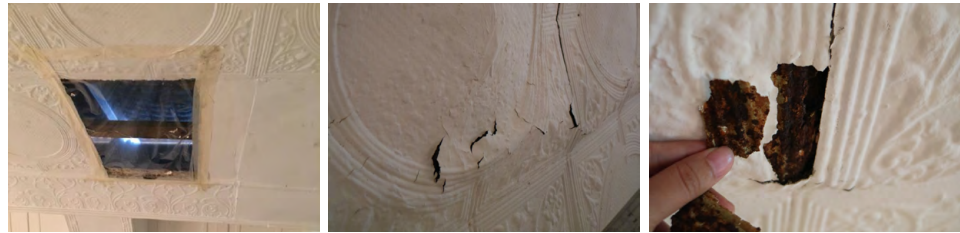
**Right:** Incompatible patching of ornamental ceiling. Panel dismantled to reveal termite infested ceiling joist. **Middle:** Badly deformed metal ceiling panel. **Far right:** the thick paint layers are peeling, exposing the severely corroded metal beneath.

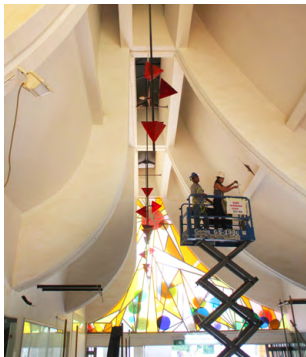
Ceiling inspection using elevated access equipment to reach high areas.

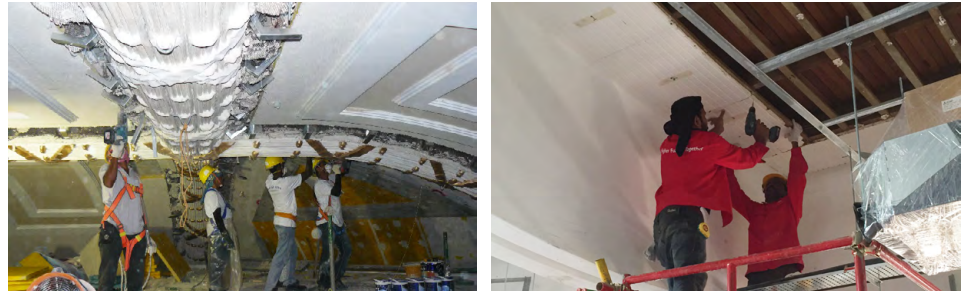
*Right: The elaborate precast ceiling ornaments of the Capitol Theatre have been painstakingly restored, while the badly deteriorated plaster on lath trim had to be replaced with new material that matched the existing design. Far right: Installation of replica timber strip ceiling to replace the deteriorated sections.*

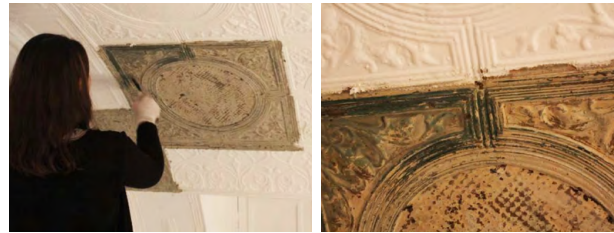
*Trial for paint removal of ornamental metal ceiling panel.*

It is much more challenging to restore stamped metal ceilings in the local context due to their extremely fragile nature and usually poor condition. It is critical to first stabilize and consolidate the surface as preparatory works that precede the actual conservation and repair work. A new substrate would need to be designed and installed to reinstate the integrity of the ceiling.

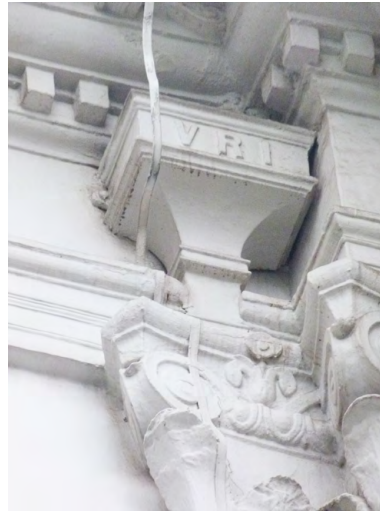
*Right: Cast-iron rainwater head or hopper incorporated as a building ornament. Far right: 1929 newspaper advertisement for cast-iron rainwater pipes.*

By the 1920s, most buildings in Singapore were outfitted with gutters and downpipes. The most common types were made of **cast-iron** or **galvanized iron (GI)**, produced in Scottish foundries as prefabricated segments, marketed via sales catalogue, shipped, and assembled quickly on site. Later on, rainwater goods became available in mild-steel. A major manufacturer that supplied to Singapore was Walter Macfarlane & Co. in Glasgow. Due to their robust material, where maintained properly, most historic rainwater goods are found to be intact and still in serviceable condition.

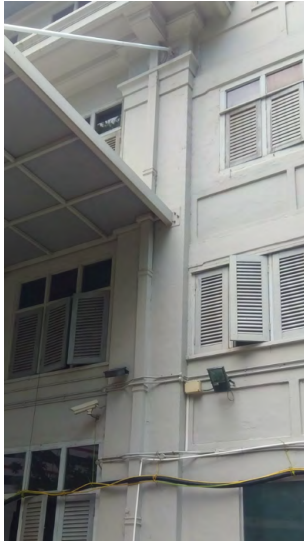
*Rainwater goods that are an integral part of the historic building design may be retained and restored as heritage elements even if they no longer perform the main drainage function.*

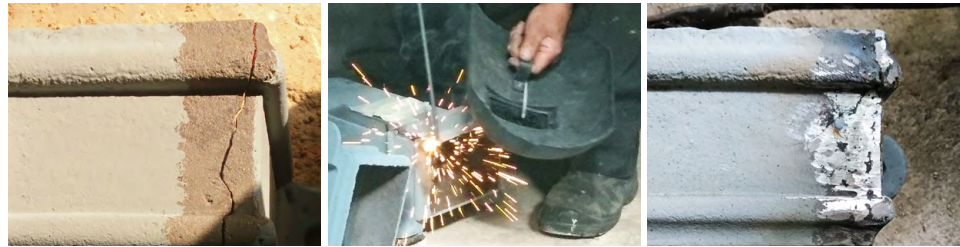
*Crack repair by welding for cast iron downpipe.*

For partial replacement of badly damaged or corroded parts, new parts or new casting can be welded to the existing. The replacement parts should be of the same metal composition as the surrounding original parts to ensure compatibility and avoid bi-metallic corrosion. Welding can also be used for crack repair. Cast iron is difficult, but not impossible to weld – the work should be carried out by professional and experience welder. There are many methods of welding cast iron such as the traditional arc welding, metal inert gas welding and tungsten inert gas welding. There is a need to control the speed of welding and the current applied to prevent overheating and cracking of the cast iron. The use of nickel-based electrodes is recommended.

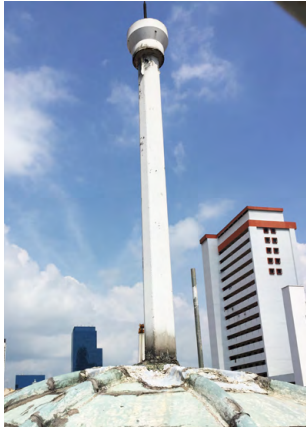
*Corrosion, paint peeling and staining observed around the anchor point and joints of a metal flag post mounted atop a copper dome roof.*

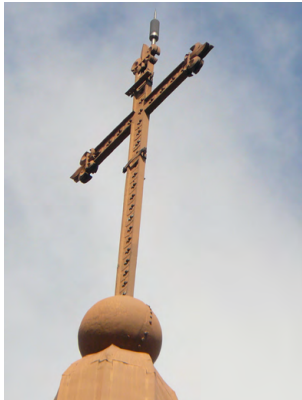
*Brass crucifix at Cathedral of the Good Shepherd. Crucifixes on top of church spires are often highly inaccessible, and usually repaired and restored when the main building undergoes major works.*

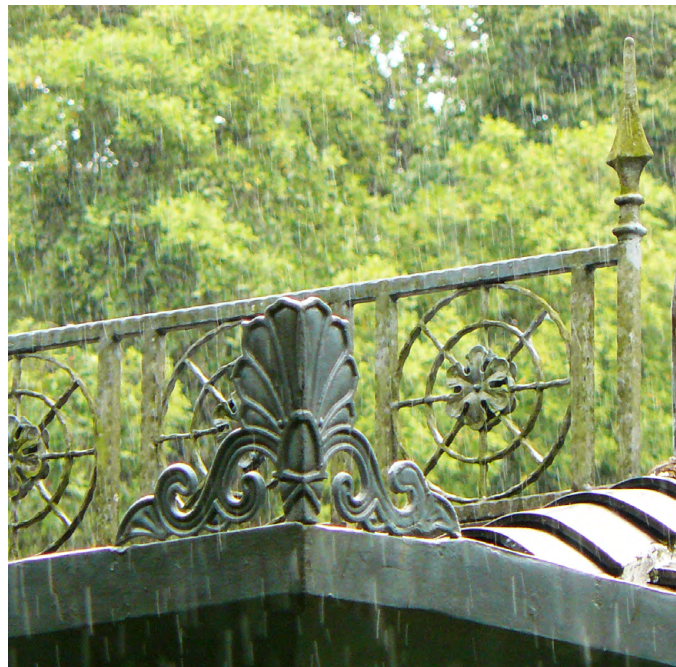
*Such roof ornaments, along with the pavilion they adorn, were usually ordered as a set off the same cast iron foundry catalogue and imported from UK in the colonial period. While the antefix is original, the ridge ornament behind has since been inappropriately replaced with a wrought iron replica.*

For ornamental roof ridge, an accurate documentation of the features and missing parts should be made via drawings, photography or 3D scanning. Such recording should help to identify damaged or missing parts that need replacement or repairs.

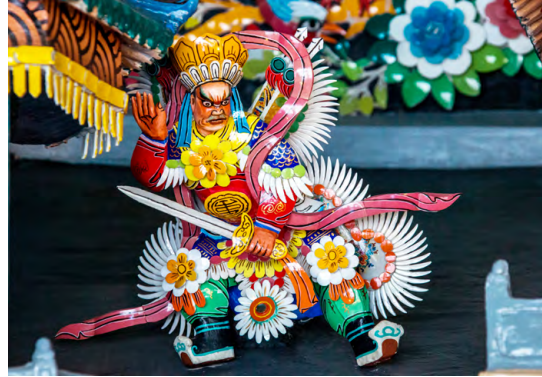
Shards cut from purpose-made glazed ceramic coloured bowls, secured in place with mortar, are used to create a variety of motifs.

Restored qianci figurine at Wak Hai Cheng Bio. The ceramic shards are used for clothes or draperies while the faces and limbs are usually moulded in plaster and painted with pigments.

In Singapore and around the region, it is not uncommon to find 3-dimensional and bas-relief ornamentation that is composed of cut ceramic shards secured with mortar, more commonly as decorations on roof eaves and ridges, but also seen on façades and interior walls, typically on buildings of Chinese origin or influence.

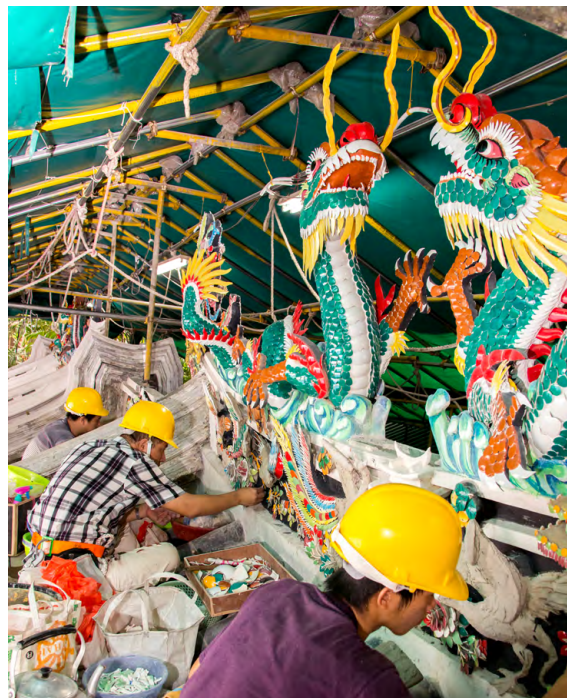
*A temporary roof is erected while skilled artisans are flown-in to undertake the delicate and painstaking work of restoring rooftop qianci at Wak Hai Cheng Bio.*

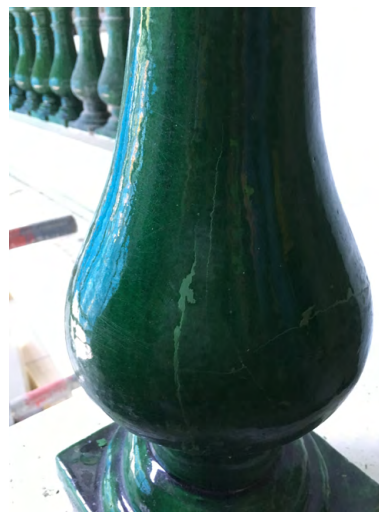
*Patching of fine cracks on green glazed bottle balustrade.*

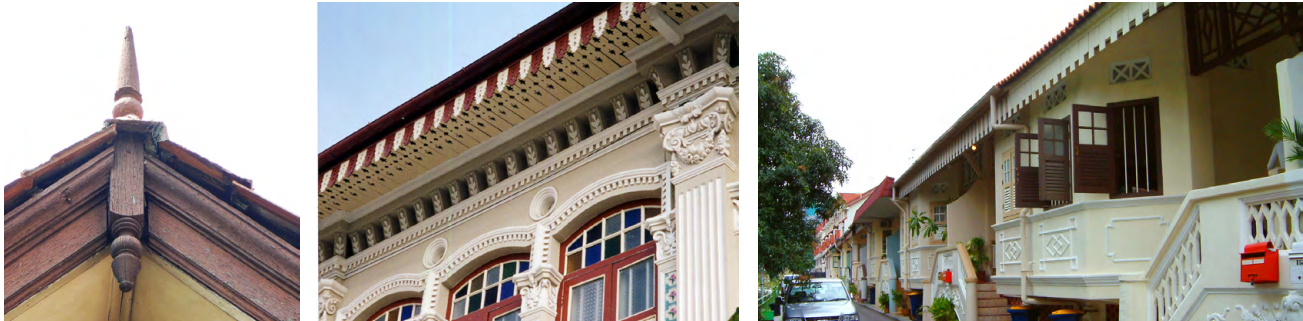
*Left: Gable end finial and profiled fascia board at the Rectory of Cathedral of the Good Shepherd. Middle: Decorative timber fretwork that doubles as drip detail to break up the rainwater runoff. Right: Dentil-like fascia design composed of simple timber strips in alternating lengths.*

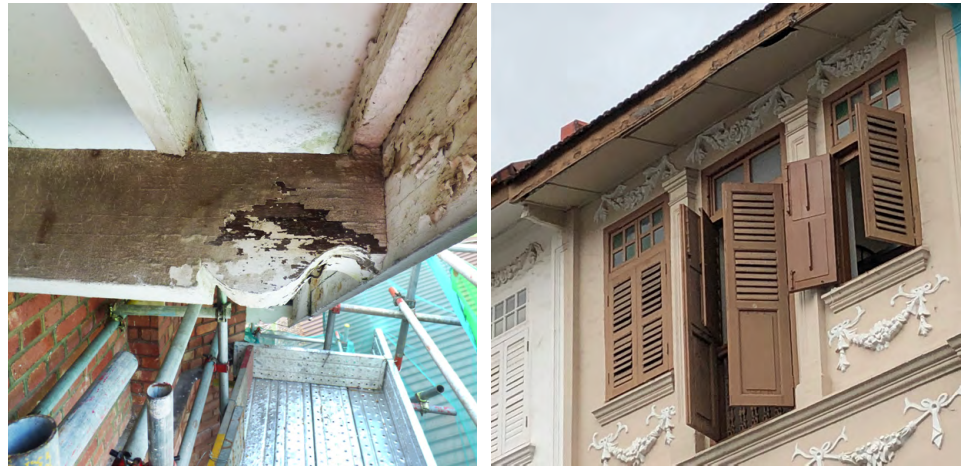
*Left: Paint peeling and wet rot of fascia board and supporting rafter end.  
Right: Deteriorated shophouse fascia and soffit.*
