CONSERVATION TECHNICAL HANDBOOK

Volume 3 | Facades

URBAN REDEVELOPMENT AUTHORITY

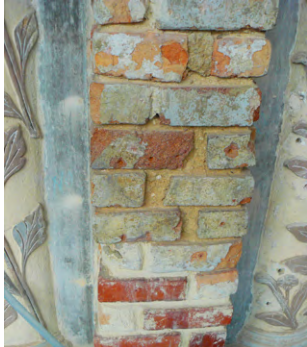
Brick substrate exposed after removal of incompatible plaster render at Stamford House.

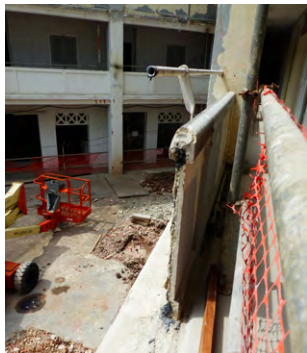
*Plaster rendered on metal mesh substrate (**above**) for lightweight parapet wall (**top**) at the former Traffic Police Headquarters.*

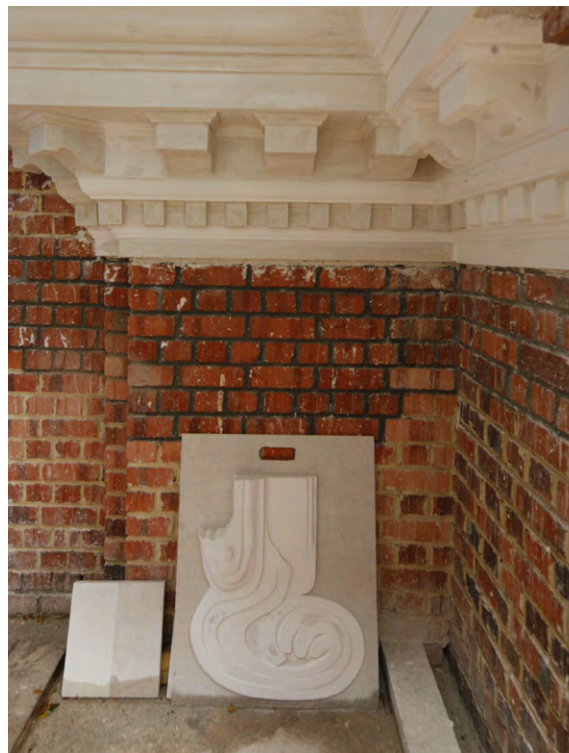
Mock-up for ornamental plaster mouldings at Victoria Concert Hall.

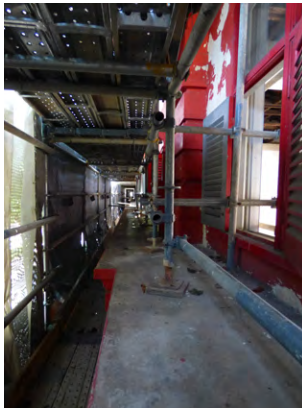
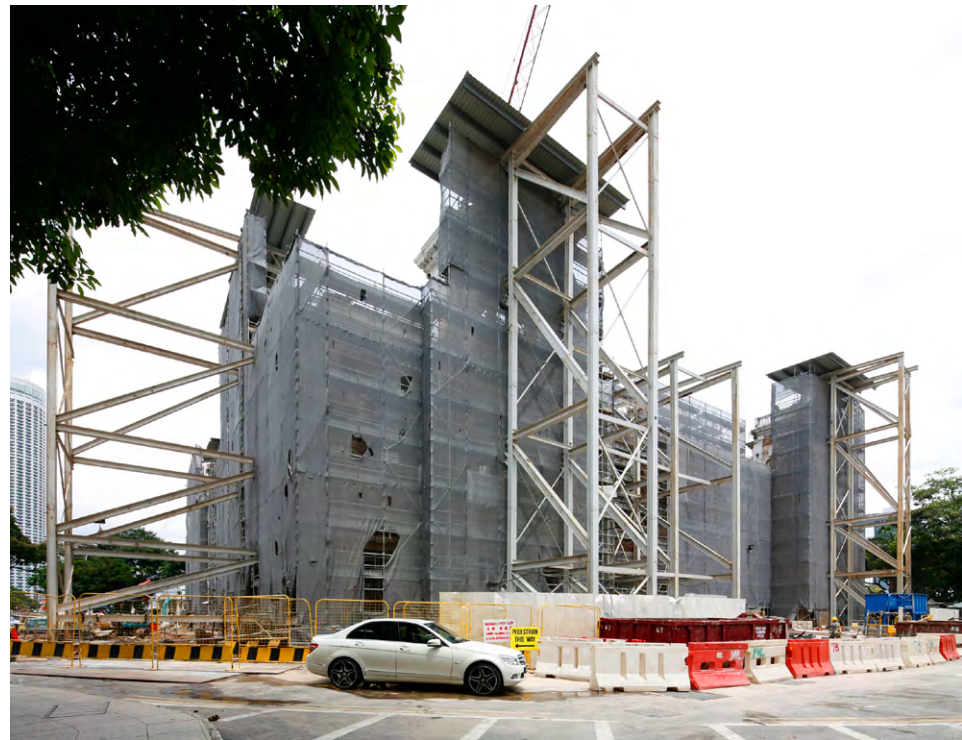
Above: Temporary structural propping for facades. **Left:** Scaffolding and props erected without impacting facade fabric and finishes – anchorage achieved by padded clamping and utilising existing openings.

Scaffolding, erected for high-level inspections or works, is frequently located along facades. Structural propping may also be set up to support facades during major conservation works where interventions affect interior structures. Utmost care should be taken when designing scaffolds or propping, to minimise direct anchorage or tiebacks on the facades, and to avoid impacting key features. Tiebacks or clamps should not come into direct contact with the building fabric, and should be padded with foam spacers.

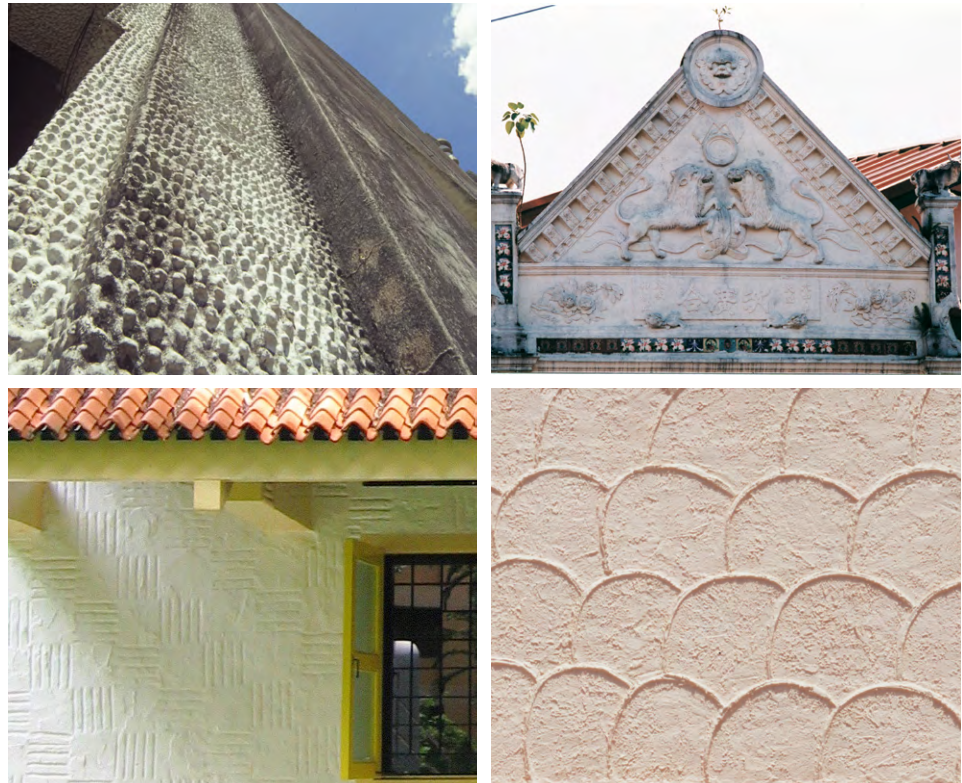
Clockwise from top left - hand-tooled ornamental plasterwork found at: former Ford Factory (1941); shophouse pediment (c.1890s); St. Andrew's School (1940); former Anglo-Chinese School Cairnhill campus (1928)

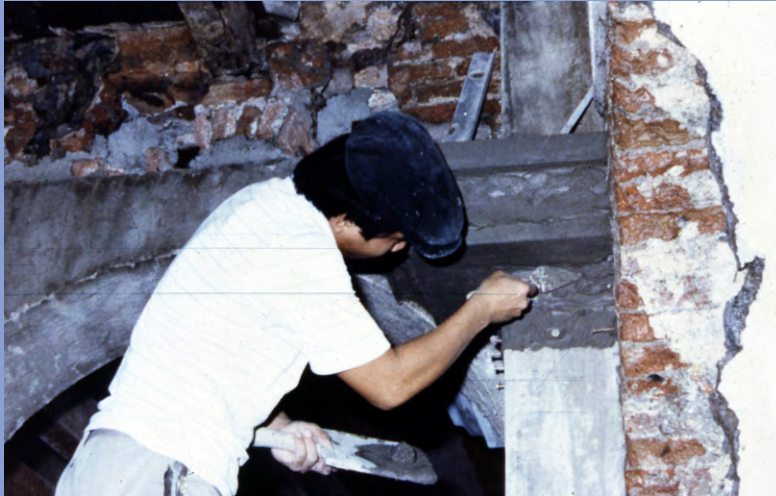
It is unfortunately common for early restoration works, especially those carried out in the 1980s to 1990s, for pure Portland cement-based render to be used to replace, patch or 'repair' deteriorated lime-based render.

Traditional lime-based renders are sympathetic towards old brick masonry walls, as such lime-based layers are softer and weaker than clay brick masonry. Due to this, deterioration more commonly occurs in the plaster, which can be easily replaced without damaging the masonry walls.

Portland cement-based renders, on the other hand, are much stronger and more rigid, often with high shrinkage rates. This type of render bonds very strongly to the masonry wall, making it difficult to be removed without damaging the masonry substrate during repair and restoration works. When applied over historic lime render, the cement render can also cause cracking and debonding of the historic lime-based layer.

Tell-tale signs of wrongly-executed repairs include dark greyish coatings underneath paint layers, spalling of plaster as it delaminates from the substrate, as well as debonded paintwork.

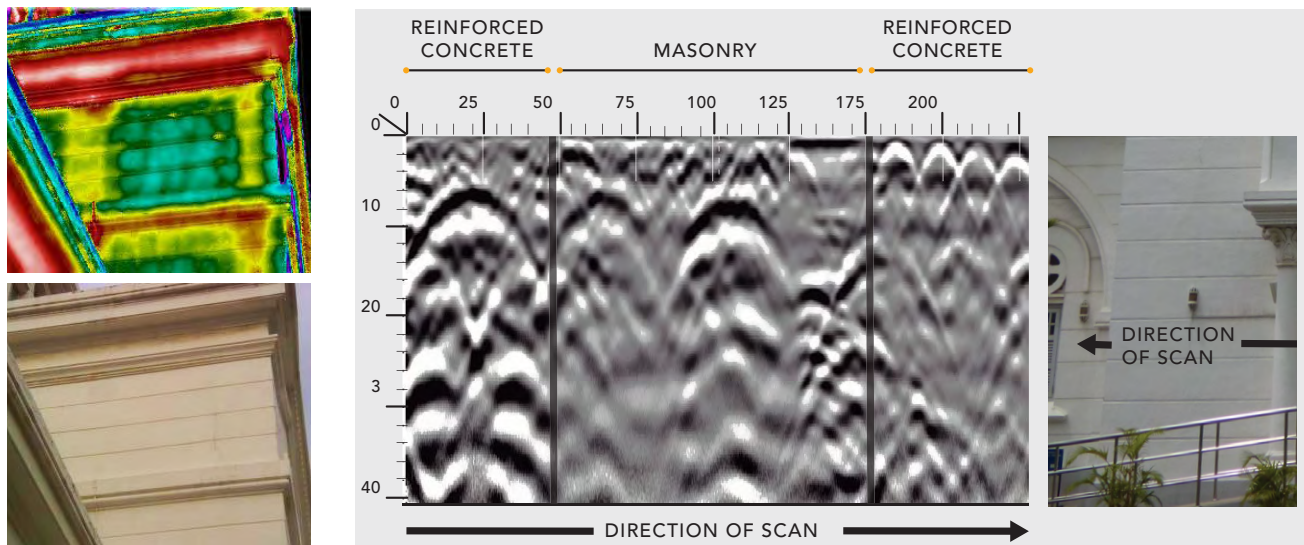
Left: Infrared Thermography scans quickly identify areas of plaster that have hollowness, trapped moisture or construction anomalies, which show up as 'cold spots' against the rest of the facade. **Right:** Surface Penetrating Radar scans can help to identify the structure of the substrate without having to hack through the plaster.

- **Infrared Thermography** to detect plaster hollowness or presence of trapped moisture.
- **Surface (Ground) Penetrating Radar** to identify hidden construction details, presence of moisture and trapped salts.
- **Pendulum Rebound Hammer** to measure the surface hardness, which shows the soundness and integrity of the render.
- **Karsten Tube Test** to test the plaster's moisture retention, and determine the durability of the existing render.

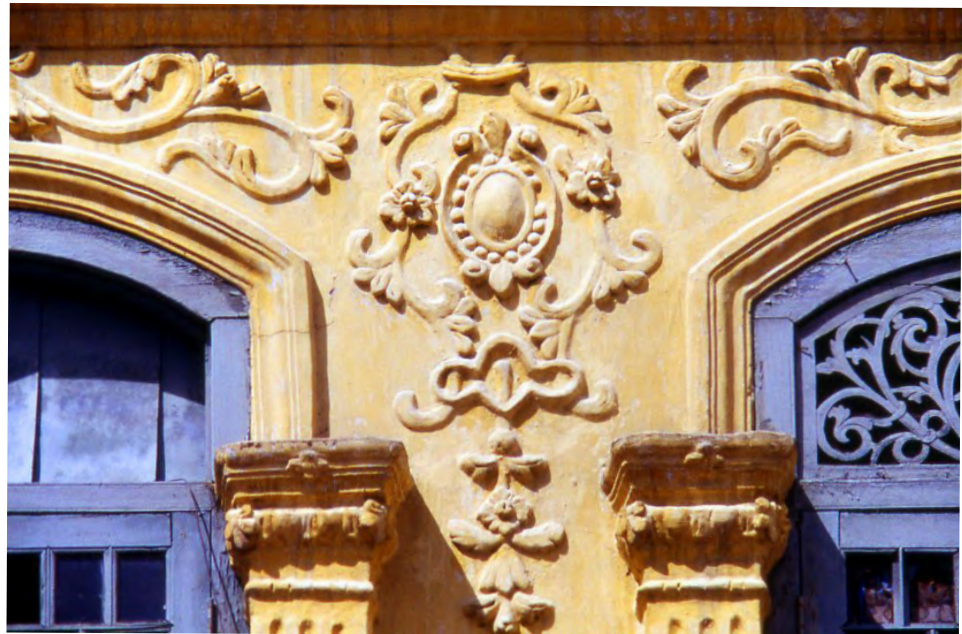
Unless harmful for the building, imperfections, colour variations and patina should not be considered as dilapidation or defects. As an example, the decorative plaster in the photo above is not perfectly symmetrical, but this demonstrates its hand-made quality.

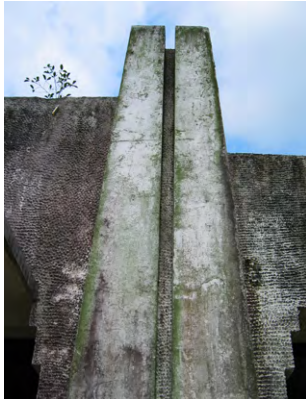
Cleaning can be a very delicate procedure, particularly when dealing with painted or textured plasters. Cleaning methods need to be evaluated and tested case by case, ensuring there is no damage to the surface textures during the cleaning process.

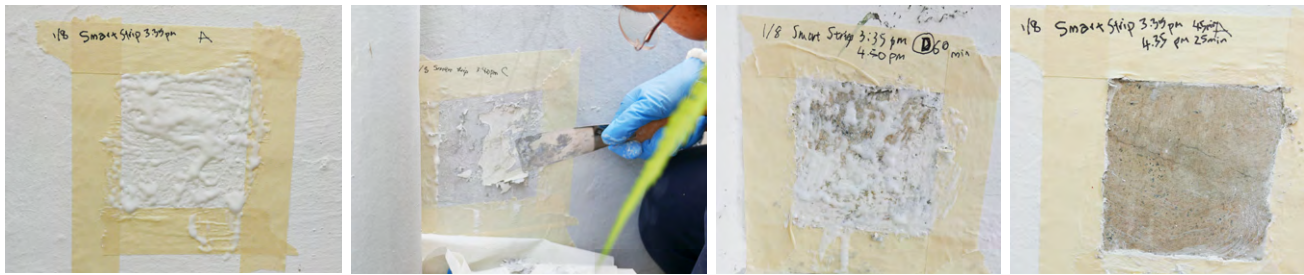
The images above show the sequence of application of ecofriendly paint stripper, combined with manual scraping, for removal of paint over plastered finishes.

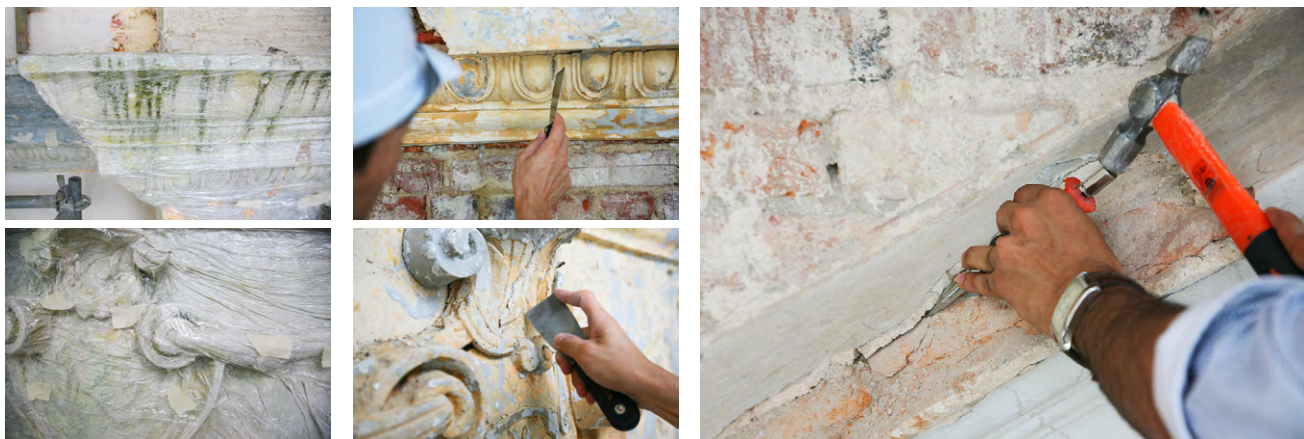
Left: Removal of paints by application of chemicals on the surface. The surface is wrapped in plastic to improve the chemical softening of paints. **Middle:** Manual paint removal for delicate relief details. **Right:** Removal of incompatible cementitious layers by chiselling.

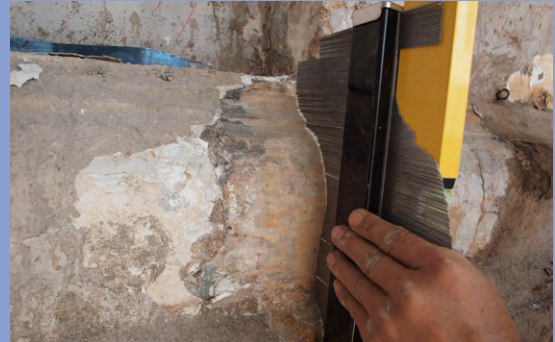
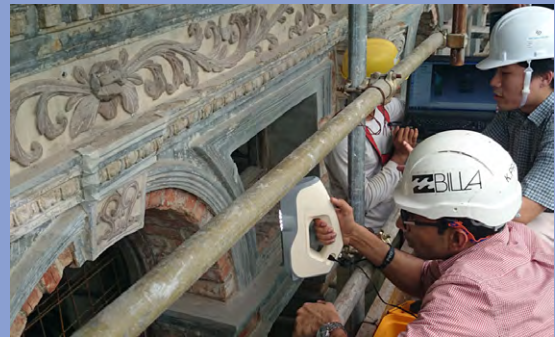
Ways to document ornamental plaster for restoration - Top: Profile gauge measuring devices. Above: Handheld 3D scanning device.

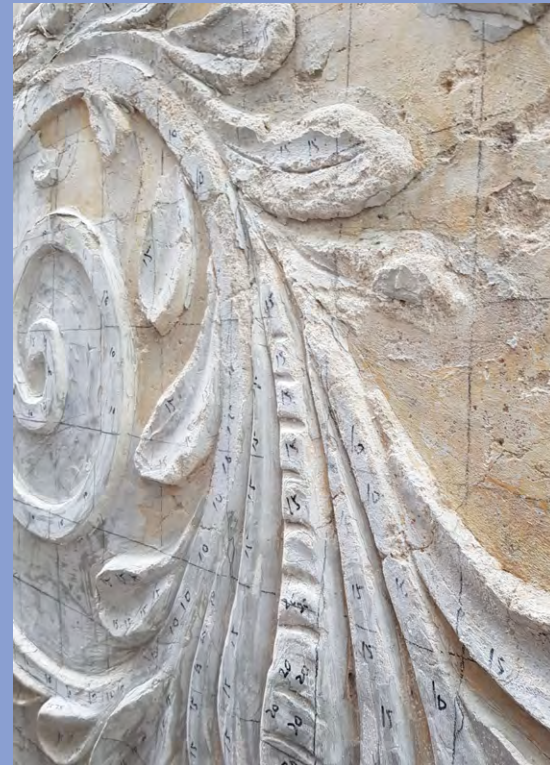
Penciled grid over ornamental plaster to facilitate copying of details onto paper.

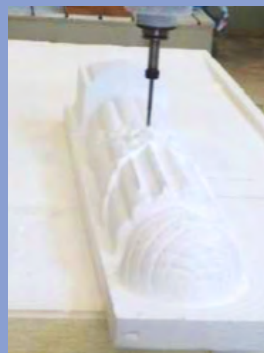
In the images above, the ornament has been measured by laser scanning and replicated in fiberglass using 3D modelling.

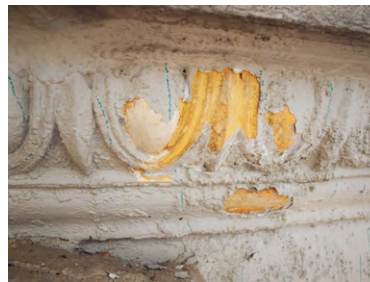
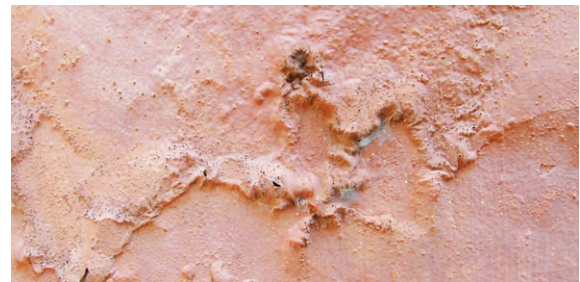
Right: Fine plastered details are obscured by thick coats of paint.

Far right: In some cases, past repainting applied over already peeling paint or defects can cause plain wall surfaces to appear textured or pitted, which can be unsightly.

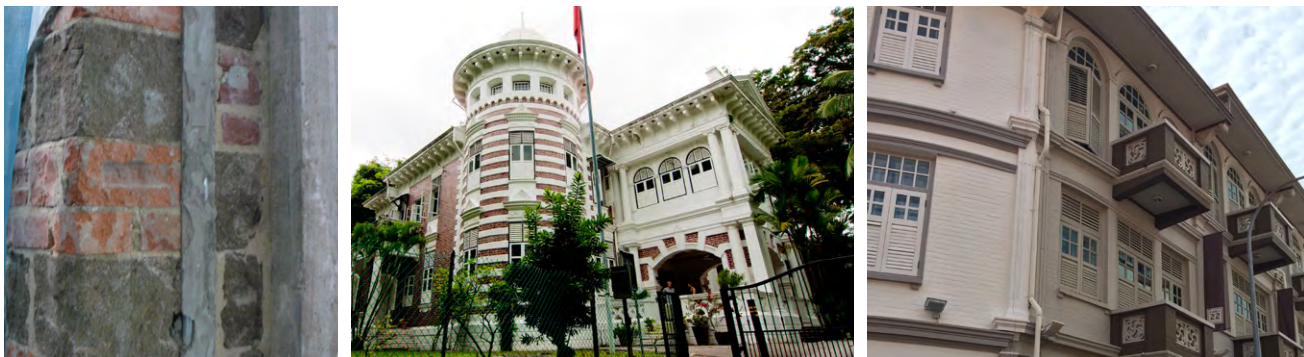
Left: Hybrid masonry walls constructed from brick and concrete blocks. **Middle:** Golden Bell Mansion at Mount Faber, constructed in an alternating combination of fairfaced and plastered brick popularly known as the "blood-and-bandage" style. **Right:** Shophouse with fairfaced brick facade painted over. The original texture, colour, and character of the building has become obscured and homogenized.

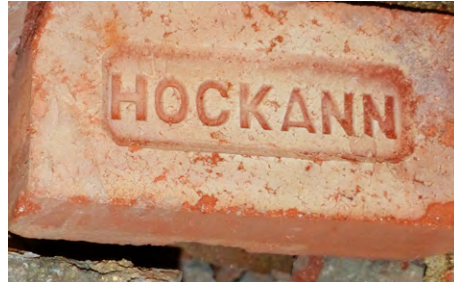
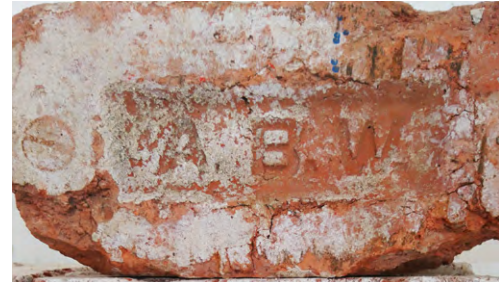
With the invention of automated processes in the late 1920s, brick was machine-pressed into blocks using a die and stamped with the manufacturer's 'marks'.

The advent of modern technology revolutionised the production method and quality of bricks. Beginning with explosives-extracted, steam-treated clay at the Borneo Company (later Alexandra Brick Works Ltd) in 1895, gradual improvements in brick appearance led to buildings in exposed 'fairfaced' finish, such as the Hill Street Fire Station (1909). Nonetheless, many other buildings still imported better-quality bricks from India, such as those at St George's Church (1911). Subsequently, machines were introduced in 1927 that automated the entire process from quarrying to crushing, mixing, forming and finally baking.

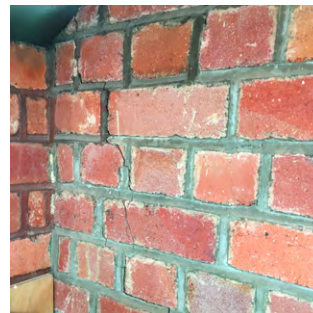
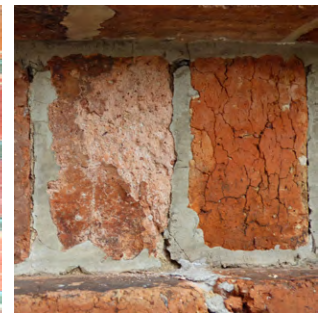
Left: Stepped cracks along mortar joints. **Middle:** Cracking through bricks can indicate structural stresses. **Right:** Cracks on brick surface resulting from shrinkage or expansion of the brick.

- Staining due to environmental soot or bird droppings
- Biological growth
- Cracks
 - along the mortar joints induced by movement of the building due to settlement
 - through the brick, which may indicate structural stresses
 - on the brick surface resultant from shrinkage or expansion of the brick
- Moisture from rising damp causing dissolution of salts within the clay brick material. The salts are brought to the surface, or encapsulated within the brick wall, resulting in surface erosion or expansion of the brick itself, which eventually degrades.
- Deterioration resulting from inappropriate past repairs, such as incompatible cement-based plaster coatings and sealant coatings, or painting over exposed brick, which can trap moisture within the walls.

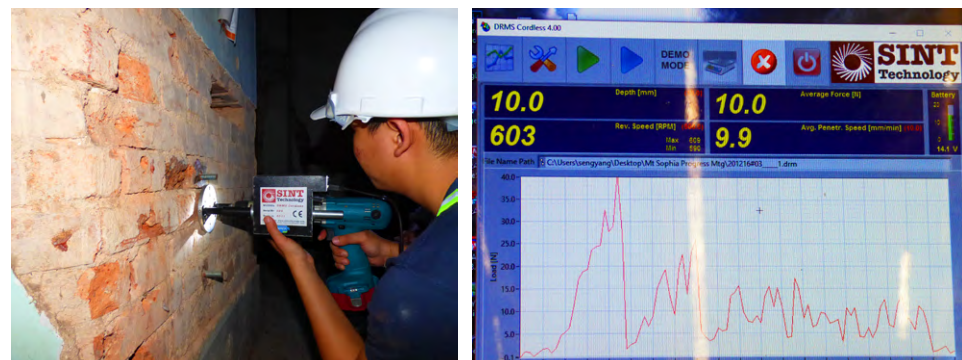
Top: The Pendulum Rebound Hammer is a quick, easy and non-destructive way to measure the strength of the brick's surface, but may be limited in measuring thicker walls. **Above:** Coring sections can be extracted for detailed study of the brick material, although such works are highly destructive.

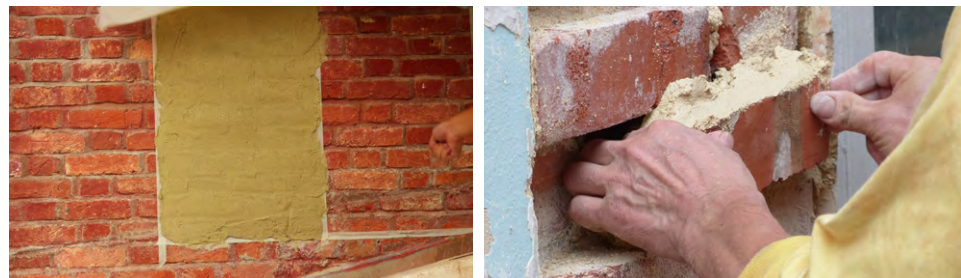
Left: 5-6mm-thick desalting poultice is applied and left to cure for three weeks before it is washed away. The surface is then tested for salts to determine the effectiveness of the treatment. **Right:** Brick replacement should be carried out using brick of similar strength and composition as the existing.

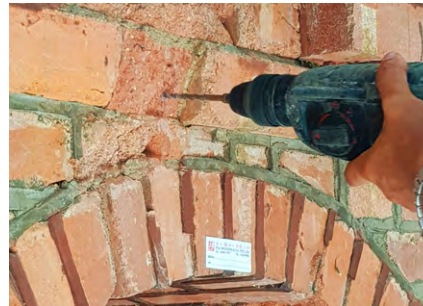
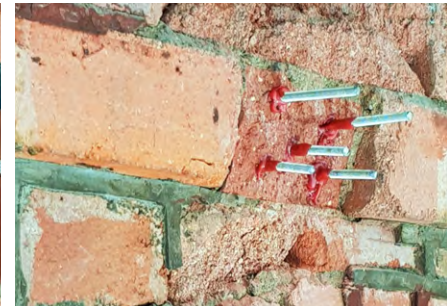
In some cases, steel rods may be drilled into the area to secure the new brick.

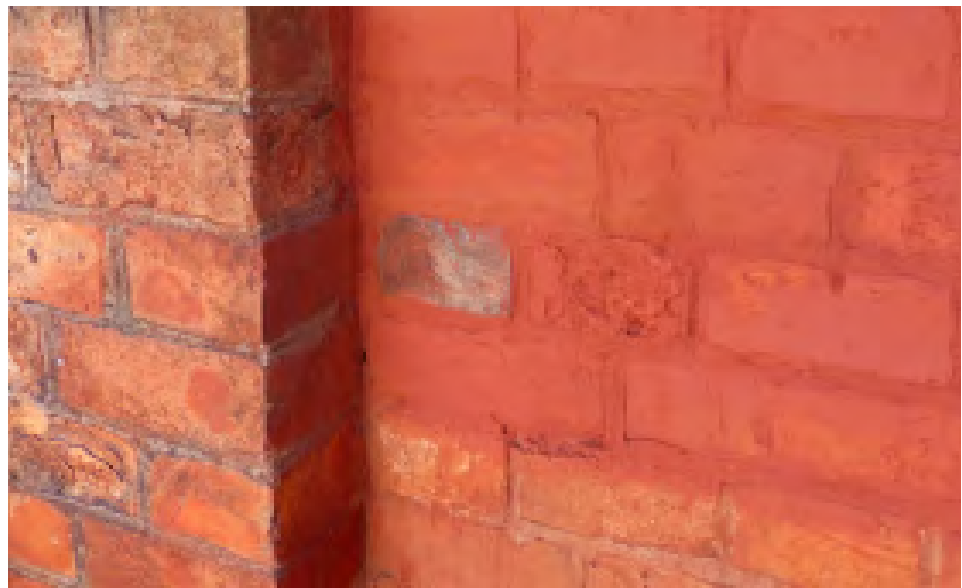
If the brick colour is extremely uneven, colour washes may be gradually applied in thin layers. However, it should not be thickly applied over the brick as this can appear unnatural and unsightly.

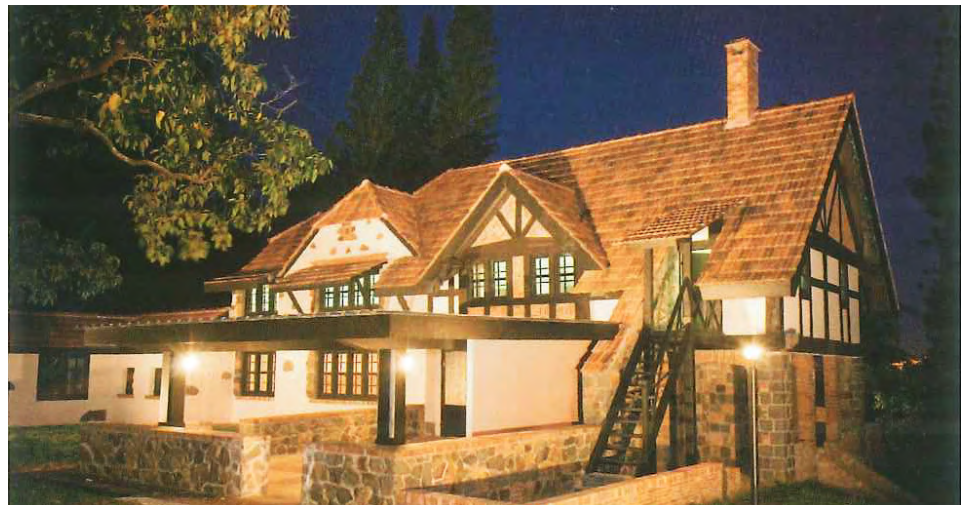
The fairfaced stone masonry walls on House No. 1 at Pulau Ubin, originally the house of Chief Surveyor Langdon Williams, displays the impeccable quality of the granite quarried from the island.

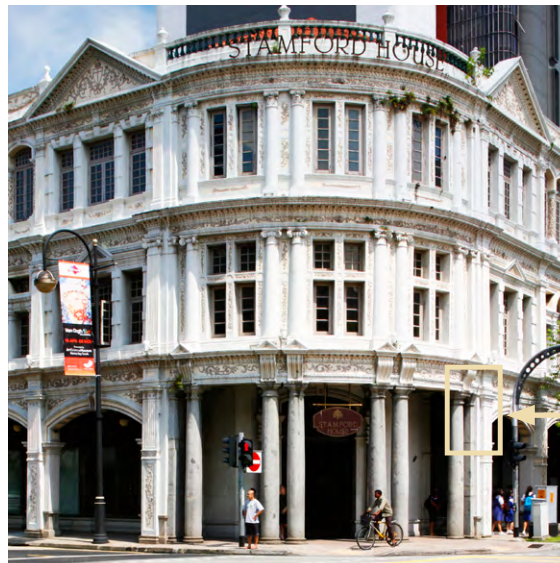
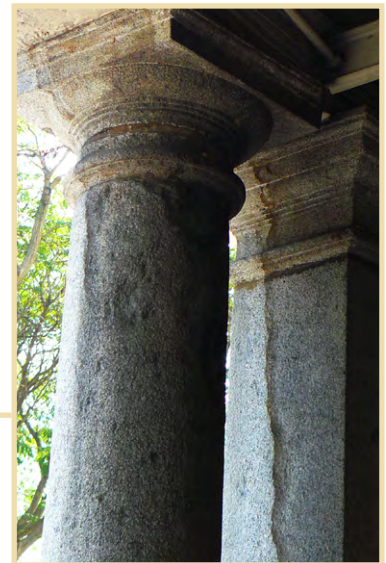
Stone columns of Stamford House adorn its prominent street corner entrance along the five-footway.

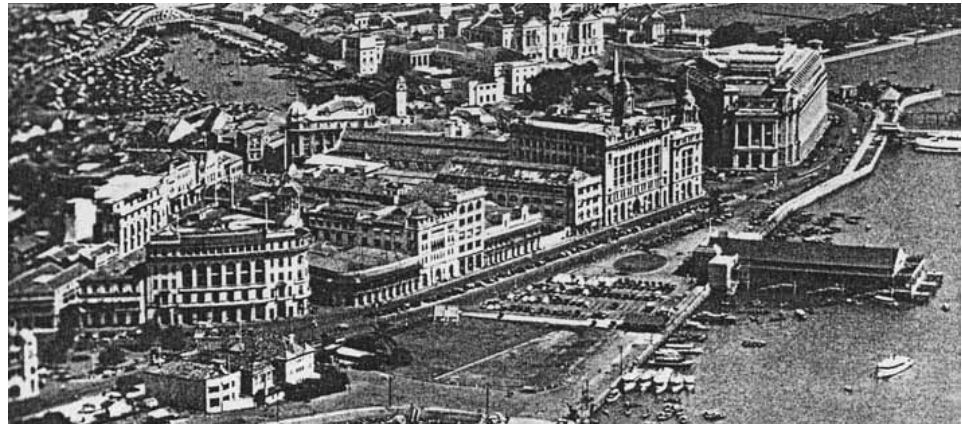
Right: The Singapore seafront, until the 1970s, was well known for its signature skyline featuring Union Building, Clifford Pier, and General Post Office. Together with the Supreme Court and City Hall, and the Straits Settlements Volunteer Corps Drill Hall, these were all finished in Shanghai plaster. **Above:** Another notable example is the Chinese Protectorate Building.

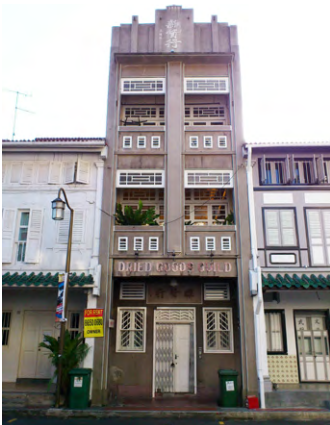
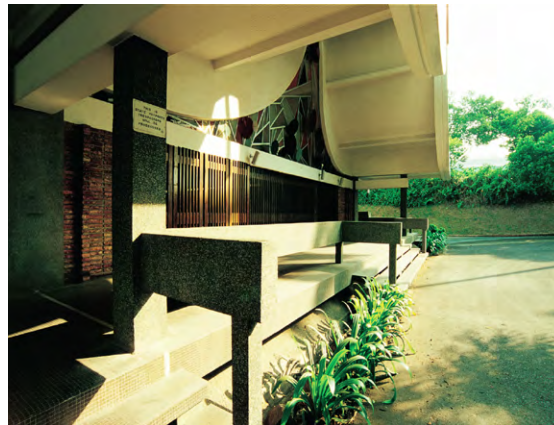
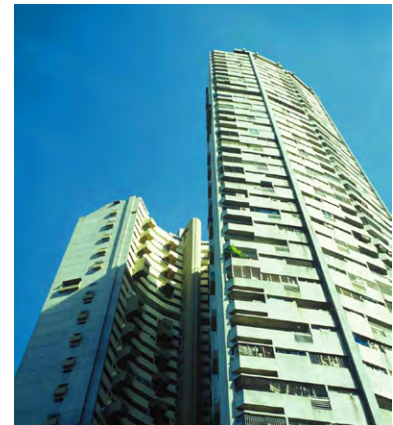
Shanghai plaster is commonly found on interwar period buildings including the Dried Goods Guild (**left**), and remained popular well into the 1970s, as seen in the Trinity Theological College Chapel (1969) (**middle**) and Pearl Bank Apartments (1976) (**right**).

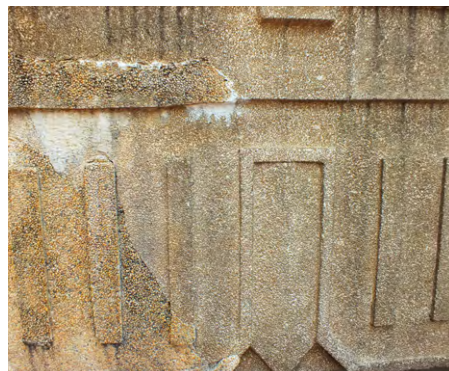
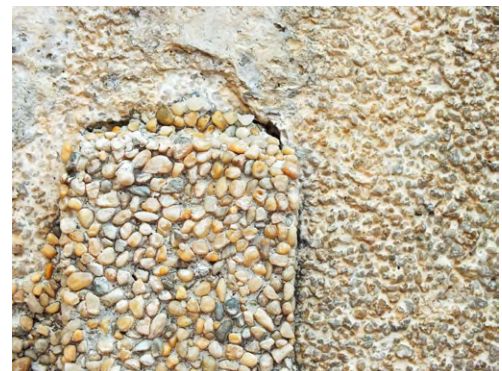
Incompatible patching using modern-day pebblewash, which appears incongruous against the historic Shanghai plaster. The white 'stains' along the patch lines are salts efflorescence arising from water ingress through the seams.

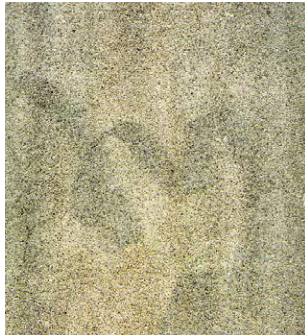
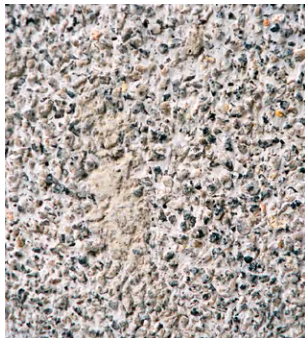
Top: Permanent scarring of Shanghai plaster due to abrasive action by high-pressure water jet.

Above: Shanghai plaster corroded by high acidity cleaning product.

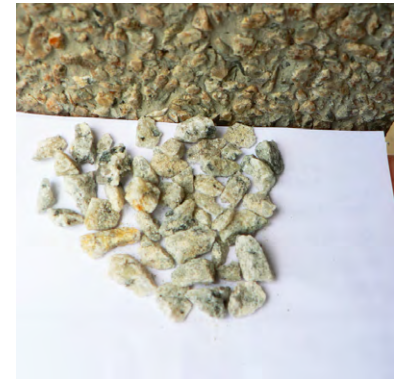
Bearing in mind that half or more of a weathered Shanghai plaster surface is exposed aggregate, careful aggregate selection (**far right**) and size grading is extremely important for patching. Even differences in aggregate angularity (rounded pebbles vs. crushed stone), or mismatch in ratio of mortar to aggregate, will be noticeable in the final repair (**right**).

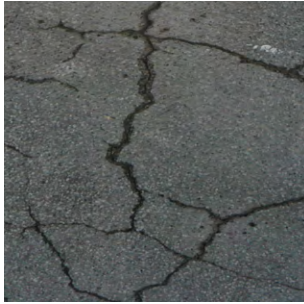
After rainfall, uneven patches may appear on wet Shanghai plaster finishes, due to different rates of water absorption between historic surfaces and the new patch repairs. The 'map-pattern cracks' as shown in the photo may also become more pronounced.

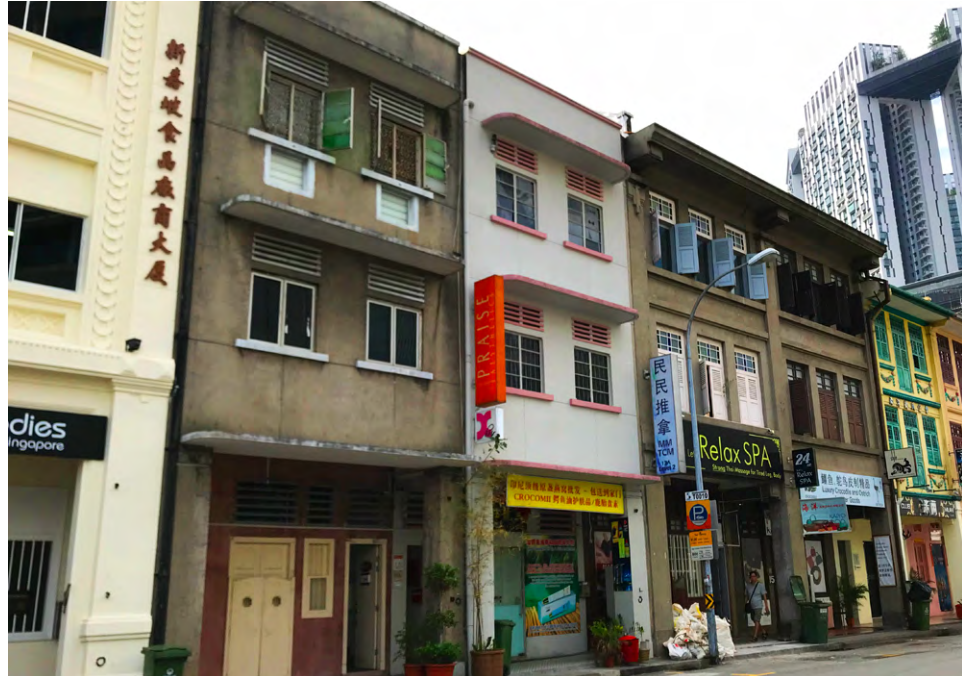
A row of shophouses with Shanghai plaster facades at Bukit Pasoh - the tactile and historic character is lost when painted over, since they appear like plain plastered facades.

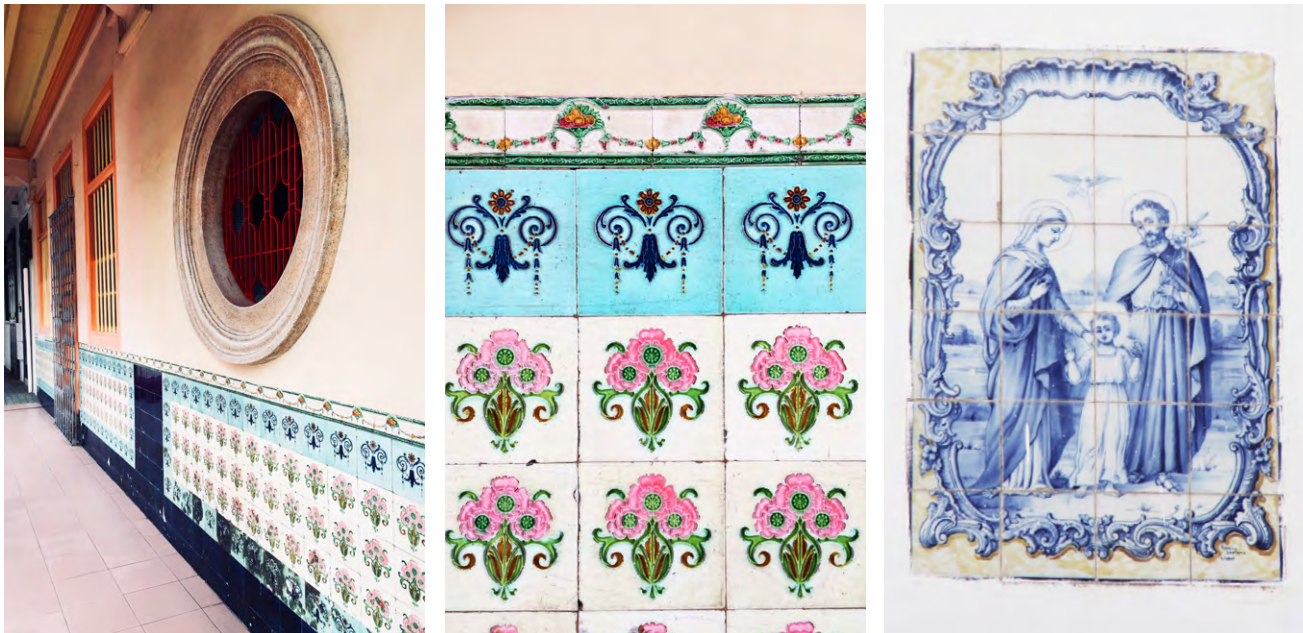
Left, Middle: Colourful Art Nouveau floral designs were a popular choice for dadoes on shophouse and townhouse inner-leaf facades. **Right:** Azulejo or Delft-influenced blue-and-white tiles on the facade of St Joseph's Church.

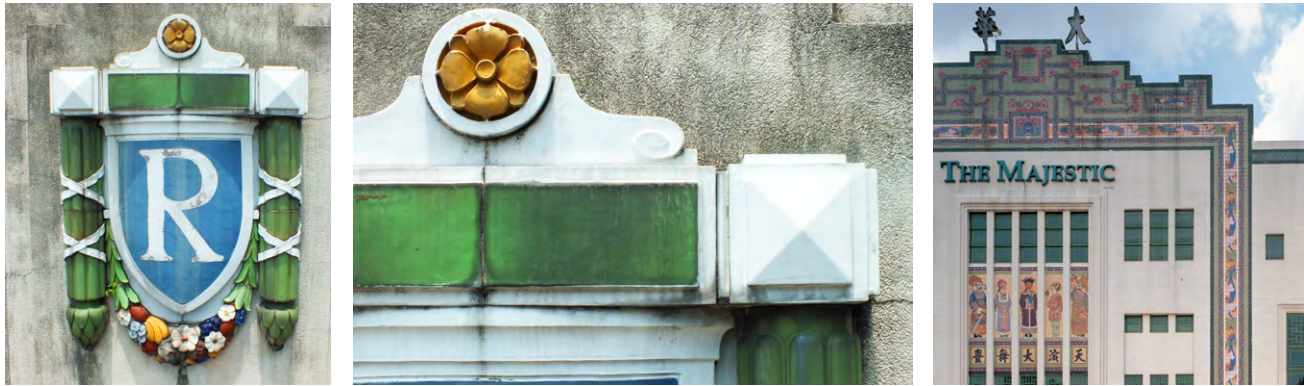
Left, Middle: Customised glazed terracotta units were tailored to create a set of four coat-of-arms on the Tanjong Pagar Railway Station main facade, featuring the initials of the Federated Malay States Railway. **Right:** Majestic Theatre facade

Facade decorative tiles on prewar buildings were usually applied selectively as accents, such as dadoes flanking the main entrance on the verandah or five-foot-way inner-leaf facade, or feature panels adorning pilasters and parapets. An exception was the Tien Yien Moh Toi (1929, later Majestic Theatre), featuring a Chinese-Art Deco facade design composed entirely of Belgium-made ornamental tiles supplied by French agency house A. Clouet & Co.

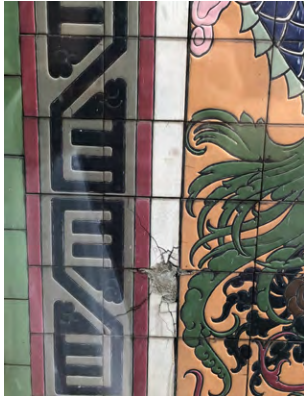
Some defects can be manmade, such as insensitive renovation works to install services.

The first stage of diagnosis involves a visual survey and mapping of observable defects such as cracking.

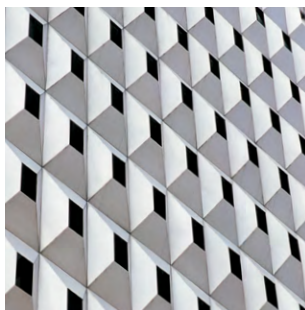
Metal eggcrate clad over an older shophouse facade instantly lends the building a dignified appearance.

Beyond their utilitarian function, the crisp profiles and detailing of metal screens impart a distinctive character. The Lea Hin Building (1964) employs a combination of square eggcrates and star motifs, derived from its company logo, in their shading devices. These motifs are arranged in a checkerboard pattern, as a playful advertisement for the firm's metal building components.

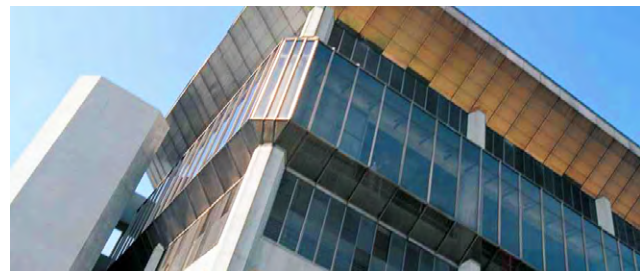
Left: The use of metal fins and star-shaped motif cut-outs on the Lea Hin Building creates an imageable identity. **Right:** The Telok Blangah Substation sleekly clad in bronze anodized aluminium and glass cladding.

Full-fledged metal cladding made its appearance during the early 1970s, as seen on the overhead bridge at the Change Alley Aerial Plaza, which featured prefabricated rolled steel profiled sheets. The 1974 Telok Blangah Substation is one of the earliest curtain wall buildings, clad in a medley of solid and perforated bronze anodized aluminium and glass modules. The gloss and texture of these new materials give rise to a sleek, even futuristic quality, projecting a progressive post-independence architectural identity.

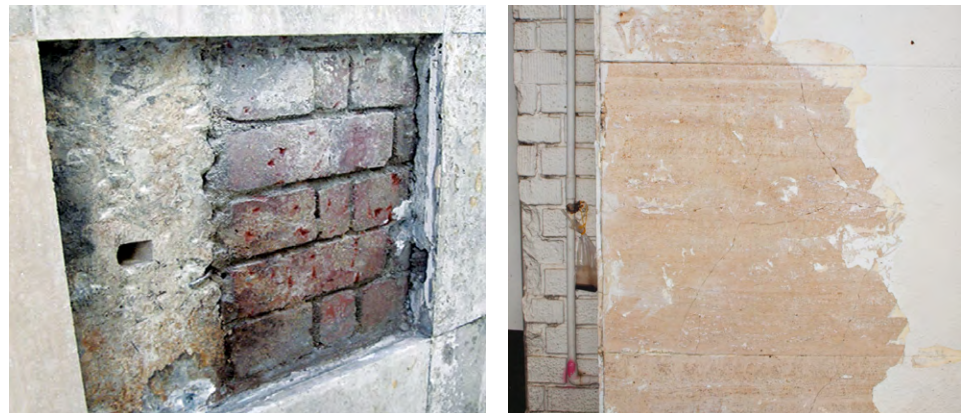
Left: Water ingress through mortar joints can affect the adhesion of the panel to the substrate, resulting in debonding. **Right:** Cracks on the panel near the frame, possibly arising from movement of the building.

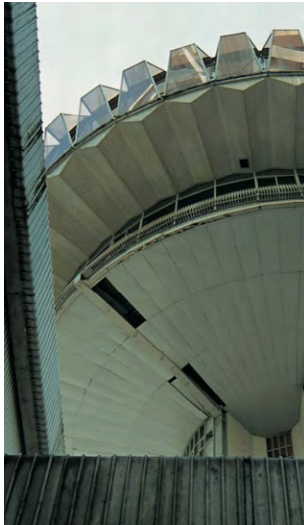
Multiple signs of damage in the metal cladding, including missing units, warpage, dislocation, staining and corrosion.

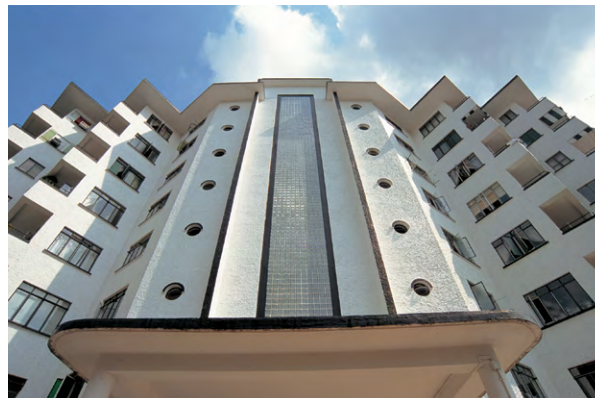
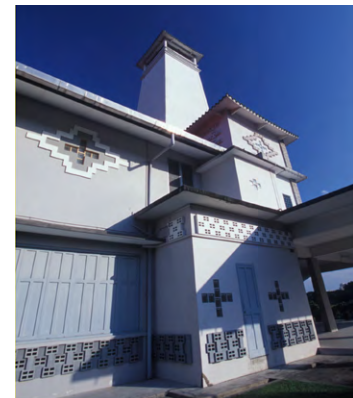
Right: Winstedt Road postwar civil service flats with a central glass block feature wall that lets in natural sunlight into the staircore. **Far right:** Facade cross motifs composed using glass blocks double as toplights at St Joseph's Church.

Despite being expressed as infill walls, glass blocks had the added advantage of high compressive strength. Glass block walls could span across great vertical heights of facades, making them popular for lighting up vertical spaces like stairwells. They were also popular as decorative features that could be inset into walls without a frame, such as for clerestories as well as skylights.

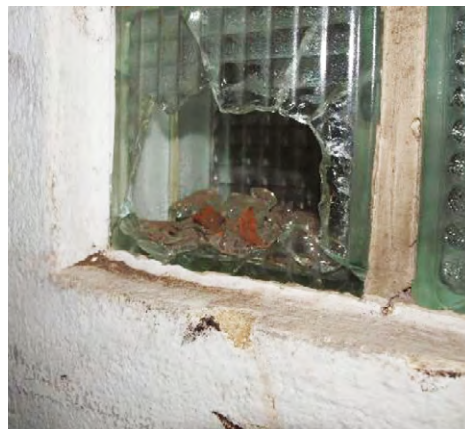
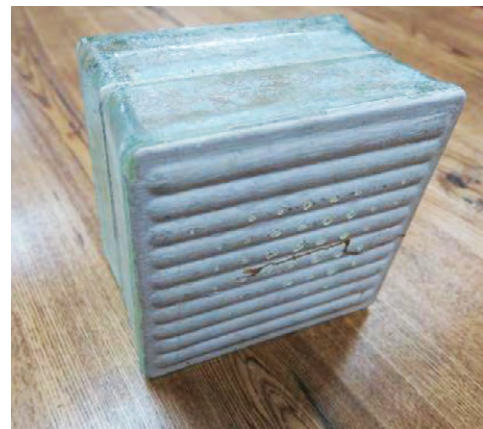
Right: Broken glass block.
Far right: Painted surface on a glass block.

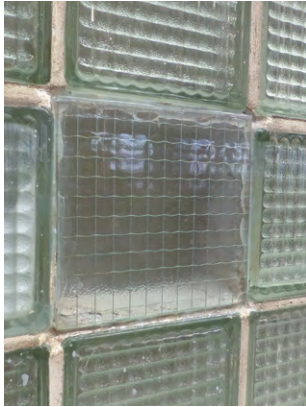
Latter-day ad hoc 'replacement' using a piece of wired glass. Missing blocks should instead be inserted with a matching replacement unit to restore not just the appearance but also structural integrity of the glass block wall.

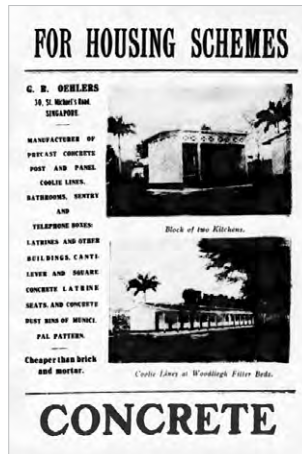
Above: 1927 advertisement of mass produced precast concrete vents and parts.

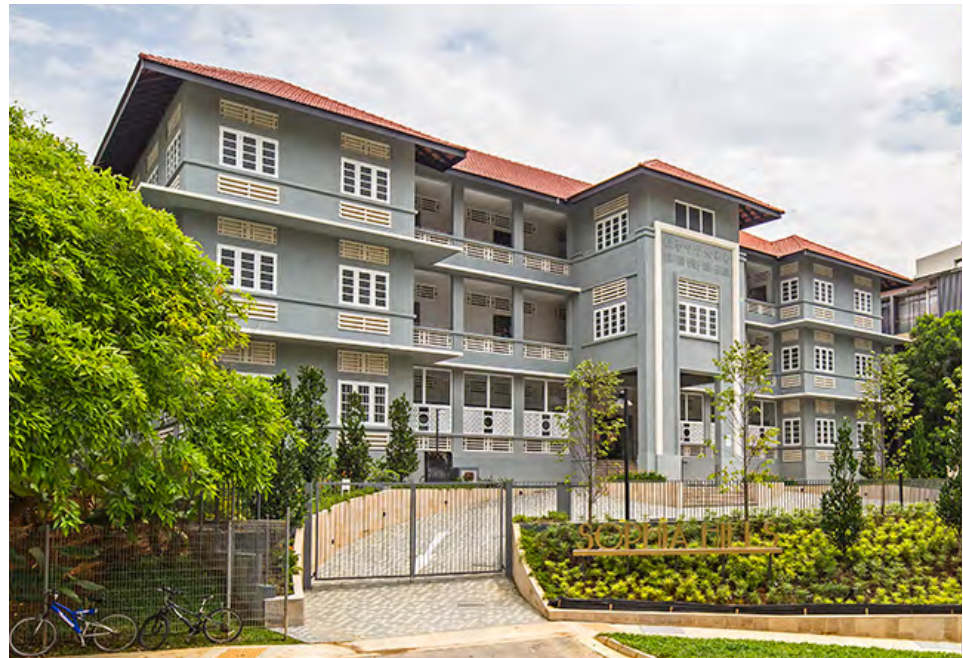
Right: Nan Hua High School at 2 Adis Road (1941) features a series of cantilevered precast RC fins.

While reinforced concrete manifested mainly as building structure, small areas of facades incorporated concrete in their construction. Advancements in construction technology led to mechanisation and standardisation and allowed for factory prefabrication of building parts such as balustrades, vents and window awnings. The corresponding penchant for geometric clean lines of the Art Deco movement during the interwar years pushed the requirements of this technology, producing wafer-thin, continuous cantilevering fins that wrapped horizontally around building perimeters.

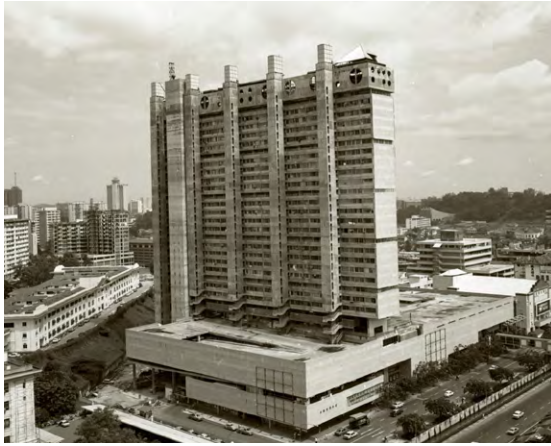
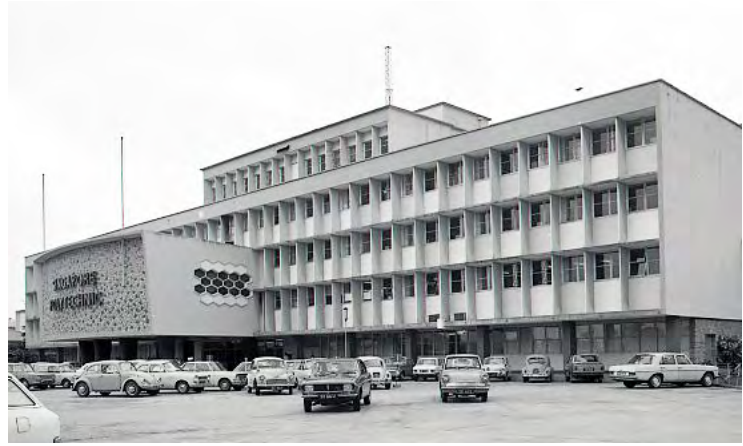
Left: People's Park Complex (1973) - the podium is clad with rusticated concrete panels, designed such that each could be lifted manually by one or two workers. **Right:** Singapore Polytechnic at Prince Edward Road (1972) - concrete panels are used as infills for the structural frame. Slender sunshading fins express the buildings structural and design datum.

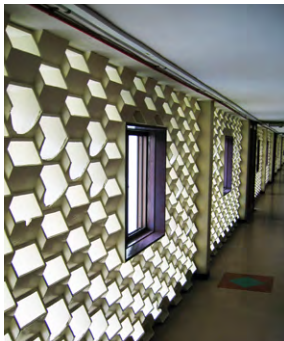
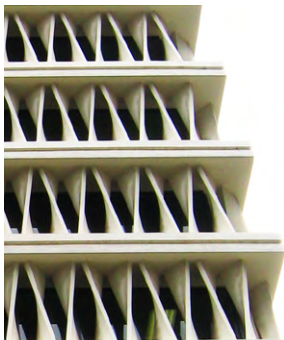
Top: Breathable facade screen wall at SGH Housemen's Quarters (1950s). **Above:** Wing On Life Building (1975) - precast 'twisted' RC panels doubling as screen wall and structure.

The postwar years saw the peak of concrete prefabrication technology. Spurred by a need for standardisation, and in response to the idea of the tropical building envelope serving as an environmental filter, precast ventilation blocks in a variety of designs and combinations were developed for building facades. Mass-produced in the factory and assembled on site, they were an attractive but practical building decoration that filtered heat and glare while improving air movement, particularly for a time before air conditioning was affordable.

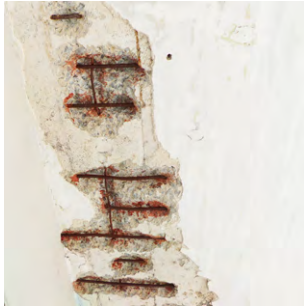
Exposed reinforcement of spalled concrete is cleaned and treated with anti-corrosion coatings, before replacement grout is applied.

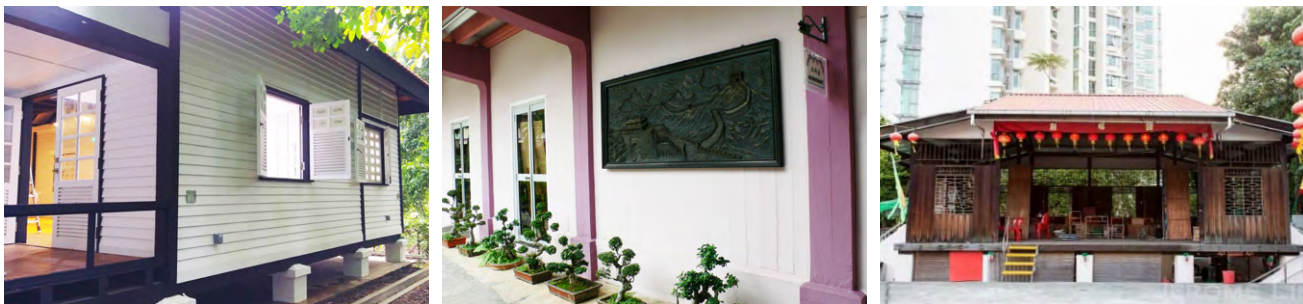
Left: Overlapping wooden boards on the facades of the former farmhouse at Dairy Farm Road. **Middle:** A rare existing example of timber sidings used for institutional buildings, at the Pasir Panjang English School. The timber lightweight infill spans between RC columns which are expressed on the facade. **Right:** Tan Kong Tian Temple Stage at Jalan Kebaya (1919). The timber structure sits on masonry piers, raised above ground moisture.

Typically, timber facades are thin and lightweight, taking the form of opaque sidings made from wooden boards joined by tongue-in-groove joints, or screens with carved wood or timber strips laid in lattice-pattern. In the traditional Malay House, the wooden board facade is an evolution from woven bamboo or nibong walls. Used in combination with columns and beams made from local hardwoods such as Chengal and Meranti, the organic nature of the material meant that the facade walls were usually designed to be replaced periodically without affecting the structure. The flipside to this is that such buildings are relatively more difficult to preserve in their entirety, since the building would have gone through multiple rounds of replacement walls and panels.

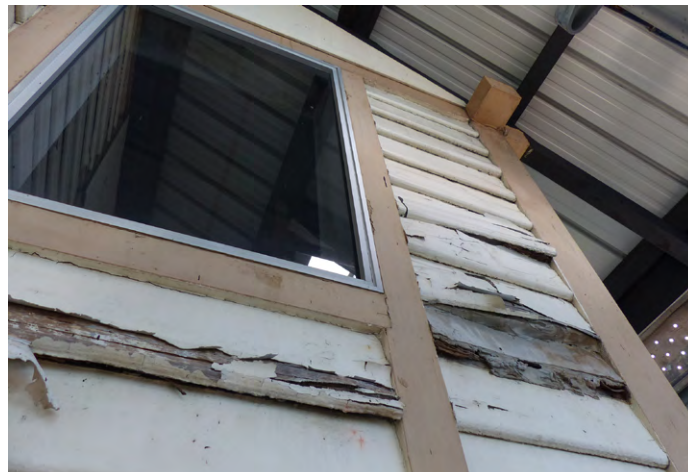
Deteriorated timber siding and poorly executed ad hoc repair using incompatible material.
