# CONSERVATION TECHNICAL HANDBOOK

## Volume 4 | Structure

# Conservation Technical Handbook

### **URBAN REDEVELOPMENT AUTHORITY**

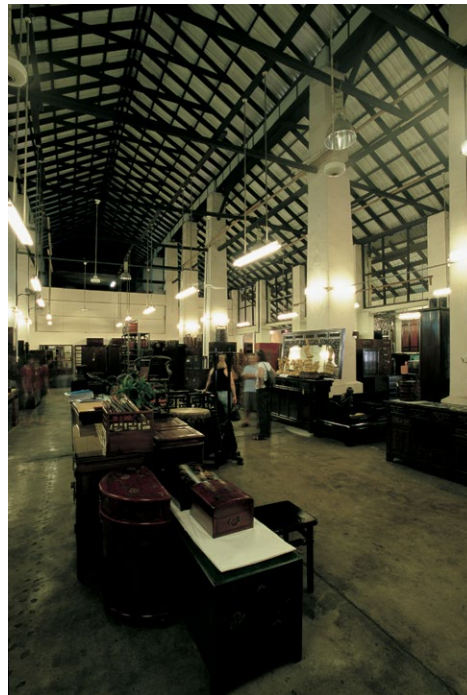
**Left:** Timber roof structure on massive masonry columns at former Tanglin Barracks (late 19th century). **Right:** Reinforced concrete structural frame as an integral part of architectural expression, Kampong Arang Housing Development Board flats (1960s).

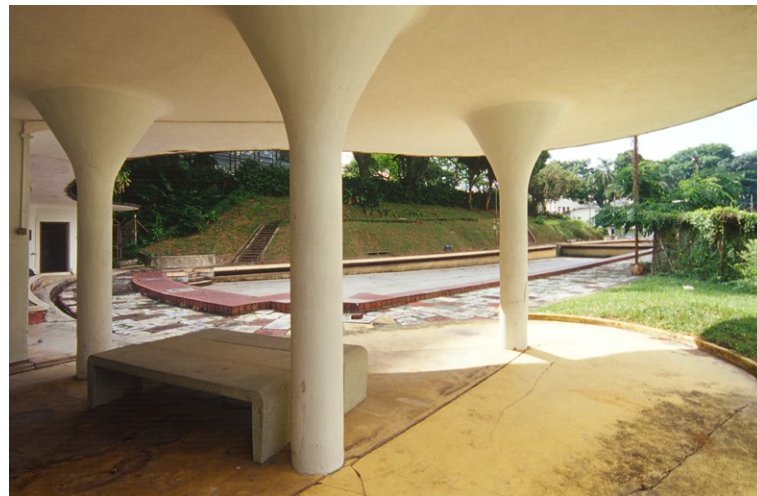
Flared mushroom columns and cantilevered flat slab roof in reinforced concrete, former Yan Kit Swimming Complex (1952).

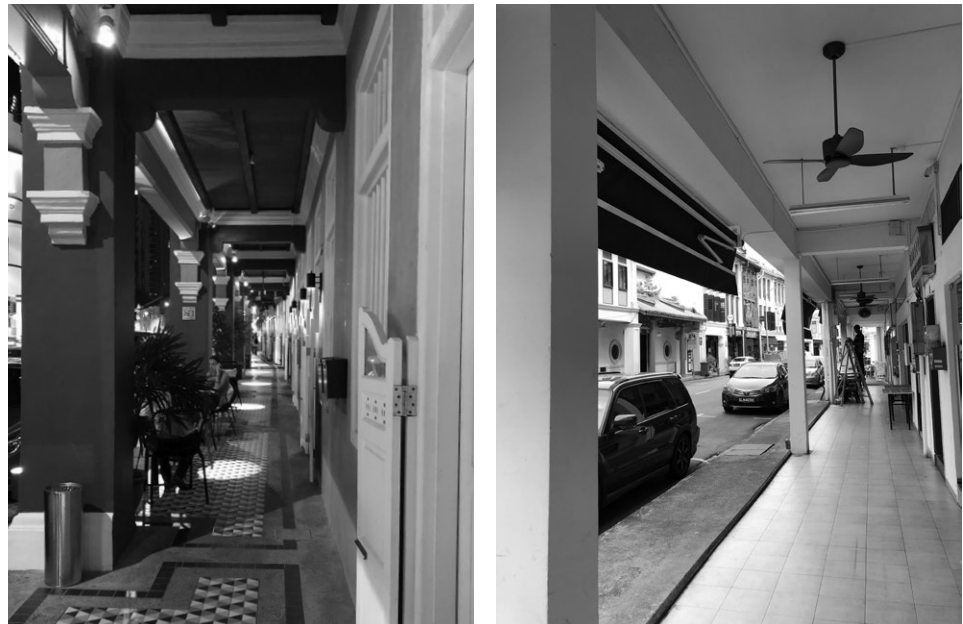
*Structural systems form the basis of scale and spatial character of historic buildings. These qualities should be taken into consideration when devising conservation interventions. The five-foot ways along prewar shophouses with masonry and early reinforced concrete (RC) structure have a more intimate sense of scale to the colonnade (left), as compared to the openness of space along a postwar building with slender and long-spanning RC members (right).*

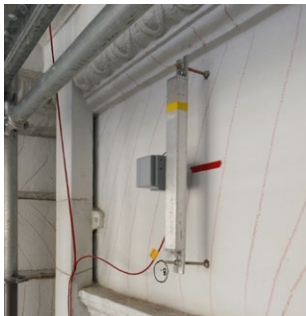
Monitoring devices -  
**Top:** A crack gauge monitors the changes in width of a crack over time. Widening cracks are a cause for concern and should be addressed with the help of structural and building conservation specialists.  
**Above:** High-precision instrumentation using laser technology to monitor building settlement.

Where signs of distress or damage cannot be addressed immediately, these should be closely monitored either visually or with the help of common **monitoring devices**. Any sign of progressive deterioration should be noted and brought to the attention of structural engineers and conservation specialists.

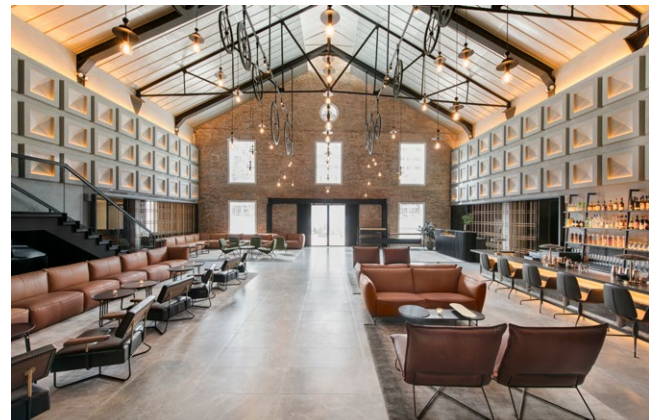
**Right: Structural Restoration** – Restoring the geometry and structural integrity of a timber column through whole-section ‘timber-to-timber’ partial replacement of the decayed lower portion. **Far Right: Structural Addition** – Historic steel roof trusses were restored with new I-section portal frames sensitively inserted in between to meet increased roof loading needs, in the adaptive reuse of a former oil mill into a hotel. New structures could be easily distinguished from the old by a discreet difference in design without detracting from the heritage presentation.

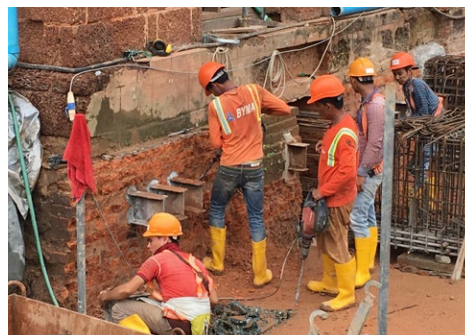
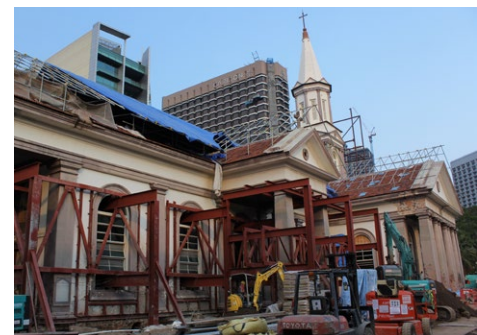
**Right: Foundation Strengthening** – Underpinning works to strengthen masonry building foundation. **Far right: Temporary Support** – Protective bracing of façade structural masonry wall while foundation underpinning was carried out at the Cathedral of the Good Shepherd.

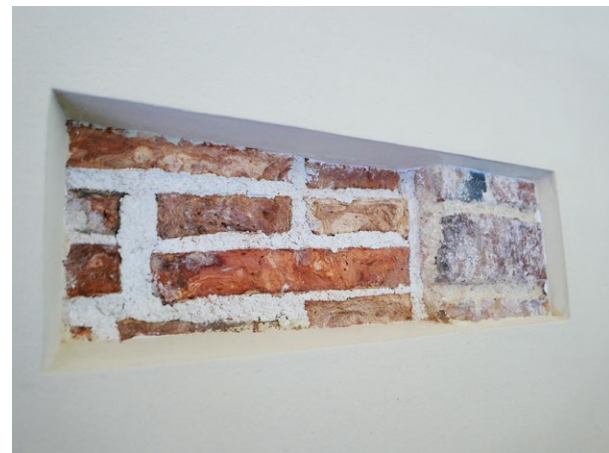
– Even originally hidden parts of the building structure may be showcased as part of the heritage presentation, to showcase a richer narrative. **Right:** The brick vault foundation of the former Tainan Prefecture Hall (1916) as seen through a glass floor panel.

**Far right:** The panel of exposed structural masonry wall of Cathedral of the Good Shepherd shows how the two building phases (1845 and 1888) used bricks of different manufacturing processes.

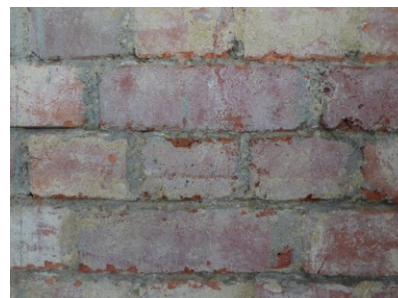
*Right: Larger standardized industrial bricks from Alexandra Brickworks, seen at the former Traffic Police Headquarters (1929).*

The labour-intensive early kilns were eventually phased out with the arrival of **industrial brickmaking** at the turn of the century, where machinery and high-powered kilns produced high-strength standardized bricks.

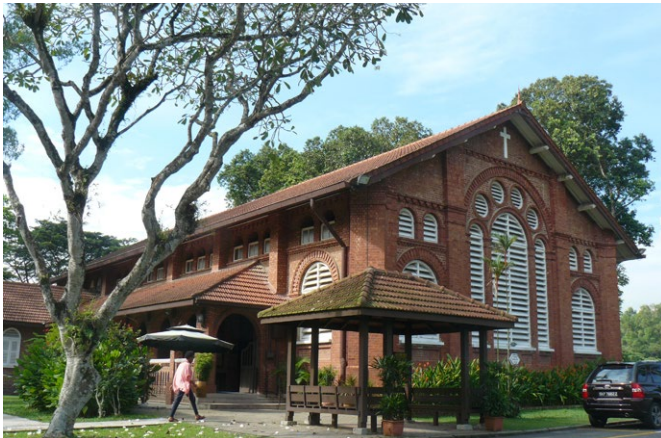
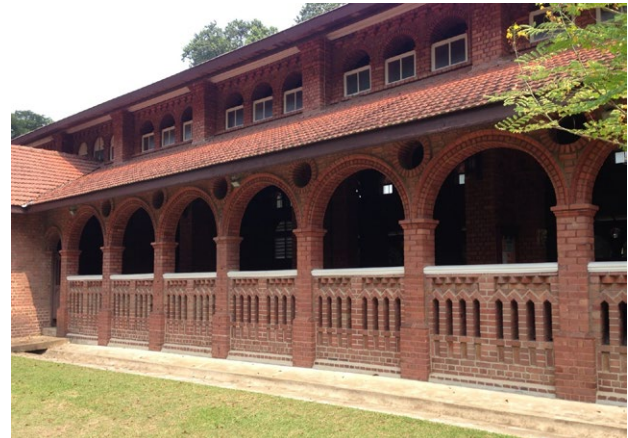
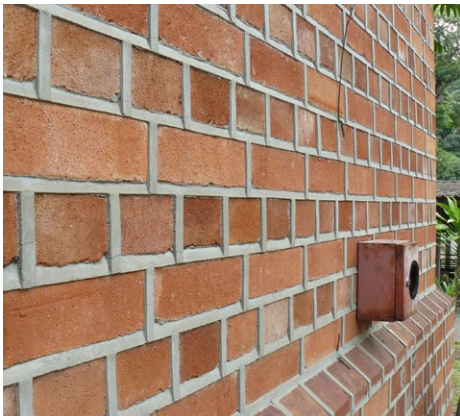
**Top row and left:** Fairfaced load-bearing brick walls in English bond, and brick arches at St. George's Church (1913). **Right:** Buttressed brick wall at Tanjong Pagar Railway Yard staff quarters.

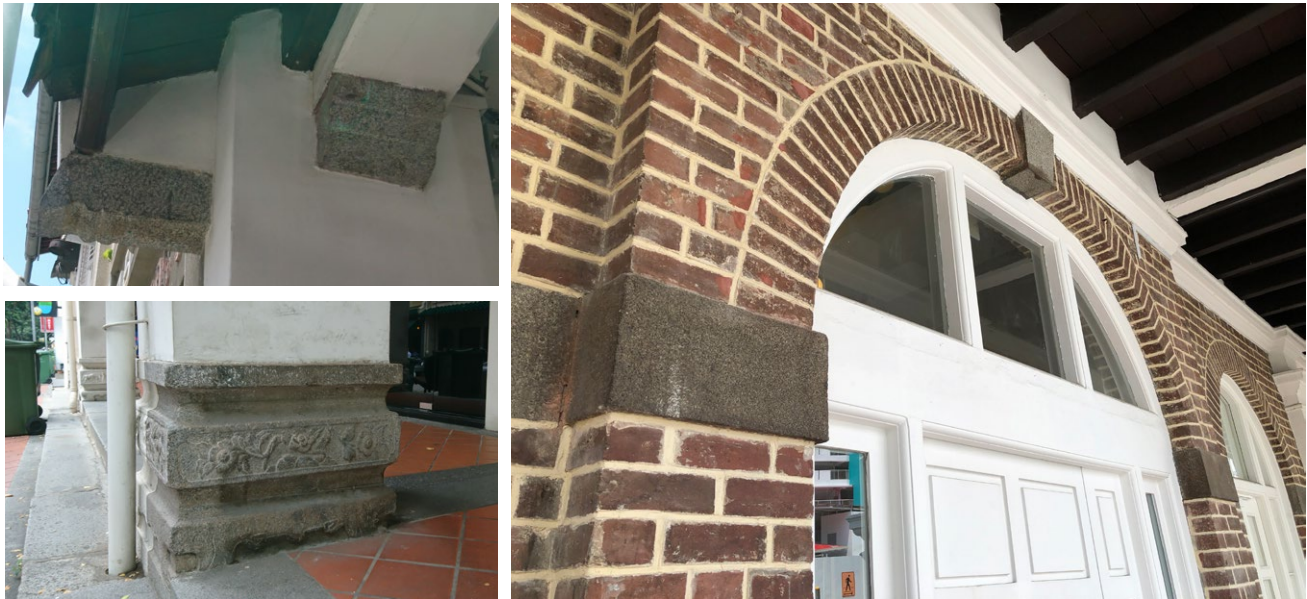
**Left:** Granite elements commonly appear in shophouses/townhouses as corbels supporting timber structures (top), and more rarely, as ornamental column bases (above). **Right:** As seen on the innerleaf facade of the former Jinriksha Building, granite keystone and impost are positioned where the compressive load is concentrated along an arch.

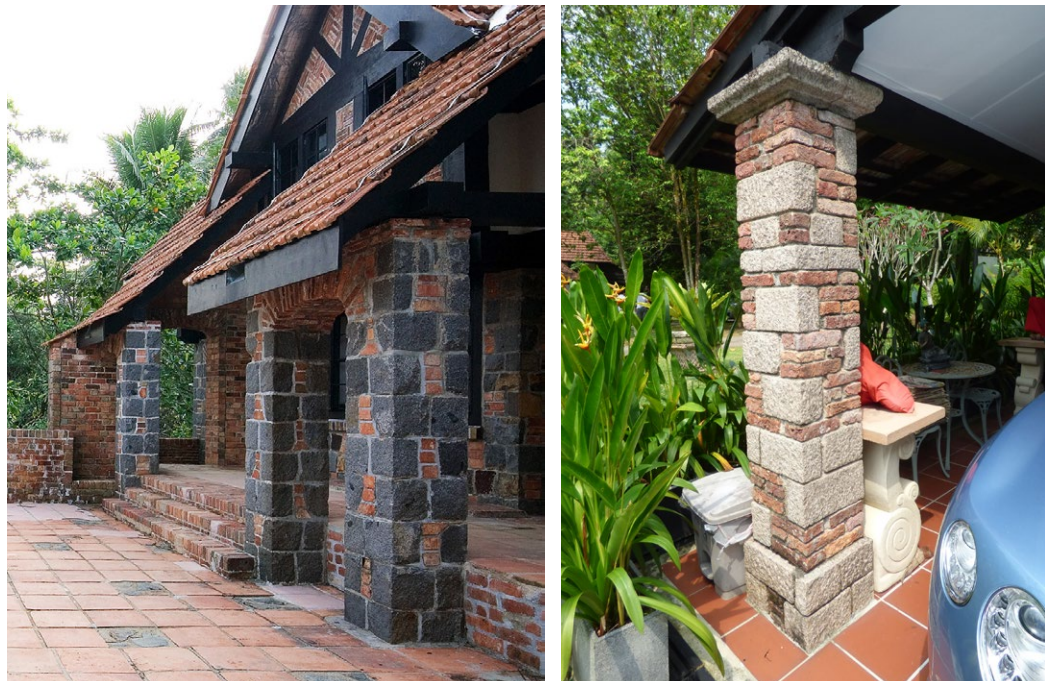
Examples of fairfaced masonry columns designed with an interplay of stones and bricks that showcase artisanal construction and fine workmanship at **(right)** House No. 1 on Pulau Ubin, and **(far right)** postwar government housing bungalows at Stevens Road (c. 1948).

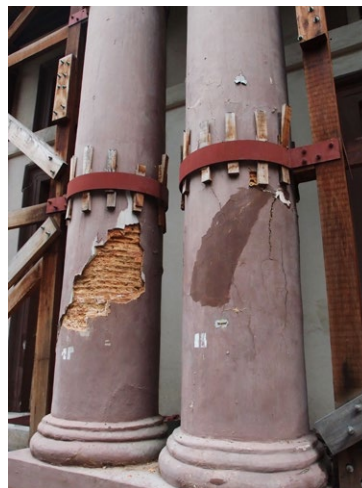
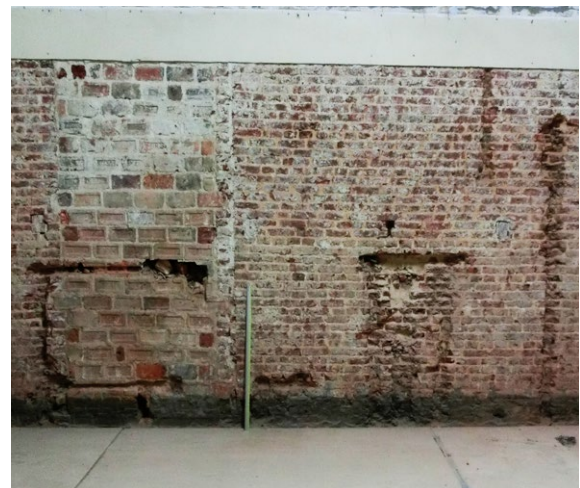
**Right:** Brick masonry columns damaged by ground settlement caused by tunnelling works. Temporary bracing was put in place until structural repairs could be carried out. **Far right:** Excessive chasing of services into the wall results in a loss of mass and compromised strength of the load-bearing brick structure.

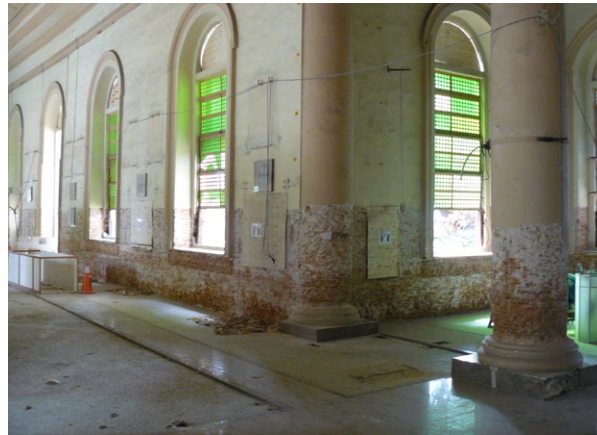
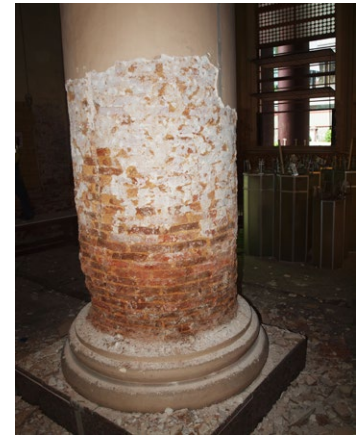
Rising damp caused by incompatible latter-day paint resulted in salt attack that eroded the brick substrate at the base of the columns and load-bearing walls. Plaster along the base has to be removed as part of conservation treatment.

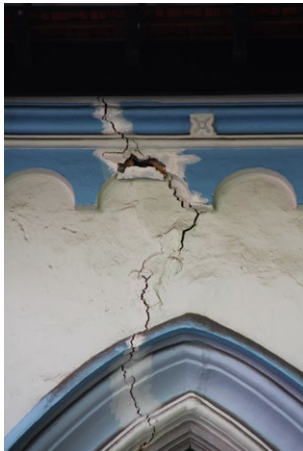
Visible sign of structural defect – crack through arch structure.

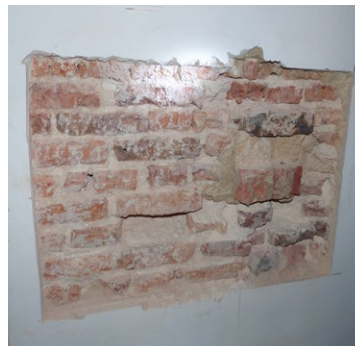
**Far right:** Drill resistance measurement being carried out on a load-bearing brick masonry wall, with real-time results represented in graphical form on a laptop connected to the equipment.

Specialist equipment, such as the Drill Resistance Measurement System for brick masonry, is deployed to evaluate the strength and condition of existing structures to establish the conservation rehabilitation workscope.

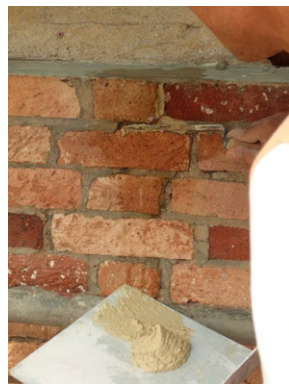
*Repointing trial for fairfaced brick masonry wall.*

**Repointing** – The outermost 10–15mm of the mortar is known as ‘pointing mortar’, which is generally designed to be weaker than the wall substrate. Once this becomes loose or eroded by weathering, the loss of material may affect the structural integrity, especially for members with a large surface-to-mass ratio such as columns. Replacement with compatible mortars – known as ‘repointing’ – will be required. Friable or incompatible mortar joints should be removed and replaced with new compatible mortar.

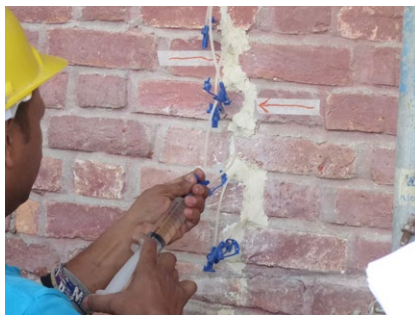
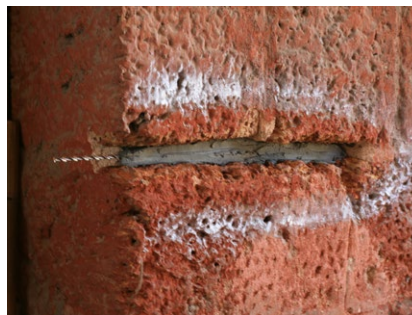
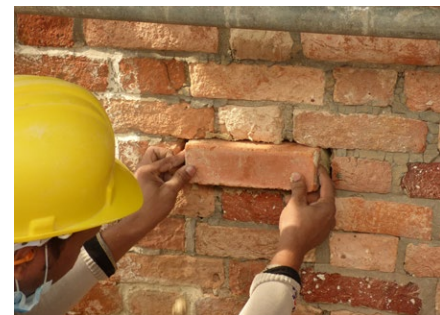
**Left: Grouting** – Brick masonry crack repair by injecting compatible grout. **Middle: Tie and stitch** – Helical spiral bar reinforcement provides stitching repair for masonry walls that have large cracks through several bricks. Pointing mortar underneath the affected areas of masonry is chiselled and raked out. Stitching is then done by embedding stainless steel anchors into the mortar directly underneath the brick units before sealing with an appropriate mortar. **Right: 'Cuci-scuci'** – Localized brick replacement.

**Localized reconstruction ('cuci-scuci')** – Structural integrity can also be restored by highly localized replacement and relaying of masonry units and mortar using original and compatible materials. While there is some loss in historic materiality, the method nonetheless allows for retention of most of the unaffected masonry structure, instead of rebuilding entirely.

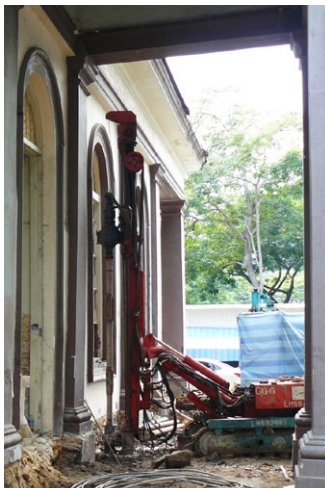
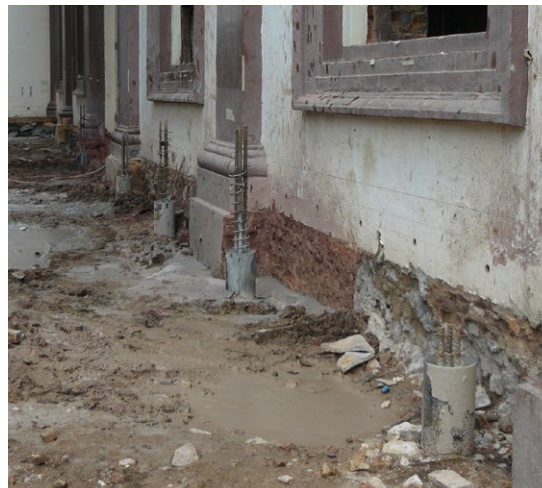
**Left:** Compact piling rig that could be accommodated beneath the porch of the Cathedral of the Good Shepherd. **Middle:** Micropiles are installed next to existing column bases to strengthen the masonry strip foundation and address severe structural damage caused by ground settlement. **Right:** Diagram of brick foundation strengthening by micropiles.

**Underpinning and micropiling** – Underpinning refers to the strengthening of foundations of existing buildings, typically in pad or strip form. The objective is to spread the load or transfer it to deeper soil or bedrock with higher bearing capacity. In particular, the micropiling method, which uses small-diameter piles (usually reinforced concrete) driven by compact-size piling rigs, is well-suited for historic buildings where access and headroom may be restricted. To minimise impact on existing historic floor slab and floor finish, micropiles could be installed on the exterior and the load transferred via cantilevered needle beams. Where this is not feasible, affected historic elements such as floor tiles may be carefully dismantled and reinstalled after strengthening. The historic foundation should be properly documented prior.

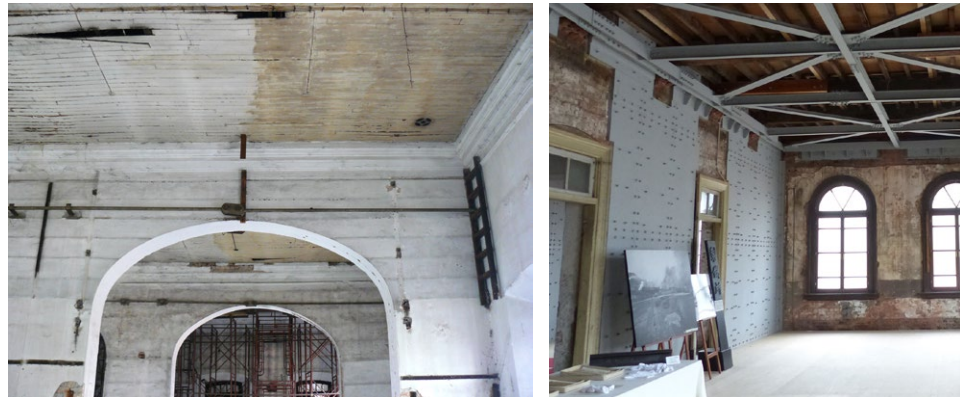
**Far right:** Steel plate jacketing of interior load-bearing brick masonry wall as part of temporary seismic strengthening measure prior to long-term rehabilitation works. This will, however, result in loss of historic ornamental plasterwork.

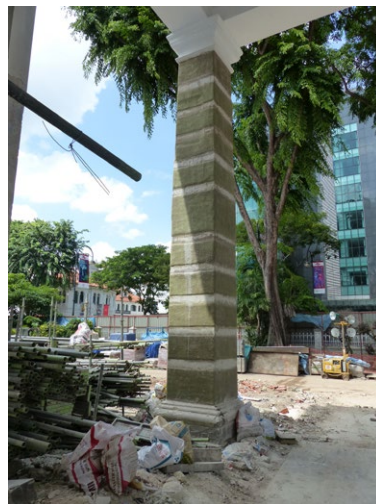
*Deployed as a last resort, here the severely compromised brick masonry column is strengthened with carbon fibre-reinforced polymer strips. Gaps are designed to allow for some degree of breathability for the historic brick substrate.*

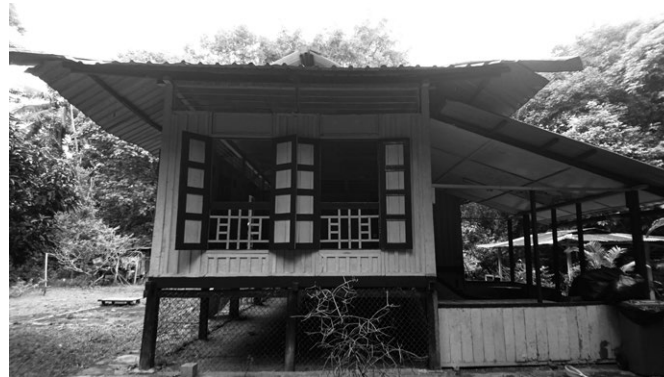
A historic kampong house at Pulau Ubin featuring timber post-and-beam main structure with timber siding infill and lattice balustrades.

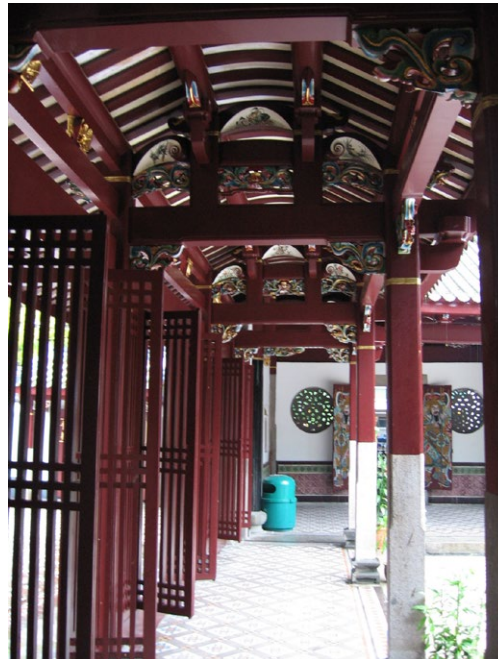
*Traditional Chinese timber construction with elaborate carved and painted structural members at Thian Hock Keng temple.*

These present varying timber building traditions and construction techniques. In general, Chinese traditional timber structures are connected using hidden **dowel and mortise-and-tenon joints**, while colonial-introduced practices tend to include the use of external and embedded **metallic connections**, such as nuts and bolts, metal plates and tension rods, working alongside timber joinery to achieve structural performance.

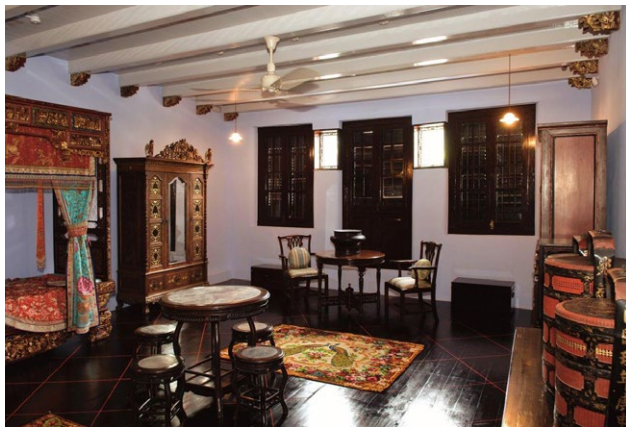
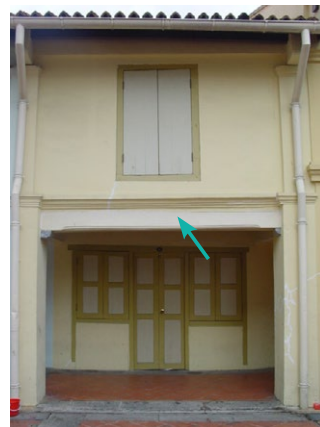
### Structural Elements of Shophouse – Timber Floor and Roof Systems

Timber structural features that contribute to the interior spatial quality of historic shophouses/townhouses should be retained and exposed. **Left:** The upper-storey timber floor system comprises beams and joists that span the party walls, reinforced with stone or timber corbels. Timber floorboards are laid across the joists, with tongue-in-groove joints.

**Middle:** The timber main beam spanning over the five-foot way becomes a key facade feature. **Right:** Given the narrow span, the roof system could do without trusses or rafters, featuring timber purlins directly spanning across party walls, with battens laid closely along the slope of the pitched roof to receive unglazed V-shape clay tiles.

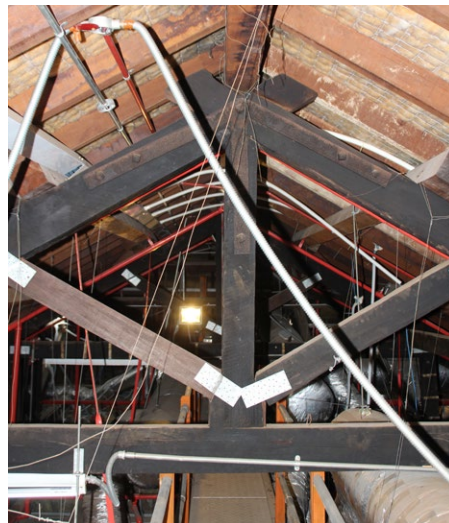
*Study of timber roof truss construction details, including joinery and fastening types.*

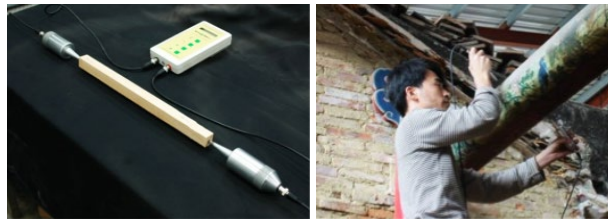
*Stress wave technique – calibration of the equipment prior to measurement of a horizontal timber structural member.*

- **Stress wave** technique involves the transmittal of sonic or ultrasonic sound wave through the target member, with the resulting variation in corresponding velocity used to detect interior voids or deteriorations, providing a global, or overall, condition assessment of the timber member.

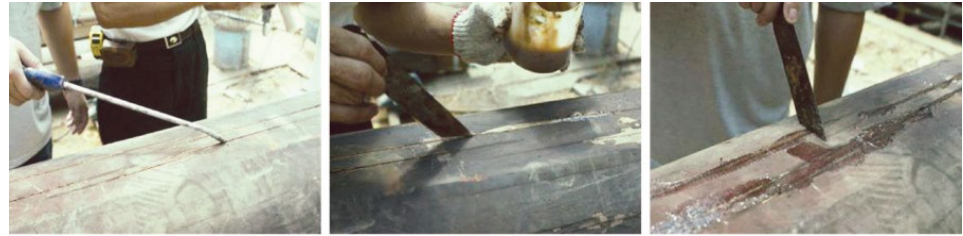
*From left:* Clearing of debris within fine cracks; fill the cracks with epoxy-cum-wood sawdust mixture; level or sand down surfaces, and air-dry upon completion.

**Minor repair with epoxy resin-sawdust mix** should be sufficient for slight damage such as fine or shallow cracks.

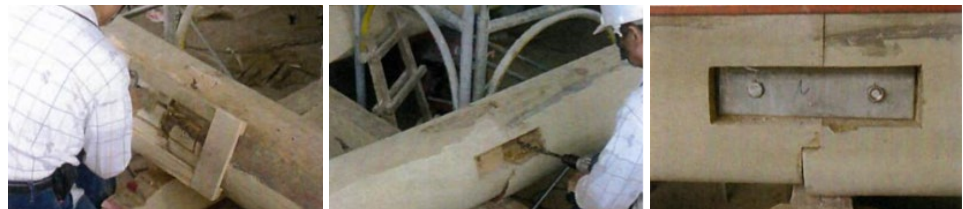
Reinforcing the existing half-lap dovetail jointed purlins with new bolted steel plates – the steel connectors will subsequently be concealed by patching with timber of similar species and grain to mitigate the visual impact of this intervention.

**Mechanical restraints** may be introduced as a temporary or long-term repair measure, for example to prevent existing cracks from widening or introduce resistance to joints to address known stresses such as tunnelling vibrations.

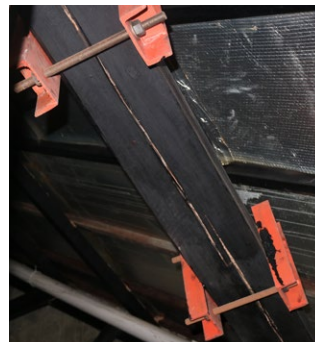
*Far left:* Detail drawing of reinforcement of the joint between timber floor joist and load-bearing masonry wall by introduction of steel joist hanger brackets – this will also protect the joist ends from moisture ingress due to rising damp in the wall. *Left:* Historic purlin restrained with steel clamps to prevent the split from widening – a method with high visual impact only for temporary application, or when concealed from view.

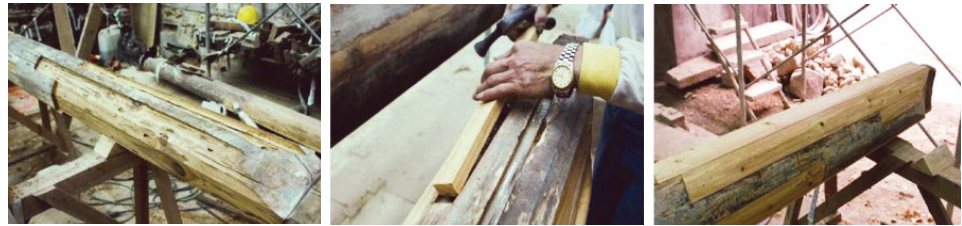
*From left:* Removal of damaged regions with tools leaving clean, straight surfaces to receive new wood material; new or recycled wood are tooled to the right dimensions and scarfed onto the existing timber - epoxy mix may be used as an adhesive; level or sand down surfaces, and air-dry upon completion.

**Timber-to-timber** repair addresses moderate partial damage such as by termite or fungal attack, or deep seasoning checks. The two main categories are patch or face repair that addresses surface damage, and whole-section repair where a complete cross-section is replaced. New or recycled wood material of the same or similar wood species is used for repair. New fastenings – often steel – may be introduced where historically there were none. Epoxy-resin may also be deployed as an adhesive.

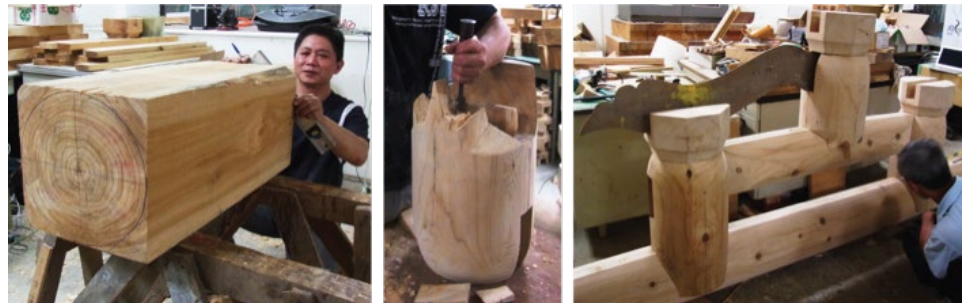
*From left:* Setting out the dimensions for the refabrication of the roof short post member (gua-tong 瓜筒) of a traditional Chinese timber roof structure; tooling of the new gua-tong; trial-assembly of the completed gua-tong with the rest of the retained historic timber roof structure members.

**Like-for-like localized replacement** using similar wood species and grain may be considered if structural members are damaged to an extent that they can no longer function structurally and are beyond feasible repair.

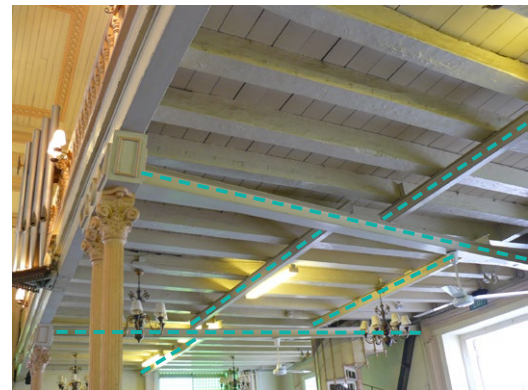
**Right:** Addition of steel cross-ties (highlighted) to improve the stiffness of historic timber frames, on the walls and roof of the barn house at Hokkaido University. **Far right:** Addition of steel I-beams (highlighted) to the original timber floor system, likely to accommodate the added weight of the extended organ at the Cathedral of the Good Shepherd.

**Addition** involves introducing new members to the existing structural frame, for example adding new joists between existing ones. The Professional Engineer should ensure that the existing structure is able to support the increased loading; alternatively the new members may be designed as self-supporting frames – this may be done to lighten the load borne by historic timber members, enabling them to be retained in situ without compromising the overall building structural performance.

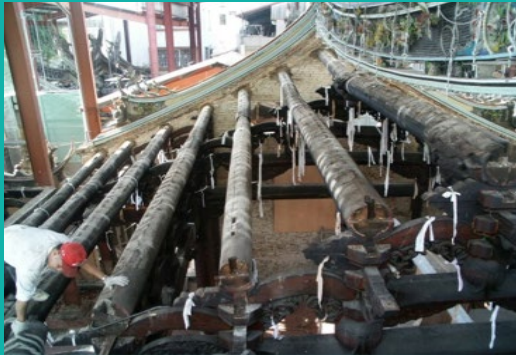
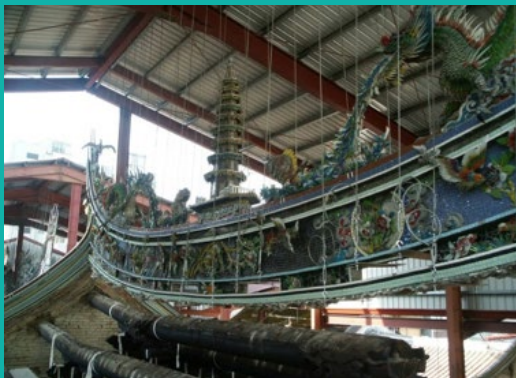
Left: Each timber member is identity-tagged with cloth strips before dismantling. Below left: In Taiwan, ornamented roof ridges of high heritage and artistic value are recommended for conservation. Instead of being dismantled, they are retained in situ during *luojiadaxiu* using suspended steel plate supports hung from a temporary shelter structure.

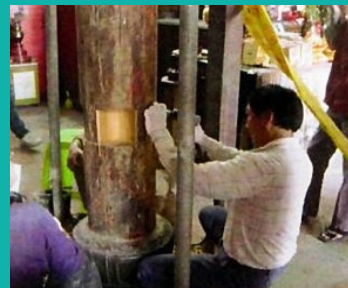
#### Partial repair of timber column base section:

Above from left: Temporary structural support in place around repair region; marking out the truncated lower region and master carpenter working on the cross-shaped joint in situ; removal of lower column base and temporary supporting of the original column with a newly shaped cross-joint; fabrication of a new cross-jointed column base with the same wood species. Right: Joining of the new and old column on-site with mechanical fastening and epoxy.

Although it ensures a thorough rehabilitation, given the great time and cost involved in *luojiadaxiu*, interim structural issues that surface tend to be deferred, with temporary supports put in place for long periods. Another possible 'middleground' measure would be a **partial dismantling and repair approach** (*jubuzhengxiu* 局部整修) that has been recently developed in Taiwan. Temporary supporting systems are carefully designed around the affected region to allow for the replacement of the target member(s). Although the preparations for executing this approach may be more complex compared to the traditional dismantling procedure, the overall repair time is significantly shortened and impact on the historic fabric minimized.

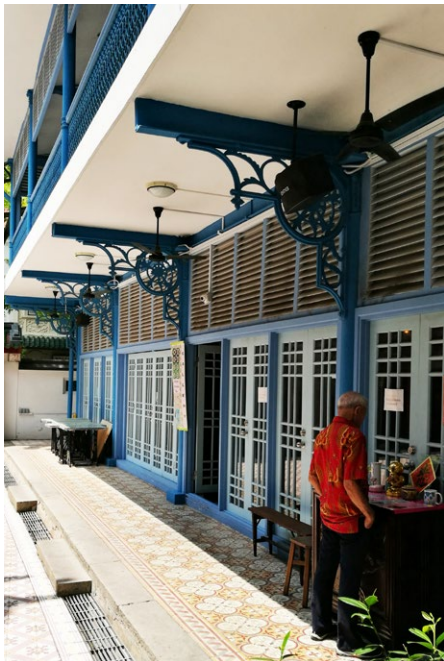
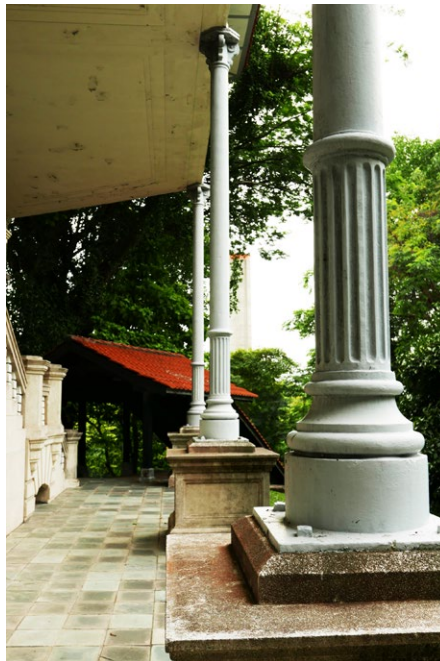
**Left:** Cast iron columns, spandrel beams and decorative brackets at Chong Wen Ge (1850s) within the compound of Thian Hock Keng Temple. **Right:** Cast iron columns fronting the house entrance at 11 Keppel Hill (ca. 1890s).

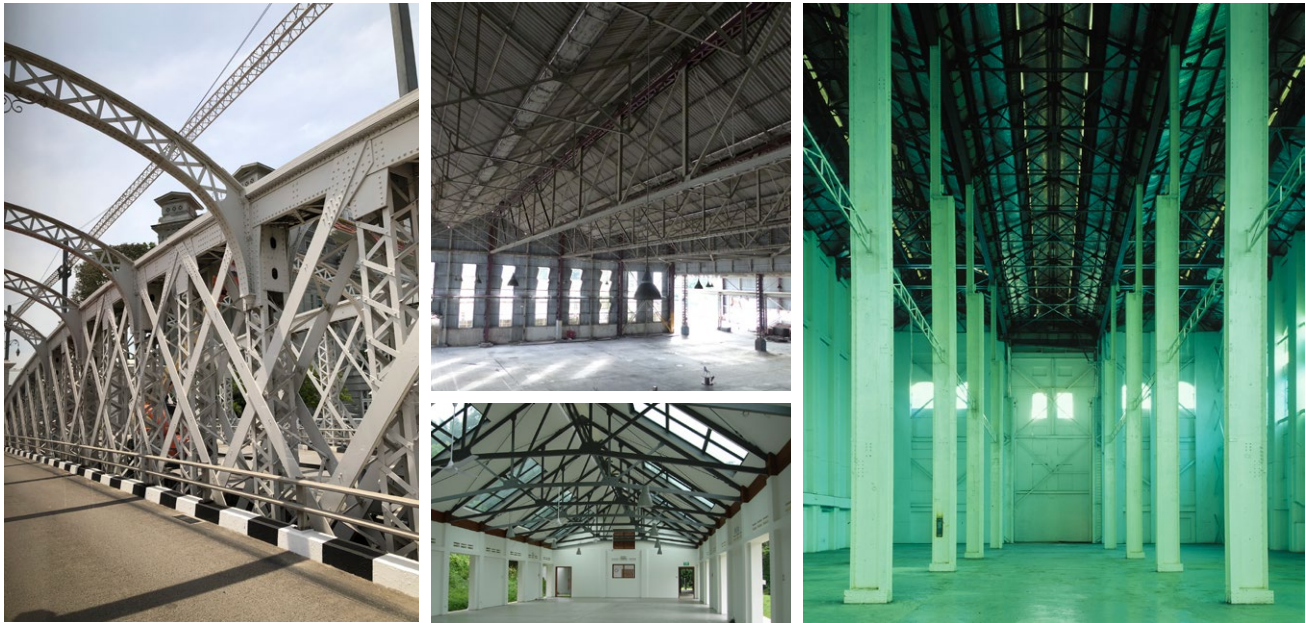
**Left:** Anderson Bridge (1910). **Middle from top:** Singapore Civil Aerodrome hangars (aka Kallang Airport, 1939); Dairy Farm cowshed (1930s). **Right:** St James Power Station (1926).

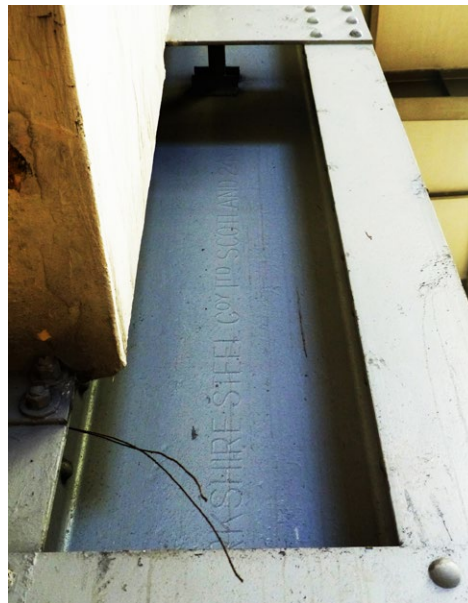
*Brand imprint found on historic steel structural member in Pasir Panjang Power Station (1953) indicating provenance from Lanarkshire & Co., Scotland.*

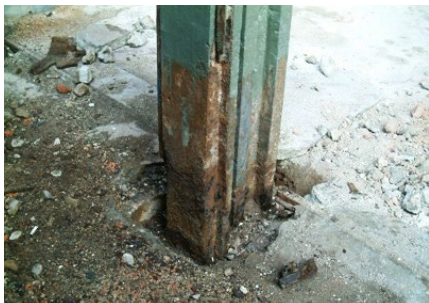
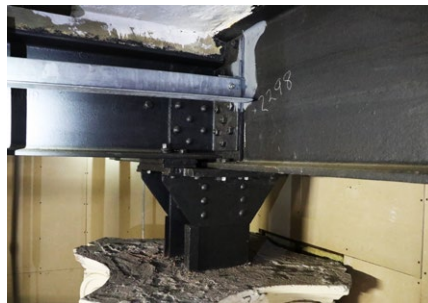
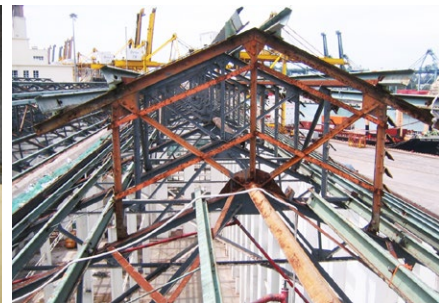
**Left:** Corrosion of steel column base due to rising damp. **Middle:** Joint between steel beams and column. **Right:** Connection details of a steel roof truss with jack roof.

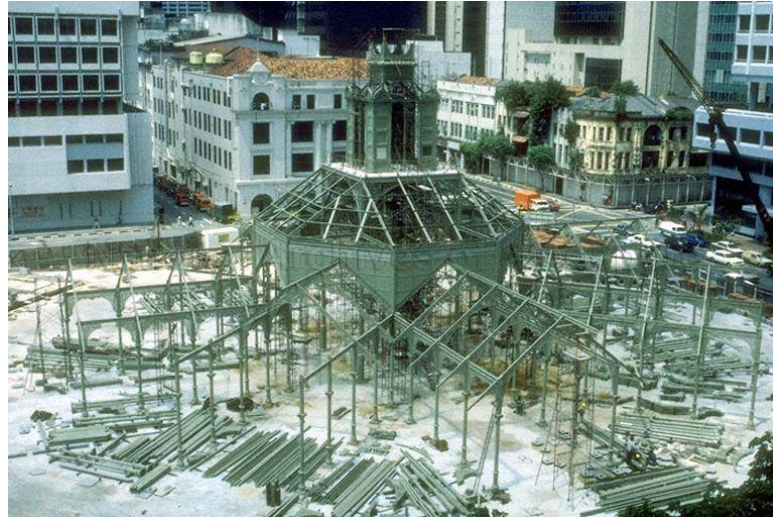
*Telok Ayer Market was dismantled and reassembled in 1988 during restoration works.*

Entire buildings in exposed structural iron, such as the cast iron Telok Ayer Market or standalone garden pavilions, could potentially be dismantled for comprehensive restoration or even relocation, not unlike timber frame structures. In most cases, however, steel structures are used in combination with other types of structural systems or integrated with other parts of the historic building, and dismantling may impact on these elements or finishes. Instead, conservation interventions are carried out in situ.

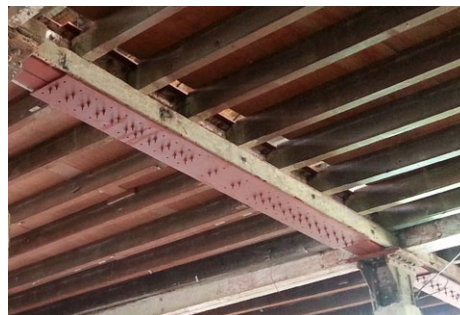
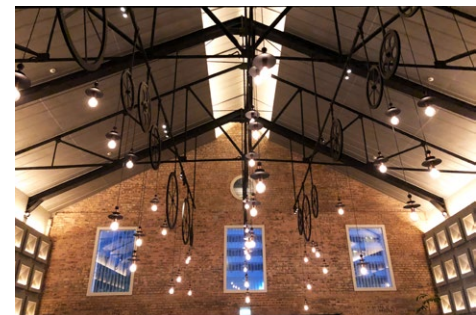
***Right:** Strengthening of steel beam by bolting steel plates to the bottom flange. **Far right:** Sensitive addition of steel portal frame between historic roof trusses allowing for distinction between old and new without detracting from heritage presentation.*

Strengthening steel plates can also be welded directly to a historic steel structural member. However welding a steel plate to wrought iron or cast iron is not advised. The high temperature during the welding could cause the wrought iron surface to delaminate, while cast iron melts at a lower temperature compared to steel and will not form a proper bond with the welding alloy and steel.

**Addition** involves introducing new members to the existing structural frame, for example adding new steel floor joists or roof trusses between existing ones. The professional engineer should ensure that the existing structure is able to support the increased loading; alternatively the new members may be designed as self-supporting frames, in steel or reinforced concrete – this would lighten the load borne by the historic metal structural members, enabling them to be conserved in situ without compromising the overall building structural performance. Additional structures should nonetheless be sensitively designed and located to avoid any impact on other historic elements or creation of visual clutter in historic spaces.

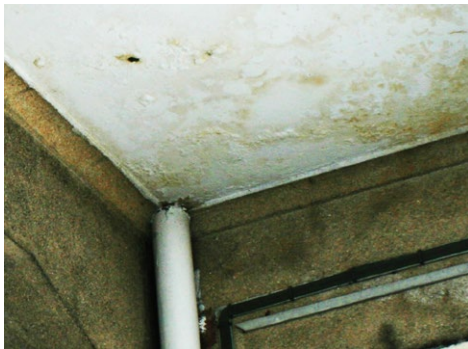
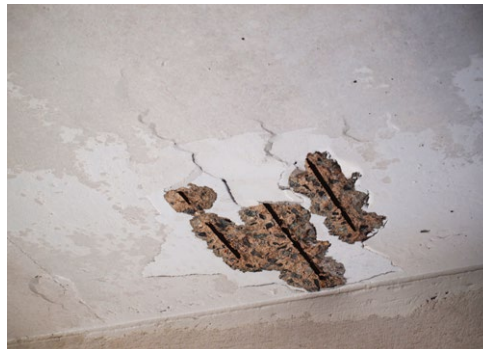
*From left: Bubbling paint, seepage stains and efflorescence at soffit of concrete slab; spalling of concrete slab undercroft; corrosion of steel reinforcement and salt attack of concrete due to rising damp.*

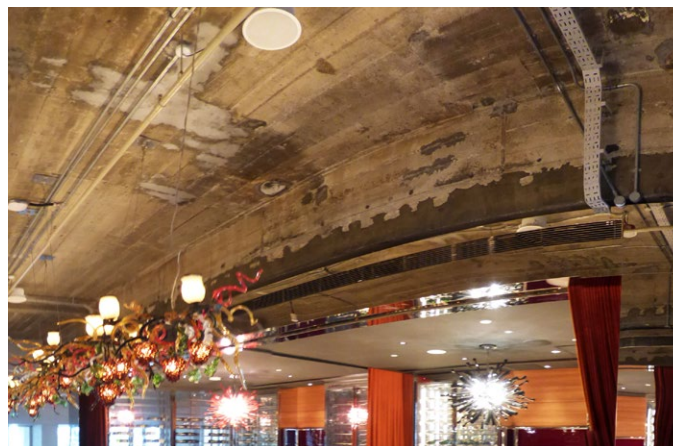
Existing RC beam strengthened through increase in sectional depth by casting of new high-strength concrete beam below (note darker material along the bottom of the beam).

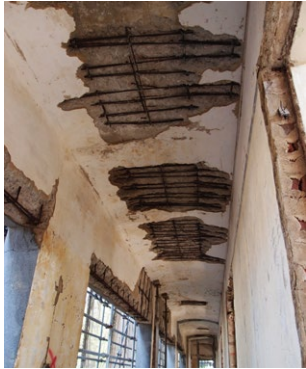
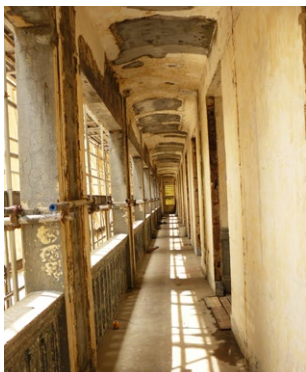
*From top: Concrete patch repair – removal of affected concrete cover to expose rebar for cleaning and treatment, before patching with compatible mix.*

**Patch repair** may be carried out to address minor to moderate defects on the concrete cover. Affected concrete surface is removed to expose the steel reinforcement, to be cleaned and treated with a primer to protect from further corrosion, or replaced if steel sectional loss is excessive. The concrete surface is then reinstated using a compatible concrete mix. A moderately invasive technique, this method should be constrained to localize repair only where needed.

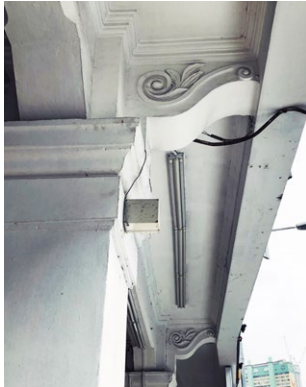
*Ornamental facade RC feature corbels that may be adversely affected if strengthening is applied.*

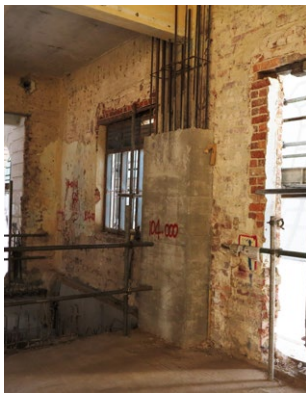
*Addition of RC column to support existing beam and stiffen the masonry wall.*

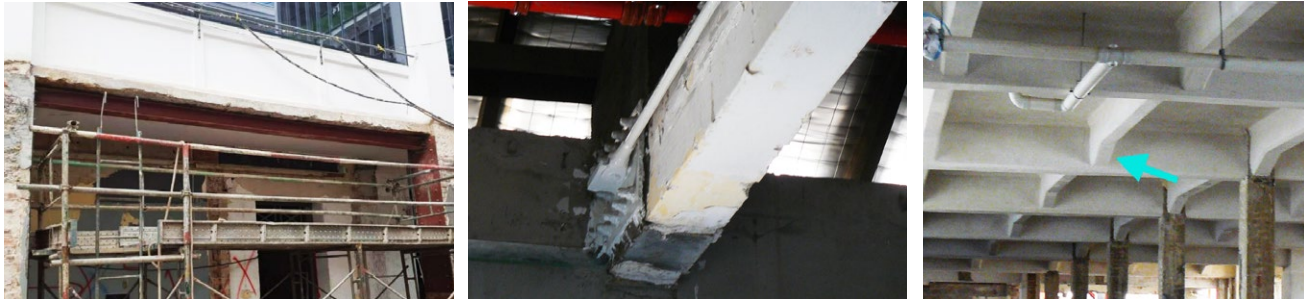
**Left:** Steel jacking by installing steel plates on the columns and a new I-beam attached to the existing RC beam.

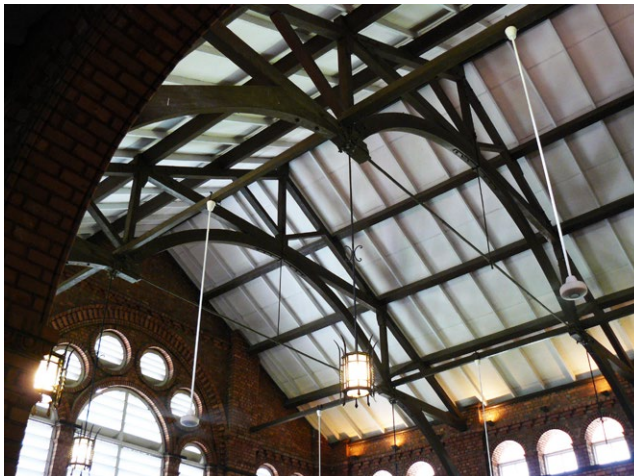
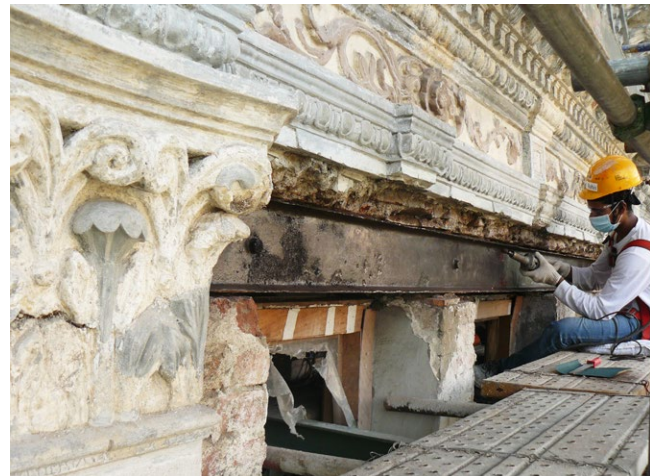
**Left:** Composite timber roof trusses with iron tensile ties, St George's Church (1911). **Right:** Stamford House, a steel-frame building with masonry envelope built in 1904, has historic 'ferro-concrete' where steel I-beams are found encased in brick concrete on its facades.

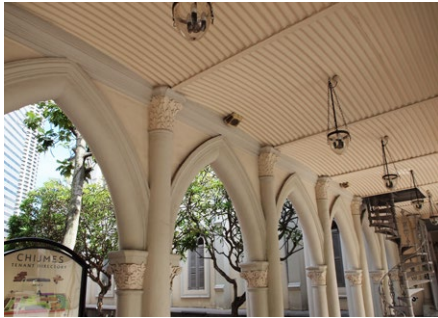
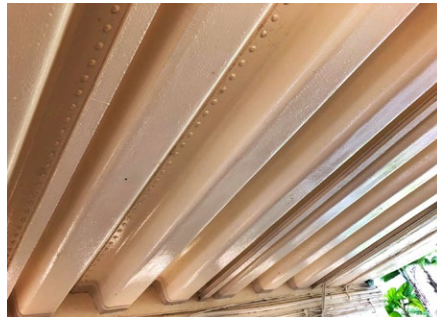
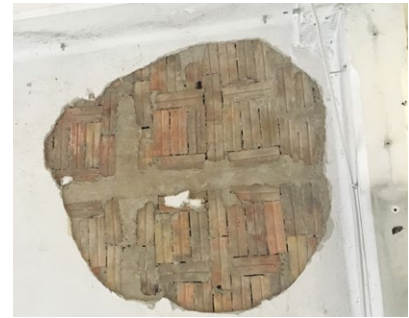
**Left:** Concrete slab soffit with curved corrugated steel permanent form, at Convent of the Holy Infant Jesus (1900s, current-day CHIJMES). **Middle:** Heavy gauge iron jackets as permanent form at a 1900s road bridge over a former railway line (current-day Neil Road). **Right:** Hollow pot slab construction with ribbed cast concrete and clay 'pots' formwork infill.

Corrugated steel deck may also double up as **permanent formwork** and external reinforcement for cast concrete slabs. 'Hy-Rib' was developed in the 1900s as a self-supporting metal lath or mesh reinforcement that served also as a substrate/formwork that the concrete mix could be directly cast in/applied on.

Another type of permanent formwork comprised hollow blocks (or 'pots') in clay or concrete packed closely to form the soffit voids of cast in situ ribbed concrete floors. Known as **hollow pot slab**, this was devised to reduce the dead load and material (as compared to solid slab construction) while maintaining its fireproof property. Precast concrete blocks were also used in combination with clay bricks in the construction of **composite load-bearing masonry walls or columns**.

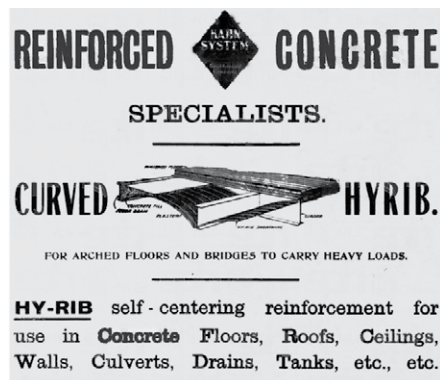
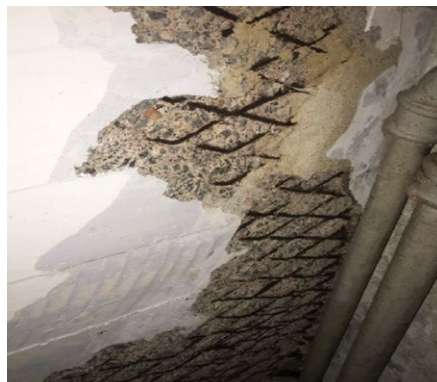
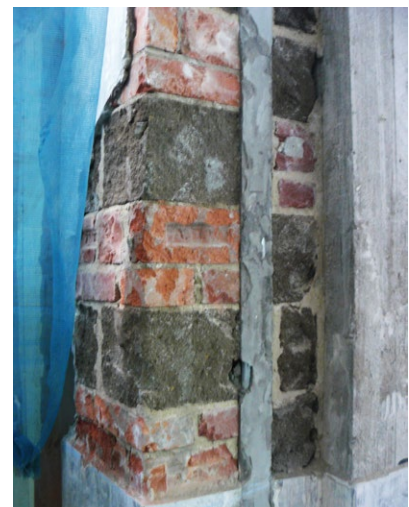
**Left:** 1910s advertisement showing the use of curved 'Hy-Rib' mesh reinforcement in concrete vaults spanning between I-beams. **Middle:** Spalled concrete cover reveals mesh-formed concrete construction. **Right:** Composite masonry wall with clay bricks and concrete block, Stamford House (1904).

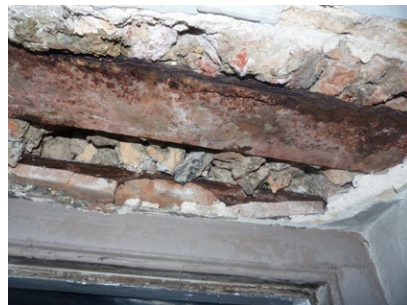
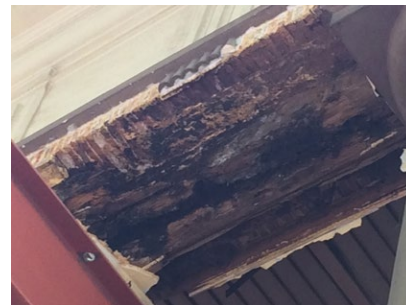
**Right:** Double I-beam encased in brick concrete, already flaking with corrosion. **Far right:** Timber beam encased in masonry already severely compromised by wet rot went undetected until mid-construction.

Poorly maintained **timber composite construction** may suffer from wet or dry rot, and termite infestation of the timber elements. A common cause of problems encountered in local half-timbered construction is moisture trapped by inappropriate unbreathable paintwork, which may also lead to deterioration of the plaster and brick masonry infill. In rare cases where timber beams are found encased within brick masonry, moisture ingress may also result in wet rot, or termite infestation may occur at the beam ends or where there are cracks. Insect infestation in timber that are embedded or thickly painted may remain undetected until structural failure occurs, or when a breakout inspection is done. Timber members may also undergo structural deformation from weathering, loading stresses or settlement, in turn affecting the infill or encasing brick masonry.
