# CONSERVATION TECHNICAL HANDBOOK

## Volume 4 | Structure

# Conservation Technical Handbook

### **URBAN REDEVELOPMENT AUTHORITY**

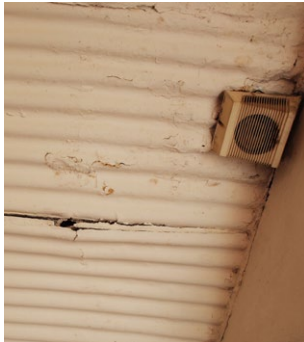
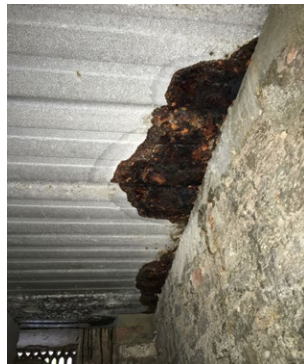
*Corrugated steel form and concrete composite slab with water seepage, paint failure, and steel corrosion occurring at the slab-to-wall junction.*

Similar to reinforced concrete, **embedded steel** may undergo corrosion due to ingress and retention of moisture due to rising damp, inappropriate paintwork, and cracks in the encasing brick masonry or concrete. In the case of **external steel reinforcement**, corrosion may arise from direct exposure to the atmosphere or moisture due to paint peeling or drainage issues.

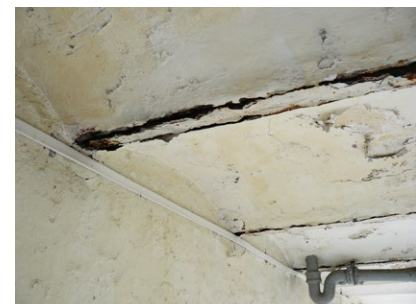
*Surface-penetrating radar scan reveals a composite slab system with reinforced concrete vaults spanning between steel joists.*
