CONSERVATION TECHNICAL HANDBOOK

Volume 5 | Doors and Windows

URBAN REDEVELOPMENT AUTHORITY

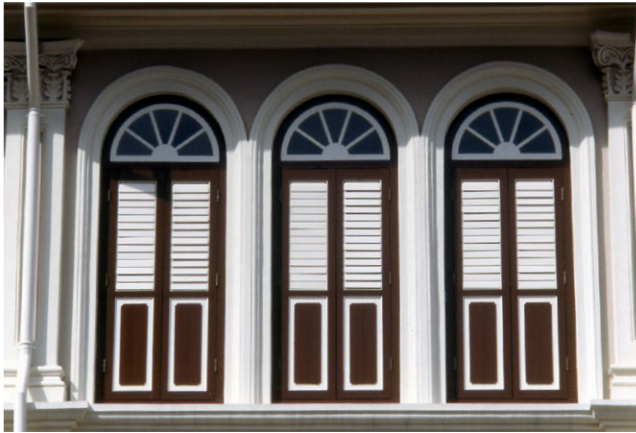
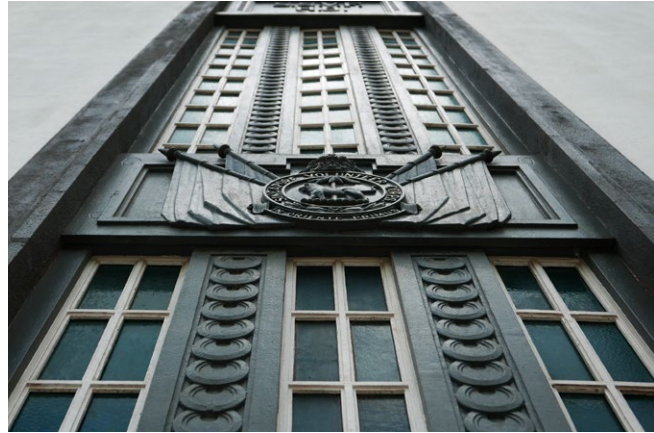
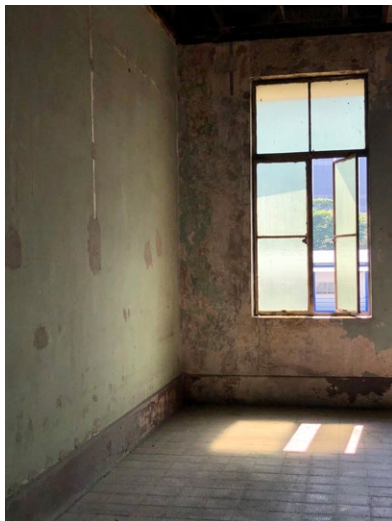
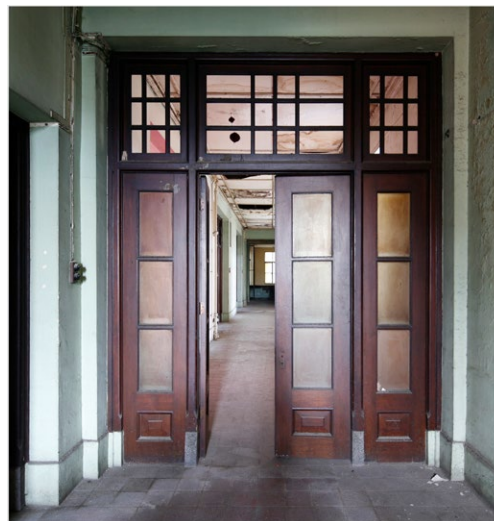
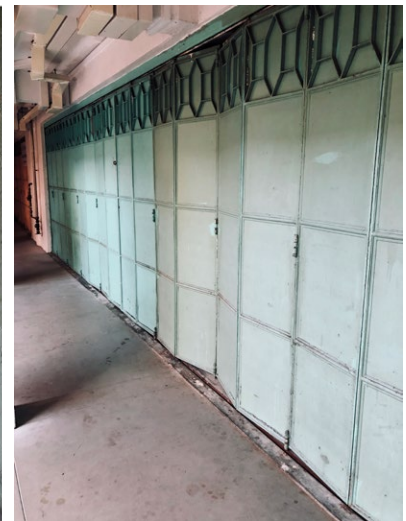
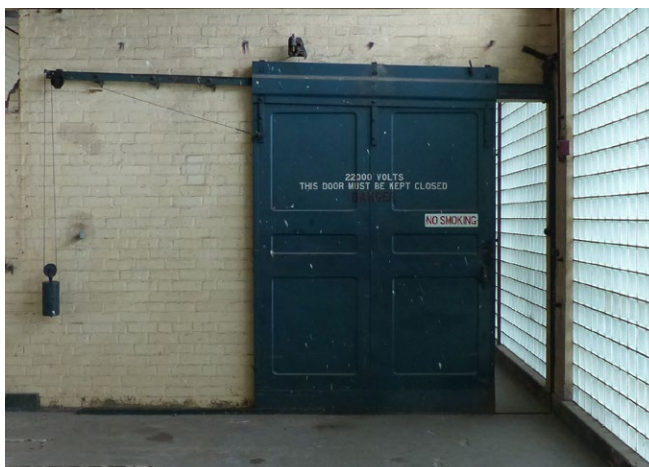
Top left: French windows with louvred timber shutters and fanlight, framed by moulded plaster architrave, 28 Sago Street shophouse. **Top right:** Cast iron feature window with tinted glass, former SSVF Drill Hall. **Second row left and middle:** Tanjong Pagar Railway Station mild steel pivoted windows with toplight and tinted textured glazing; interior hallway entrance timber door with tinted glazing, top vents and terrazzo heel stone. **Second row, right:** Folding sliding metal door at ground floor shop unit, Everton Park public housing estate. **Left:** Top hung high security sliding steel door with weighted lever, former Pasir Panjang Power Station.

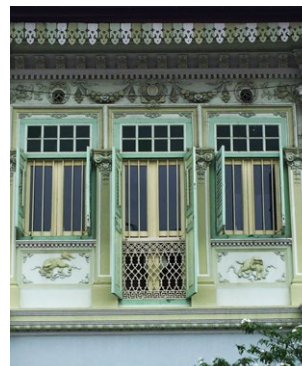
Left: Added secondary windows that are operable allow for maintenance of the historic fenestrations, as seen at this conserved townhouse.

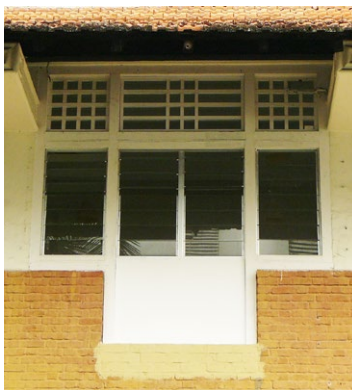
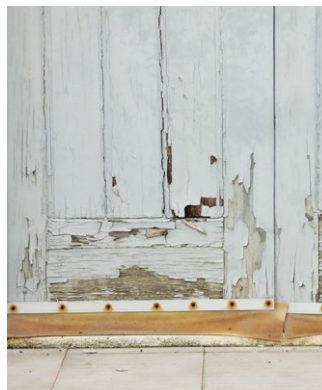
Left: Insensitive boarding up and replacement of timber french window with 'naco' louvres. **Middle:** Paint peeling and wet rot due to weathering, lack of maintenance and use of incompatible paint. **Right:** Historic feature window boarded up on both inside and outside, preventing maintenance, exacerbating deterioration and leading to loss.

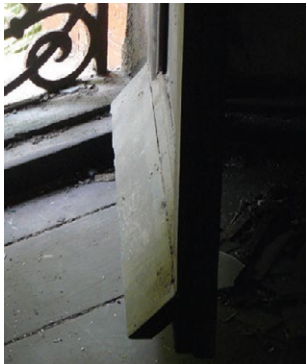
Top: Off-site repair of historic timber window.

Above: Addition of a rail with inclined profile at the bottom of a historic timber door/french window helps reduce rainwater ingress by shedding splashback and runoff.

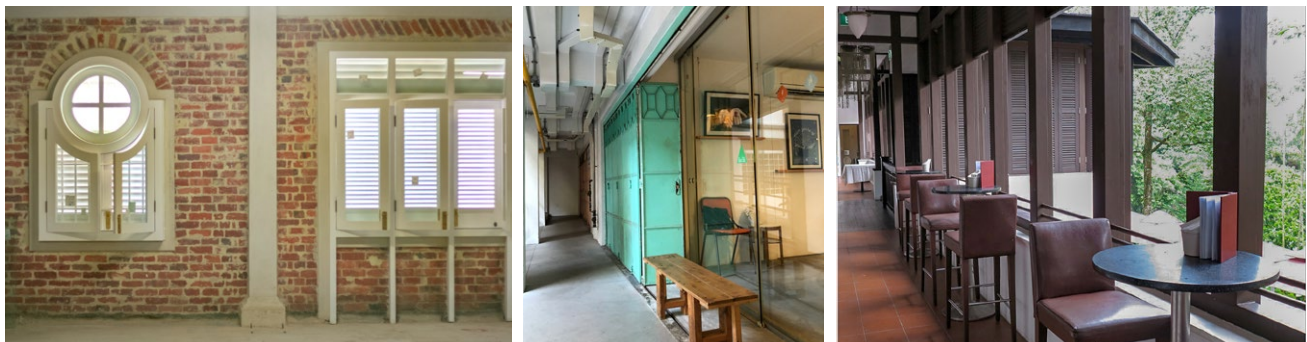
Left: Interior view of new timber frame secondary windows being installed, sensitively integrated with the historic window design. **Middle:** Frameless glass secondary sliding doors installed behind historic metal accordion gate. **Right:** New safety rail (horizontal steel bar) added to historic verandah timber frames of a restored bungalow due to the low sill height.

Nevertheless, additions should be designed for minimal visual and physical impact, and not overwhelm the heritage opening. As such, while secondary doors and windows may be in a different material, they should generally assume a simple design that does not obstruct the operation – whether casement, or pivoted, or folding-sliding – nor maintenance of the historic. The design should also take care that installation methods and anchor points do not damage existing heritage elements. Sometimes new framing supported off the existing walls or floor beams may be required if the secondary windows are too large and hefty to be placed within the existing opening.

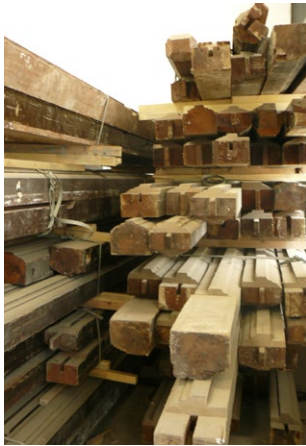
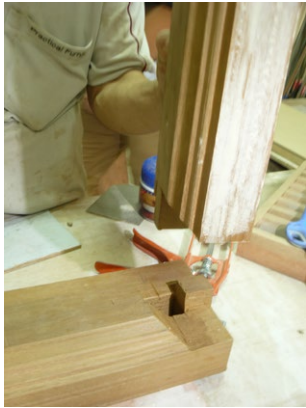
Historic timber components of windows that are not retained are carefully catalogued and dismantled, stored and set aside for reuse and repair of severely deteriorated elements that are conserved.

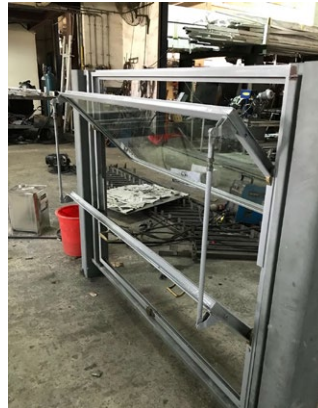
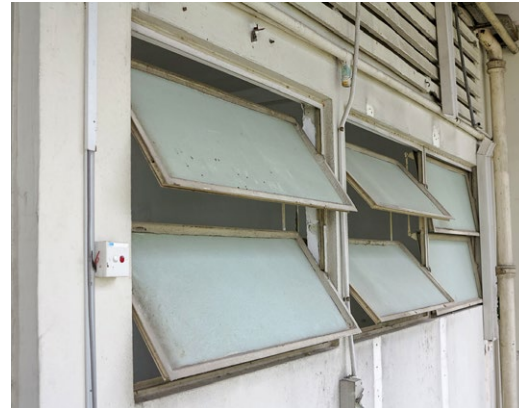
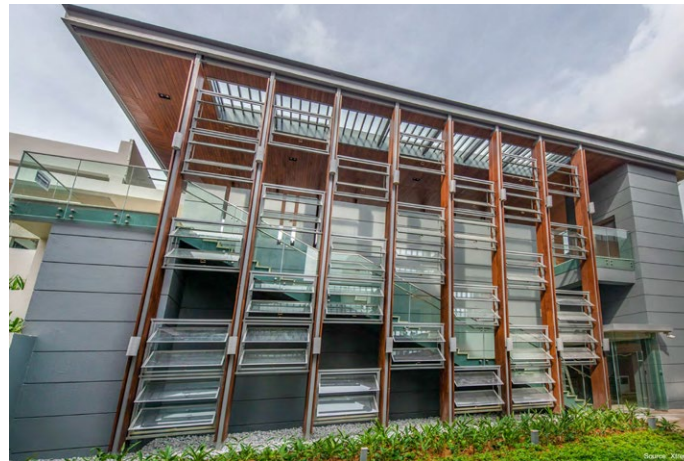
Historic Crittall brand mild steel framed pivoted windows were carefully dismantled from the former MGS Sophia Blackmore Hall, restored and adapted as a feature screen on the redeveloped site, as part of the heritage interpretation strategy.

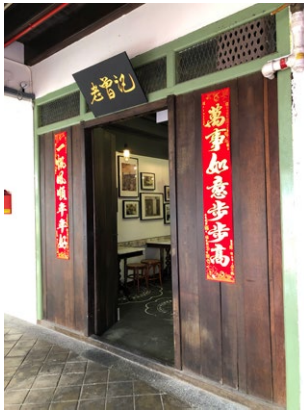
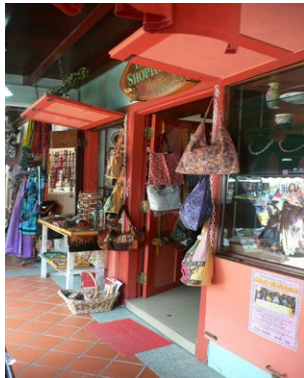
Early shopfront fenestration types with dismantlable timber boards (**top**), and split top and bottom panels or 'Dutch' windows (**above**).

Early shophouse fenestration types, designed to facilitate mercantile and/or warehousing activities of the period, reflect Singapore's history as a colonial trading outpost. An example commonly found in the Kreta Ayer (Chinatown) area comprises a timber frame shopfront with a central double swing door flanked by **full-height dismantlable timber boards** that provided security, but that could also be fully removed to create a wide opening when the shop/warehouse is open for business/loading. Another example is the '**Dutch**' door/shutter, similar to those found on Dutch colonial-era buildings in Malacca, and can still be seen at Bussorah Street. Typically, an opening has top and bottom operable solid timber panels. The top could be opened for ventilation while the bottom remains closed for partial screening, or both could be opened for loading and trading. When opened, the bottom panel of a 'Dutch' window can also be propped up as an extended display surface for goods.

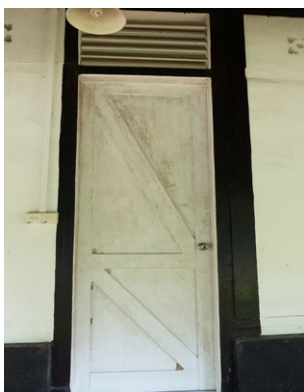
Board and batten door

Plank/Board and Batten: A simple door/window constructed of timber boards in a row, parallel throughout its length and held together by perpendicular and diagonal support battens. There are also variations of such construction, for example, double planked as well as battened and ledged. These are often deployed as service area doors for heavy usage.

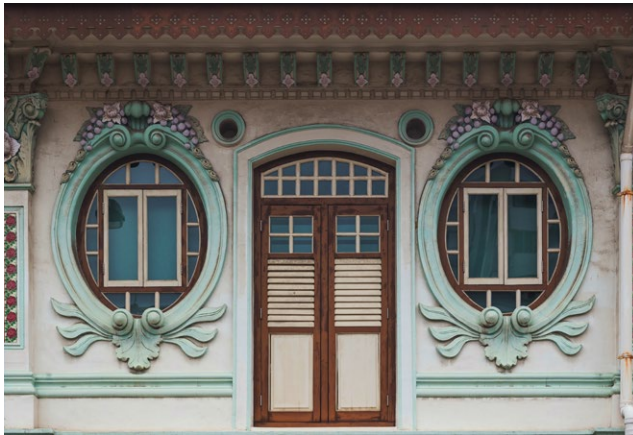
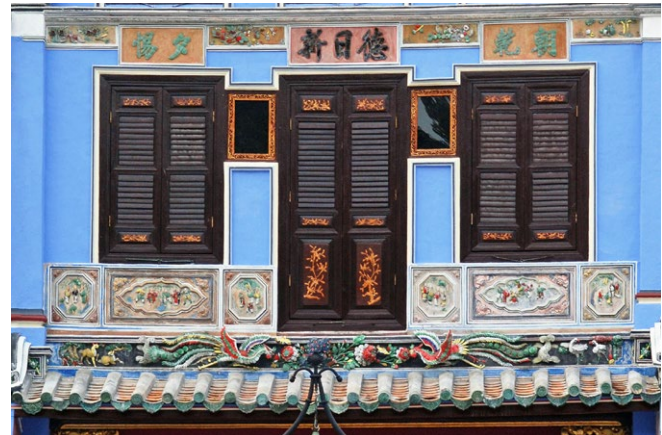
Left: French panelled window flanked by ox-eye windows, Syed Alwi Road shophouse. **Right:** Carved timber louvred shutters with a central french window, in composition with plaster and ceramic shardwork ornamentation, townhouse at 157 Neil Road.

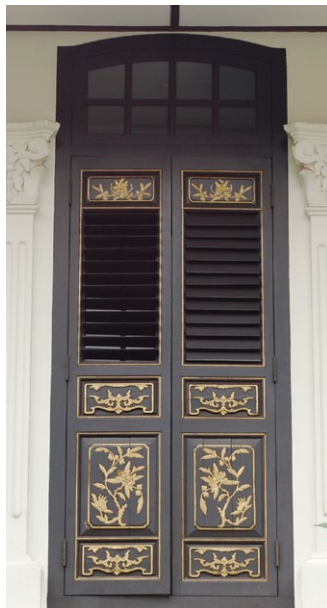
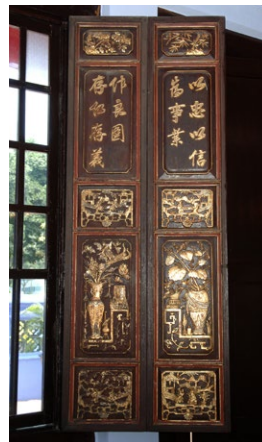
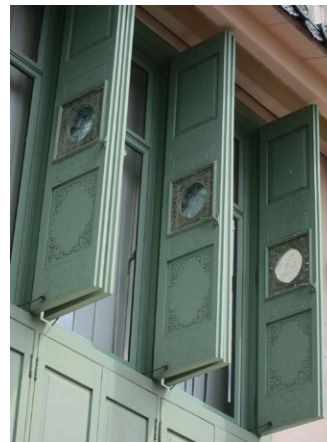
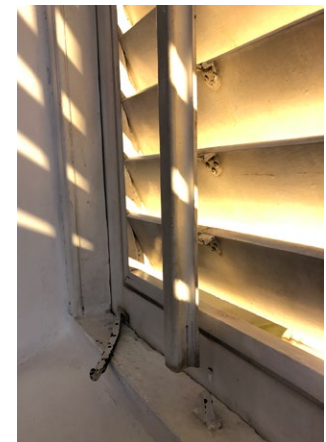
Left, middle: Elaborate carved timber panel windows. **Right:** Operable timber louvres, controlled by a tilt rod, facilitates natural ventilation.

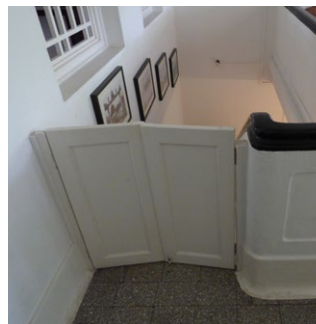
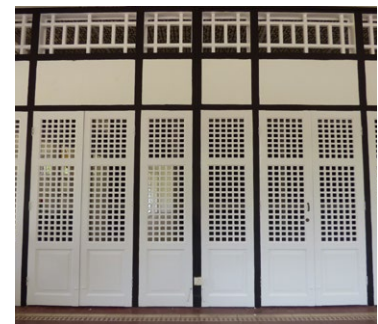
From left: Casement window with glazed lattice; Low timber safety gate at the head of the staircase; Lattice doors and top vents forms breathable building envelope.

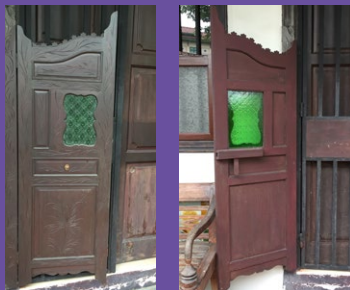
Exterior- and interior-facing sides of a pintu pagar with coloured embossed glazing panel.

Pintu pagars are made of timber, usually tropical hardwood. The leaves are hung via brass or bronze spring hinges from timber posts, usually also ornamented and fixed to the main door frame. The leaves are typically panelled, infilled with solid or latticework carved timber, or tinted and textured glazing. Apart from the hinges, other ironmongery features include latches and stays to keep the leaves in position.

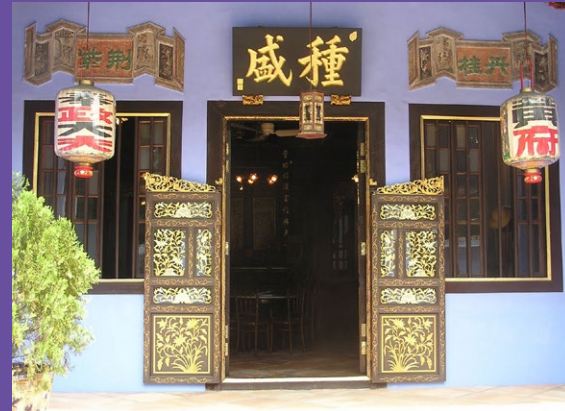
Pintu pagar with intricate carvings and gilded wood at the entrance of a townhouse at 157 Neil Road.

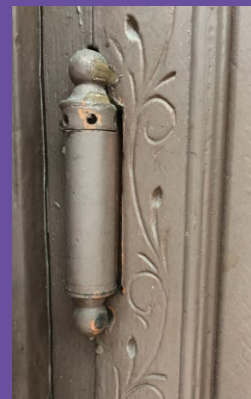
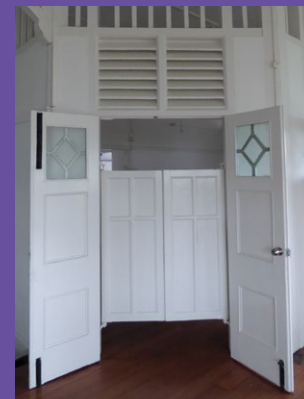
Above left: Detail of a spring hinge. Above right: Pintu pagar in a house interior setting. Left: Pintu pagar with Chinese motifs and latticework panelling at an Emerald Hill townhouse.

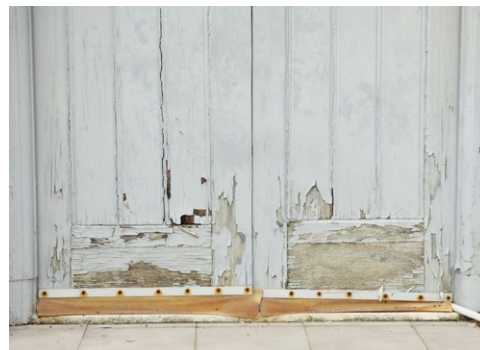
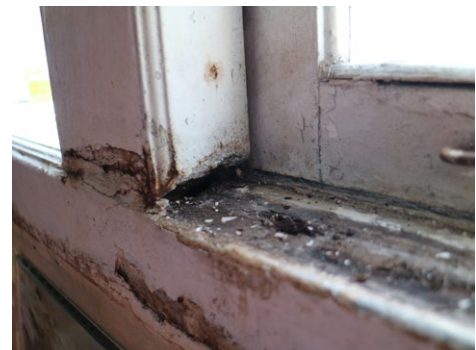
Wet rot at susceptible locations – door kickboard and window sill.

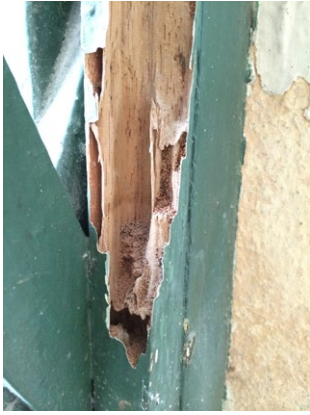
Termite attack in timber components leaving extensive trails.

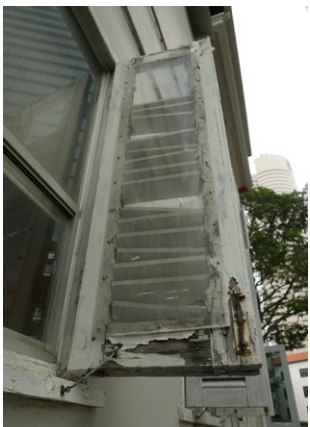
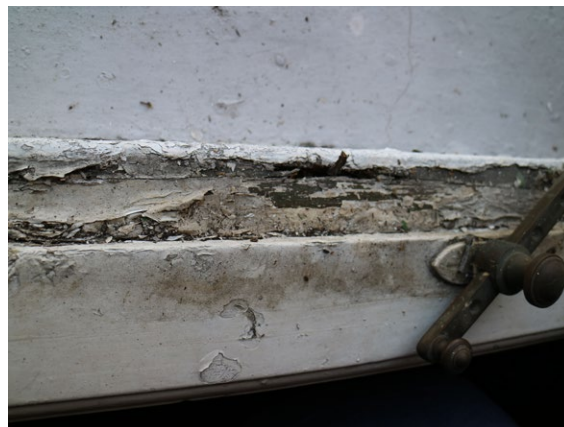
Far left: Dislodged louvres, wet rot and rusted ironmongery.

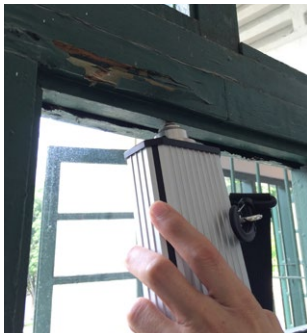
Timber resistograph carried out on window frame.

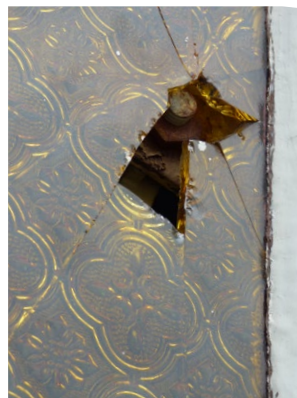
Regular maintenance repair includes the temporary sealing up and eventual replacement of any broken glazing, to keep out any water ingress that may cause further damage to the historic window and even the building interiors.

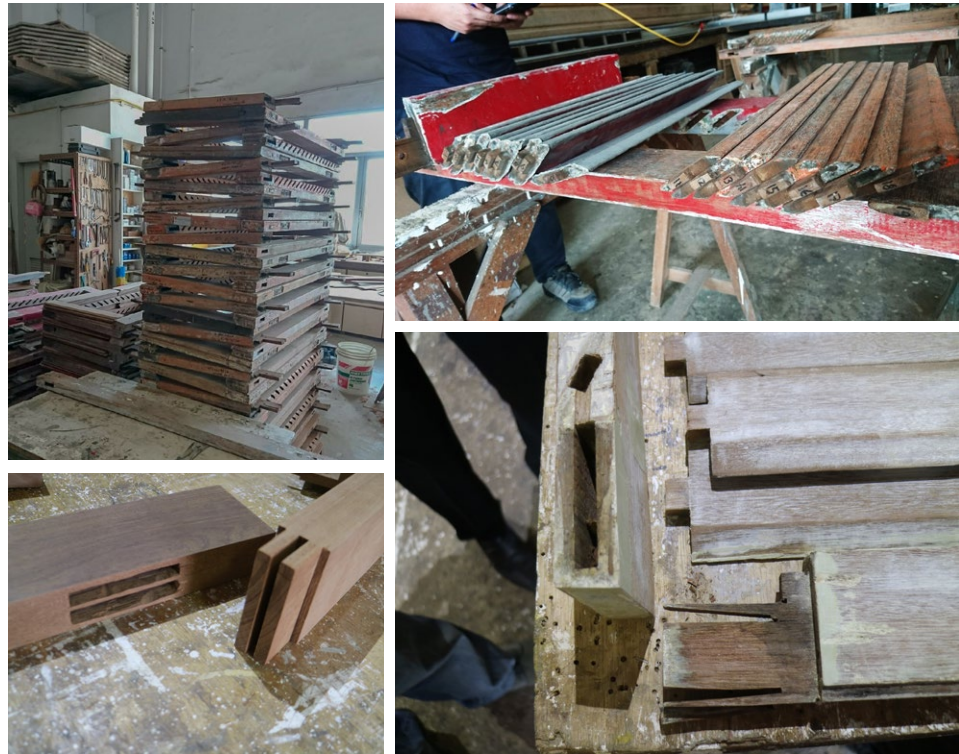
Timber doors and windows dismantled for off-site storage and bench restoration in a carpentry workshop. Components such as louvres and frames can be taken apart for closer study of joinery details and thorough cleaning/paint removal.

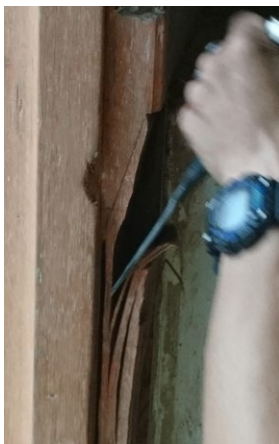
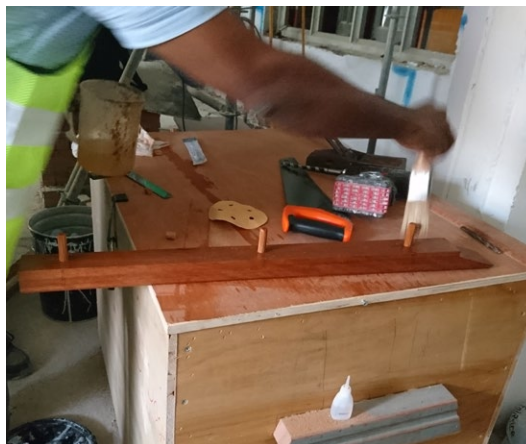
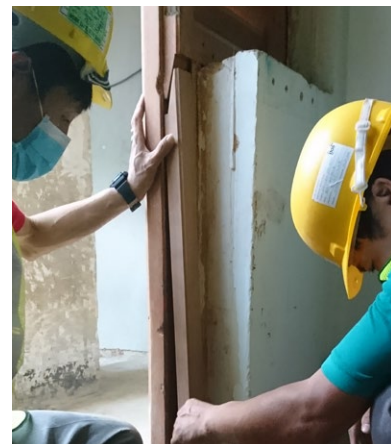
Left to right: In-situ timber-to-timber conservation repair – decayed wood is removed and scarf joint carved from the existing. Replacement member of the same species is tooled and coated with preservative before being fitted to the existing frame.

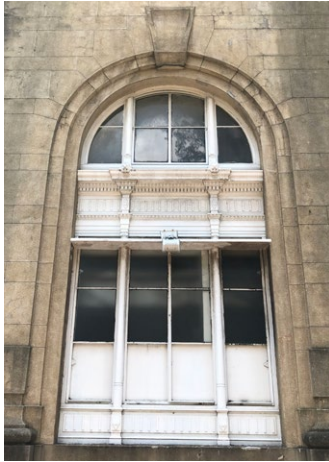
Left: Mild steel fixed and top hung windows with integrated safety railing illuminating the staircase landing at Sophia Blackmore Hall, former Methodist Girls' School, Mt. Sophia campus. **Right:** Mild steel pivoted window with security lattice grille installed in 1939 at the Cathedral of the Good Shepherd.

Technological advancements in steel and sheet glass production enabled the creation of **mild steel** windows with thin frames and large glass expanses, befitting reinforced concrete buildings that could achieve bigger openings. These were introduced to Singapore as early as the 1910s, touted as being more lasting than timber windows while allowing more daylight through. Like cast iron windows, these were prefabricated patented products and came with accessories such as hinges, handles and stays. Recommended in prewar advertisements for ‘offices and bungalows’, early examples included premier commercial buildings at Raffles Place, Capitol Theatre (1931), Chee Guan Chiang House (1938), and government buildings, including schools.

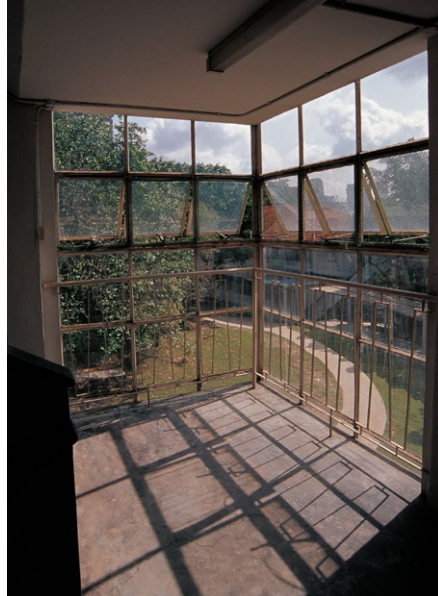
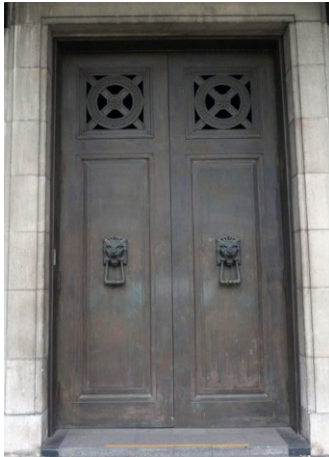
Left top: Brass doors at City Hall (1929). **Left bottom:** Cast iron window straddling two storeys at Tanjong Pagar Railway Station (1932). **Below from left:** Bronze windows supplied by Henry Hope and Sons Co., and 'Dreadnought' steel fireproof door with counterweight door closer at Pasir Panjang Power Station (1953).

The predominant material used was **ferrous metals**, and known surviving heritage metal doors and windows are mainly of wrought iron, cast iron or mild steel. The more costly bronze and brass were mainly reserved for **ironmongery** such as hinges and handles. A characteristic Art Deco feature, bronze doors were used at high profile buildings such as the bronze collapsible gates at the former Kallang Airport (1937), and “extruded manganese bronze” triple-opening doors at the MacDonald House (1949) banking hall, but many have long since been replaced. A rare surviving example can be found at the former City Hall (current National Gallery). Elaborate historic cast iron windows could be found adorning grand former government buildings such as on the main facades of the Straits Settlement Volunteer Force Drill Hall (1931) and former Tanjong Pagar Railway Station (1932).

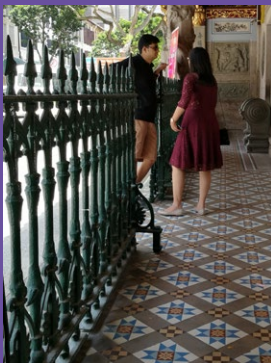
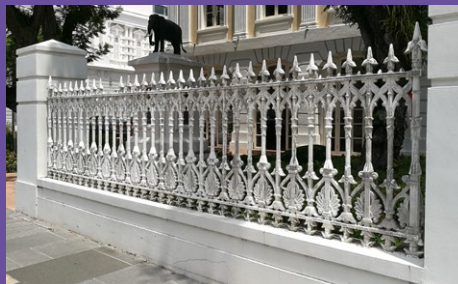
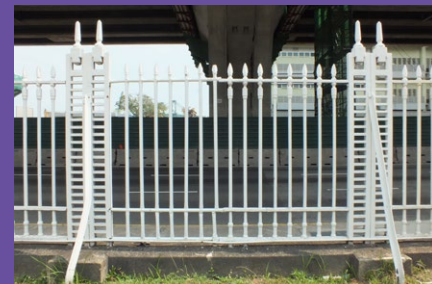
From left: Ornamental cast iron fencing and gates at Thian Hock Keng (from Scottish foundry Walter MacFarlane & Co.), Old Parliament House, and featuring Art Deco design at the Tanjong Pagar Railway Station.

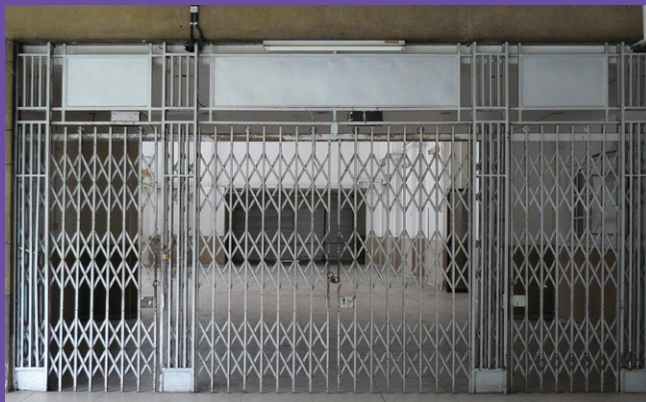
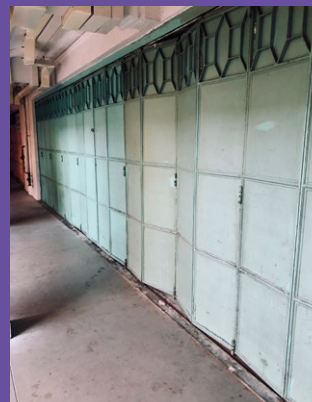
From far left:
Collapsible gates at Tanjong Pagar Railway Station (1932); Mild steel sliding folding doors with integrated ventilation grilles (sealed up) at Everton Park Housing Board estate ground floor shop units (1965).

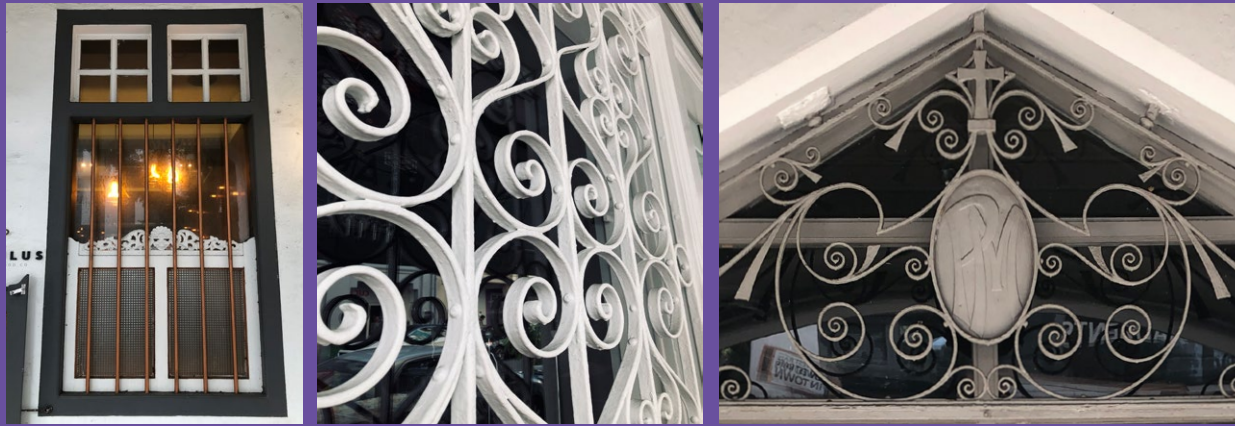
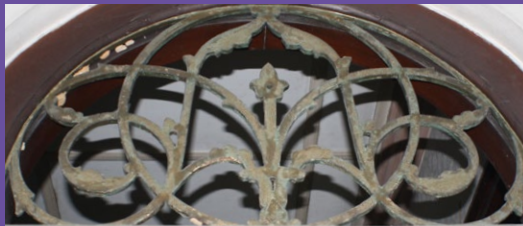
PREWAR DESIGNS – above from left: **Simple mild steel vertical rods at Neil Road shophouse; Riveted mild steel strips formed into ornamental tendrils at Keong Saik Road shophouse; Grille integrated with cross and initials at St. Joseph's Church Parochial House; Left: Decorative cast bronze top vent with plant and floral motifs above a house interior door.**

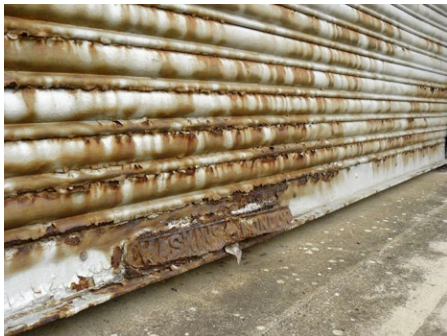
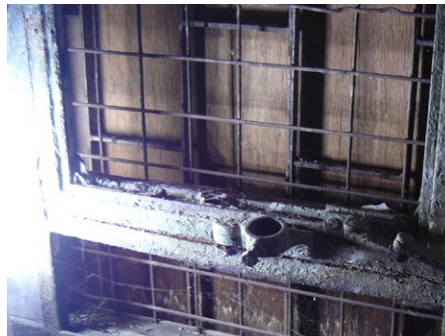
Far left: Peeling paint and rust corrosion of prewar galvanized steel military garage roller shutter at former Beach Road Camp.

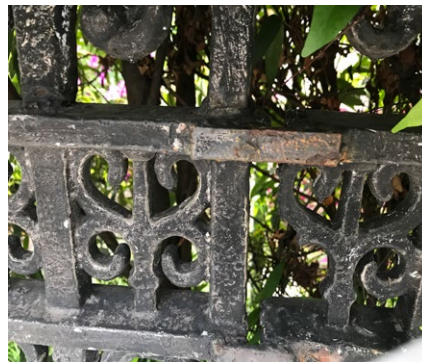
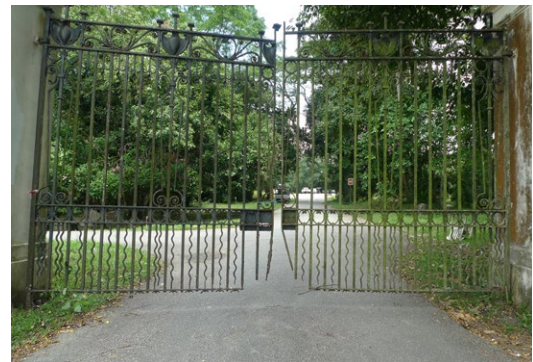
Right: Overpainted cast iron fencing with defects at joint between units – dislodgement, corrosion, inappropriate ad hoc welding patch repair.

Far right: Historic metal gates at Bukit Brown Cemetery – corrosion and breakage at lower edges that tend to receive impact and are exposed to ground moisture.

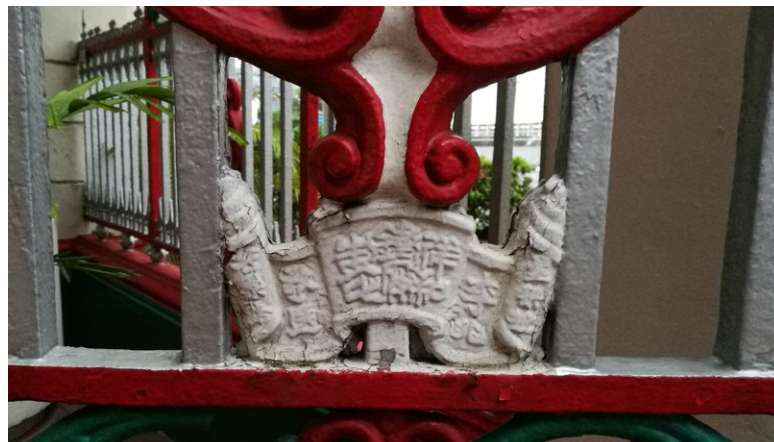
Ornamental detail and condition of historic clan house gates obscured by thick overpainting – NDT can provide an initial assessment of the underlying metal condition and the thickness and types of coatings.

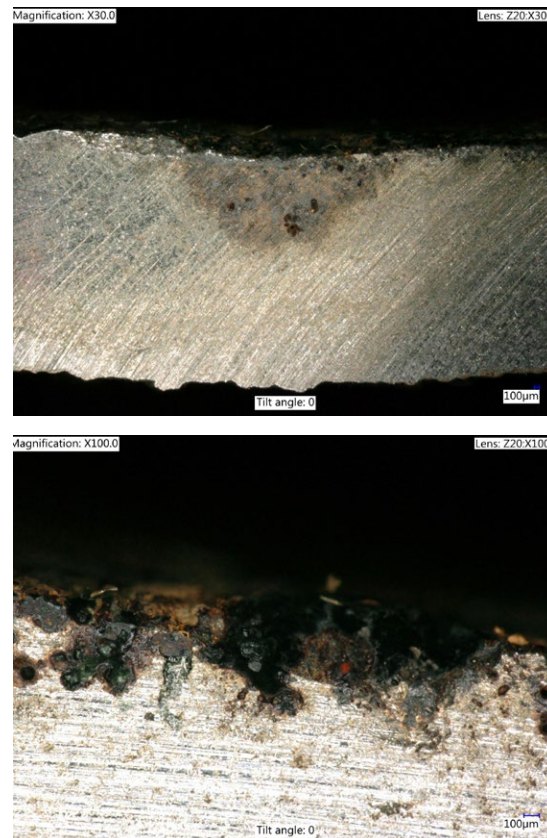
Microscopic imaging at different magnification showing corrosion extent and microstructure of an extracted stainless steel sample.

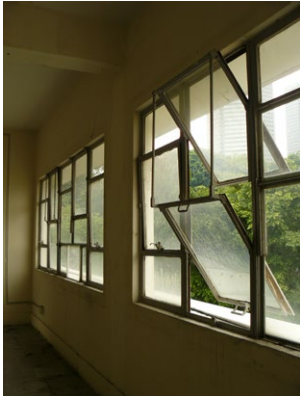
Original and replica mild steel pivoted windows at the former Brittonia Club (later NCO Club). Reinstatement using replicas was done for window locations where the original had been demolished.

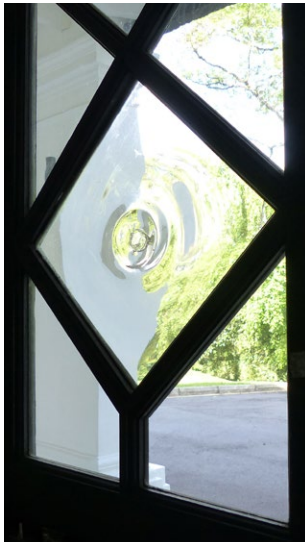
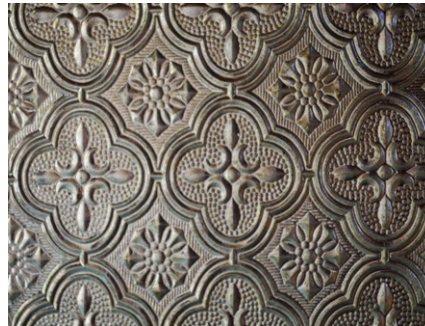
Left: By using embossed rollers, the technology of rolled sheet glass produced glass in a myriad of repeating patterns, such as the floral pattern shown here, which became so popular with the Straits Chinese that it is known colloquially as "Peranakan Glass".

Right: Green tinted embossed window glazing backlit by daylight, Teck Lim Road.

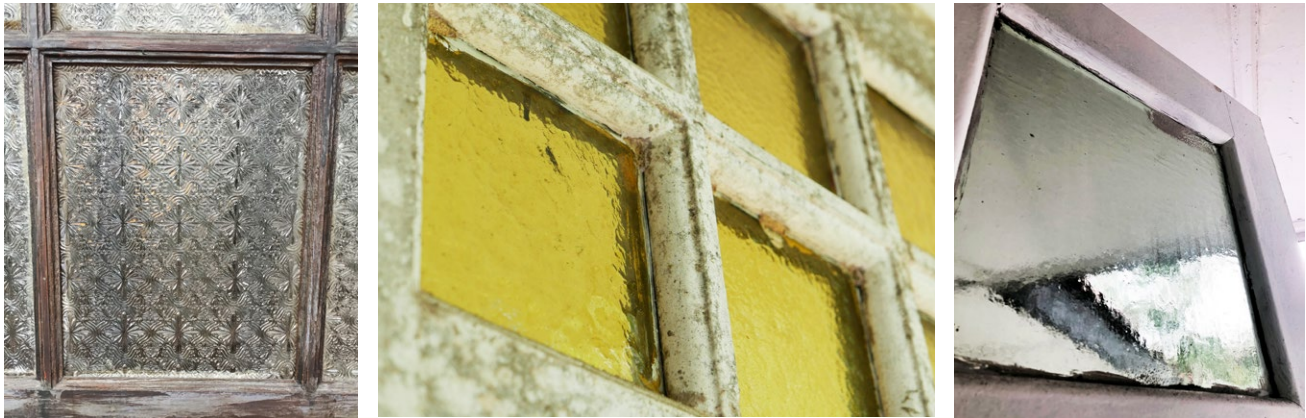
From left: Embossed rolled glass at shophouse in Geylang; Yellow tinted, and clear, glass with uneven 'crafted' texture at interwar period bungalows.

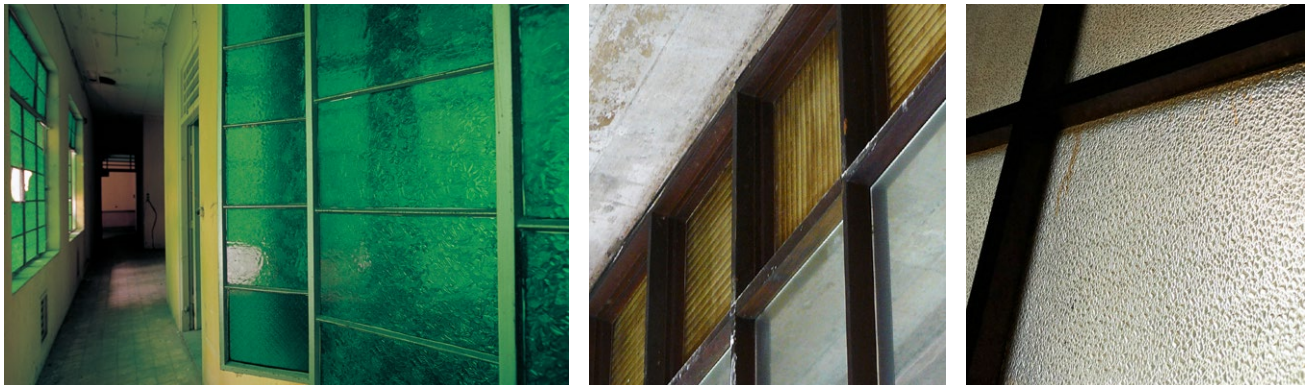
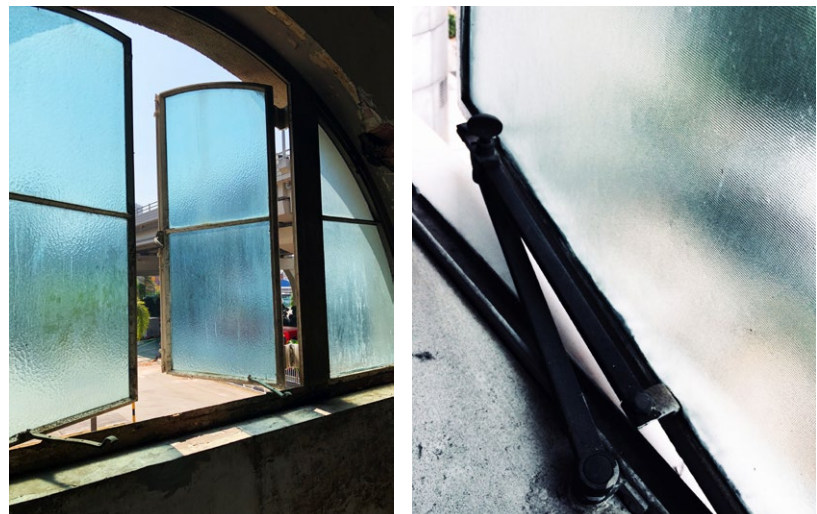
Above from left: Green tinted embossed glazing on mild steel windows, Chee Guan Chiang House (1939); Original fluted glass along top of timber screen, former Britannia Club (1953, aka later as NCO Club); 'Sparkle' textured glass, popular from the 1930s to 1970s. **Right:** Blue tinted textured glazing, large for its time, at former Tanjong Pagar Railway Station (1932). **Far right:** Fine grain cross reed textured glazing on 'Hope' brass windows, former George Street Telephone Exchange (1959).

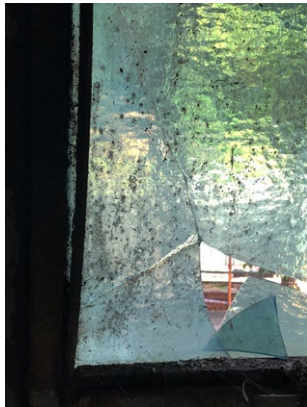
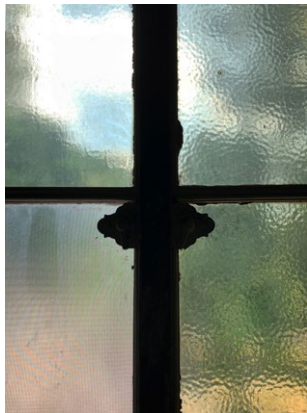
Top: Breakage, staining and dislodged beading due to frame distorted from corrosion. **Middle:** Inappropriate replacement with mismatched glass type – the two panes on the right are original. **Above:** Damage to historic glazing by intrusive installation and inappropriate overpainting.

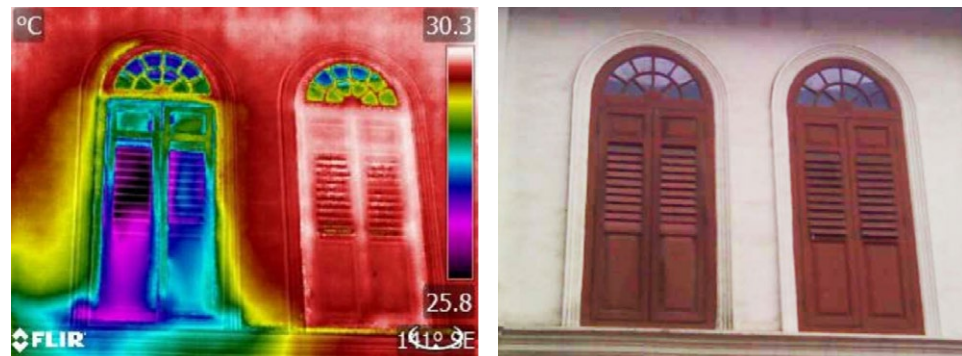
The thermogram shows cold air leaking from the left window, likely due to sealant failure of the interior secondary window glazed panel.

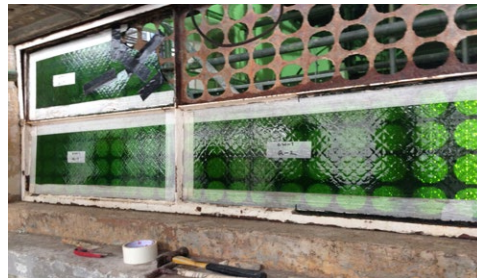
Taping the edges of glazing panels for protection prior to taking down the windows for dismantling the glass.

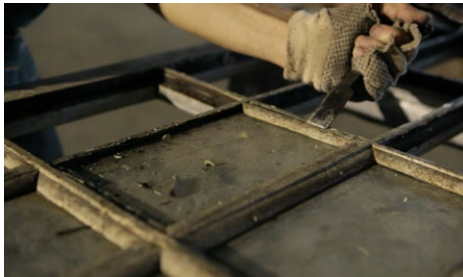
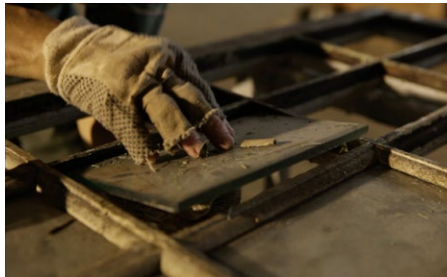
**TIMBER LATTICE WINDOW:**

*These should be dismantled in reverse order of their construction. Any beading should first be carefully taken out (**far left**). Sometimes the bottom rail needs to be dismantled by removing fixing pegs, before the glass can be slid out.*

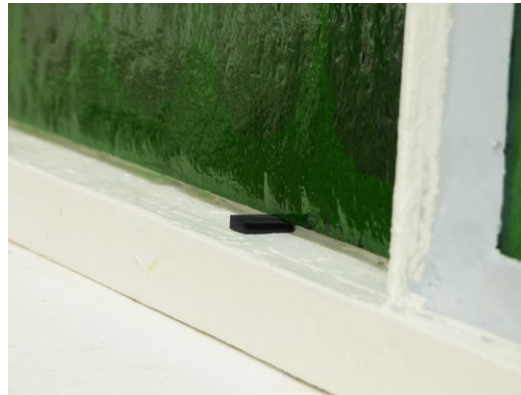
To prevent slipping during installation, a rubber 'stopper' can be placed underneath the edge of the glass.

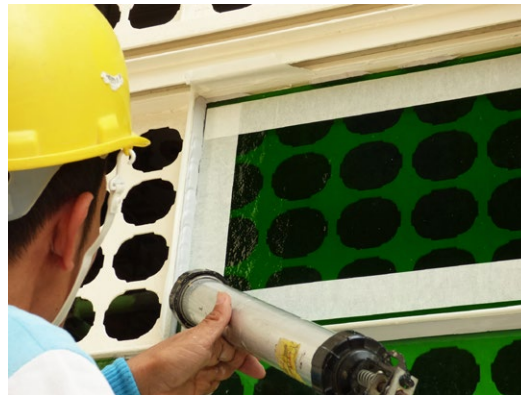
If using structural silicone for steel window glazing installation, the glass should first be masked to prevent staining, allowing a gap for the joint, and the sealant applied by a skilled worker.

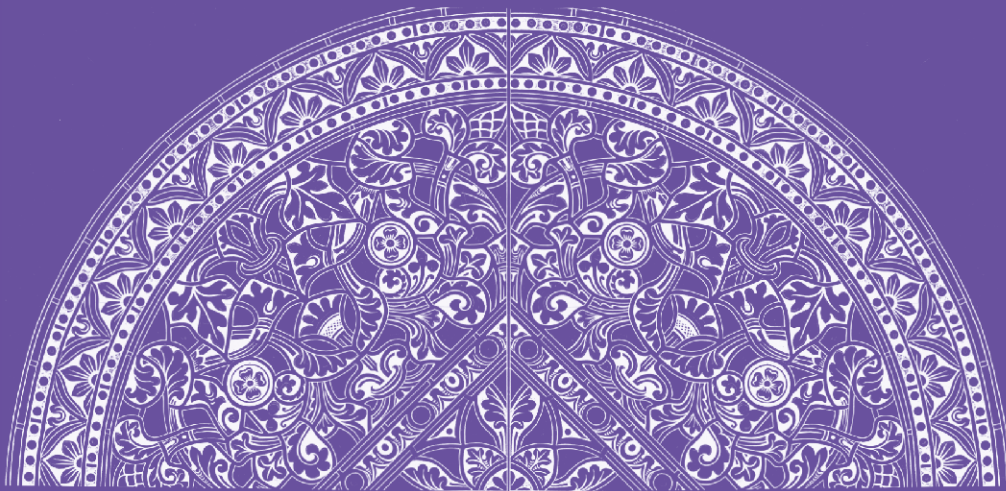
Cartoon of a stained glass fanlight for the Cathedral of the Good Shepherd.

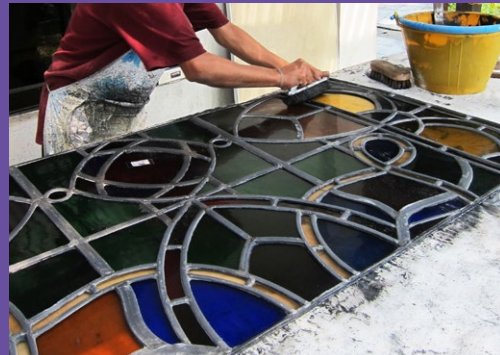
Above: **Glass before (left) and after (right) firing in a kiln.**
 Right: **Applying conservation putty to a stained glass panel to make it watertight and 'cement' the ensemble of glass and lead into place.**

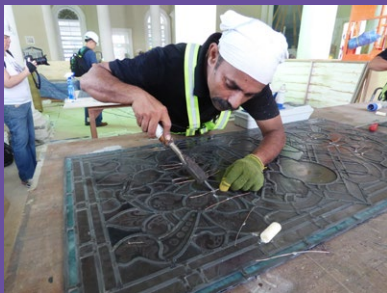
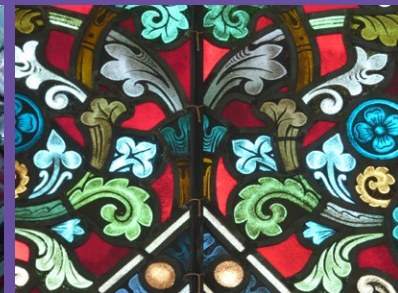
INSTALLATION – Copper ties are soldered to the lead comes on the interior-facing side of the stained glass, and used for securing the panel onto supporting tie rods fixed within the wall opening.

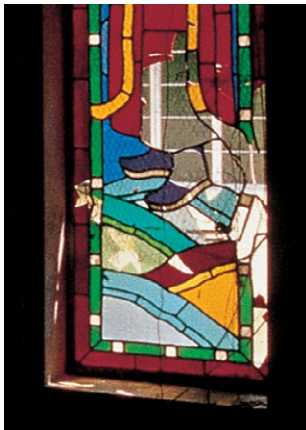
Missing and broken glass pieces on stained glass window.

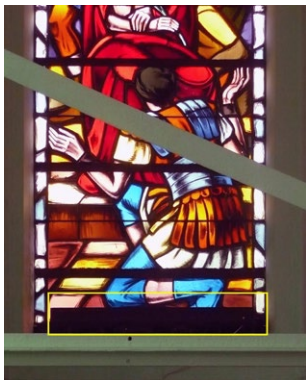
Top: Past incorrect inside-out fixing causing damage to the stained glass fanlight.

Middle: Bottom of stained glass buckling inwards (*near end*) and outwards (*far end*), torn protective wire mesh, and fallen putty (accumulated debris on ledge). **Above:** Water ingress in a window.

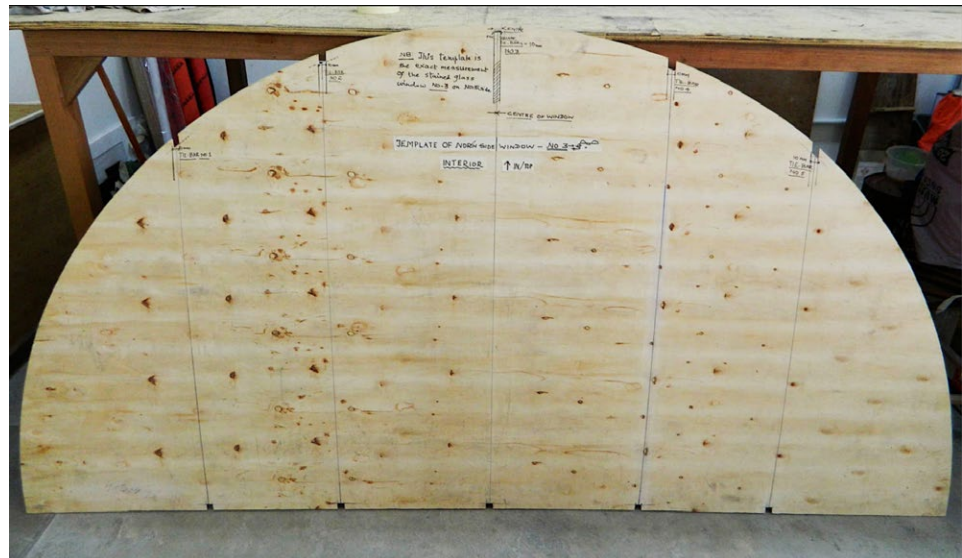
The conservator cuts exactly sized plywood mock-ups of each stained glass window – a fanlight in this case – marked with the locations of tie rods, to be provided to the builder to ensure a proper fit.

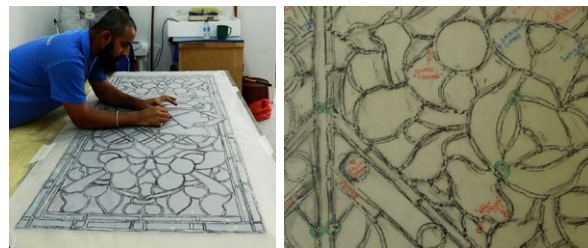
Rubbings serve as a one-to-one documentation of the lead and glass ensemble, base drawing for marking up defects and proposed repairs, and reference template for creating replacement lead and glass pieces.

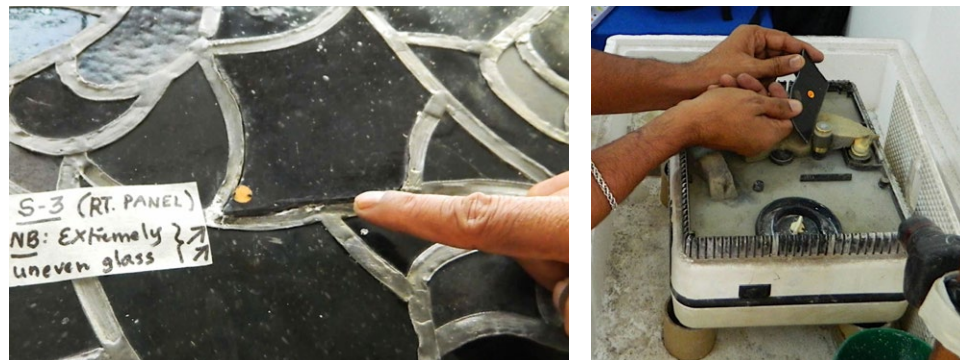
Right: Early handblown glass often has uneven thickness – overly thick pieces may lead to localized stress in the lead matrix. **Far right:** For maximum retention of historic material, instead of replacement, such pieces may be carefully released from the lead comes and put to the grinder for tapering their thickness, before reinstalling.

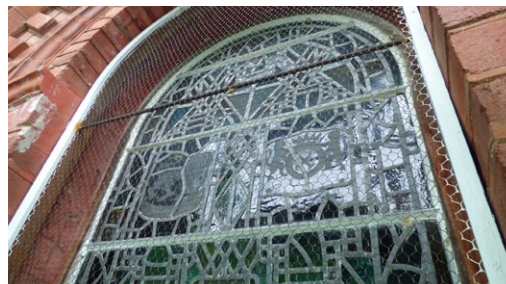
Early type wire mesh protection.

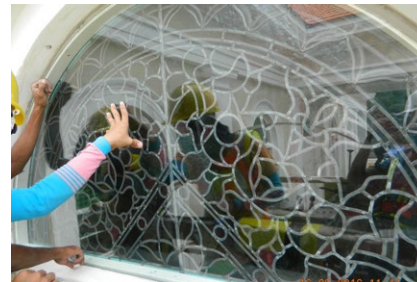
Mixed ventilated system

Installation of new external protective glass layer.

Isothermal glazing: Apart from an external protective glazing layer, a gap is maintained at the top or bottom of the stained glass. This effectively ventilates the interstitial space, keeping the temperature on both sides of the stained glass window the same, and greatly reducing condensation. However, it should be devised in consultation with a conservation specialist, and subject to on-site trials in the actual microclimatic condition before implementation.

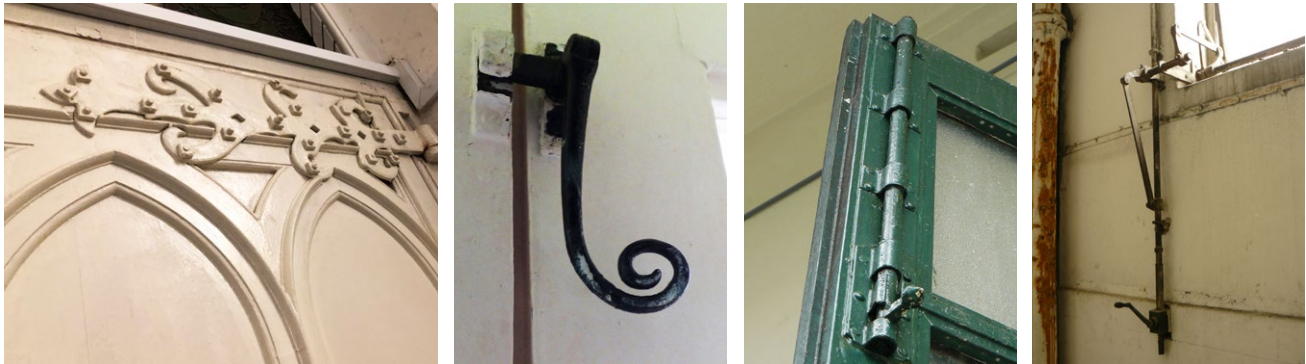
Left to right: Heavy duty gate hinge for large, hefty cathedral doors, possibly in wrought iron and dating to 19th century; Bronze casement fastener with 'hook' detail; Long tower bolt for securing heavy doors; Bronze window operation lever with crank for opening and closing clerestory windows from the postwar period.

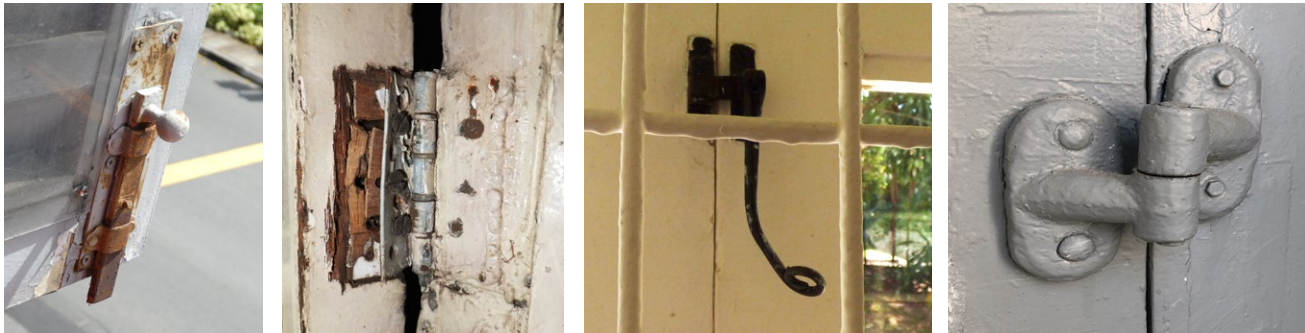
Left to right: Corrosion of window tower bolt; Overpainted, jammed and dislodged butt hinge; Casement fastener with hook handle bent out of shape; Overpainted barrel hinge with mismatched screw fasteners probably from past inappropriate replacement.
