CONSERVATION TECHNICAL HANDBOOK

Volume 5 | Doors and Windows

URBAN REDEVELOPMENT AUTHORITY

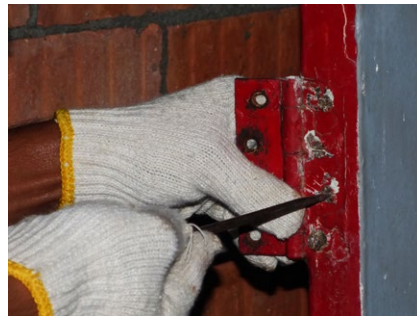
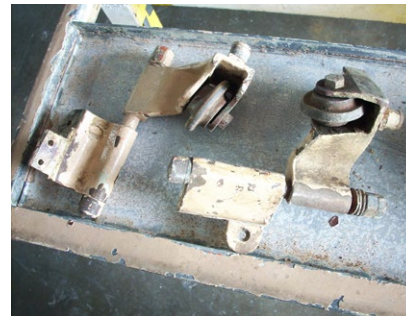
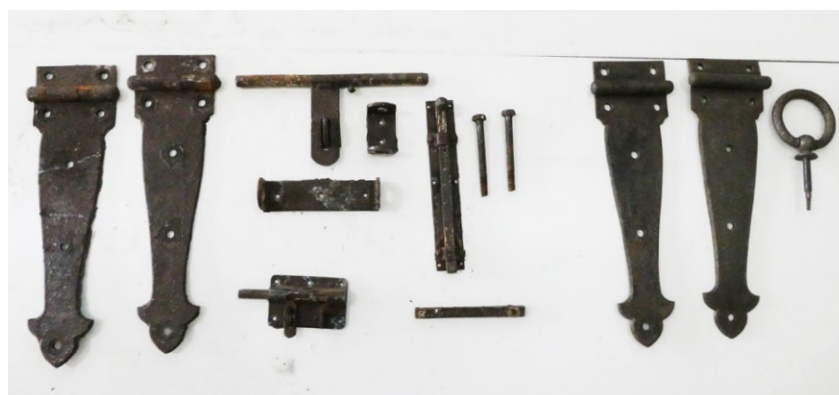
Top left: Careful manual dismantling of historic butt hinge. **Top far left:** Dismantled roller hinges of a top hung sliding-folding mild steel door. **Bottom:** Dismantled and disassembled ironmongery for documentation, cleaning and repair of each part before reassembly and reinstatement.

The principle objective of conservation intervention and maintenance repair is to arrest deterioration, restore mechanism operations, as well as reinstate historic design and finish. If the doors, windows or ironmongery items need to be **dismantled** – such as for paint removal – thorough and detailed **documentation** of each item or part should be carried out. The ironmongery fixing and assembly method should be carefully studied and dismantling/disassembly carried out manually to avoid damage. Each part should be labelled and documented accordingly.

Cleaning may be carried out using neutral soap with thorough rinsing and drying. Damaged mechanical movable parts should be repaired using matching and compatible material. For **ferrous items** (wrought iron, mild steel), rust residue may be removed by copper wire brush; fine grit sanding and chemical stripper may be considered for paint removal following trials. For **copper-based items** (bronze, brass), gentle polishing should be done with lint-free cloth using nonabrasive metal polisher. Paint may be softened and removed by hot-soaking the ironmongery parts in a solution of baking soda or mild detergent, using a nylon brush to remove more stubborn stains.

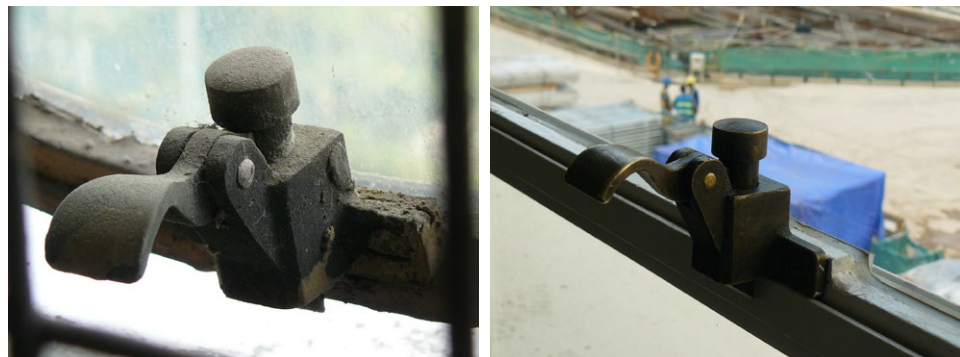
Original top hung casement fastener (left) and a replica (right). Working within the limits of the metal workshop, the replica is made with a simplified profile that can be distinguished upon closer scrutiny, but bearing sufficient likeness to the original to allow for a coherent heritage presentation.
