# CONSERVATION TECHNICAL HANDBOOK

## Volume 7 | Paints and Coatings

### **URBAN REDEVELOPMENT AUTHORITY**

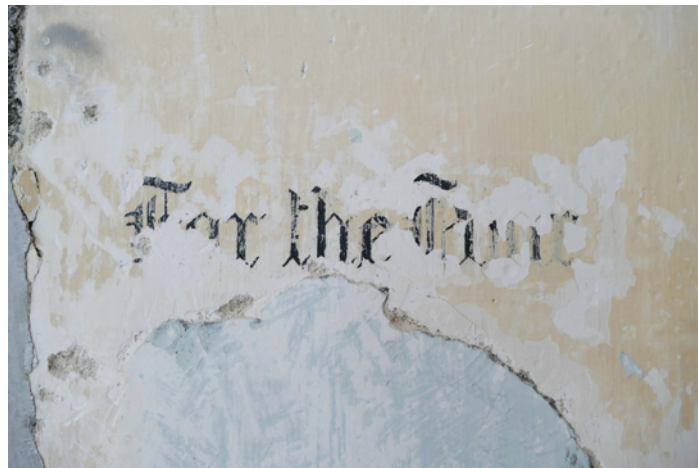
*Following paint removal, a historically significant hand-painted sign was uncovered in the Church of St Teresa, indicating the original location of a donation box 'For the Poor'.*

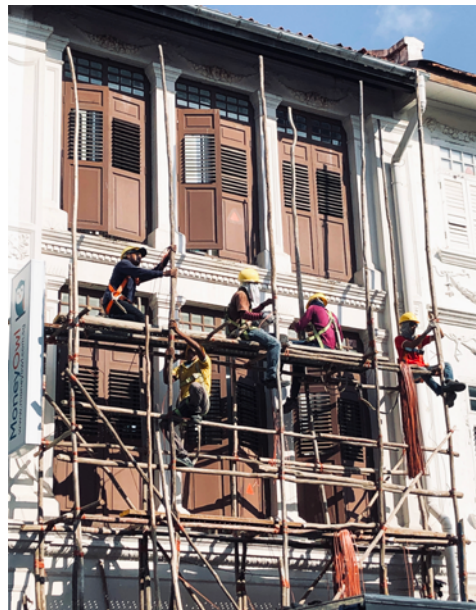
*Scaffold being set up for shophouse facade maintenance cleaning, painting and repair works.*

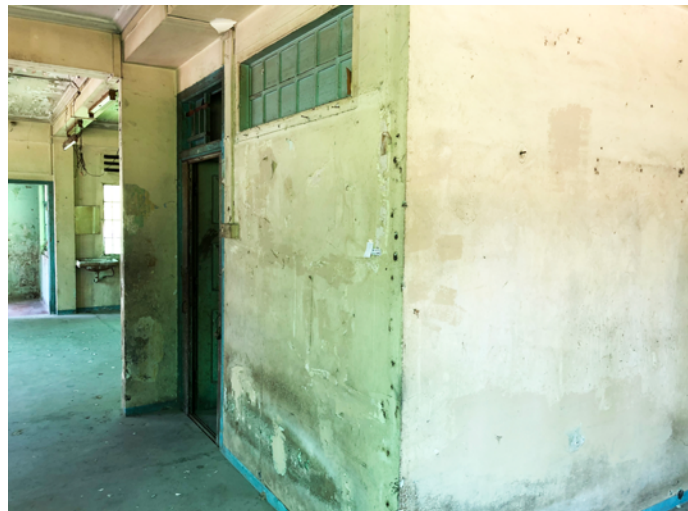
*A range of paint degradation observed in this interior space: moisture-related mould growth, blistering, delamination, etc. Buildings left vacant for long periods, or obscured areas (such as behind shelving, above false ceiling), often have aggravated deterioration due to lack of maintenance.*

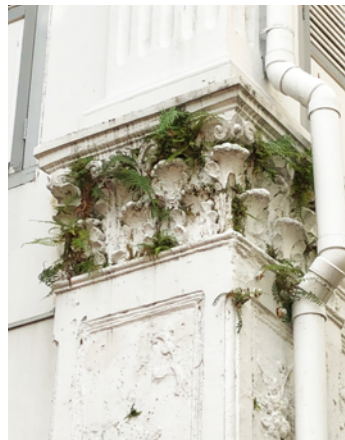
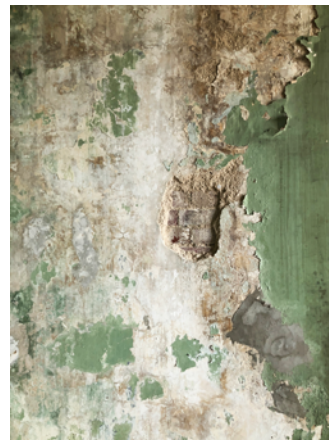
**Right:** Left unaddressed, the plant growth on this shophouse column capital has now caused deterioration to paint, plaster, and likely even brick substrate.

**Far right:** Paint with blistering, efflorescence and peeling arising from plaster substrate deterioration, which is in turn caused by roof leakage.

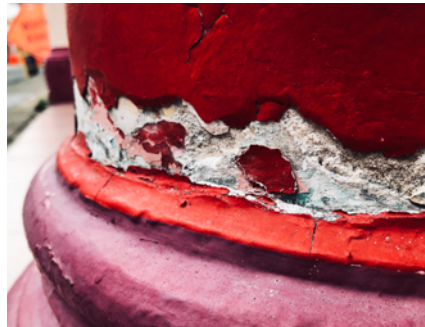
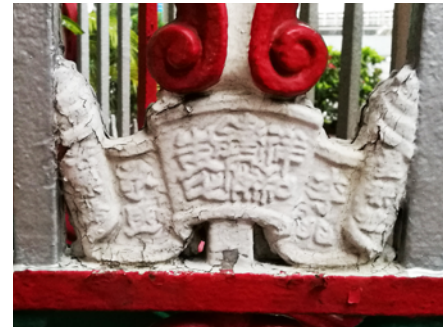
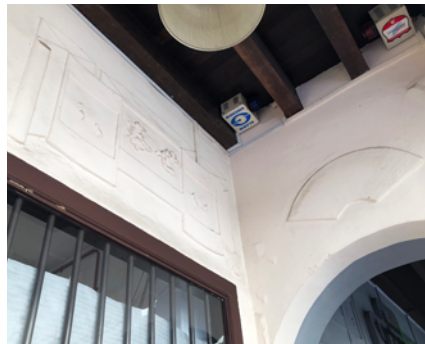
**Above left:** The recent red coat was applied over existing paint defects, which continued to fester and within a few months affected the top layer.

**Left:** Fine mural painted artwork panels crudely obliterated by overpainting, leaving only the scroll- and fan-shaped outlines in relief.

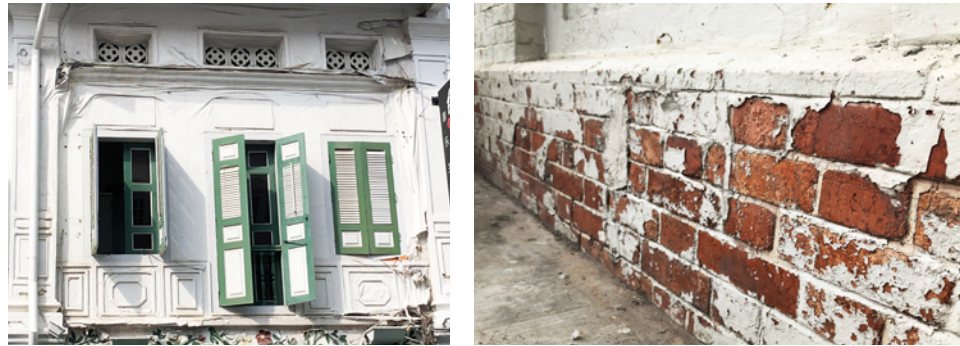
**Left:** Film-forming paint applied on historic shophouse facade results in extensive delamination, bulging, water retention and plant growth behind the unsightly 'loose skin' of coating. **Right:** Overpainted historic fairfaced bricks – the unbreathable coating not just obscured the original masonry but also caused its deterioration.

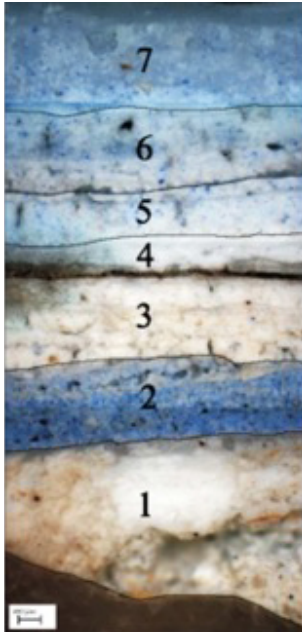
*Microscopic image of polished thin section prepared from extracted plaster sample, with historic coating layers identified and sequence numbered.*

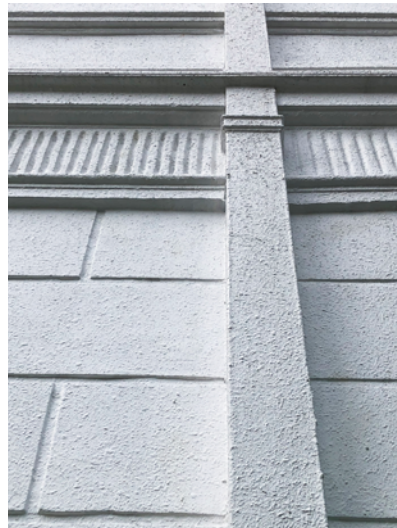
**Left:** The white coating can be visually assessed to be a recent spray-on textured coating, chemically incompatible with and obscuring the original materiality of Shanghai plaster and cast-iron downpipe.

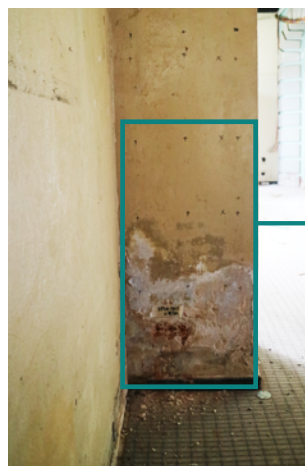
Microwave moisture tomography maps the distribution of wall moisture at different depths.

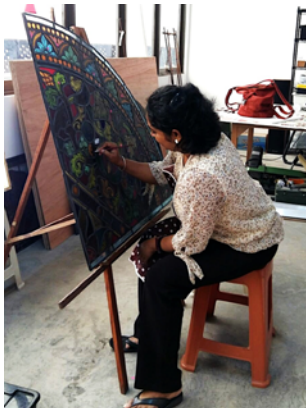
*Specialist artisan workshops with the needed skills and experience should be engaged to work on the restoration and reinstatement of painted fine art and decoration - architectural stained glass in this case.*

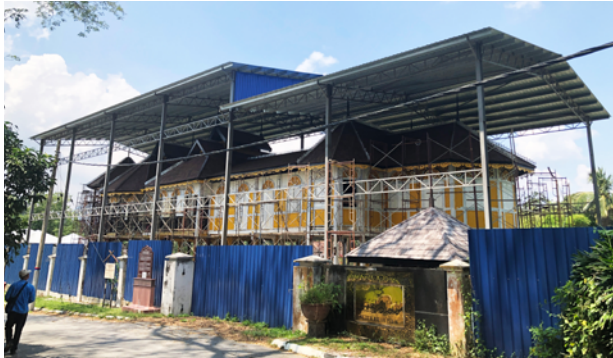
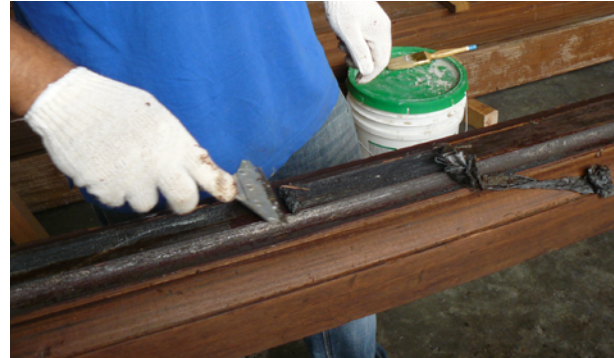
**Left:** Temporary roof protection during conservation works to protect delicate or vulnerable finishes from the elements. **Right:** Paint removal using chemical stripper and manual scrapping during off-site bench restoration of timber doors.

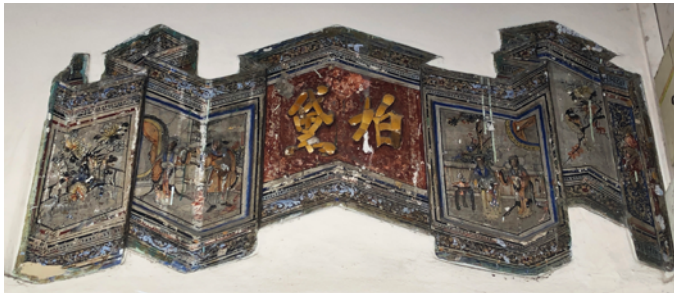
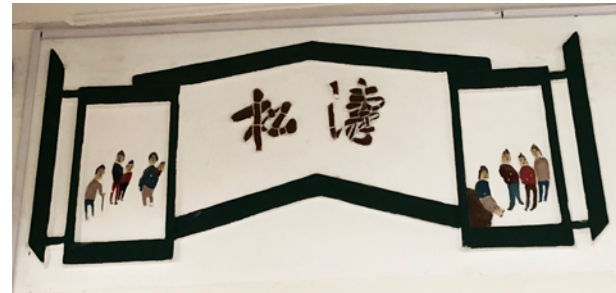
**Left:** Rare historic mural relief of a conserved townhouse with relatively intact historic paintwork. Where there may not be enough resources for a full restoration, the historic artwork, even if deteriorated, should be simply retained and stabilised. **Right:** Crude, insensitive repainting resulted in vandalism of the mural relief artwork, and the loss of fine details, iconography and symbolic meaning.

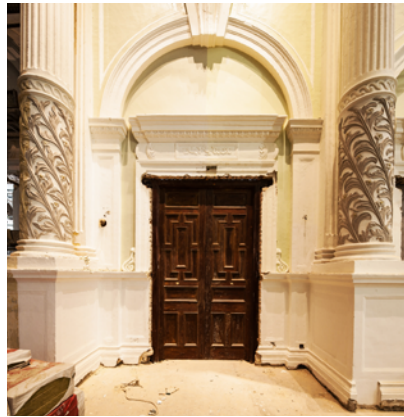
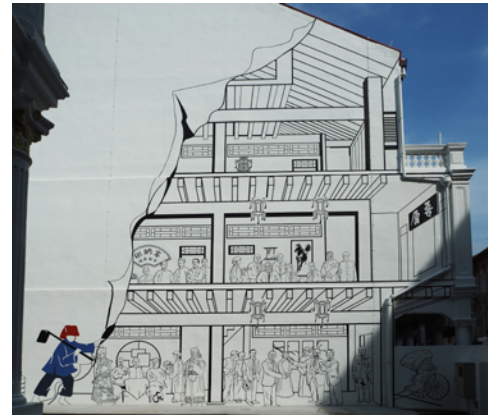
**Right:** Mock-up of new colour scheme for historic interior – pastel green on flatwork, off-white mouldings, and warm grey stucco reliefs.

**Far right:** New mural on the plain side wall of a clan house depicting an imagined historic scene of activities taking place behind the walls.

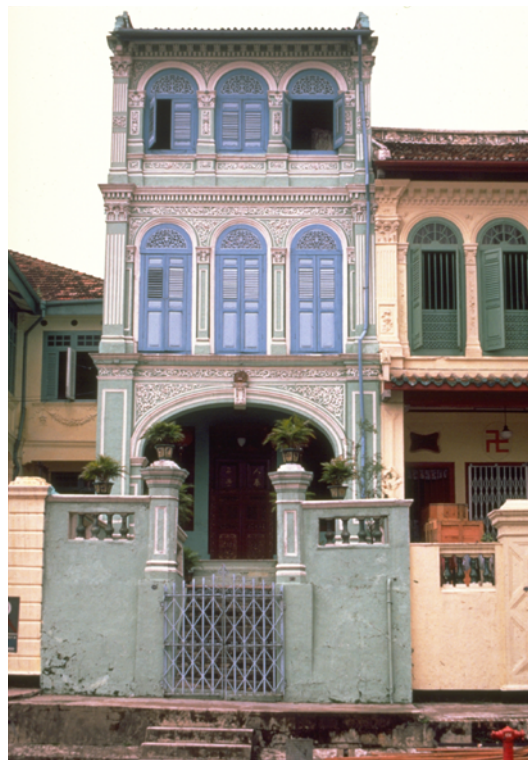
*1971 archival photo capturing a common historic colour scheme of townhouses, where ornamental moulding details are picked out in white and contrasted against pastels, with painted timber windows in a different tint.*

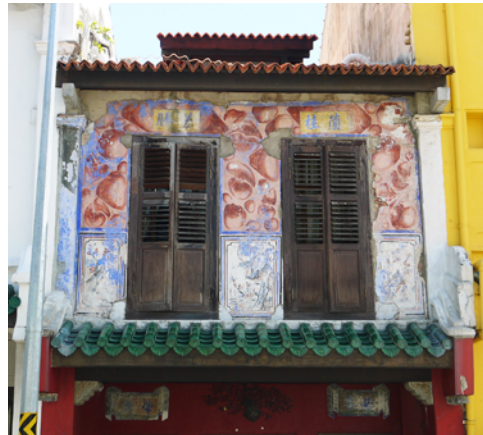
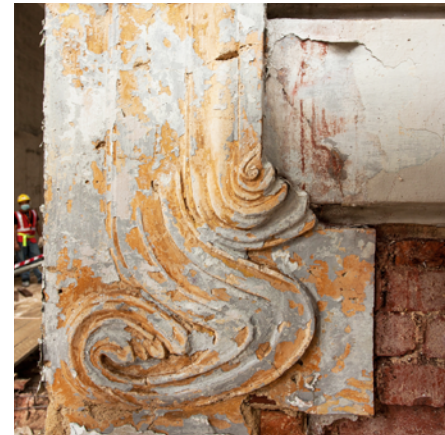
**Right:** Mural artwork covering the entire facade dominated by oxide red on an ultramarine blue background, 66 Spottiswoode Park Road.

**Far right:** Historic colour schemes of ochre limewash followed by white and grey camouflage are revealed after latter-day incompatible paint has been stripped, at Victoria Concert Hall.

However, the recent discovery of the original painting scheme of a 1890s townhouse during renovation works showed that there were more variations and types of paintwork than what most assumed. The columns and innerleaf facade of the five-foot way are painted a rust-red hue, while the upper storey facade featured a bold mural of rust-brown and ultramarine blue patterns above framed decorative vignettes.

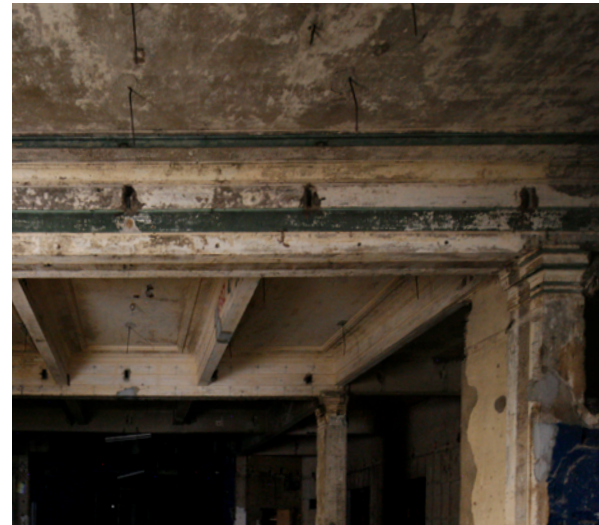
**Left:** Interior photograph of the Capitol Theatre when it just opened, showing tonal differences and highlights, with reflective gold on the mouldings appearing as dark lines. **Right:** Residual paintwork of historic art deco colour scheme found on the beams and columns of the former Capitol Theatre restaurant.

The Journal of Institute of Architects of Malaya observed in a feature write-up that the interior surfaces at the Capitol were painted with a cream coloured flat-tone or matt finish paint. Public areas such as the entrance corridor, foyers and restaurant, were rendered a multicoloured effect obtained by stippling one or more colours on a ground tint. The vaulted ceiling and dome were finished with 'a texture which is very attractive in artificial light, and kept mainly in silver-grey with green stippled panels on a rough texture, and mouldings have been picked up in gold, together giving a very pleasing effect.'

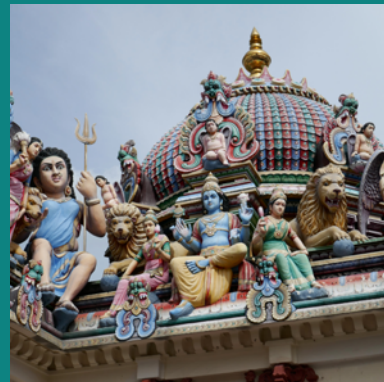
**Modern synthetic paints used on relief sculptures and dome.**

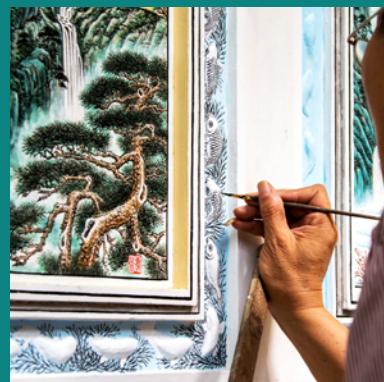
**Fresco painting using mineral pigments.**

Prewar painted artworks commonly found on historic townhouses, Chinese temples, Hindu temples and churches are often frescoes. **Fresco** is a mural painting technique where pigments are applied directly on freshly rendered, moist **lime plaster**. The coloured pigments become an integral part of the plaster finish as it cures.

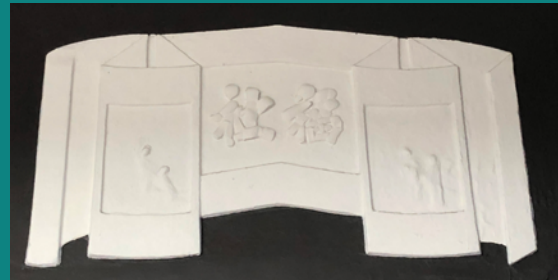
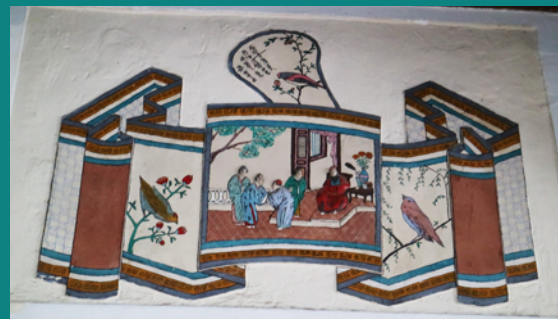
**Common issues observed on painted murals of conserved townhouses resulting in loss of heritage character and artistic value:**

Top: **Overpainting and loss of visual coherence**  
Above: **Inappropriate restoration - repainting of historic artwork with lesser skill. Details tend to be omitted and colour scheme changed due to lack of proper documentation, research and paint studies prior to restoration.**

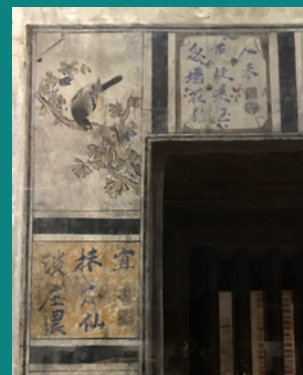
*Historic mural art that was gently cleaned, stabilised and protected, with missing sections filled in using the tratteggio technique, to retain its historic character. The artworks were uncovered after paint stripping during the adaptive reuse restoration of Lhong 1919, Bangkok, Thailand.*

- **RETAIN WITH SENSITIVE TOUCH-UP:** Where authenticity is prioritised alongside visual coherence and heritage presentation, apart from conserving the existing artwork, the Italian-developed technique of **tratteggio** could be applied, where missing parts are filled in using repetitive brushstrokes, referencing historic documentation to closely match the original. The new infill parts remain distinguishable, but only upon close scrutiny. Where original details are unknown due to lack of records, these are not recreated from speculation; rather, matching neutral colours are applied, providing just enough visual cues for a coherent reading of the original artwork.

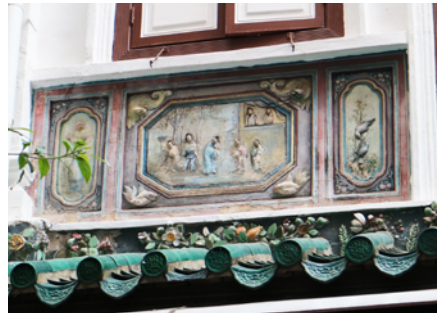
**Left:** Weathered and faded mural artwork on a historic townhouse facade.

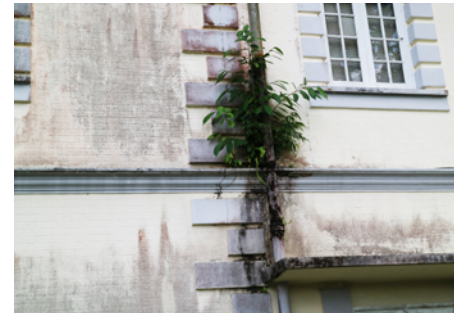
**Right:** Downpipe leakage left unaddressed resulting in staining, algae and plant growth.

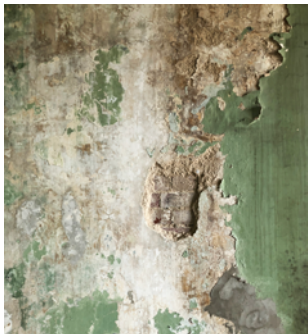
**Above:** Blistering and peeling of interior paintwork, in addition to plaster failure, due to long-term water ingress from roof leakage.

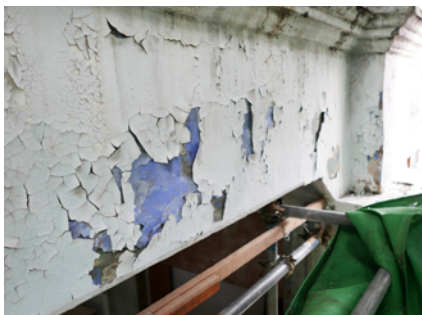
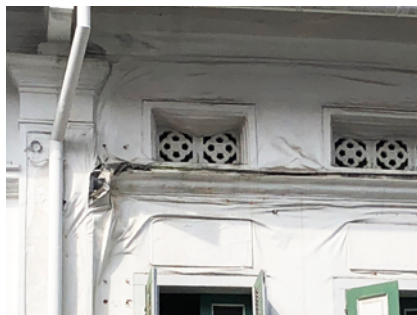
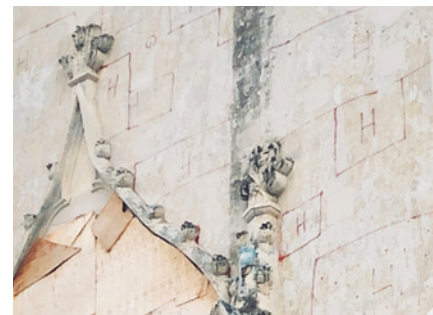
**Left, middle:** Cracks, delamination, bubbling and sagging of film-forming emulsion paint inappropriately applied on historic walls. **Right:** Following paint removal, hollow-sounding plaster is marked up according to tactile survey of facade.

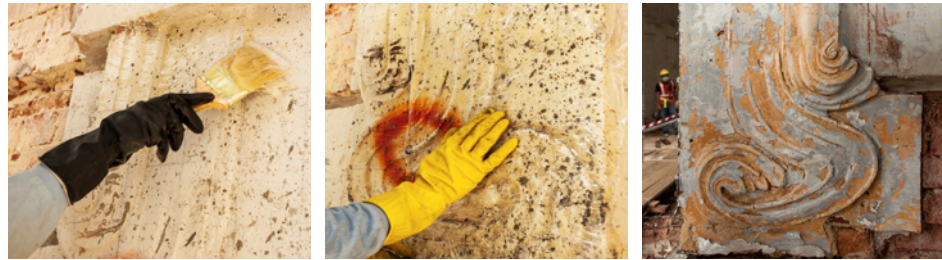
Chemical paint stripper is applied on the painted plaster moulding, covered with shrink wrap and left to act on the paint coats, before removal by scraping.

- **Manual paint scraping**
- **Low-pressure water jet**
- **Low-pressure rotary jet-blasting** for paint removal from textured historic finishes such as Shanghai plaster.
- **Chemically compatible paint strippers** may be applied and left on to break down the coating, before removal by scraping.

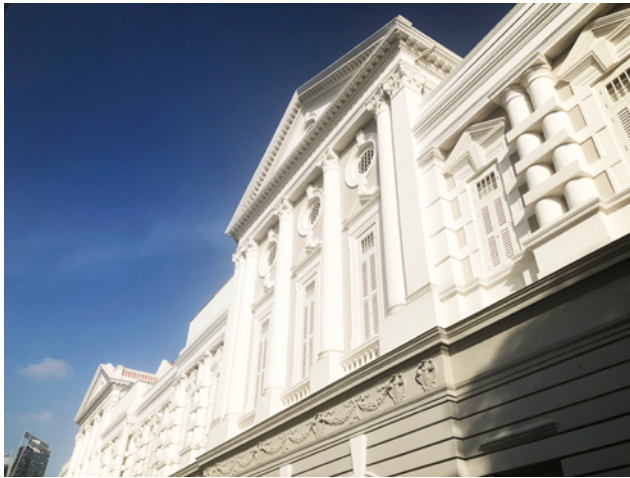
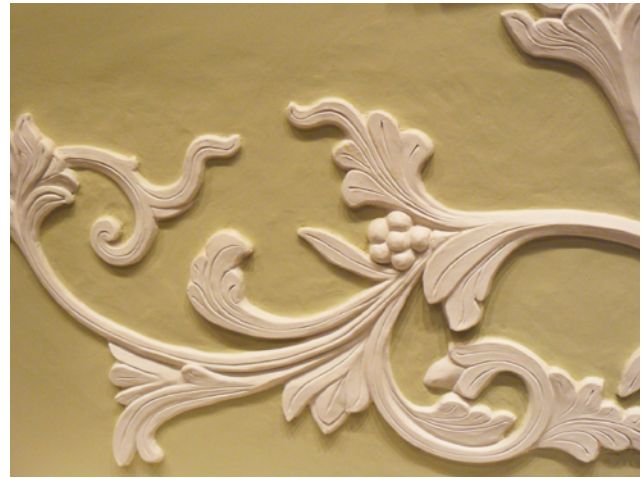
Exterior and interior repainting using mineral silicate paint, which requires thorough removal of past coatings.

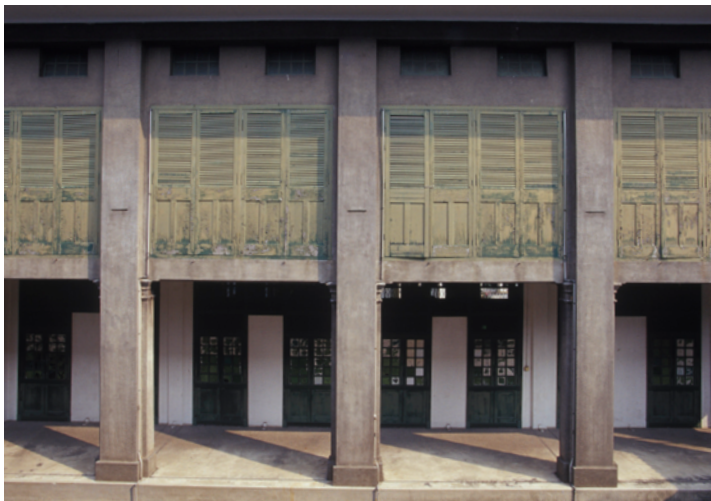
**Left:** Many government buildings had their fenestrations painted in 'Brunswick green' in the postwar years, including the Victoria School. The second storey french windows, being more exposed to the elements, were more faded and discoloured than the sheltered ground floor doors. **Right:** Historic interior with timber finishes that are just dark stained to retain the warmth and tactility of natural wood grain, Tanjong Pagar Railway Station.

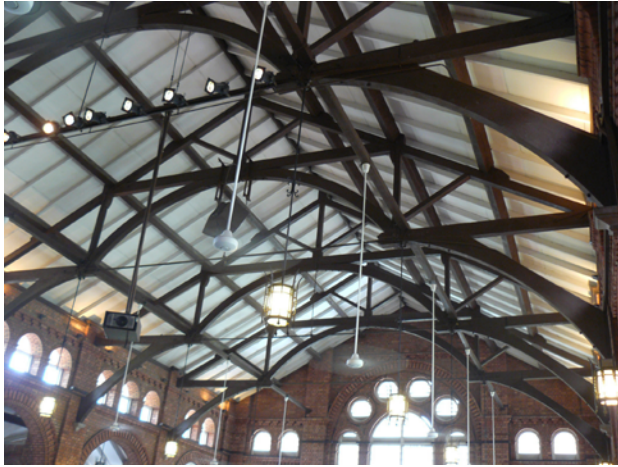
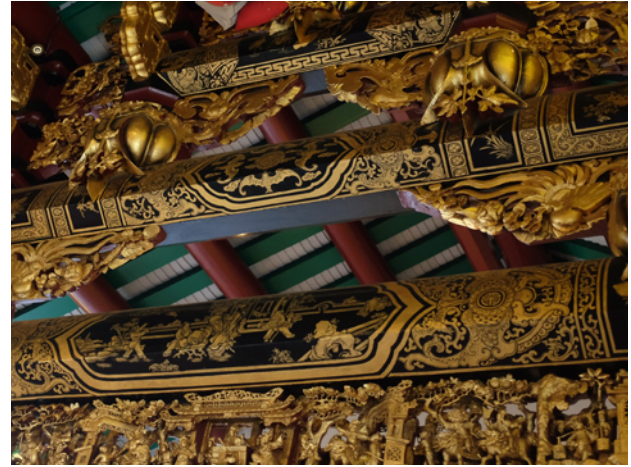
**Left:** Painted roof trusses, St George's Church. **Right:** Carved timber structures finished in daqi and decorated with oil-based gilding artwork, Wak Hai Cheng Bio.

Fenestrations, roof elements, exterior sidings and structures, being subjected to more stresses including exposure to elements, and which may be more challenging to replace or less accessible, were commonly coated with **oil-based paint** or **lacquer** for more lasting added protection. In the case of opaque paints, undercoats may be applied, serving to even out substrate surfaces and provide termite resistance, etc. **Daqi**, or Chinese lacquer paint, is a hard, opaque finish traditionally applied on timber structures and elements in Chinese houses and temples.

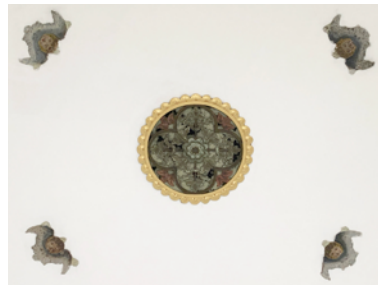
*Residual historic painted artwork on the timber ceiling of a former convent chapel – though retained, the delicate silhouette of the historic mural artwork is marred by the insensitively executed current day paintwork.*

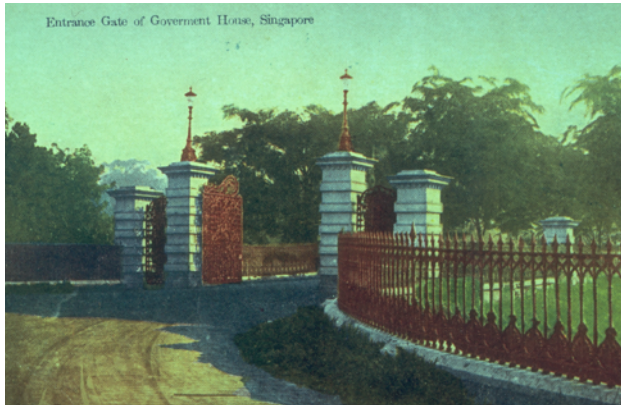
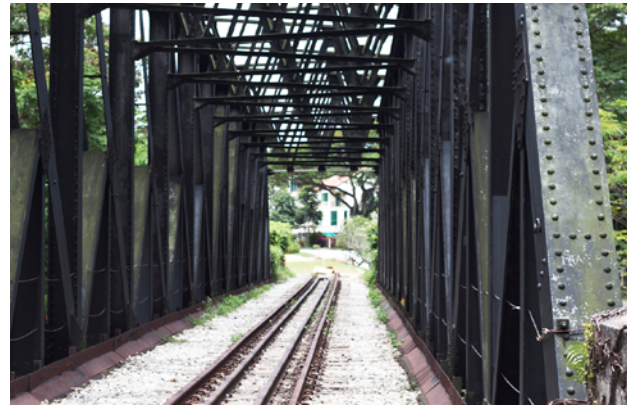
**Left:** Tinted postcard showing imported cast-iron ornamental fencing at the Istana depicted as red - likely red lead paint. **Right:** Iron structures assembled from imported prefabricated parts were often shop-primed in the foundry and finished with coatings later, black lead paint being a common colour.

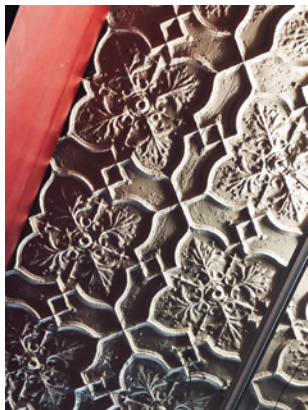
Historic pressed metal ceilings are usually painted in the local context.

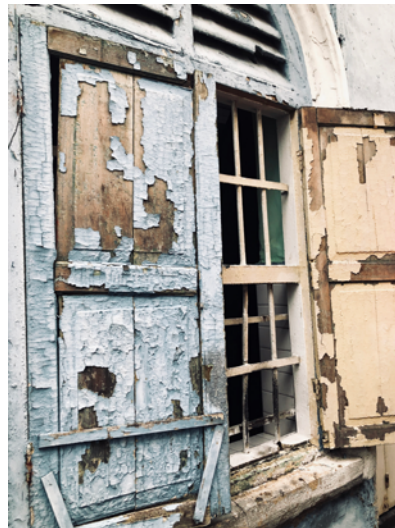
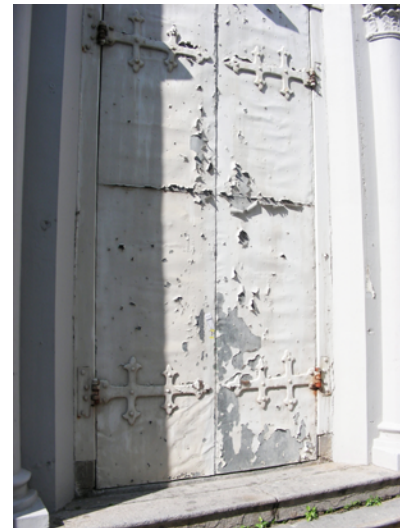
**Right:** Cracking, flaking and loss of oil paint from natural ageing and weathering.

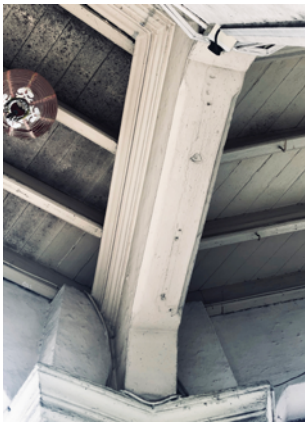
*Painted timber ceiling of a shophouse five-foot way – only planks on the left side are mould-infested, indicating a persistent moisture problem.*

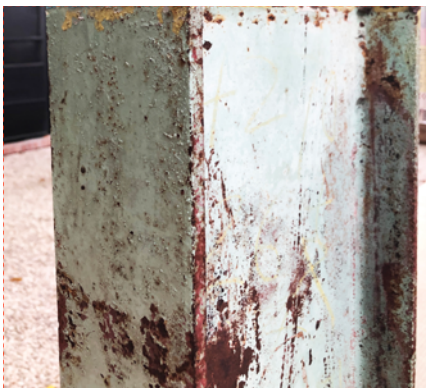
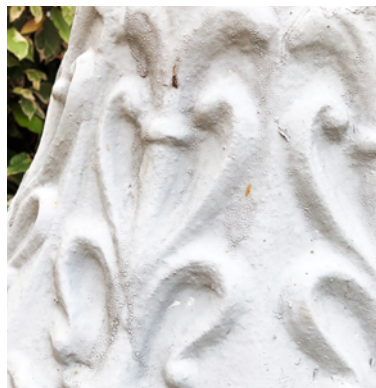
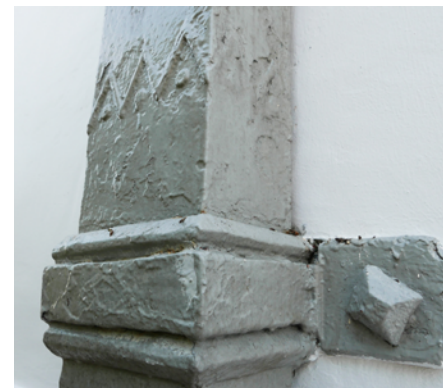
*Left: Fading and rust staining on a painted H-column. Middle: Wrinkling of paint film due to coating that is overly thick or applied before the undercoat has dried. Right: Overpainted rainwater downpipe, obscuring the ornamental profile and any festering defects.*

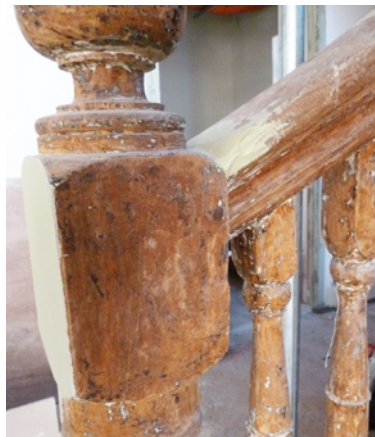
**Left:** Historic timber staircase with existing defective paint stripped, and patched with timber putty as part of substrate preparation for new paintwork. **Right:** Timber paint seriation microscopic image cropped to show silver-coloured aluminium primer as the first layer applied on the timber substrate.

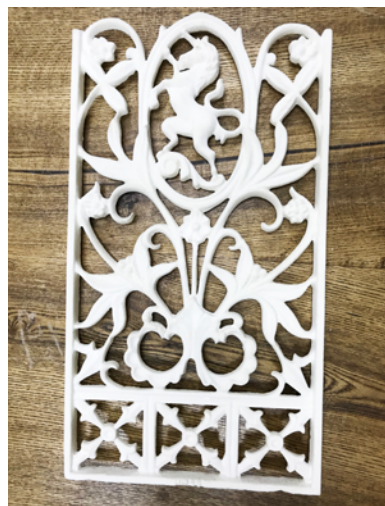
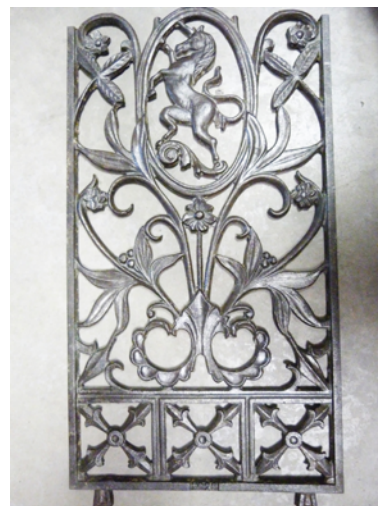
*Cast-iron balustrade stripped to SA 2.5 grade in preparation for repainting – the removal of multiple paint coats reveals the fine profile and details.*
