No. 2 Bukit Manis Road

Old Guard to Avant Garde

2005 AWARI

British military building rejuvenated to a modern spa

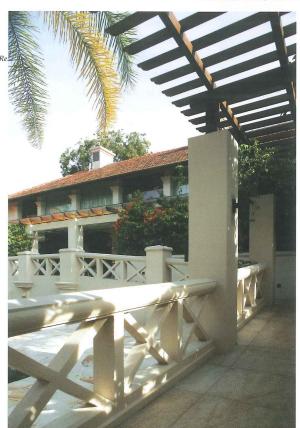
Heritage building forms a picturesque backdrop to the swimming pool

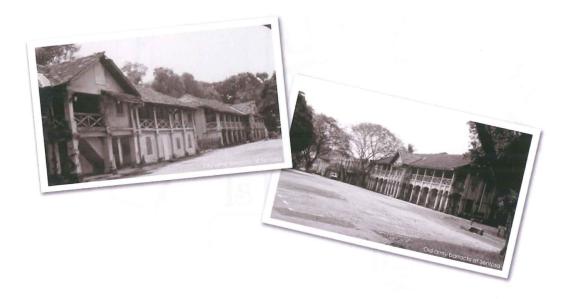
Blk 59 on Sentosa Island was one of the many buildings built by the British between the 1880s to the 1930s to accommodate the garrisons for the coastal defence of the island and the harbour. This colonial building was one of 16 buildings on Sentosa Island granted conservation status on 14th May 2004, for their historical significance due to their long military use and other significant events. Therefore, extra care was taken and the 3R principle of maximum retention, sensitive restoration and careful repair was observed when converting the building to its new use of a spa treatment centre so that the inherent spirit and ambience of the building could still be retained despite its new function.
