CONSERVATION TECHNICAL HANDBOOK

Volume 6 | Interior Elements

URBAN REDEVELOPMENT AUTHORITY

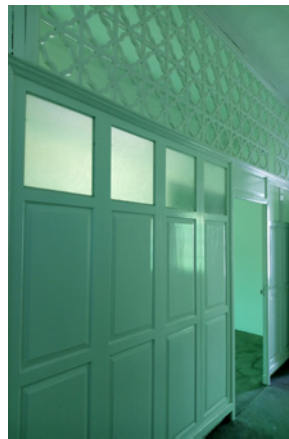
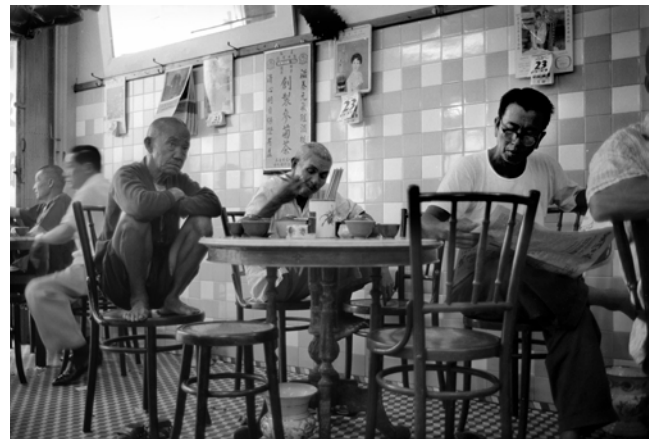
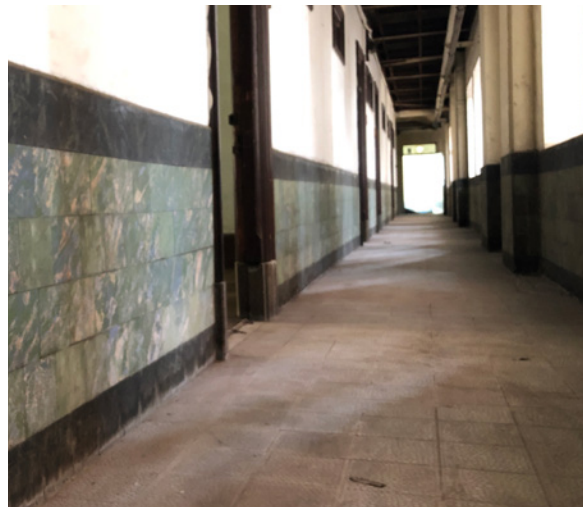
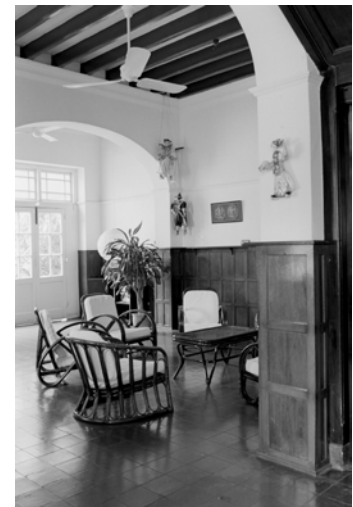
Clockwise from right:
Carved timber screen and partition, Teck Lim Road shophouse; 1960s coloured glazed ceramic tile dado arranged in a grid pattern - a common feature of early coffee shops; timber panel dado, 1920s colonial government bungalow; rare surviving rubber tile dado, Tanjong Pagar Railway Station (1932).

Dadoes refer to protective finishes installed along the lower half of interior walls that could be in tiles, timber panelling, textured or moulded plaster, paint or coating. Dadoes could be simple affairs when applied in service areas such as kitchens or bathrooms, or highly decorative when found in main spaces or public areas like living rooms and five-foot ways.

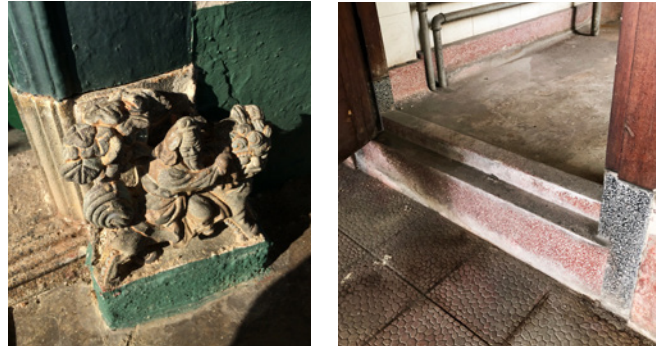
Right: Ornamented carved granite heelstone with Chinese figurine, complemented by granite threshold, seen at a historic bungalow. Far right: Black terrazzo heelstones at the base of a timber door frame protect it from floor moisture. The heelstone is coordinated in design and crafted in situ with the red terrazzo threshold and skirting.

Skirtings are strips that overlap and protect the joint lines, providing a design transition between floor and wall finishes. Similarly, **cornices** can be found at the joint between walls and ceilings, while **architraves** mark the interface of door frame and wall. Doors may come with **thresholds** and **heelstones** made of more resilient materials such as stone, concrete or terrazzo in consideration of ground moisture. Together with dadoes, these elements visually relate to each other in the interior design scheme and usually feature simple mouldings. They are commonly in timber or plaster, while additional skirting materials include tiles, in situ terrazzo and occasionally stone.

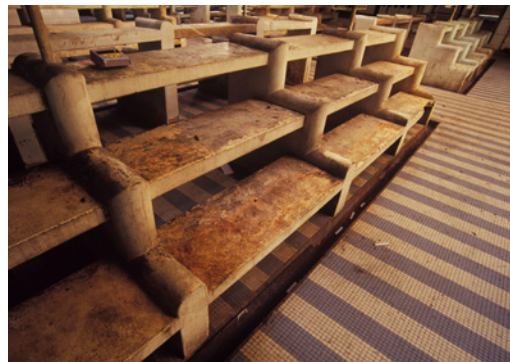
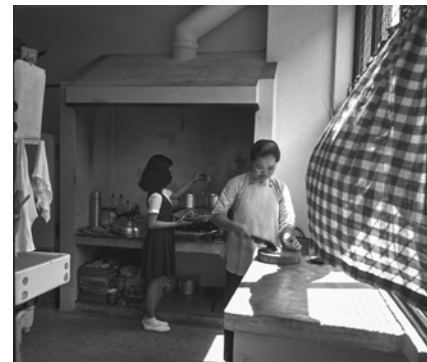
Right: Pre-cast concrete stepped stall display counter, Commonwealth Avenue Wet Market (1960). Far right: Built-in concrete stove and hood connected to flue, 1950s flat.

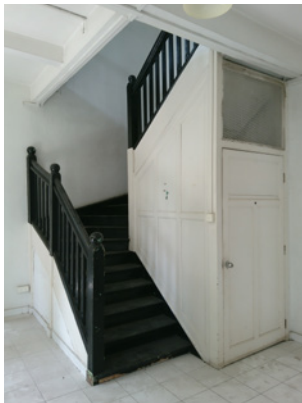
Historic timber staircase with winder steps and storeroom tucked into the undercroft.

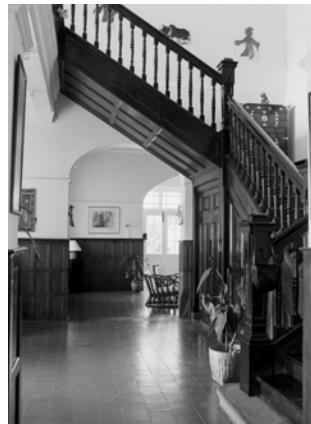
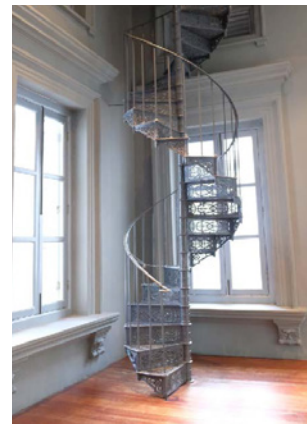
Far left: 1920s three-quarter-turn timber staircase of a colonial government bungalow (1920s).

Left: 1890s cast iron spiral stairs assembled from prefabricated modular units, National Museum.

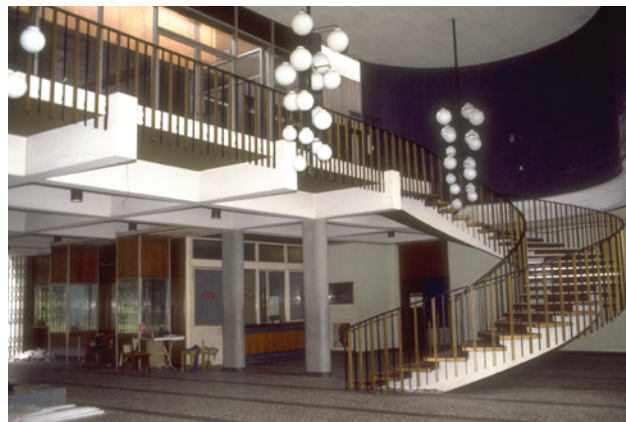
Open-well spiral stairway with curved reinforced concrete stringer supporting carpeted treads with brass balustrade, National Theatre (1963).

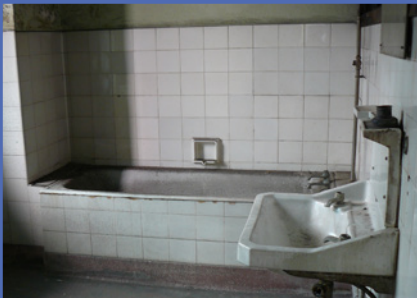
1930s sanitary fittings found in the Tanjong Pagar Railway Station Hotel en suite rooms, with the imprint 'Stonite', a trademark of UK enamelled sanitary ware manufacturer W.R. Pickup Ltd.

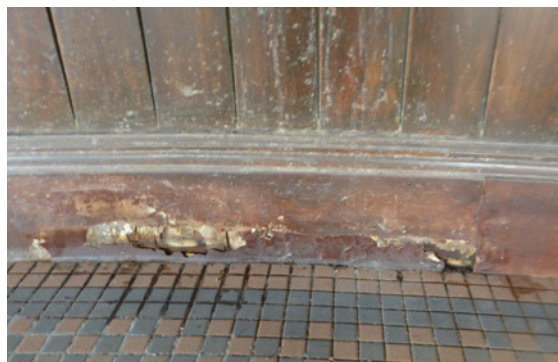
Inadequate and inappropriate maintenance: Wet rot at the timber skirting may have been caused by constant exposure to moisture without sufficient ventilation or time to dry out. It was further painted over, likely to cover the initial stains, leading to trapped moisture and worsening of the untreated rot.

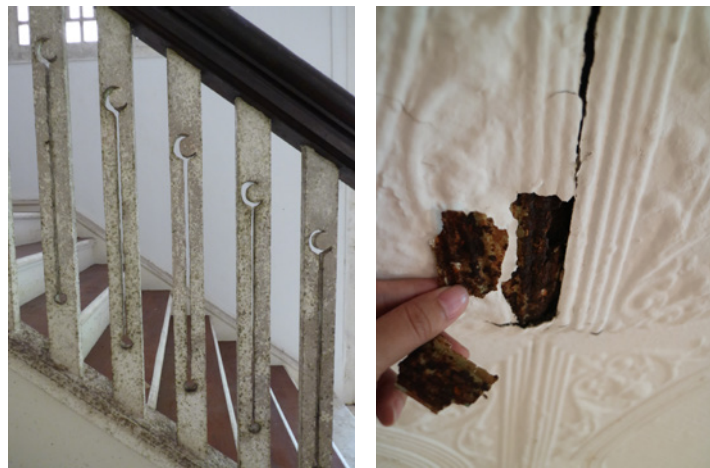
Left: Historic buildings left locked up and unoccupied for long periods become vulnerable to mould infestation in the warm and humid local climate. Right: Severe rusting of ornamented pressed metal ceiling due to moisture from condensation in the roof space arising from the introduction of air conditioning.

One major environmental change that Singapore's historic buildings are commonly subject to is the introduction of air conditioning. If not mitigated by careful mechanical engineering design, the resulting temperature and humidity difference between interior and exterior, as well as poor air circulation, may lead to recurring issues related to moisture and thermal movement. These include vapour drive drawing moisture through walls, condensation, mould/algae growth, loosening of joints and distortion.

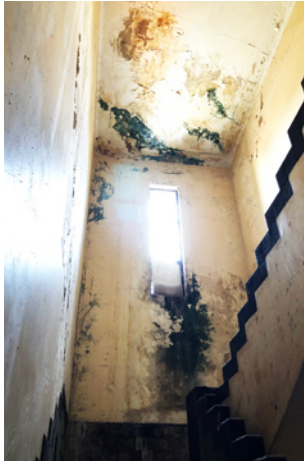
Left unaddressed, rain infiltration through a deteriorated building envelope eventually affects interior finishes and elements – in this case, extensive paint and plaster failure, and mould infestation.

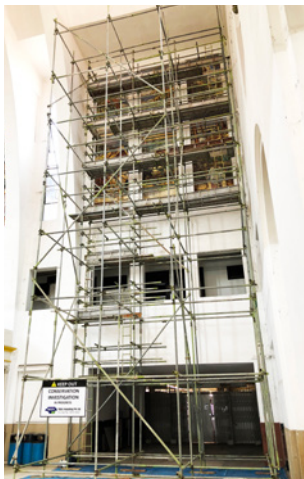
Conservation maintenance inspection using temporary scaffold to access high-level mural wall tiles.

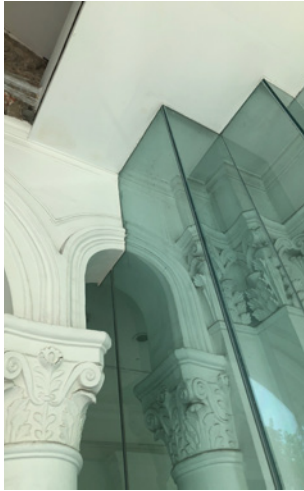
Insensitive addition of glazed enclosure for air conditioning. Apart from the physical impact and compromised heritage presentation, there is insufficient space behind the glass for the proper maintenance of the ornamented plasterwork.

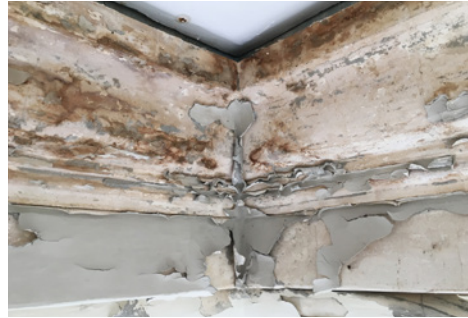
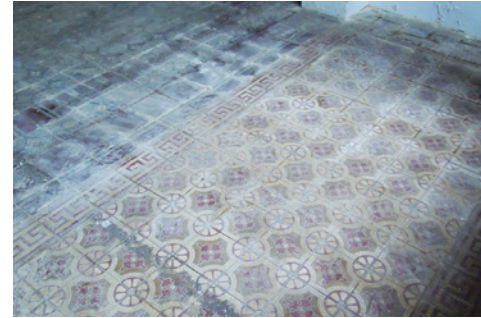
Left: Incompatible film-forming paintwork applied on ornamental plaster traps moisture, resulting in plaster deterioration. Right: Ornamental cement tiles stained by latter-day glued-on carpet.

- **Incompatible maintenance products and repair materials:** Off-the-shelf or easily available products in the market are commonly used for the maintenance and repairs of historic interior finishes and fittings, often for convenience. However, not all such products are suitable for use on historic materials in terms of physical, chemical and mechanical properties. Incompatible products and methods may in fact aggravate the problem, such as cleaning chemicals that react with components in the historic finish, causing surface erosion. A common mistake is the use of cement or very hard epoxy glue to patch or repair broken internal elements, which often ends up causing staining, moisture entrapment and cracking of the historic fabric.

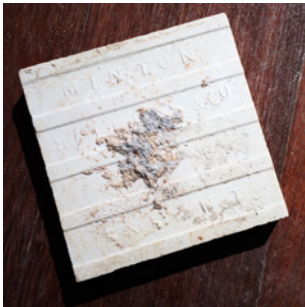
Brand and trademark imprints, such as this found on the underside of a 'Minton' encaustic floor tile unit, inform further research and provide clues on the material composition, manufacturing process, and dating of historic elements.

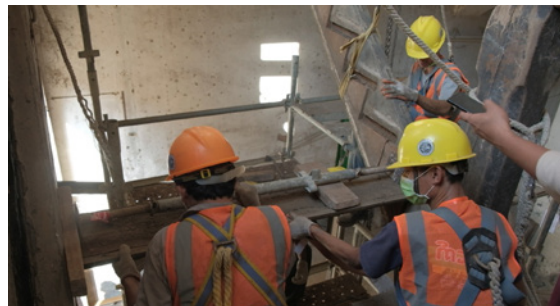
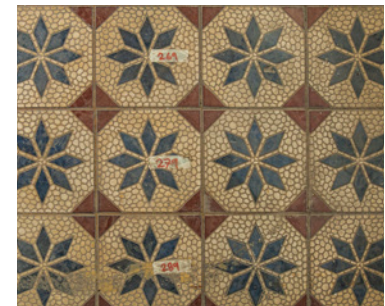
Left: Dismantling of historic teak staircase – the appropriate sequence and method are informed by detailed prior construction study. Right: Tagging of polychromatic cement floor tiles prior to their dismantling for slab reconstruction.

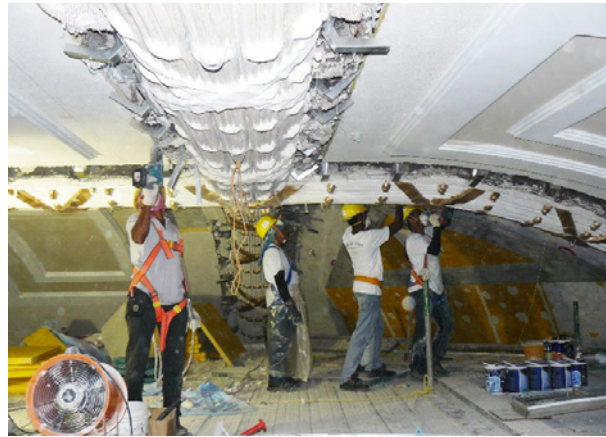
Restoration of reed motif moulding with design enhancement of its deteriorated borders, and reinstatement of rectilinear field mouldings.

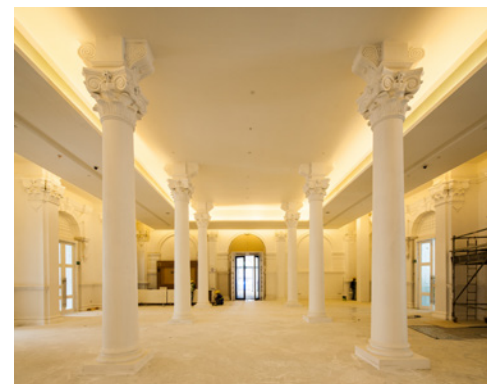
Sensitive integration of mechanical and electrical services, such as air con and lighting, in the historic foyer space enables a full appreciation of the feature column capitals in Victoria Concert Hall.

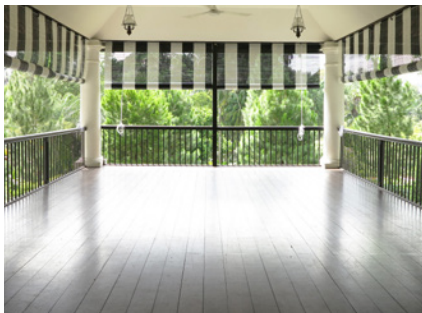
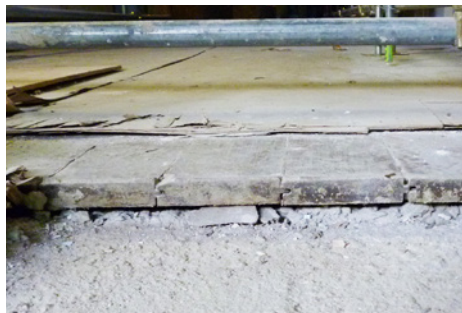
Left: Timber board flooring, Burkill Hall. **Centre:** Tongue-in-groove joints between floorboards revealed after dismantling of adjoining tiles. **Right:** Herringbone pattern parquet flooring.

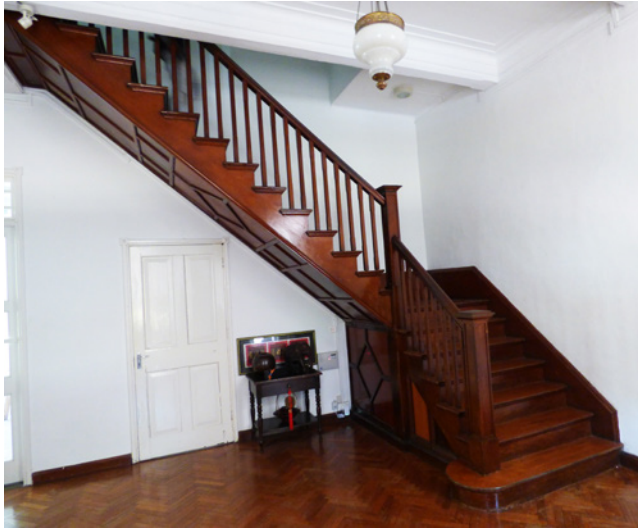
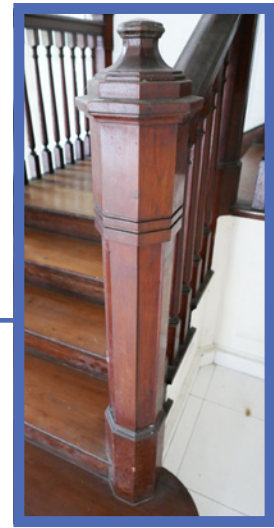
Left: Timber staircase with a bullnose starting tread and panelled undercroft. **Centre & right:** Ornate timber staircase with feature newel post.

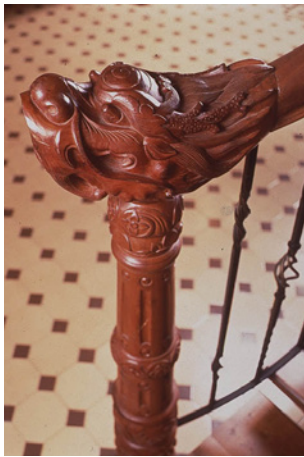
Carved timber newel post assuming the form of a dragon head.

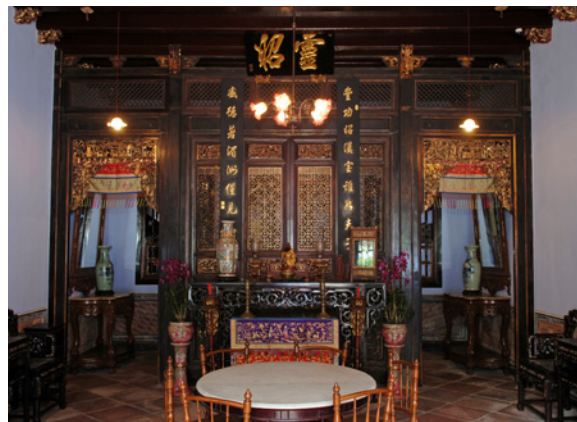
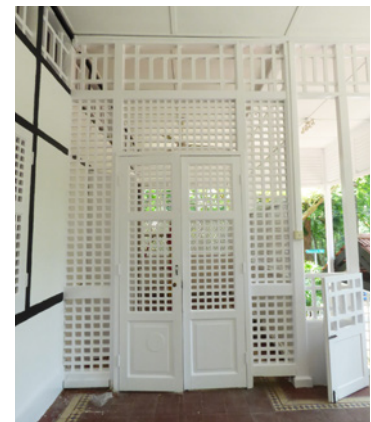
Left: Elaborate Chinese carved timber partition, or geshan, of a peranakan townhouse at 157 Neil Road. **Right:** Full-height timber lattice screen with top vents and double swing door ensures security and some privacy while facilitating ventilation.

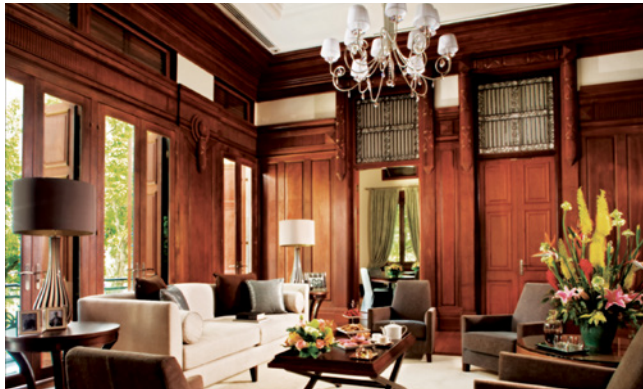
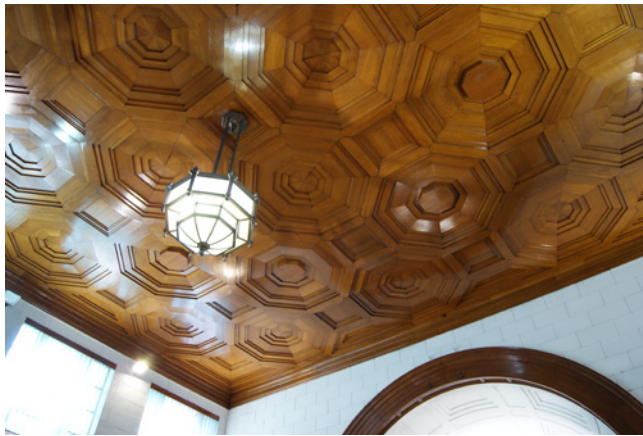
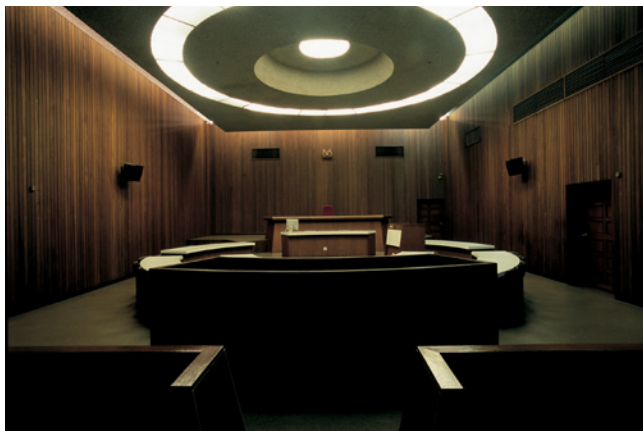
From top: Restored full-height moulded timber panelling, including cornices and architraves, 43 Amber Road (1900s); Grand timber coffered ceiling with moulded timber cornices, old Supreme Court (1939); Courtroom with timber strip wall cladding and built-in furniture, Subordinate Court (1975).

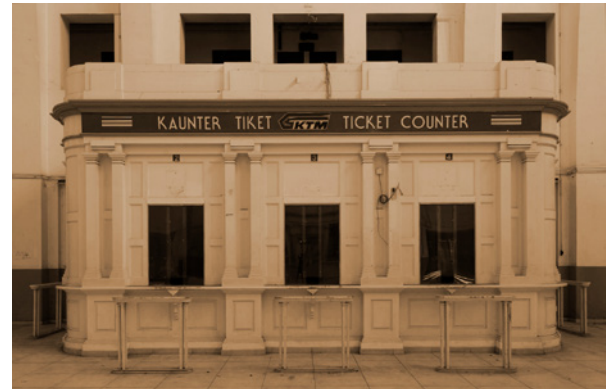
Ticket booth with timber structure and carved panelling, Tanjong Pagar Railway Station (1932). A similar booth opposite housed a newsagent.

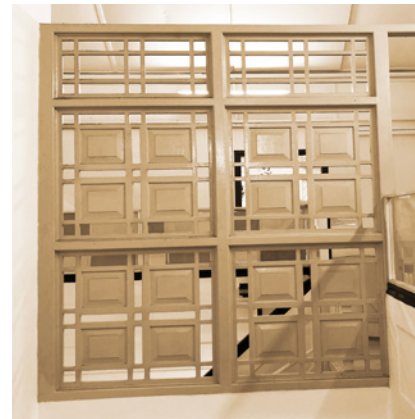
Stair hall lattice screen in tartan grid design, 1920s colonial government bungalow.

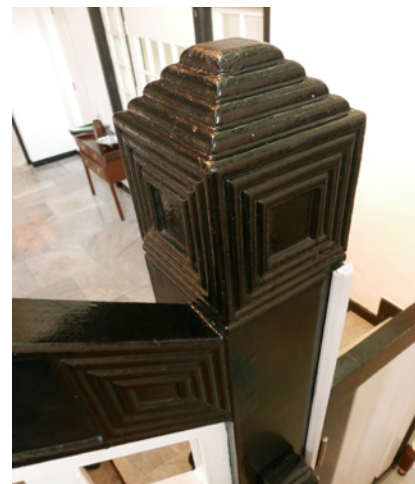
Art Deco newel post with geometric motif.

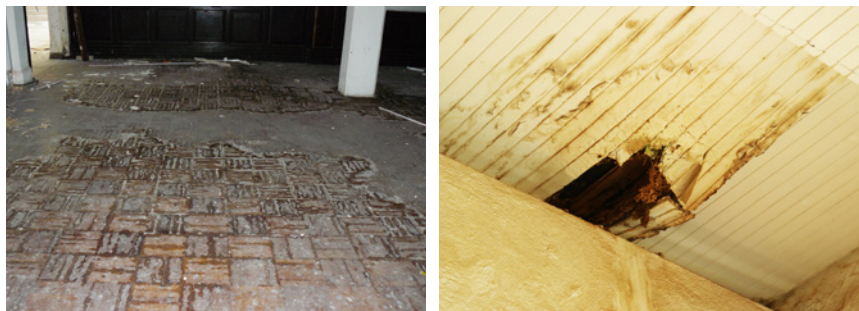
Long-term leakage and ponding on parquet flooring and timber strip ceiling causing extensive damage.

- **Moisture ingress:** Long-term saturation of timber elements in moisture, for example due to leakage, ponding or condensation, will cause even properly treated tropical hardwood to become vulnerable to bacterial, fungal and insect attack. As such, any affected areas should be marked up during inspections and the cause of moisture ingress identified and addressed urgently.
- **Wet rot** is mainly a result of fungal attack that breaks down wood cellulose and lignin. Affected areas are often where water is easily trapped and retained within the wood, becoming conducive environments for infestation. These include the ends of wood embedded within or abutting masonry or reinforced concrete – for example, where floorboards, ceiling timber frames or partition frames are fixed onto the supporting wall or floor slab.

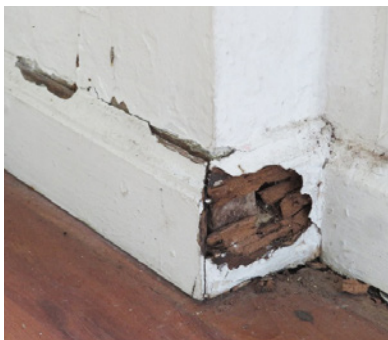
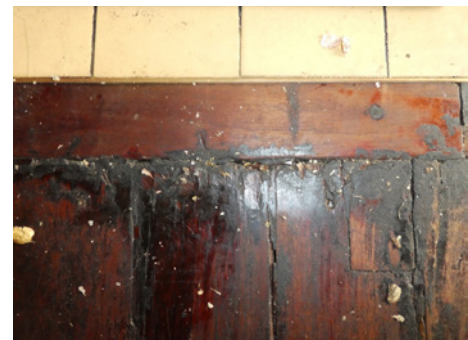
Left: Inappropriate paintwork led to trapped moisture, resulting in wet rot and termite damage. **Centre:** Timber flooring protective varnish worn off by abrasion from heavy traffic. **Right:** Constant wet mopping may lead to moisture ingress and wet rot along the floorboard edges and joints.

- **Inadequate or inappropriate maintenance works:** Overpainting could trap moisture, which may eventually lead to wet rot. Protective coatings such as varnish and lacquer that are worn off and left untreated, or failure to ensure the timber is kept dry and well ventilated, may also result in moisture-related issues. The use of inferior wood and poor or wrong fixing methods during repairs may lead to poor fit, premature wearing and deterioration, including cracks.

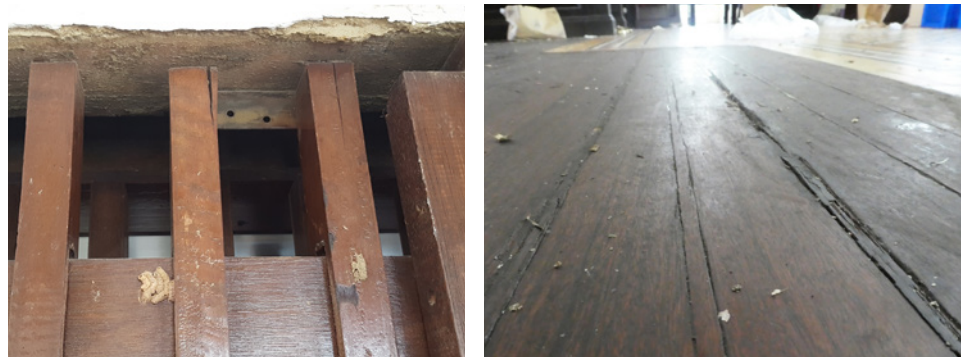
Left: Minor splits at the ends of timber slats and insect infestation. **Right:** Timber shrinkage due to temperature and moisture fluctuation from air conditioning resulting in gaps between planks.

- **Gaps, splits and checks:** Overloading could cause floorboards, ceiling boards and partition panels to crack and split. Checks between old and new timbers, or gaps between planks may form when the replacement timber used for repairs is not adequately seasoned or of a different species from the historic.

- **Excessive building movement** such as settlement or thermal movement may result in dislodgement, cracks and deformation.
- **Environmental changes:** Most commonly, the introduction of **air conditioning** results in repeated fluctuations in temperature and relative humidity, causing shrinkage and expansion in timbers and resulting in splits and distortions in the long term. Internal condensation may also occur, leading to moisture-related problems such as mould and wet rot. Vacated buildings with fenestrations closed for long periods are also conducive to excessive mould and fungal growth on interior timbers.

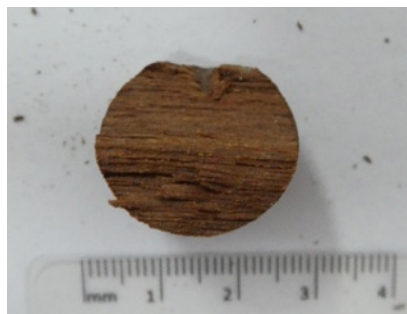
Extracted sample of a historic timber element for microscopic study.

- **Species identification** calls for sampling extraction by removing a small piece of wood for visual or microscopic examination. Timber of an identical species and treatment specification should be used for conservation repair, for better material compatibility and performance with the existing. Replacement timber must be of the same species or at least similar density and hardness as the historic ones to prevent differential deterioration, shrinkage, cracks and insect attack.
- **Others:** Other specialized investigative tests may be deployed depending on the dimension and type of elements – infrared thermography to check for moisture, wet rot and termite attack, Pilodyn test to check for wood density (for indication of fungus infestation, termites and presence of different wood species), or vibration, acoustic and microwave methods to detect active termite infestation.

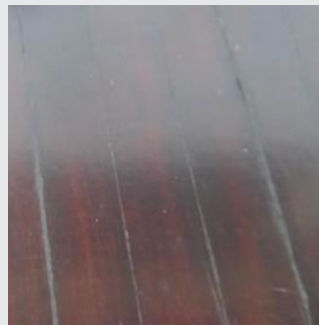
Timber floorboard
(Verandah)

Microscopic images reveal different species used for verandah and room interior floorboards.

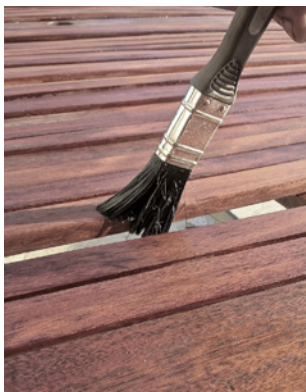
Revarnishing of wood as a regular maintenance practice.

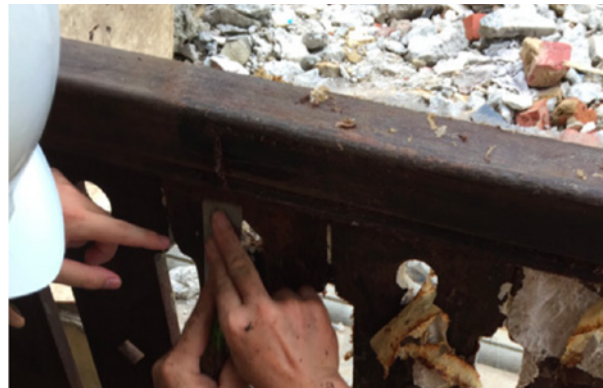
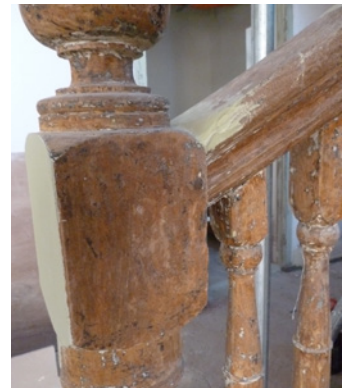
Right: Manual paint/ varnish removal from verandah balustrade by careful scraping. **Far right:** Following manual paint removal, surface patching is done on timber staircase elements by applying timber putty to minor cavities and uneven surfaces.

- **Paint stripping:** Inappropriate paint layers and stained varnishes that trap moisture, obscure historic details and obstruct operation should be removed via careful stripping by hand, using a combination of turpentine, wire wool and timber scraper. Past layers should first be recorded by paint analysis. Harsh chemicals and industrial sanding machines should be avoided as much as possible, as these will remove timber patination. Paint removal should not be carried out using hot-air guns or blowtorches due to high risk of fire hazard.
- **Surface patching:** For minor surface flaws and discontinuities such as pits, simple patching work can be carried out using a polyester-based or epoxy timber putty.

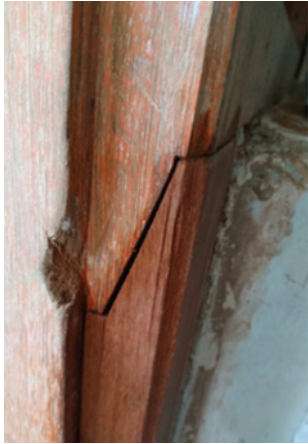
Timber-to-timber repair by splicing.

- **Timber-to-timber repair**, which is large-area surface patching or whole-section replacement by scarfing, may be required for more substantive defects. The species and properties (such as seasoning and preservative treatments, grain direction) of the replacement wood should match the existing, for performance compatibility. The scarf joint between new and old should take into account prevention of water ingress, high stress concentration, etc. These could be applicable for solid timber railings, panels, floor joists, screens, etc.

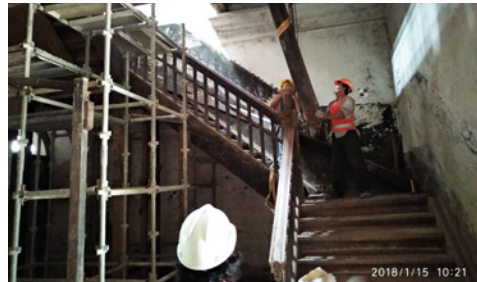
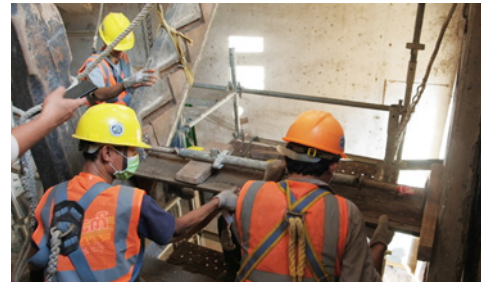
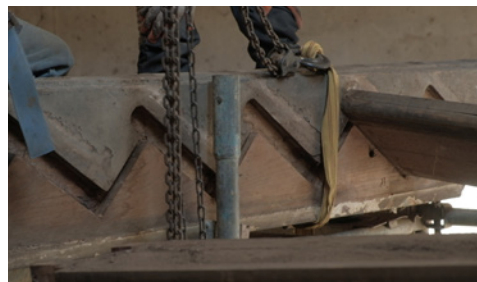
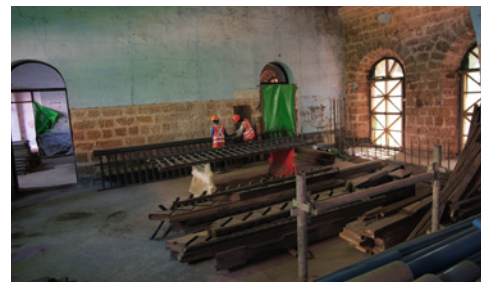
Dismantling of historic Burmese teak staircase - this will be followed by safe storage, bench restoration and reassembly after completion of the building's structural strengthening. The dismantling method and sequence should be informed by detailed construction study.

- **Reassembly**: Where large gaps are found between floorboards, a skilled joiner should be engaged to carefully re-lay all the boards to close the spacing, and any remaining gaps should be filled with added boards of matching timber, or salvaged historic planks. Timber filler strips may be used as a temporary measure until major works are next planned, or if disassembly of the timber floor may cause damage to other historic elements. Similarly, where components of other timber elements such as stair balustrades, treads and risers have come loose, they should be carefully disassembled, inspected for damage, repaired and reinstalled by a skilled joiner.

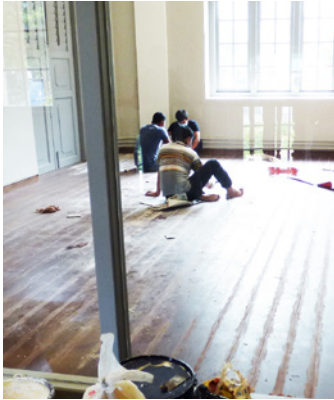
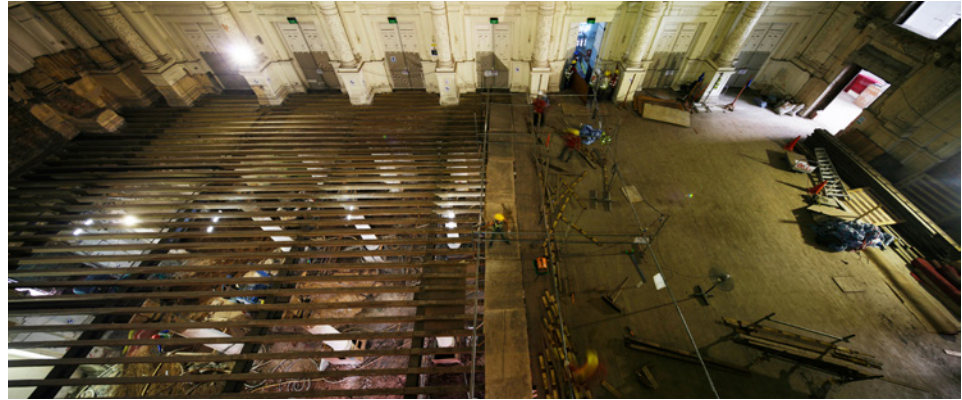
Left: Filling in the gaps between floorboards with filler strips and timber putty following reassembly. **Right:** Dismantling of timber strip flooring, revealing the joists beneath.

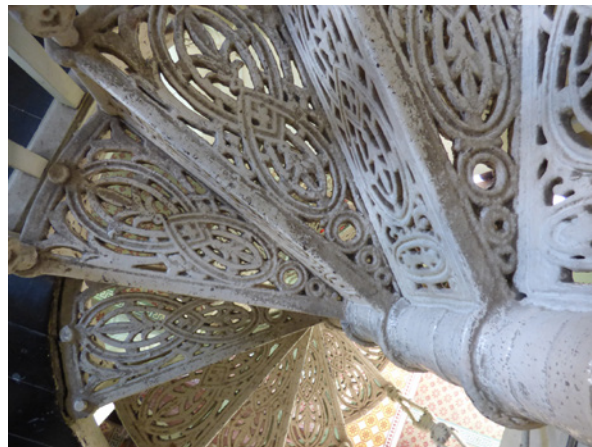
Ornamental detail of cast iron spiral staircase ordered off a catalogue and assembled on site from imported prefabricated modules, Church of the Nativity of the Blessed Virgin Mary (1901).

Interior metal **spiral staircases** can be found in some historic churches and public buildings, usually as space-saving service access. A more ornamental design that doubles as an aesthetic feature may be chosen if it is located in a relatively prominent space, such as stairways to church choir lofts. Typically made of cast iron, spiral staircases come in step-sections, pivoted from a central post anchored to the floor and held in place by the baluster units. Metal accessories are also commonly used for timber, masonry or reinforced concrete staircases, such as brass or cast iron railings, and wrought iron balustrades.

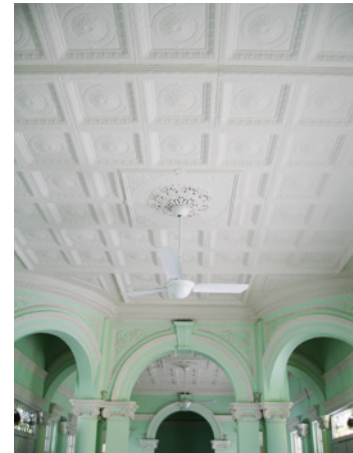
Metal ceiling “centre-flowers” as shown in a catalogue (**right**), and as found at a 1920s St Patrick’s Road bungalow at (**far right**). “Centre-flowers” are part of the metal ceiling system that may serve as the anchor point for fittings such as chandeliers or fans.

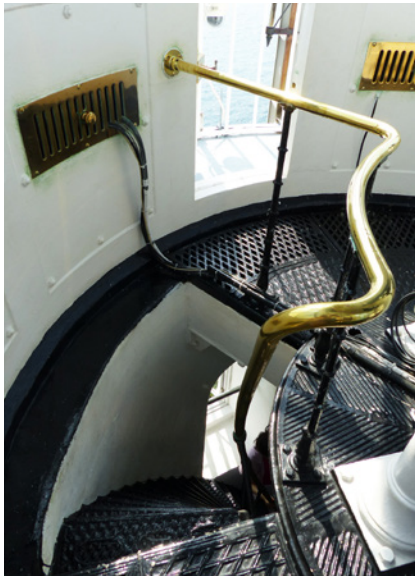
Iron spiral staircase with brass railing, and iron deck floor, Raffles Lighthouse (1850s).

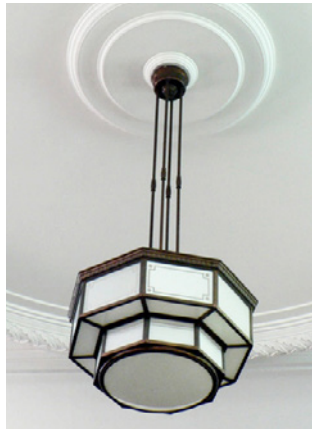
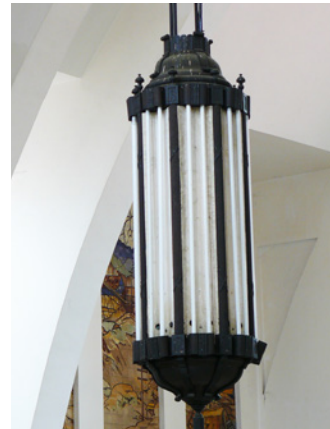
From left: Bronze pendant lights, Supreme Court (1939), and Tanjong Pagar Railway Station (1932, light installed post-war).

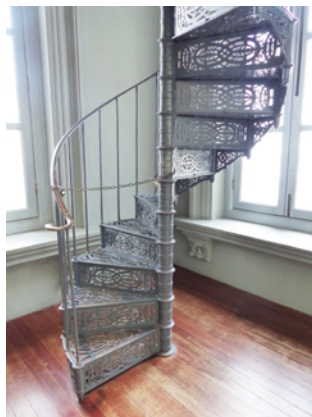
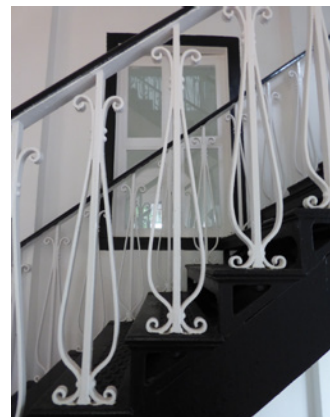
From left: Cast iron spiral staircase, National Museum of Singapore (1887), and riveted mild steel balustrade, 1920s colonial government quarter.

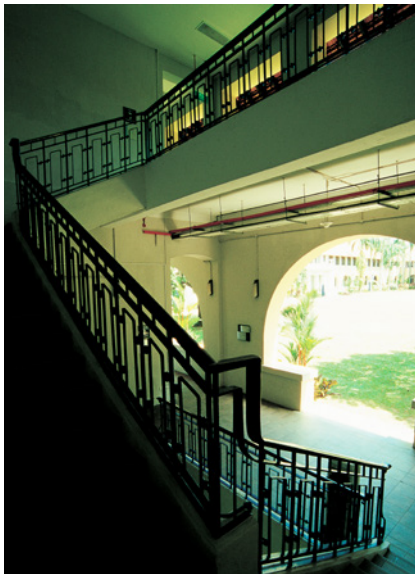
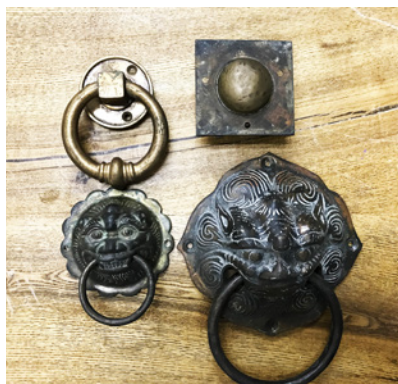
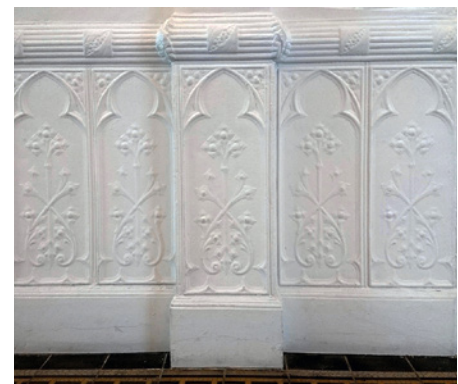
Above: Art Deco metalwork balustrade, Raffles College (1928). Left: Brass and bronze door accessories. Far left: Stamped metal panel dado, St Joseph's Institution (1910s).

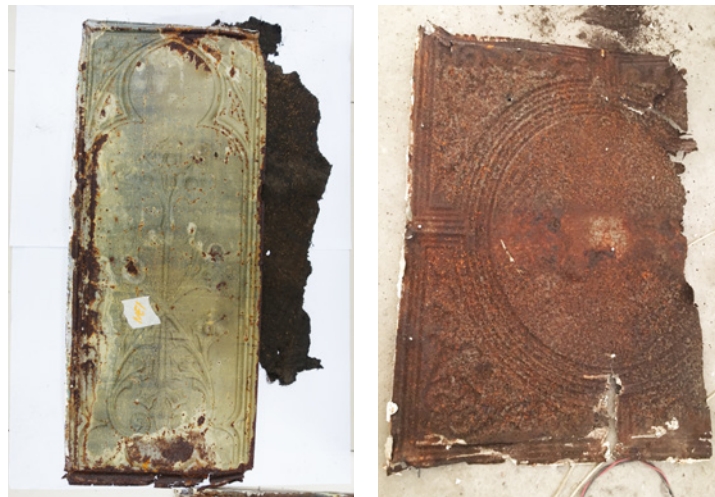
Right: Stamped metal dado panel rusting along the edges. **Far right:** Panel has completely rusted on the back, which faces the humid, under-ventilated roof space.

- Introduction of air conditioning that leads to condensation.
- Exposure to humid atmosphere from lack of ventilation, e.g., metal ceiling panelling with its back exposed to unventilated roof space.
- Installation methods such as joints and fixing points that tend to trap moisture and undergo crevice and galvanic corrosion.
- Components that are frequently handled, such as doorknobs, may have their coatings wear off and become discoloured.
- Inappropriate or inadequate maintenance, such as overpainting without rust removal, lack of regular oiling and polishing/waxing, and part replacement using a different metal causing bimetallic corrosion.

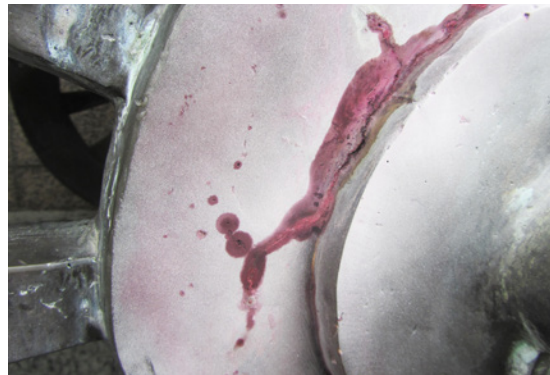
Dye penetrant test highlights presence of cracks and pitting on metal.

- **Dye penetrant and magnetic particle tests** may be carried out to detect cracks and shallow abnormalities. At-risk locations where cracks are observed may be selected for testing.
- Laboratory or portable **XRF (X-ray fluorescence)** can be used to detect elemental composition for identifying the metal type.

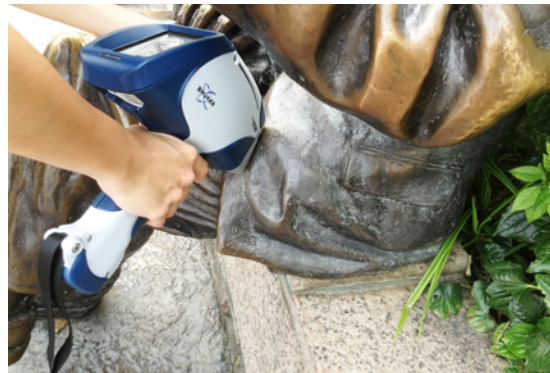
Portable XRF used for in situ elemental identification.

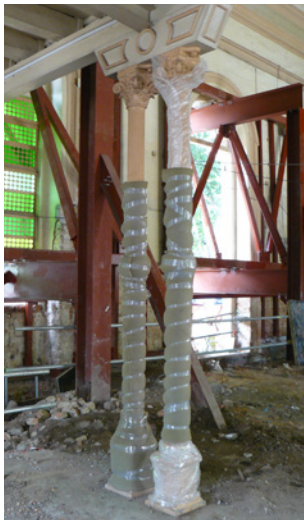
Protection of the choir loft cast-iron columns during construction stage, Cathedral of the Good Shepherd. In situ restoration of interior elements usually takes place towards the end of construction – in the meantime these elements should be well protected against accidental impact on the work site.

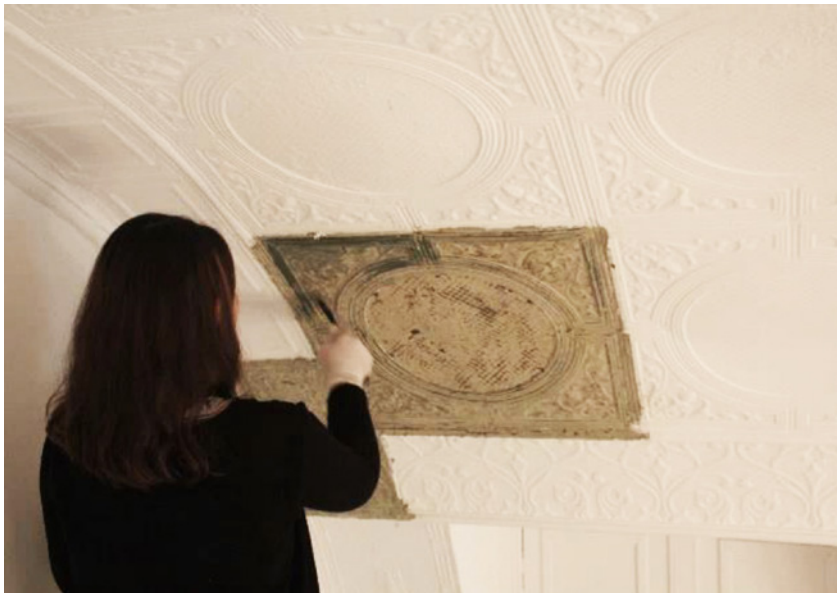
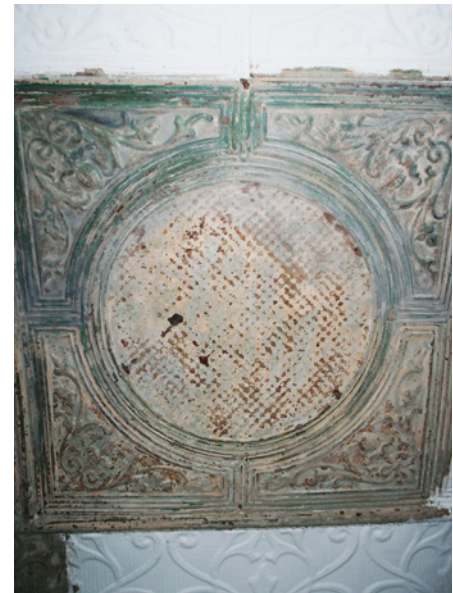
Trial paint removal of a metal ceiling panel using odour-free non-toxic biodegradable chemical stripper.

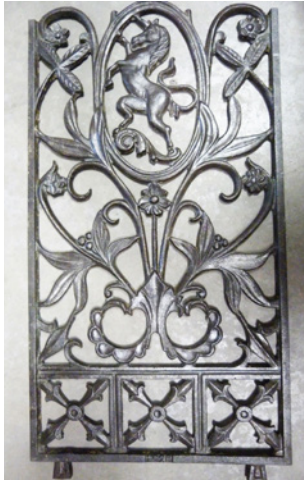
The fine details of the relief revealed, after removing multiple layers of coating from the overpainted baluster.

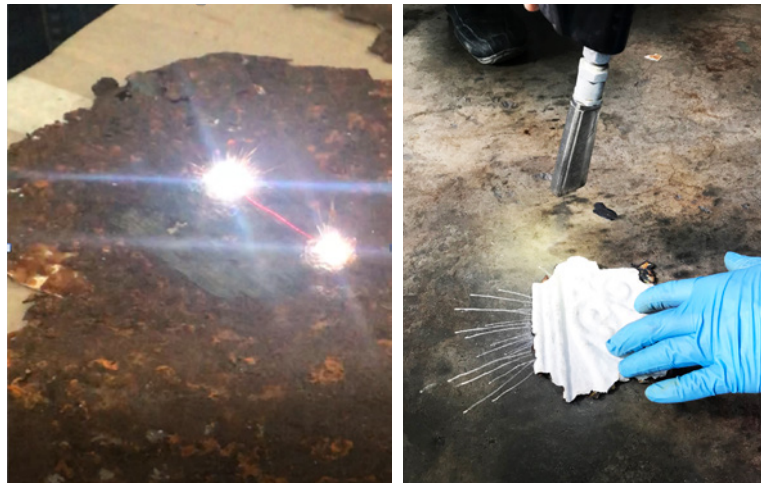
Coating and rust removal using specialist laser (left) and dry ice (right) methods.

- **Specialist methods** of coating and rust removal that are gentle yet effective, and particularly suited for intricate metal interior elements, include **laser cleaning** and **dry ice blasting**.

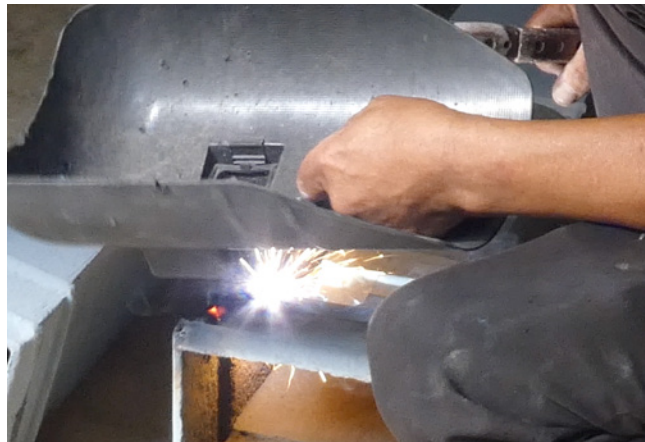
Hot repair of crack by welding.

- **Cold repair** work is particularly suitable as it can be carried out on-site and there is less risk of thermal or mechanical damage. Fastening by **bolting, stitching and plating** are typical cold repair methods. Recent technical advancements include using **non-metallic cold repair methods** such as epoxy adhesive for non-structural minor repairs. Fillers and fibres may be added to the epoxy to provide improved strength and match the texture.
- **Hot repair** methods include **brazing, soldering and welding**. For brazing, often used for repairing bronze elements, a molten filler is introduced to the heated metal parts to be joined. Soldering is similar to brazing, except that the filler used is of a lower melting point and applied to ferrous metals. Various types of welding methods are also used for the repair of ferrous metals.

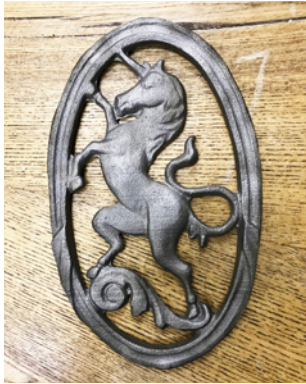
Cast-iron unicorn motif
3D test print replica using
metal powder as printing
medium, produced from
3D scanning data.

The reinstatement of bespoke or less common components may call for **small-scale replica fabrication**. Traditionally the replica would be crafted from scratch, or a hand-made mould would be modelled on an existing component, based on a measured drawing, and used to cast the parts. The results depended heavily on the workmanship of the fine metalwork foundry. More recently, **3D scanning, photogrammetry and 3D printing** have enabled more efficient and accurate replicas that can overcome the problem of unsatisfactory workmanship and the high cost of small-scale factory production.

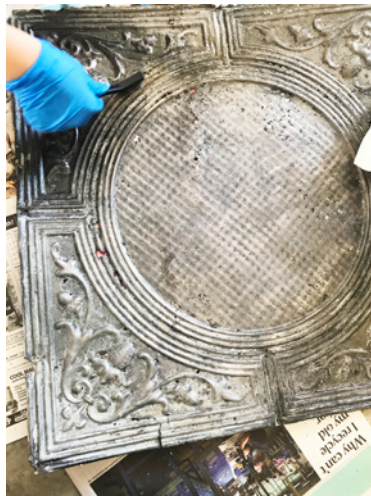
Trial application of coating on mild steel stamped metal ceiling panel with paint removed, beginning with a primer.

- Most modern **paints** used for iron-based metals comprise a three-layer system. The first layer is a primer, often a zinc or aluminium-rich primer that gives adhesion and corrosion inhibition properties to the surface. The second coat provides the thickness, durability and opacity of colour, while the final coat gives colour and texture. Common paints for metals include polyurethane, epoxy, acrylated-rubber and alkyd-based systems. It is common to repaint metal above the existing layer provided the paints are compatible. However, after several coats of overpainting, the details and features of the metal may be obscured, and paint stripping should be done.

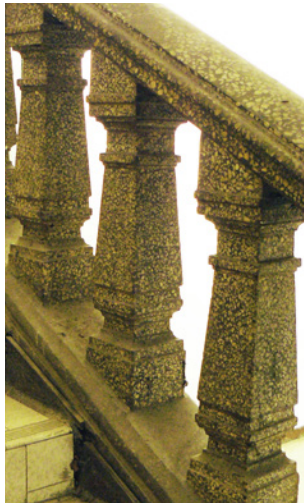
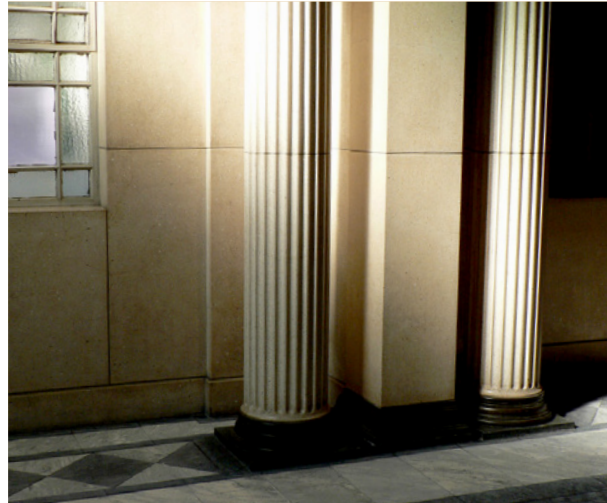
Above left: Full-height in situ terrazzo dadoes and precast terrazzo columns line the second-storey courtroom passageways of the former Supreme Court. Top right: Mother-of-pearl chipping is introduced as accents on the wall dado. Above right: Impeccably crafted fluted column in terrazzo.

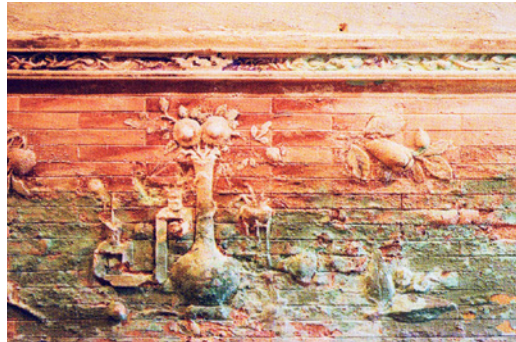
Deteriorated in situ decorative plaster dadoes, historic townhouses.

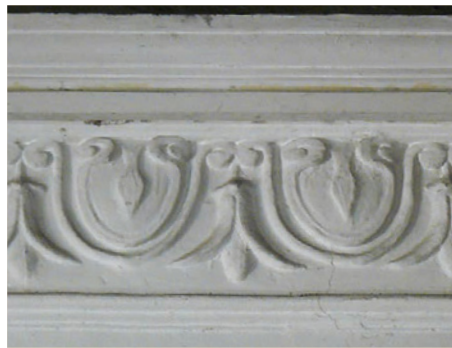
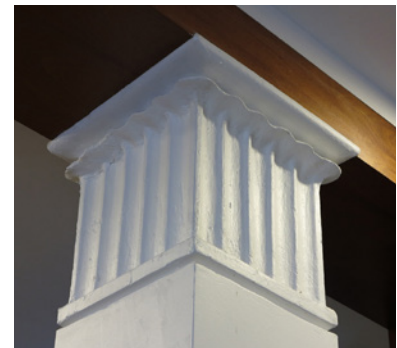
Interior cornice moulding and column capital with Art Deco motif in residences.

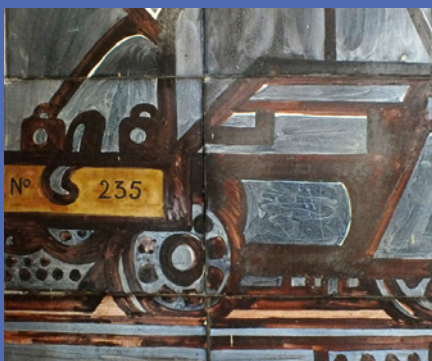
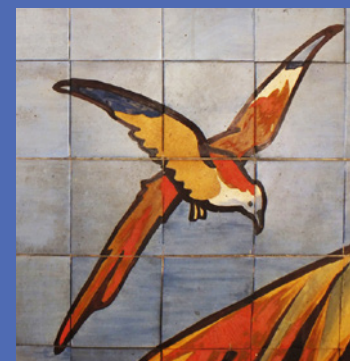
Views showing hand-painted detail of a locomotive (left) and the rich chromatic range of clouds in a sunset scene (middle). Original gold accents such as the wing tips of the bird have since tarnished (right).

Close-up inspection reveals expressive brushwork, bold use of colours, sensitive gradations and various stippling techniques, imparting depth and vibrancy to the mural artwork. There appear to be a few base colours for the tiles depending on the scenery backdrop - e.g., sky, sea, vegetation, earth, etc., which are then overpainted to create the artwork. It is likely that accents were once used to highlight certain features, through the use of special enamelled (metallic) paint on the completed work. Traces of slightly reflective overpainting are discernable, though these are now dulled and faded due to age or inappropriate maintenance cleaning in the past.

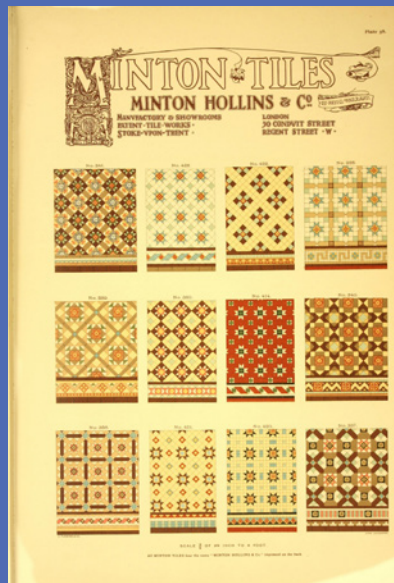
Left: Minton product catalogue featuring bichromatic and polychromatic encaustic tile in a wide variety of designs and patterns. Above: The manufacturer's imprint can be seen on the reverse side of the tile, as a mark of its authenticity.

A leading manufacturer and exporter of 'modern' encaustic tiles in the UK was **Minton, Hollins & Co.**, whose founder adopted and combined industrial production of inlaid tiles and the 'dust-press' technique, to facilitate large volume manufacturing, greatly reducing production time and costs. As a result, these tiles quickly gained popularity and proliferated across the British

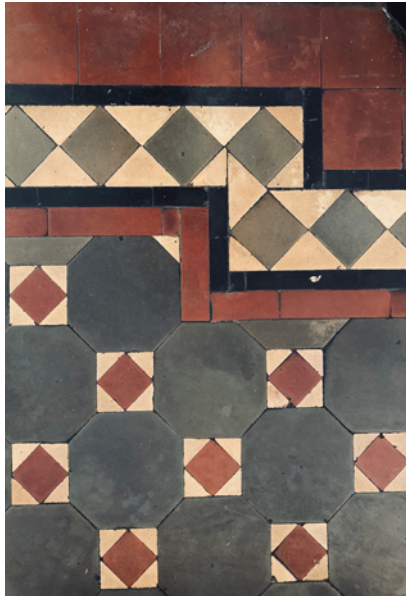
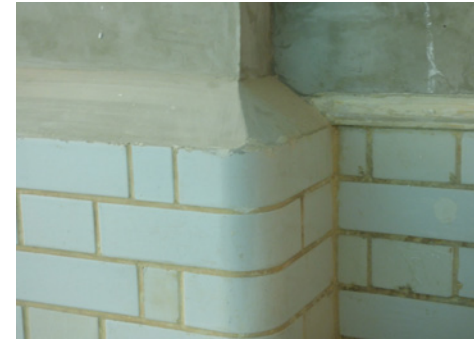
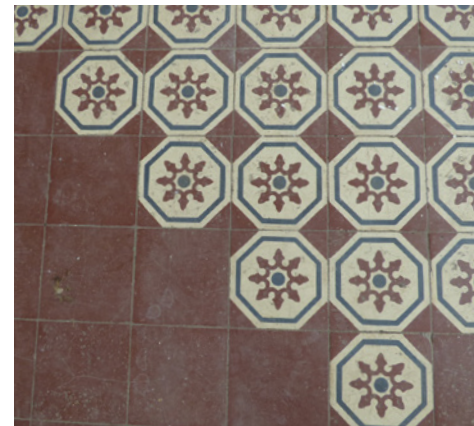
Clockwise from left: Geometric pattern encaustic floor tiles at Beaulieu House (1910s); A dado of glazed terracotta tiles, and waterspout shaped as a fish, clad in 'scales' of glazed ceramic shardwork, in a historic townhouse (1890s); Porcelain dado tiles laid in flemish bond pattern, with curved corner units, military drill hall (1930s); Flooring design composed of plain and ornamental encaustic tiles.
