CONSERVATION TECHNICAL HANDBOOK

Volume 6 | Interior Elements

URBAN REDEVELOPMENT AUTHORITY

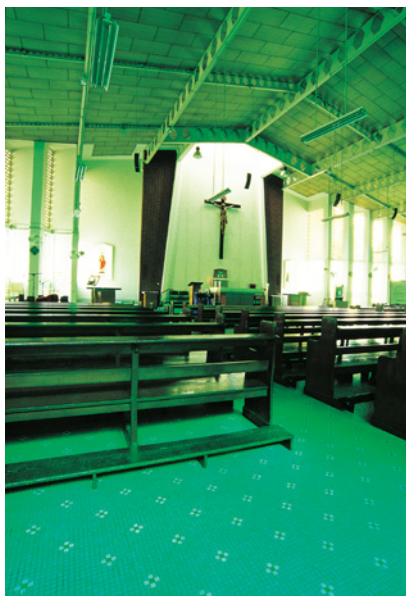
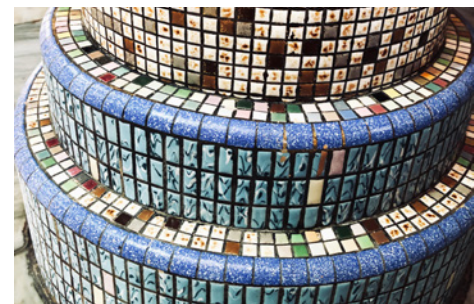
Left to right: Mosaic flooring accented with a grid of motifs, Church of St Bernadette (1959); Mosaic tiles with a raised embossed centre add visual texture and slip resistance, house at East Coast Road (1950s); Small mosaic tiles are used to wrap around curved surfaces such as this circular column in the Cundhi Gong Temple.

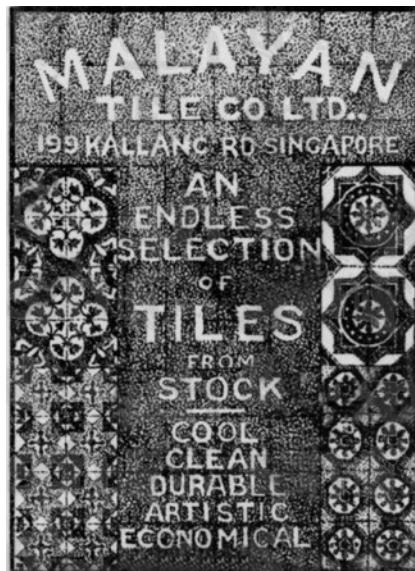
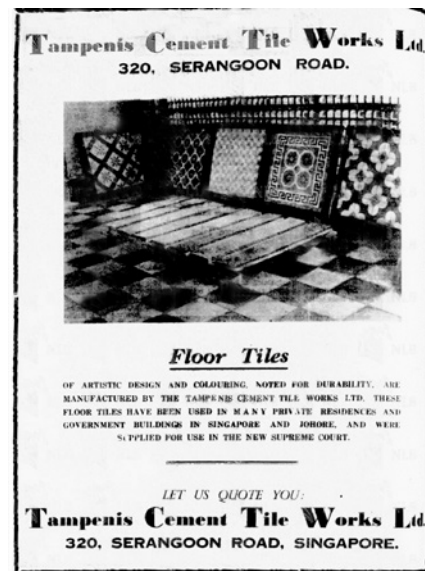
By the 1930s, cement tile manufacturing had taken off successfully in Singapore, adapting the French technology to the local context and market.

Although early **polychromatic cement tiles** adopted the design and patterns of encaustic ceramic tiles, they are of very different materials and manufacturing process. The top finishing layer comprises white cement with colour pigments added into the different compartments of the steel 'cloisonne moulds'. This was then removed, with grey **Portland cement** filling the rest of the tile body. The tile was then hydraulically pressed together and left to cure, without any need for kiln firing as in the case of encaustic tiles. This technique, patented in France in the 1850s, greatly reduced manufacturing costs. Touted as a durable, affordable and attractive product, cement tiles enjoyed widespread popularity not just in Europe but also in its colonies, notably in French Indochina and Morocco.

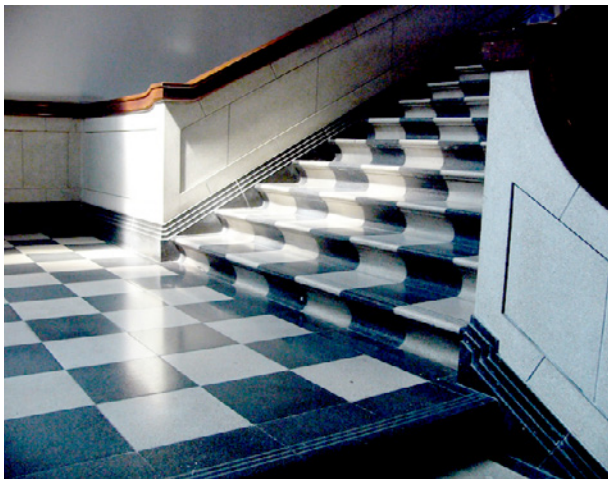
Above left: Black and white precast 'spuncrete' terrazzo tiles laid in checkerboard pattern, with special curved riser and grooved step riser units, likely custom-produced for the former Supreme Court (1939).

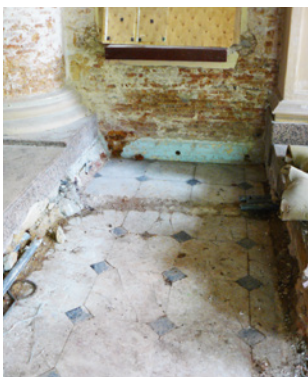
The original marble flooring at the Cathedral of the Good Shepherd, part of which can be seen in the archival photograph (**right**), was fully revealed after the latter-day mosaic flooring was removed (**left**). The marble tiles are one inch thick (**top**).

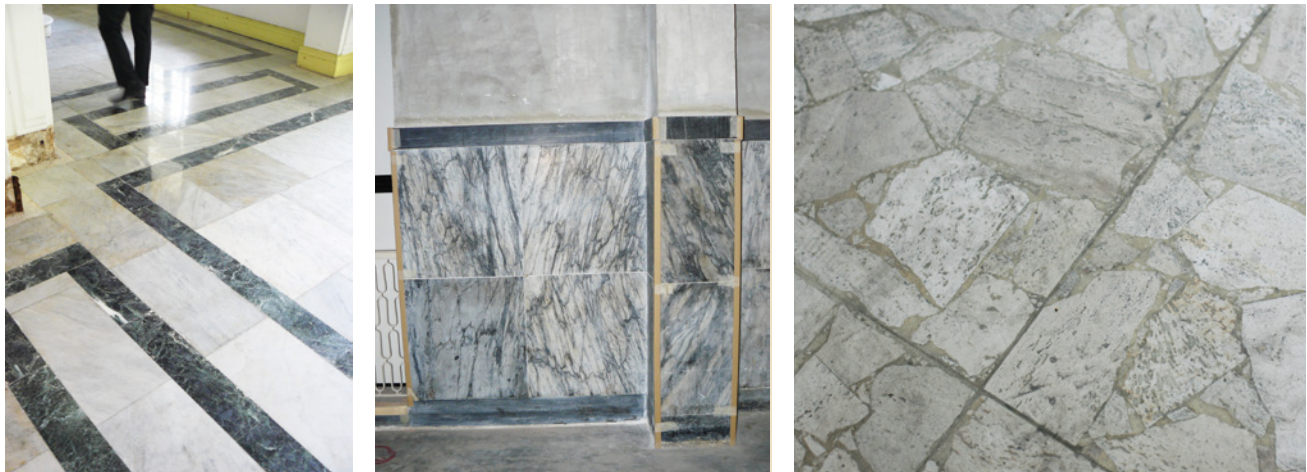
Left: Bichromatic stone flooring along the main hallway of a historic bungalow, comprising ‘field’ tiles in white Carrara marble, with border accents in dark green Serpentine marble. **Middle:** Book-matched Bardiglio Cappello marble dado in the former NAAFI Britannia Clubhouse (1953, aka NCO Club). **Right:** Detail of special Cocciame tiles comprising broken Travertino marble adhered onto a cement substrate, found in the former Trinity Theological College chapel (1969). The fragments are salvaged by-products of marble quarrying and cutting large blocks of natural stone.

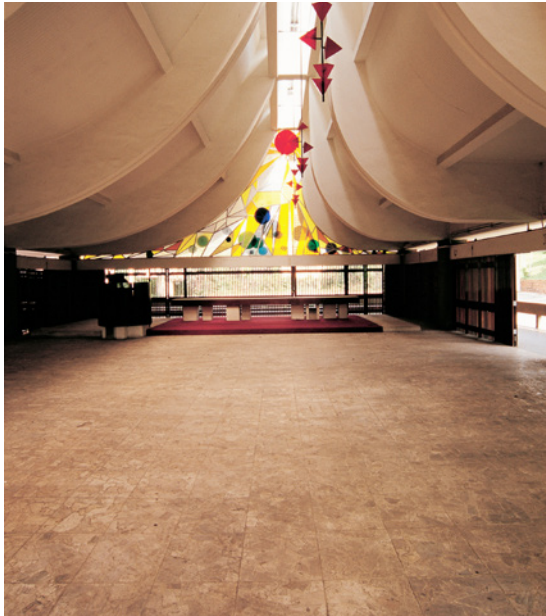
The unusual Cocciame (broken Travertine) floor tiles in the Trinity Theological College chapel (1969), since restored.

Advancements in manufacturing processes during the post-WWII period led to marble becoming more affordable, and popularized its use in more building types. An outstanding example is the expansive Billiard and Games Room of the 1950s NAAFI Britannia Club (later NCO Club and now part of the South Beach development), which features unusual grey Sicilian Bardiglio Cappello marble dadoes. Innovative hybrid products such as ‘Cocciame’ flooring – which features broken Travertino stone bound to a cement base – are used in the Trinity Theological College chapel built in 1968.

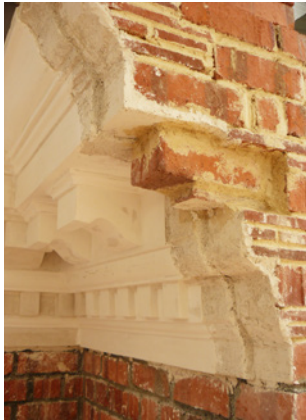
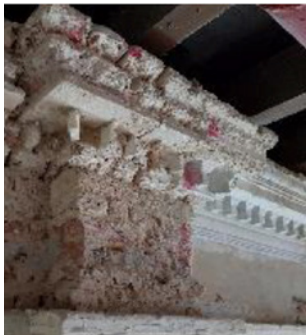
Top: Mock-up for ornamental plaster cornice showing masonry substrate build-up. Above: Exposed brick and terracotta substrate underneath ornamented plasterwork, including the cornice and dentil.

A variety of substrate materials could be used for interior finishes. **Wall finishes** could be installed on brickwork or cement block masonry, or on timber and other drywall construction. Tiled finishes were mainly fixed using bedding mortar, or mounted on a sub-frame fastened onto the wall. In situ ornamental plaster or terrazzo finishes would require a two-coat base render comprising a rough scratch coat (or 'splatter-dash') to provide sufficient mechanical key, followed by a coarse grain base coat. Sometimes, a metal lath would be added to the base coat to strengthen it prior to receiving thick or heavy architectural finishes. Both would need to be adequately cured before application of the fine grain finishing plaster or terrazzo.

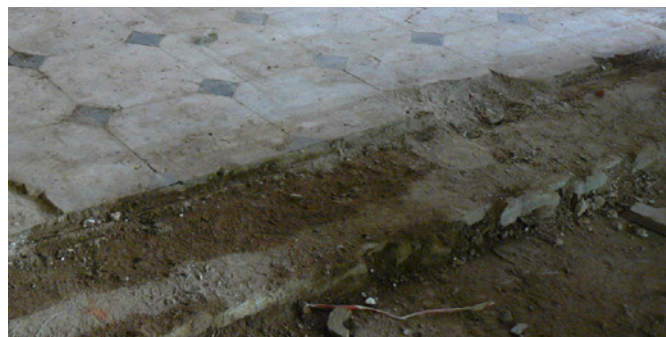
Layers of floor build-up can be clearly seen – finish layer, screed, sand blinding and compacted hardcore.

On the other hand, substrate material for internal pavement and **floor finishes** generally comprised a compacted hardcore material (or ballast), followed by a fine sand layer known as 'blinding', upon which was cast a mass concrete which consisted of brick rubble, stone aggregates bound in a lime-based mortar. A coarse-grained lime- or cement-based screed would then be laid and trowelled to receive the final floor finish. Tiled finishes would generally require bedding mortar adhesive to be applied, prior to their installation.

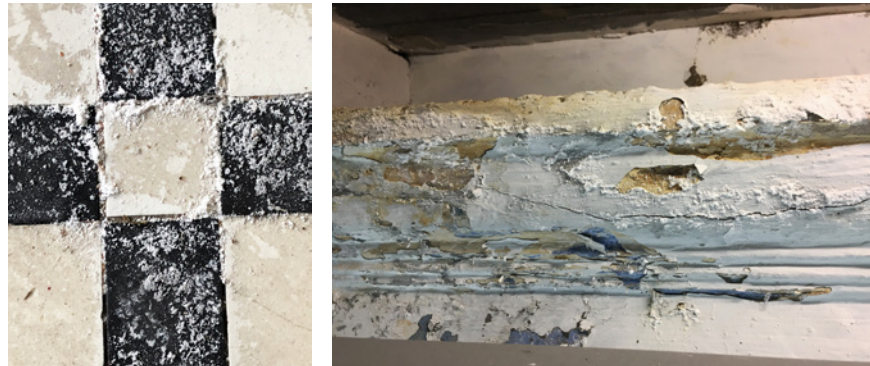
Right: Efflorescence on encaustic floor tiles caused by rising damp.

Far right: Long-term water seepage leading to efflorescence, paint peeling, and damage of ornamental plaster render.

Water ingress due to a compromised building envelope can lead to **stains and efflorescence** on interior finishes. Infiltration of water from the exterior will dissolve soluble salts within the wall, such as alkali salt from the cement binder or inherent salt in the bricks and mortar, which then travels through existing cracks to emerge on the interior finish, leaving salt deposits along the crack lines. Left untreated, continued salt build-up will lead to permanent staining. Entrapment of soluble and hygroscopic salt within the pores of stones, particularly granite, can lead to stubborn **damp or water marks** due to water retention by the salts. The presence of iron compounds such as iron oxide and pyrite can cause yellowing of stone tiles like granite and white marble.

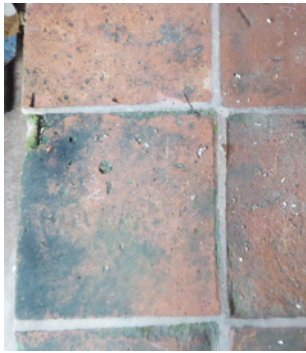
Top: Terracotta tiles eroded by heavy use abrasion.

Above: Mosaic flooring with pigmented glazing worn off, revealing the cream coloured tile body beneath.

Abrasion: Finishes in high-traffic or high contact areas often suffer from abrasion wear – loss of sheen, loss of material, deep scratches and pitting – particularly on softer materials such as marble, terrazzo and cement-based finishes. These can then lead to entrapment of dirt, soot and contaminant due to the increased porosity and surface roughness. Such residues can aggravate the deterioration by retaining moisture. Some contaminants may contain soluble matter and salt, which may then result in crystallization damage, while others may be acidic, causing dissolution of calcite based materials like marble and cement-based finishes. When the pigmented layer is worn off, the tile design may be affected. Some stones can suffer from pitting because of their inherent microstructure and mineral composition, such as the presence of mica and fissures near the surface.

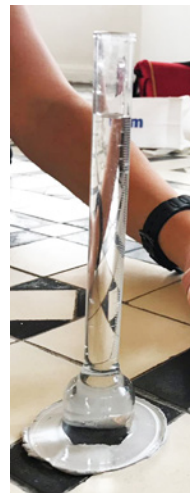
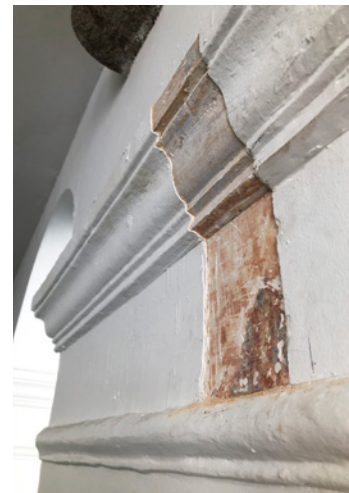
Left: Karsten Tube test on encaustic tile to assess water absorption rate by capillary action.

Right: Localized paint removal to verify presence and condition of historic plaster.

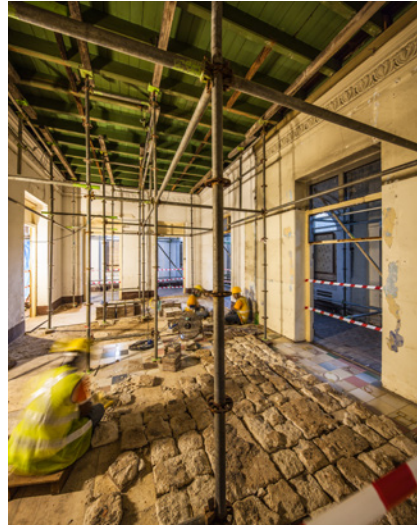
Tagging, documentation, and dismantling of historic ornamental cement tiles for off-site restoration. Dismantling of floor tiles should only be carried out if necessary – such as the need for floor slab reconstruction in this case – and it is only feasible if the adhesive bedding is sufficiently weak. Otherwise, conservation works should be carried out in situ where possible.

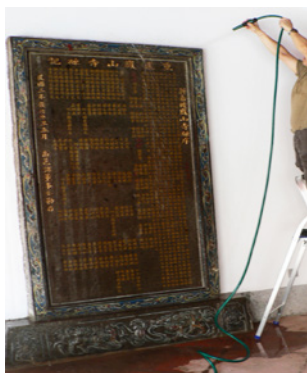
General cleaning of granite stele by rinsing with water, to be followed by scrubbing to remove loose soot residue.

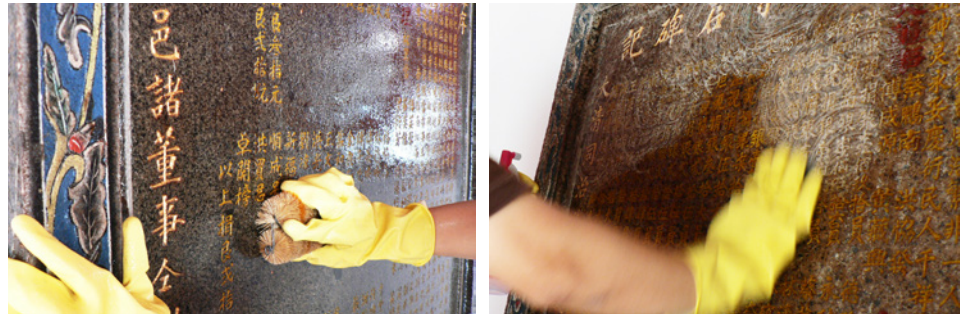
From left: After rinsing with water, abrasion cleaning is carried out by scrubbing using natural fibre bristle brush to remove loose soot residue. The surface is then sprayed evenly with a chemical stone cleaner and scrubbed in a circular motion, for removal of stubborn stains.

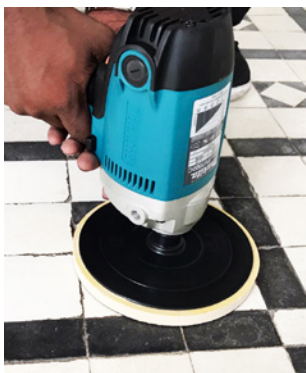
Abrasive cleaning of floor tile using handheld buffing grinder to remove incompatible coating.

- Abrasive cleaning:** Abrasive cleaning can be carried out with or without water (wet or dry). It is essential to use an abrasive which is softer than the historic finish layer, applied by a skilled hand using the appropriate tool and pressure, to minimize damage. Abrasive cleaning tools range from natural fibre bristle brush, buffing grinder, to rotary jet. The types of abrasive medium include glass beads, sodium bicarbonate, aluminium oxide, silica sand and dry ice. Abrasive cleaning is not suitable for glazed or polished surfaces. During abrasive cleaning, the work surface may be obscured from view by dust, slurry or water mist – depending on the method used. The effectiveness of the procedure depends largely on the skill of the operator who needs to evaluate the effects and make fine adjustments according to the different types of stains and surface conditions.

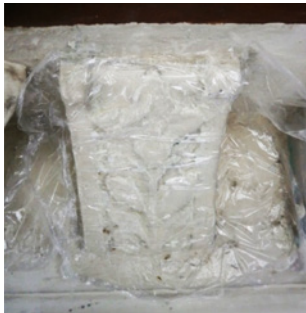
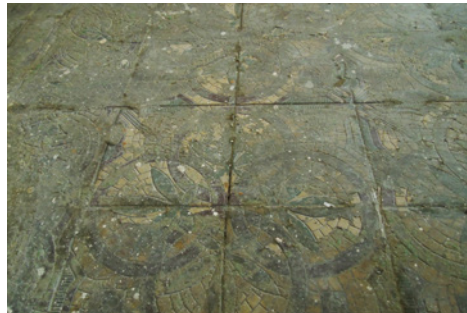
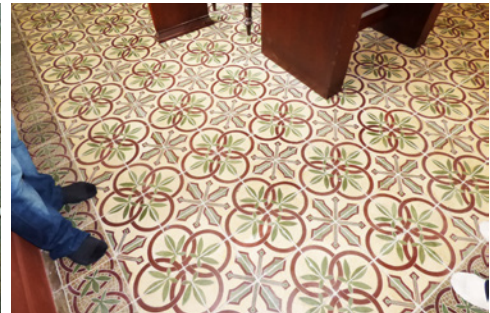
Left: Chemical paint stripper is applied on the in situ ornamental plaster, shrinkwrapped and rested, before removal of paint residue using a scraper. **Middle & right:** Polychromatic ornamental cement tiles were found with extensive staining and glue residue after removal of latter-day vinyl flooring. Conservation cleaning was carried out using pH-neutral soap and cream-based masque, and finished with protective wax.

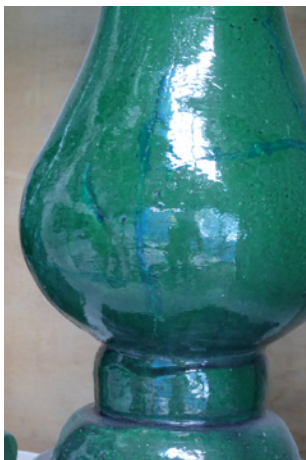
Repair of minor cracks on green glazed bottle balustrade using pigmented epoxy.

Fine cracks can be sealed with epoxy to prevent ingress of water and soiling. Crazes normally do not need to be treated. Larger cracks will need specific treatment depending on the base materials. For marble and limestone, the cracks may be sealed with epoxy or polyester, often mixed with marble and limestone powders to match the colour. Cement- and lime-based finishes, including terrazzo and encaustic cement tiles can be repaired by patching or injection with fine cement or lime grout. For terrazzo, pigments may be added into the lime or white cement to match the colour. Large cracks in marble, limestone and terracotta can also be repaired with lime with pigments to match. In some cases, nano-lime has been used successfully in the repair of finer cracks. For ceramic tiles, the cracks can be sealed with epoxy.

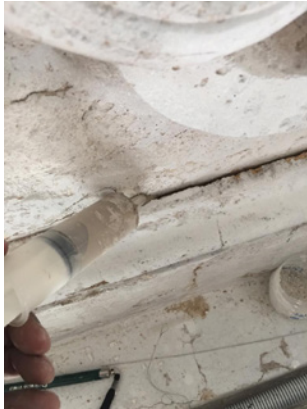
Debonding repair by injection.

Finishes that have debonded but remain in place on walls and floors can be reattached by injection with epoxy or fine lime or cement grout. However, the condition of the substrate and cause of debonding should first be investigated before any attempt to rebond the finish layer. Should the substrate be found to be in poor condition, repairs should be carried out before reinstallation of the finish layer. This may include consolidation, strengthening or replacement of the substrate such as the plaster or screed. In some instances, debonded thick finishes such as stone tiles, encaustic tiles and terracotta may be carefully removed by cutting or wedging for reinstatement. This may be necessary for instance if the floor slab or wall needs to be reconstructed.

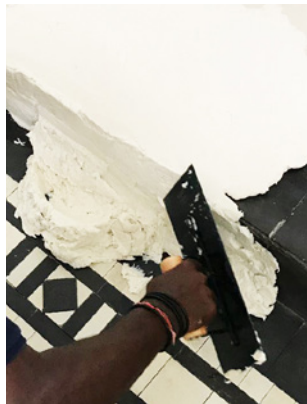
Desalination treatment by poulticing.

Finishes affected by salt crystallization will first need to be treated by removing the excess surface salt by captive vacuuming. The source of the salt should be ascertained and addressed. Residual salt in the substrate and finish layer can be extracted by desalination with poultices or packs. However, it may not be possible to extract all the salt. Depending on the nature of the salt, chemical stabilization of the salt may be carried out to render the salt insoluble. As these are specialized treatments, advice should be sought from specialists. Salt crystallization can result in disintegration of the surface of the finish layer in the form of a friable and powdery surface and flaking. Drill resistance measurement can be employed to assess the soundness of the salt-attacked surface to determine the degree of deterioration or identify the deteriorated surface layer. Consolidation and strengthening of the surface layer can then be carried out.

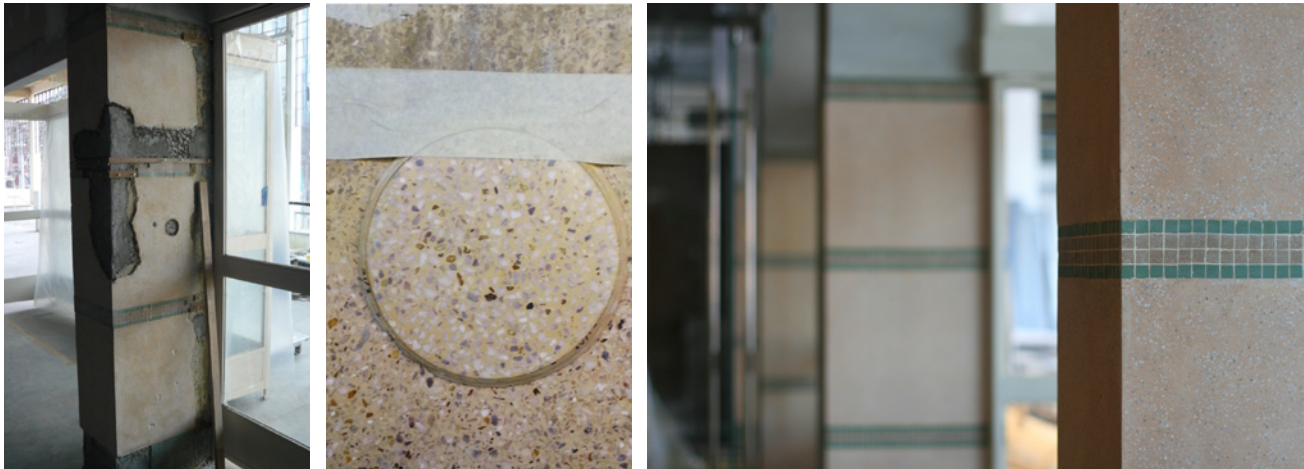
From left: Damaged in situ terrazzo render; one of the patching trials carried out to ensure visual compatibility of patching mix; selected mix is then used for restoring the rest of the terrazzo finished columns.
