CONSERVATION GUIDELINES
TECHNICAL SUPPLEMENT

THE FIRST STOREY

Five-Footway & Front Facade

June 1998

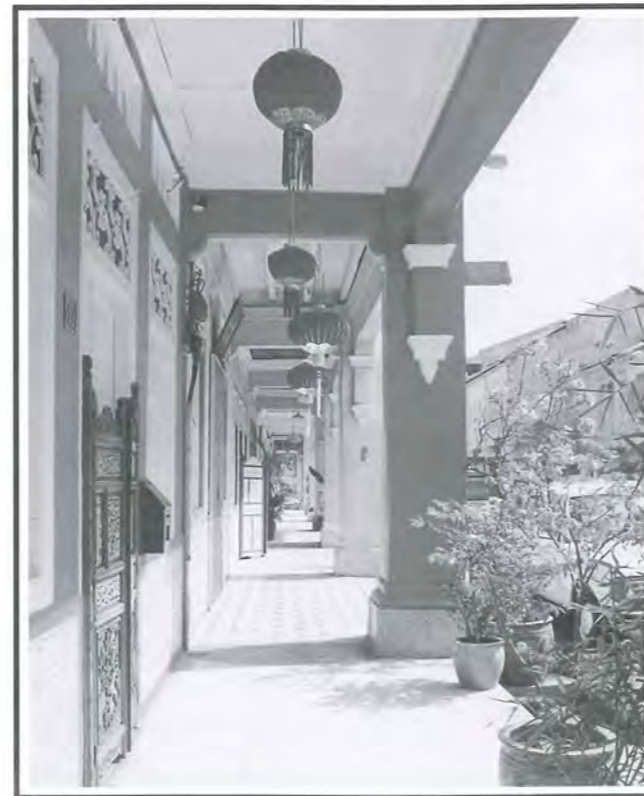
Fig 5: The key elements of the five-footway: the floor, the ceiling, the colonnade and the residential front, contribute to its traditional character.

A unique adaption to the hot and wet climate, the five-footway is a continuous colonnaded covered walkway running the length of the front and sometimes the sides of a shophouse block. Designed as an integral part of the shophouse structure, the five-footway is an important feature at the first storey of the shophouse. It serves as a sheltered space for pedestrian movement and social activities.

(See Fig 5)

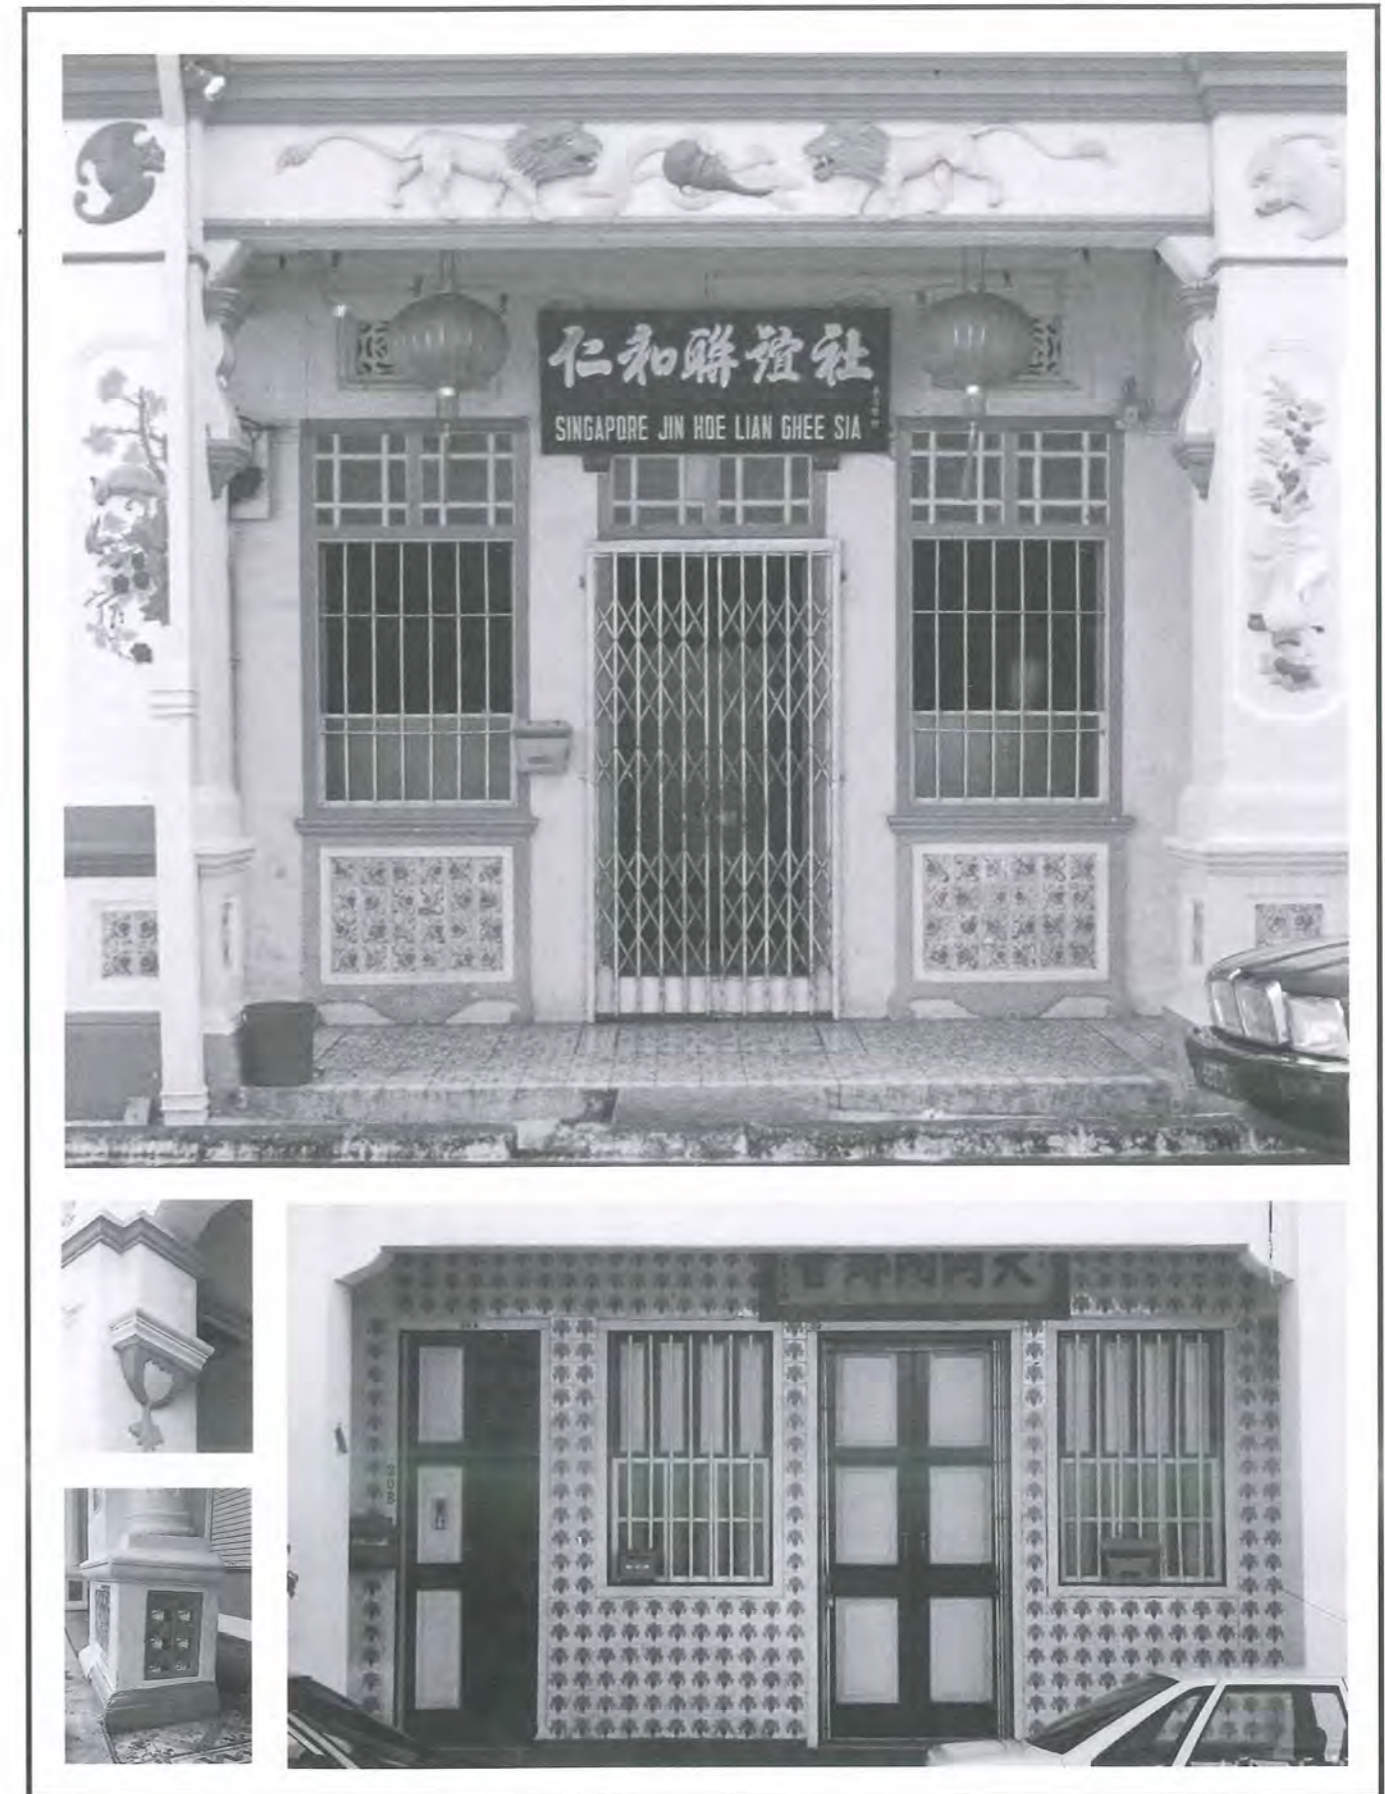
Fig 6: Examples of ornamental plasterworks and polychromatic embossed tiles found on walls and columns at the first storey.

The walls and columns framing the five-footway are plastered and painted or tiled with glazed wall tiles arranged as panels below the windows and on the columns. (See Fig 6)

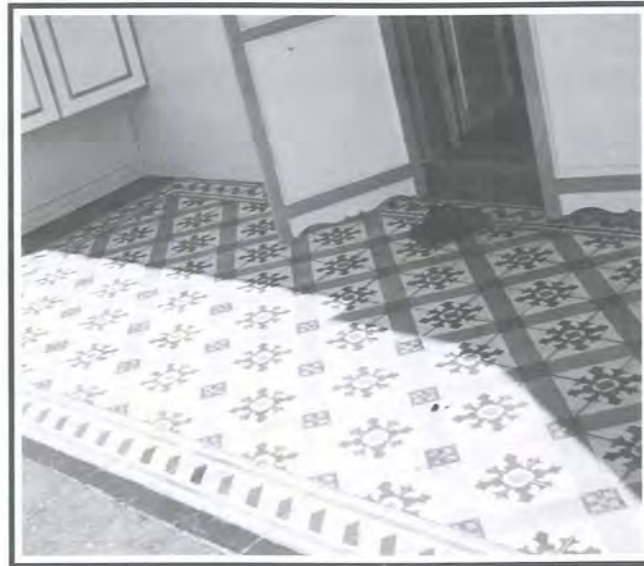
Fig 7: The use of plain cement screed along the five-footway are typical of the earlier shophouse styles.

Traditional floor finishes for the five-footways include cement screed (plain, coloured, smooth or with gridded rope indentations), clay tiles and granite slabs. (See Figs 7 to 9)

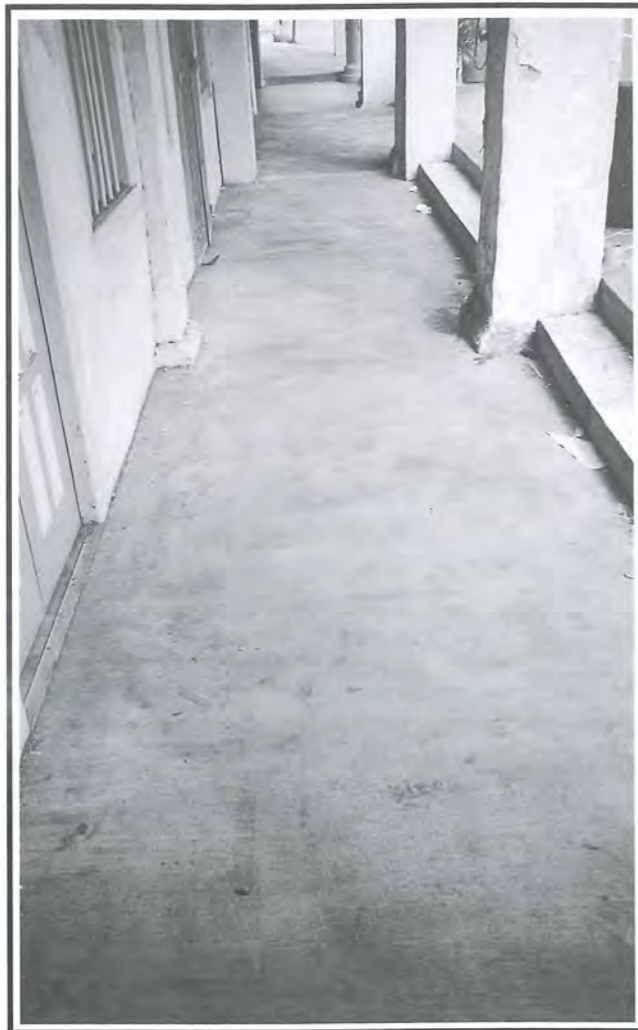
Fig 8: Elaborate use of patterned cement tiles along the five-footway is characteristic of some of the later shophouse styles.

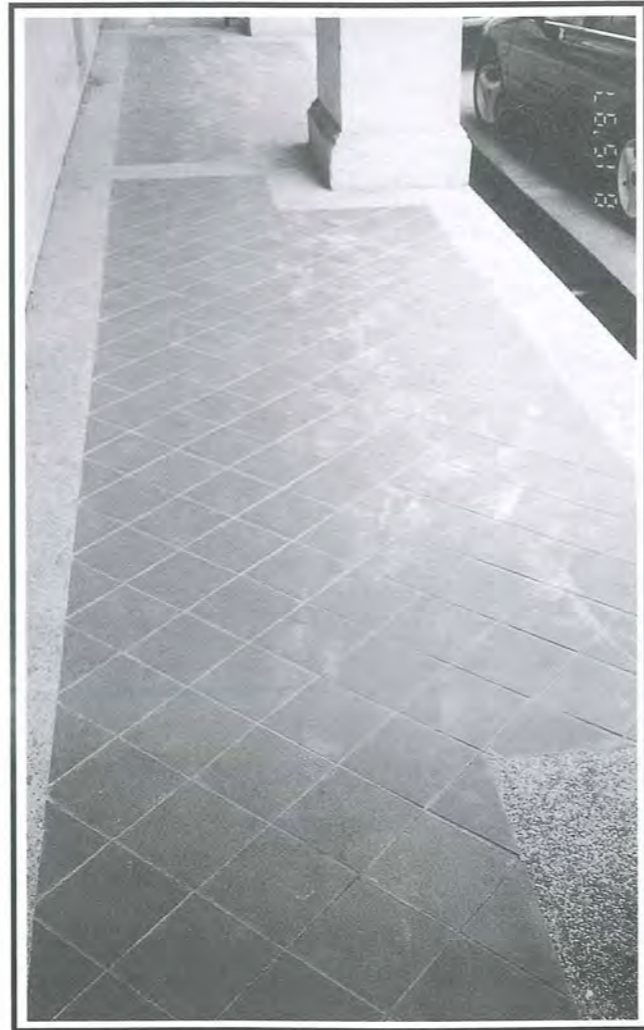
Fig 9: The use of terracotta tiles with granite edging is also commonly found.

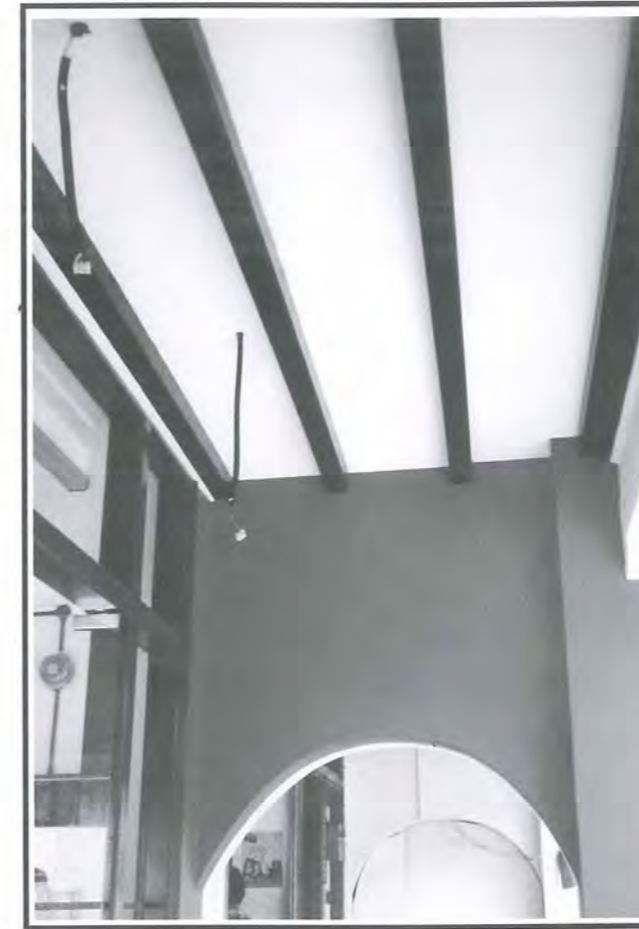
Fig 10: Exposed underside of the upper floor timber joists with the use of plasterboard to conceal the electrical conduits.

The ceilings of five-footways are essentially the underside of the upper storey floor joists and floorboards. These are sometimes concealed by a false ceiling of timber frame and cement-board finish. Elaborate cornices, e.g. dentils and plaster relief mouldings are sometimes used.

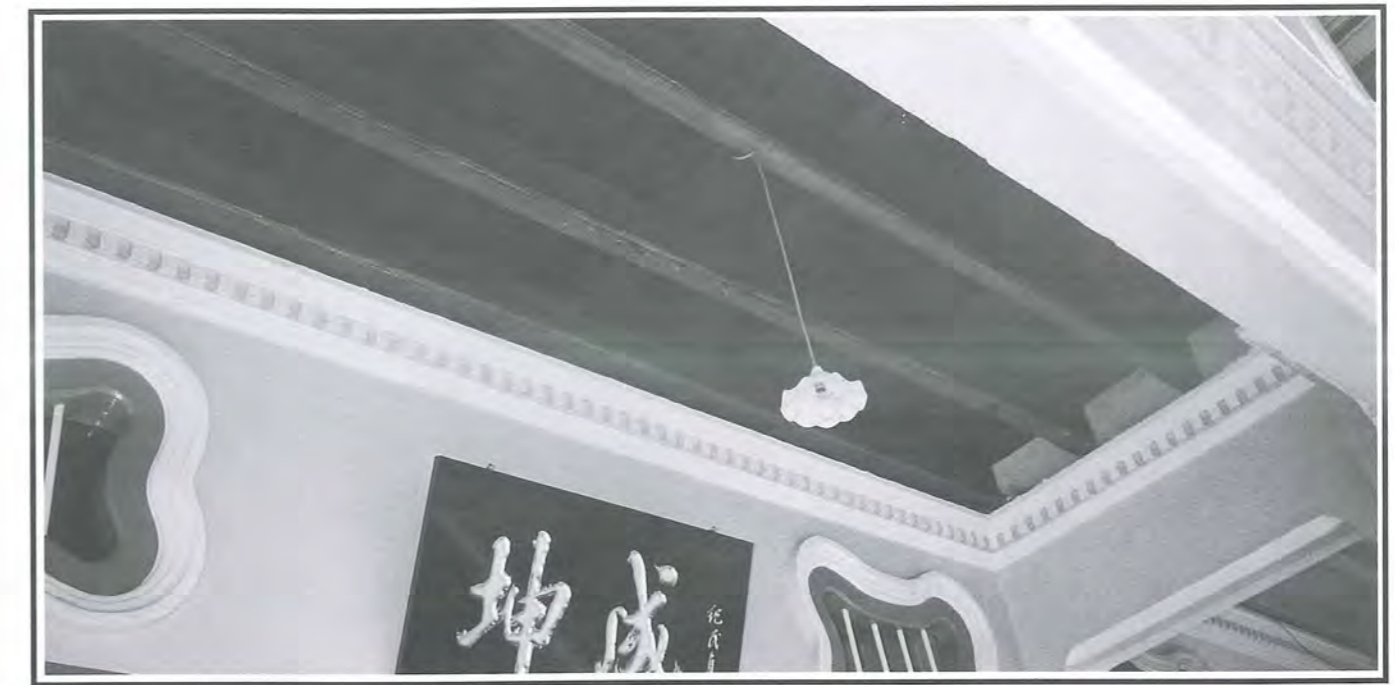
Fig 11: Exposed underside of the upper floor timber joists and floor boards enhanced by elaborate cornices.

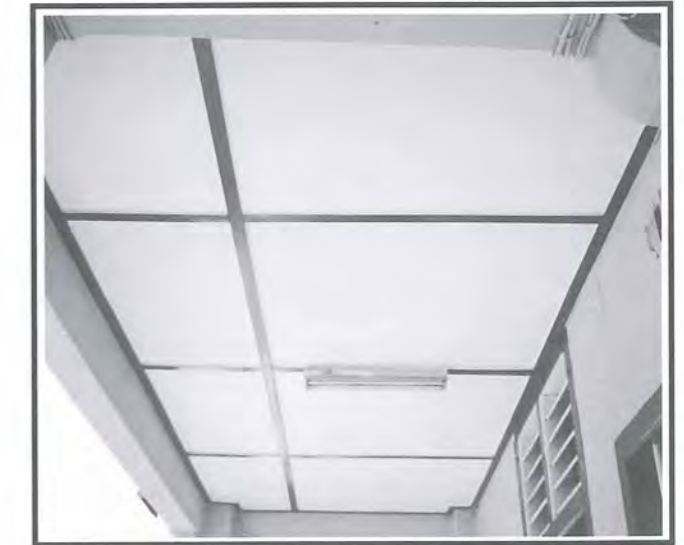
Fig 12: Ceiling of painted timber frame with cement-board finish.

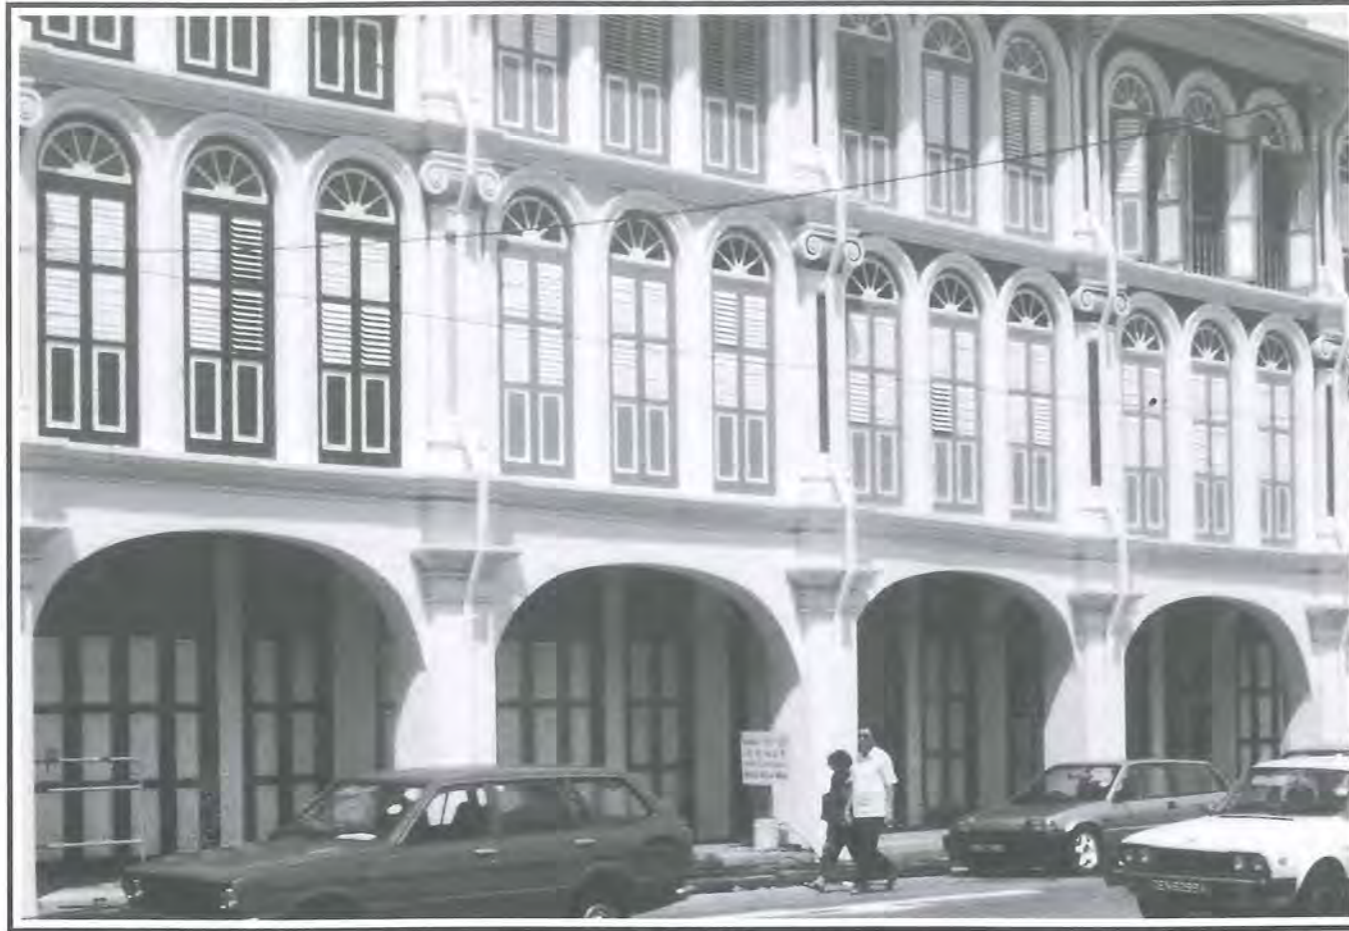
Fig 13: The arches accentuate the rhythmic progression along the five-footway.

The arches, where present, contribute significantly to the streetscape by accentuating the rhythmic progression of the five-footway.

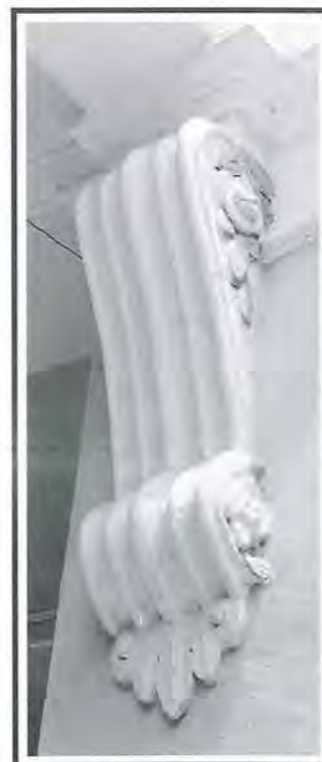
Fig 14: Corbels support the canopies at the 2nd storey floor level.

The corbels are short projections at the connections of the beams and the columns. Usually ornamented, they serve to support protruding elements such as balconies or roof eaves.

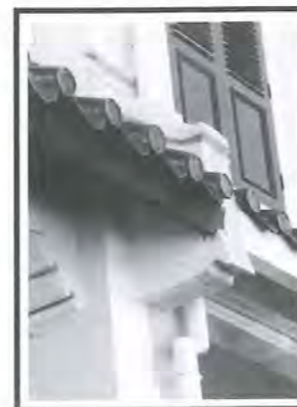
Fig 15: Ornamented corbels are often found in the later shophouse styles.

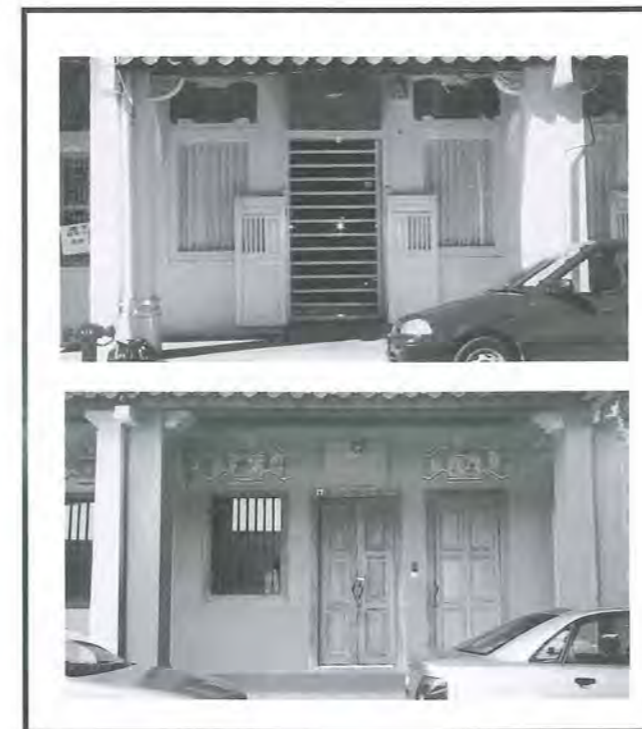
Fig 16: Residential fronts are characterised by a double-leafed timber door with a pair of timber casement windows on either side. Residential fronts which are adapted for commercial uses have two double-leafed timber doors and a timber casement window.

These are characterised by timber casement windows flanking a double-leafed timber door or by two double-leafed timber doors and a timber casement window. The rhythm created by the residential fronts gives the street a sense of intimate scale and texture. Shophouses of different styles would have distinctive features in terms of relief motifs, ornaments, vents, fanlights, relief carvings on the timber doors and pintu pagars or plaster panels. It is essential that these features are properly restored in order to retain the authenticity of the design. (See Fig 16)

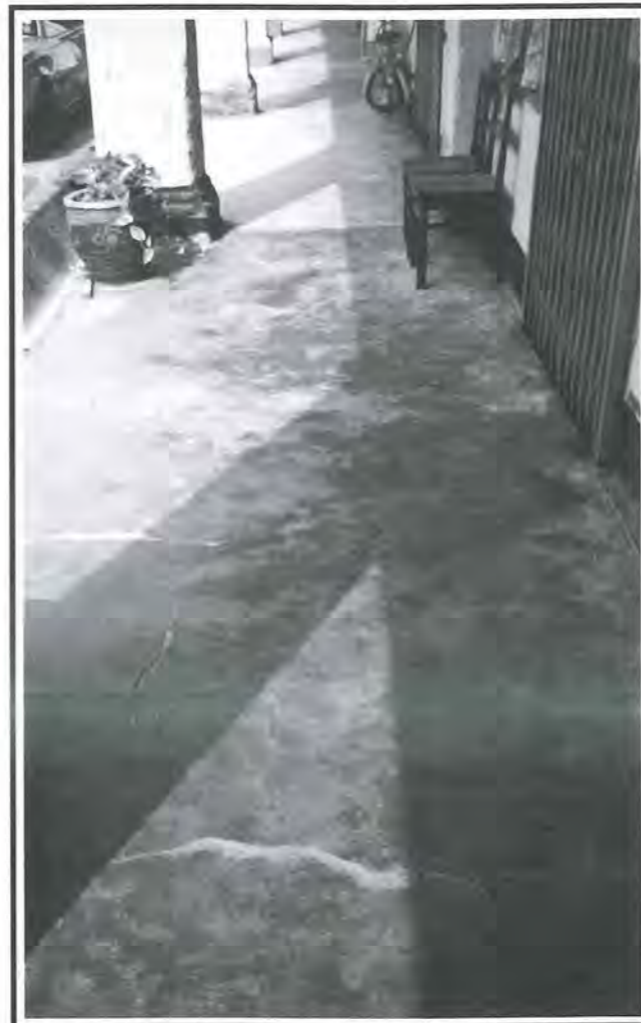
Fig 22: Cracks along the floor indicate settlement of the ground structure and possible damage to the floor slab. In such instances, repair and reconstruction works are usually necessary.

Cracks along the ground are normally due to ground settlement or movement and indicate a possible failure in the floor slab and waterproofing membrane. (See Fig 22) Some common causes of cracks are :

- a. inadequate drying-out of the floor slab causing an inequilibrium in the moisture content;
- b. lack of proper mixing of the aggregates resulting in the expansion and contraction of the floor slab.

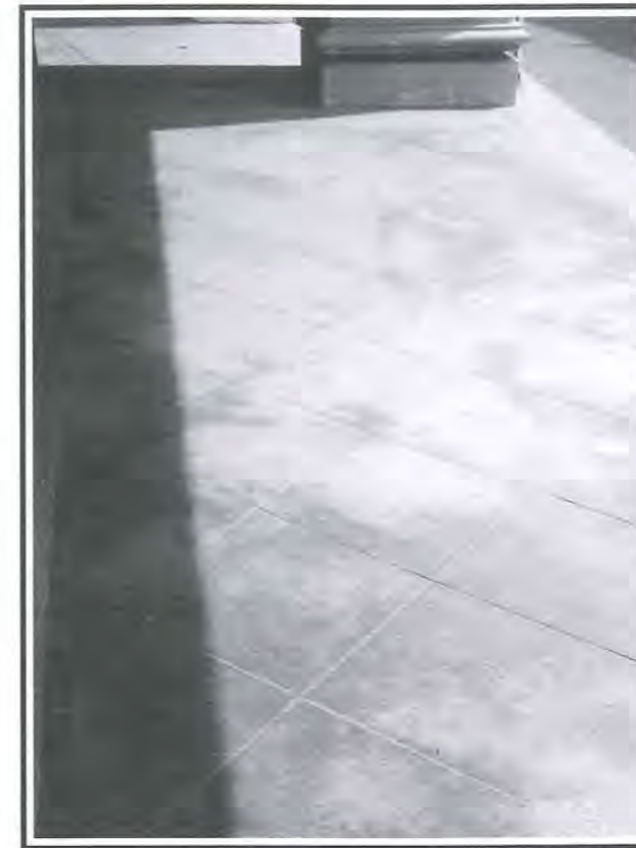
Fig 23: Deteriorated colour cement tiles due to water penetration from the ground.

Water penetration, a major cause of failure at the first storey, often occurs at the junctions of the wall and the floor where there is a break between the damp proof course (dpc) in the wall and damp proof membrane (dpm) in the floor, or where there is perforation of the dpc or dpm material. (See Fig 23)

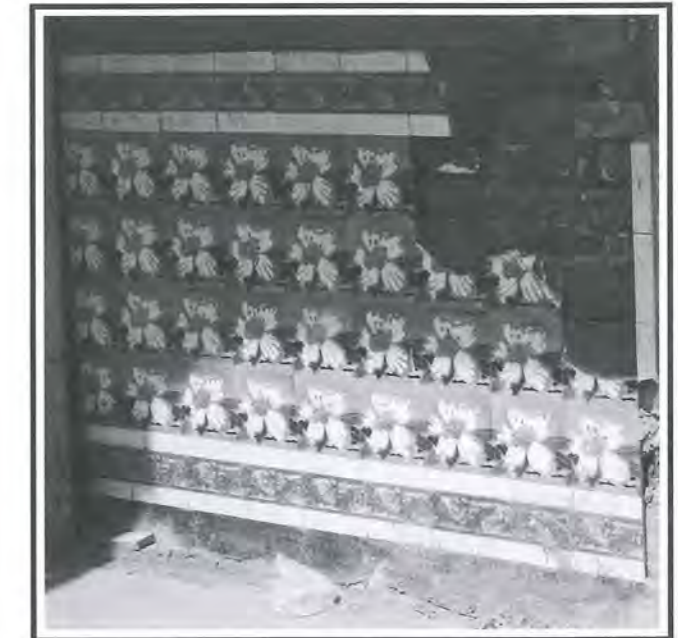
Fig 24: Damaged traditional polychromatic embossed tiles in need of repair.

If the wall and floor finishes are found suitable for retention, the wall and floor tiles should be properly cleaned and restored. If unsuitable for retention, these finishes should preferably be replaced with traditional finishes in order to retain the historic character of the conservation building. (See Fig 24)

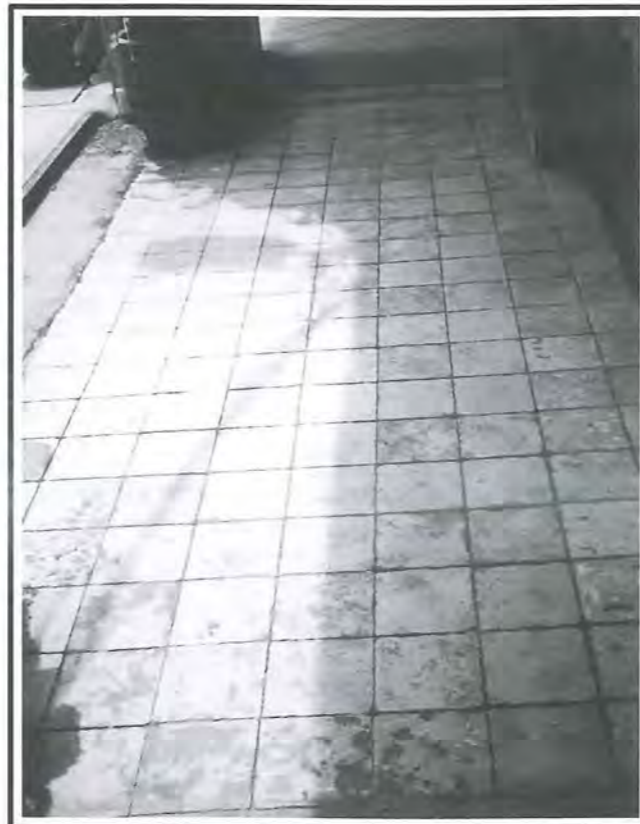
Fig 25: Minor repair works and cleaning are required for this cement floor finish.

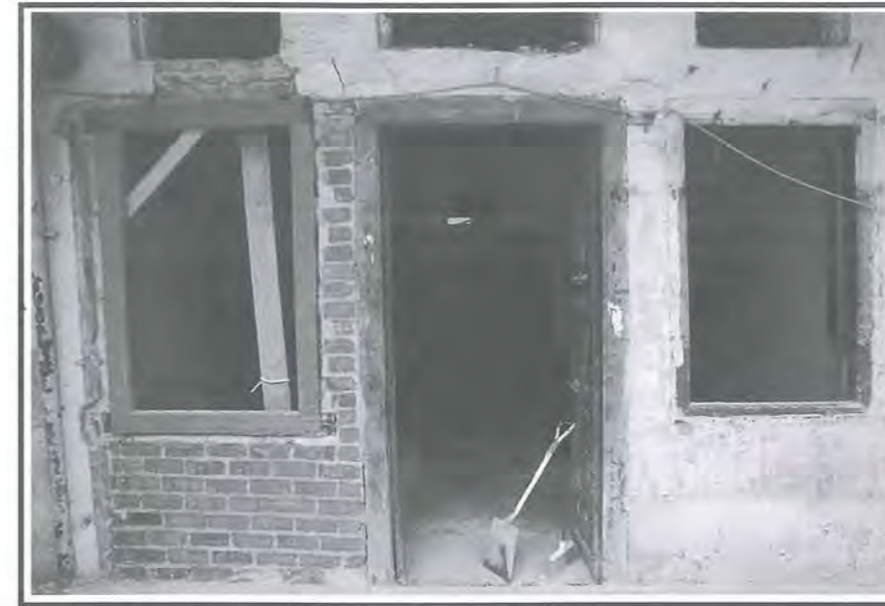
Fig 26: Part of a deteriorated residential front being replaced.

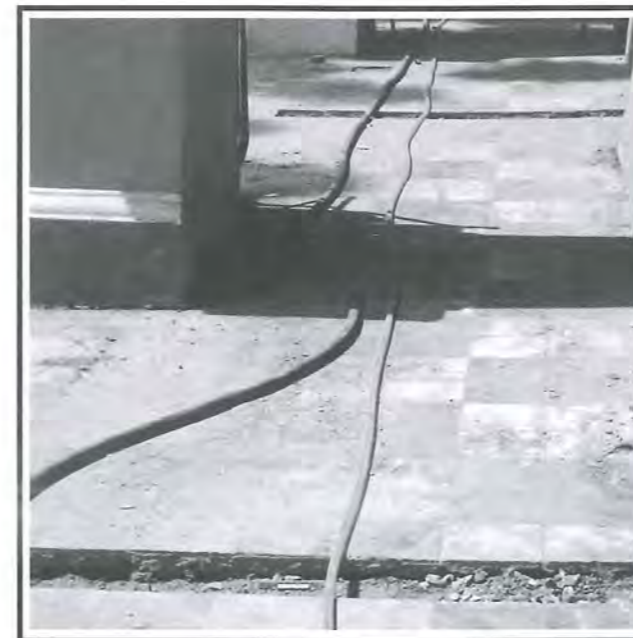
Fig 27: Works carried out to tap service mains in front of the building.

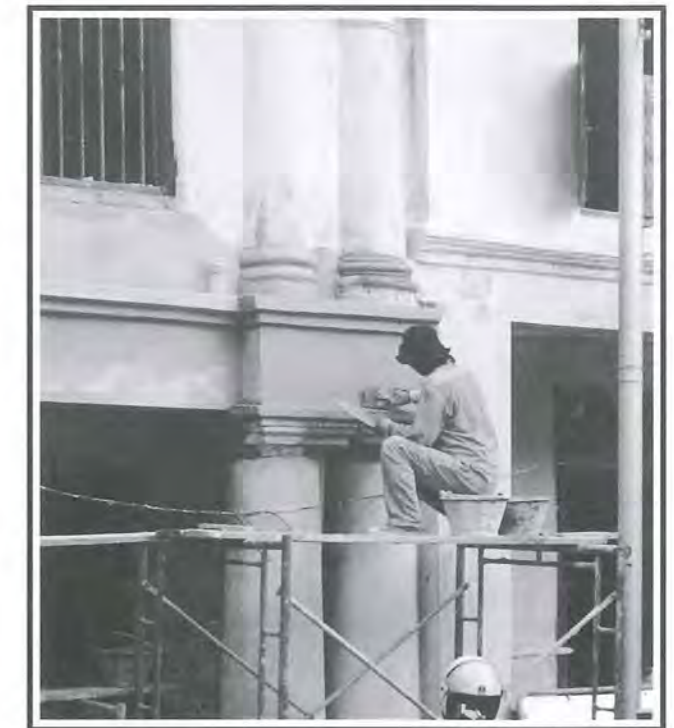
Fig 28: Spalled plaster on the capital of a column.

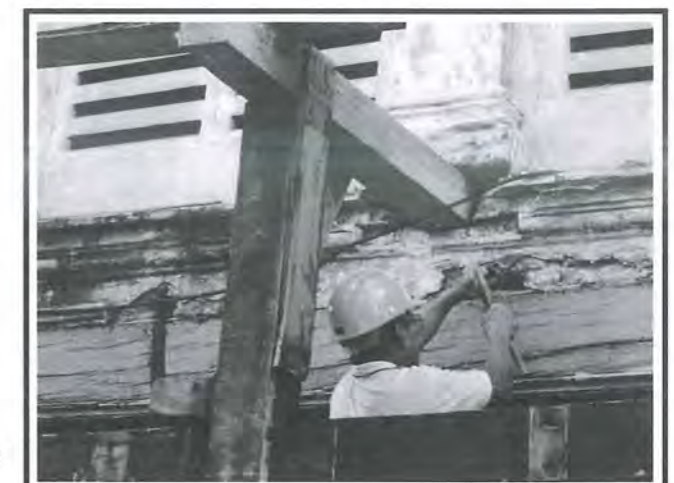
Fig 29: Restoration of column capital in progress.

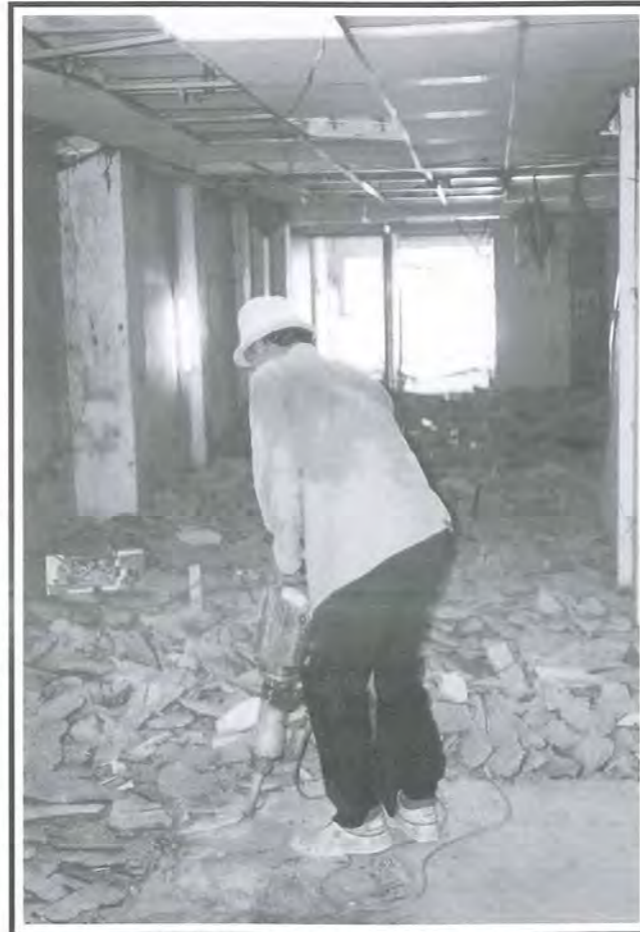
Fig 31: The existing floor slab is demolished in order to facilitate the laying of underground services.

In instances where the damp proof membrane needs to be re-laid or where additional services are required, e.g. water, electrical, sanitary, telecommunications, grease-traps etc, the ground slab would have to be reconstructed. (See Figs 31 to 33) Proper protection, such as temporary shoring or propping of the front facade walls and the upper floor structure, should always be carried out to ensure that the existing partywalls and other structural members are not adversely affected.

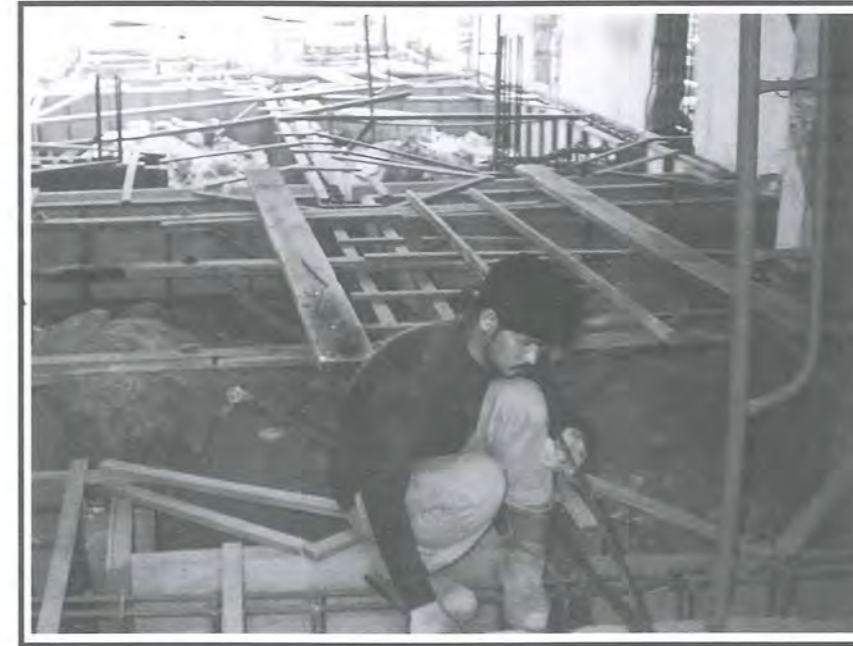
Fig 32: Reconstruction of the ground slab in progress.

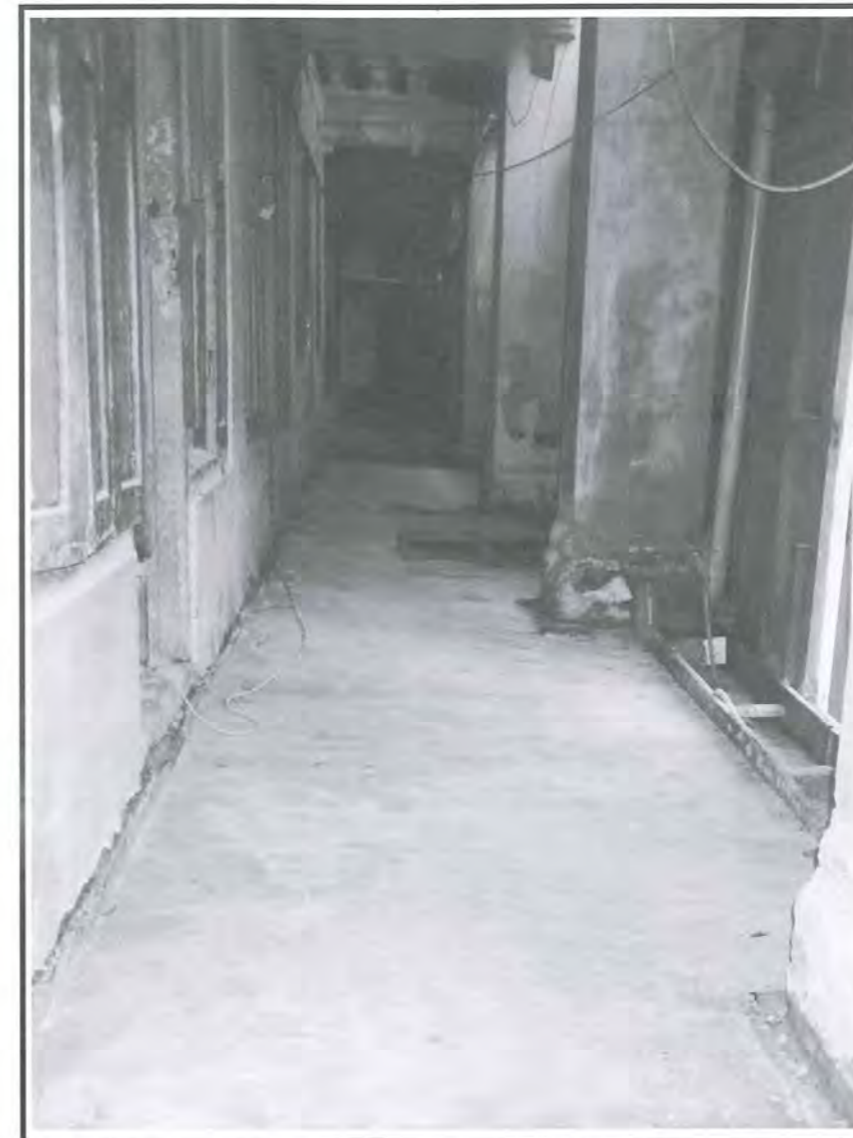
Fig 33: Ground slab of five-footway completed.

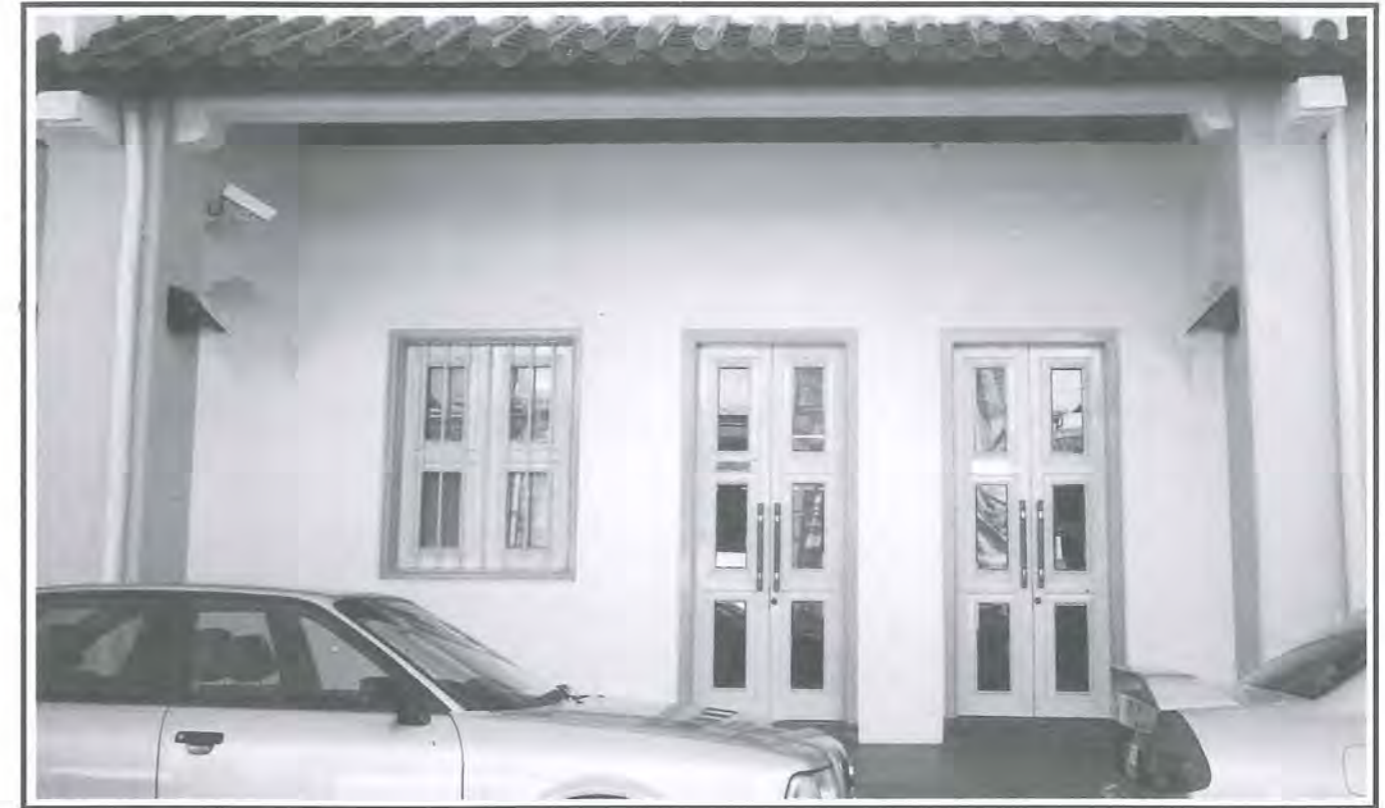
Fig 34: In facilitating a residential front for commercial adaptive reuse, timber-panel infills of the timber framed casement windows and doors are replaced with glass infills to allow for more visibility into the interior.

The shopfronts have traditionally always changed in relation to the type of trades. This flexibility for adaptive reuse continues today. In order to facilitate the conversion of shophouses with residential fronts to commercial uses, one of the casement windows can be changed to a door so that a separate staircase access to the upper storeys can be created. In addition, the timber-panel infills of the existing doors and windows can be changed to glass infills to allow more visibility into the interior of the shophouses. (See Fig 34)

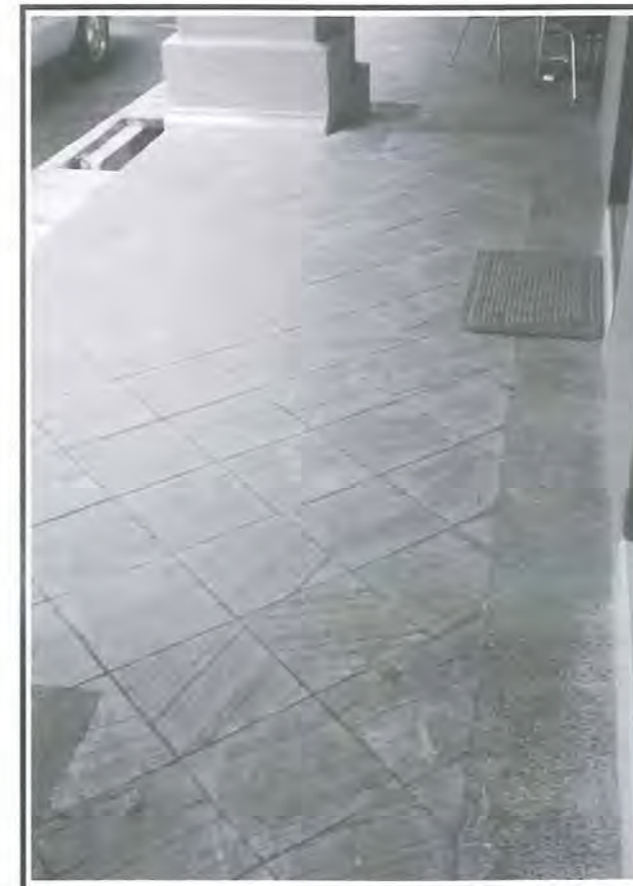
Fig 35: Although a non-traditional five-footway material, natural stone finishes are permitted.

For the five-footway, natural stone finishes such as slates are permitted (See Fig 35) but highly polished floor finishes should not be used as these surfaces are not sympathetic to the traditional character of the shophouses. They are also hazardous to the public when wet. (See Fig 36)

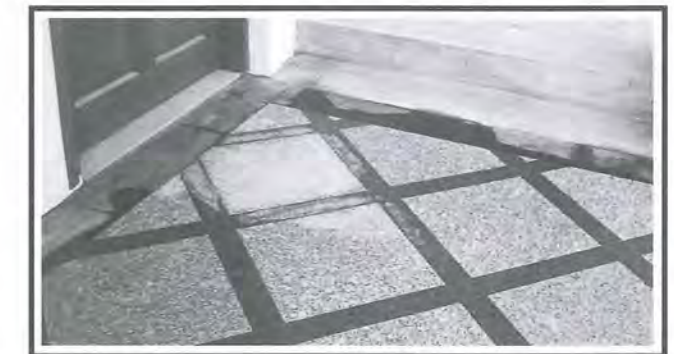
Fig 36: Polished five-footway finishes are potentially hazardous to pedestrians as they are slippery when wet.

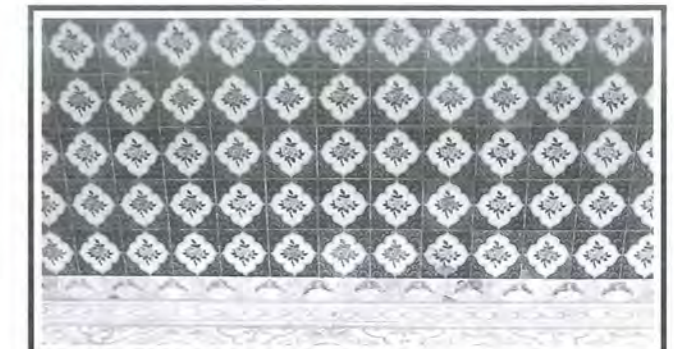
Fig 37: An example of well-restored polychromatic embossed tiles.

The polychromatic embossed ceramic tiles found below the timber casement windows on the residential fronts should be retained where possible or replaced with identical tiles. Where it is not possible to retain the damaged tiles or find similar replacements (See Fig 37), the walls should then be finished with plaster and painted.
