CONSERVATION GUIDELINES  
TECHNICAL SUPPLEMENT

UNDERSTANDING  
THE ROOFS

July 1997

SINGAPORE

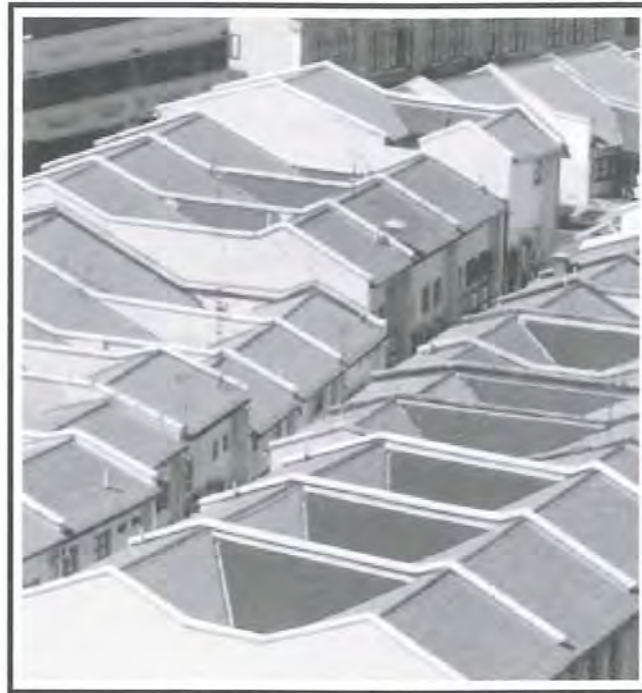
Fig 1: The double-pitched roofs with small size V-profile, unglazed terra-cotta clay tiles.

The main roofs of conservation buildings are usually double-pitched roofs. The other types of pitched roofs that are found in conservation areas are clerestorey roofs, jackroofs and ornamental green-glazed canopies. These types of roofs, though dissimilar in form and construction, have the same function, that is to provide a shelter over the shophouse and its elements. (See Fig 1 - 4)

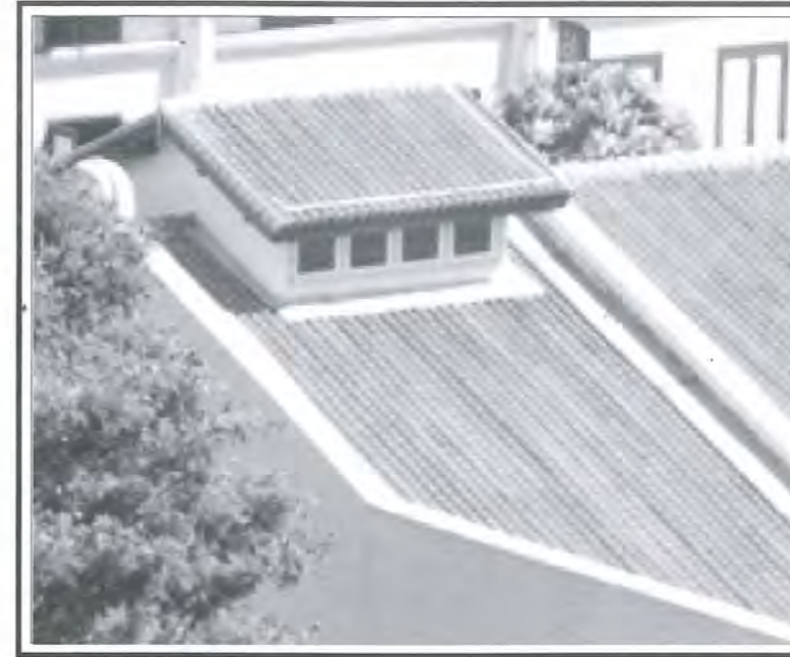
Fig 2: The double-pitched jackroof with roof tiles similar to that of the main roof.

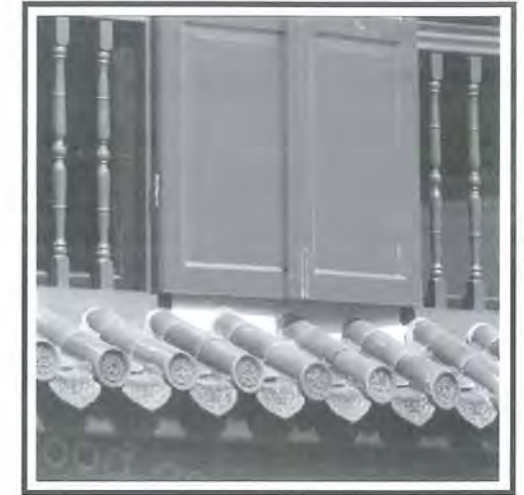
Fig 3: The ornamental green glazed canopy at the front facade is a traditional feature of the shophouse.

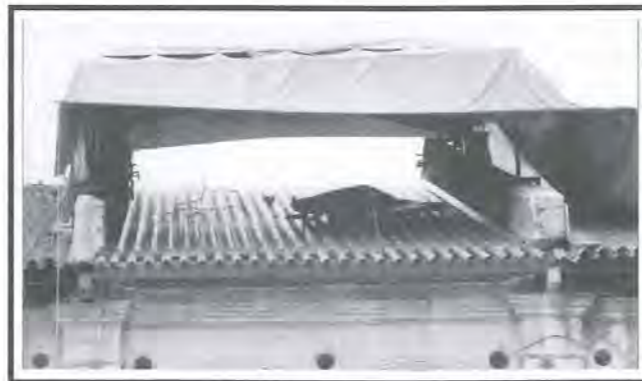
Fig 5: The temporary scaffolding, encased or covered with tarpaulin sheet, is erected over the entire roof upon removal of the existing roof cover.

Temporary protection may be necessary to prevent further damage or deterioration of the roof. A dry environment, well protected from the weather elements, is required for restoration works to proceed. There is a need to provide adequate weather protection to prevent rainwater penetration and decrease the rate of deterioration of the internal elements, walls and facade features. Upon the removal of the existing roof covering and gutters, a temporary scaffolding, encased or covered with tarpaulin sheet should be erected over the entire roof. Proper drainage through the use of temporary gutters would ensure that there is no flooding within the building envelope during restoration. Upon the completion of the roof, the temporary cover is then removed. (See Fig 5 and Fig 6)

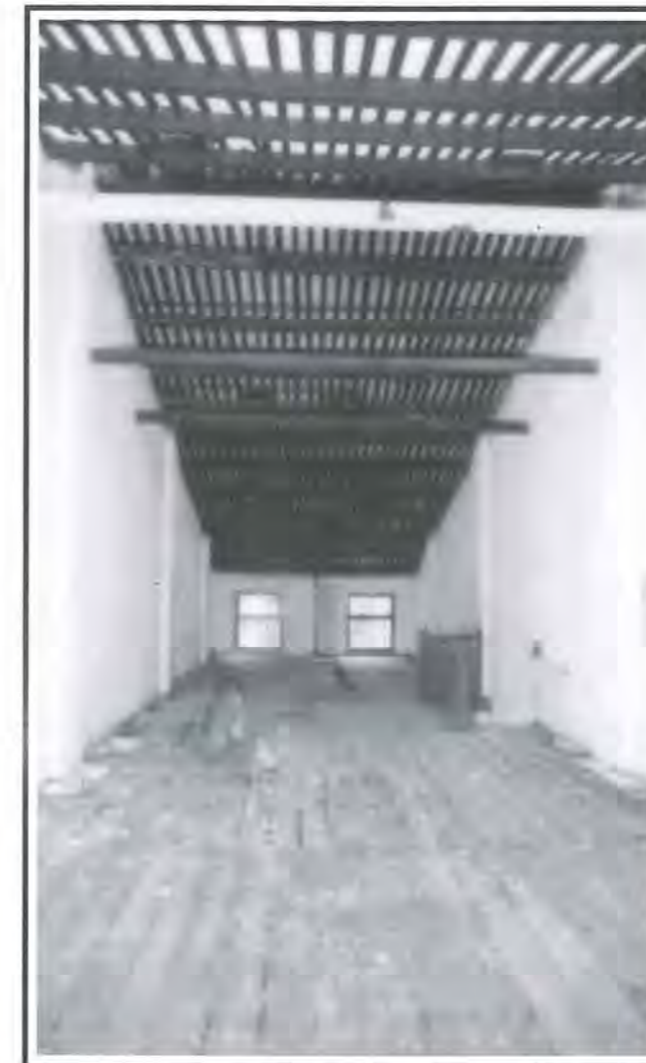
Fig 7: Lateral bracing of the structure, retention of the timber floor boards and joists, and replacement of timber roof purlins on a elemental basis will help to maintain the lateral stability of the partywalls during restoration.

Proper measures should be taken to ensure the structural stability of the entire building before the restoration process. Shoring and lateral bracing of the structure should be carried out, and the existing timber floor joists should not be removed at this stage in order to maintain the lateral stability of the partywalls. As the timber roof purlins serve as lateral restraints to the party wall, the decayed roof purlins should be replaced and repaired on an elemental basis, i.e., only one or two purlins should be removed and replaced at any one time, so as not to affect the lateral support of the partywalls.

(See Fig 7)

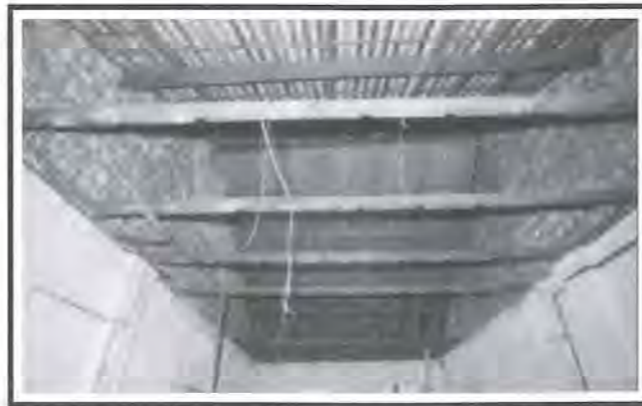
Fig 8: Visual inspection of existing roof support structure should be carried out to determine the extent of decay and structural damage.

Before restoration works begin on site, careful visual inspection of the existing roof timber support structure should be carried out to determine the extent of decay and structural damage due to various factors such as termite infestation, water penetration, and fungal attack. Areas of rot normally occur at the joints between the roof timber members and the walls. In addition, the type of timber has to be determined and a sample of the timber taken to assess its inherent strength. The use of physical probes on small sections of the less deteriorated timber supports would indicate the breakdown of the timber strength due to decay. (See Fig 8 - 9)

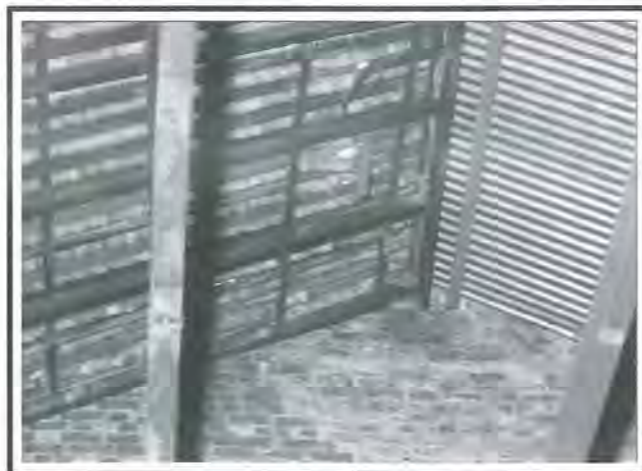
Fig 9: Decayed roof timber members, some of which require replacement while others require strengthening.

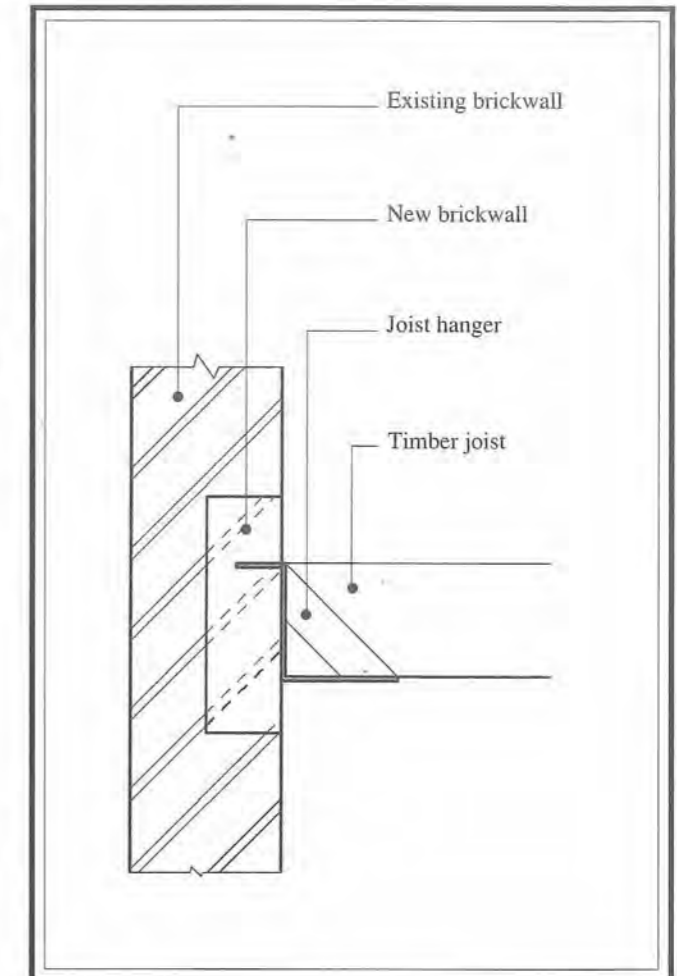
Fig 10: The use of repair joints at the areas of decay of the timber members. These areas of decay normally occur at the joints between the timber members and the walls.

The parts of the timber members partly destroyed by rot can be reformed in-situ without extensive reconstruction. This will ensure the reinstatement of the load-bearing capacity of the decayed beams. The use of repair joints at the decayed heads or feet of rafters, and galvanised steel angle plates screwed at the feet of rafters onto the wall plates for strengthening the connections are some ways of repairing and strengthening the old timber structure. (See Fig 10)

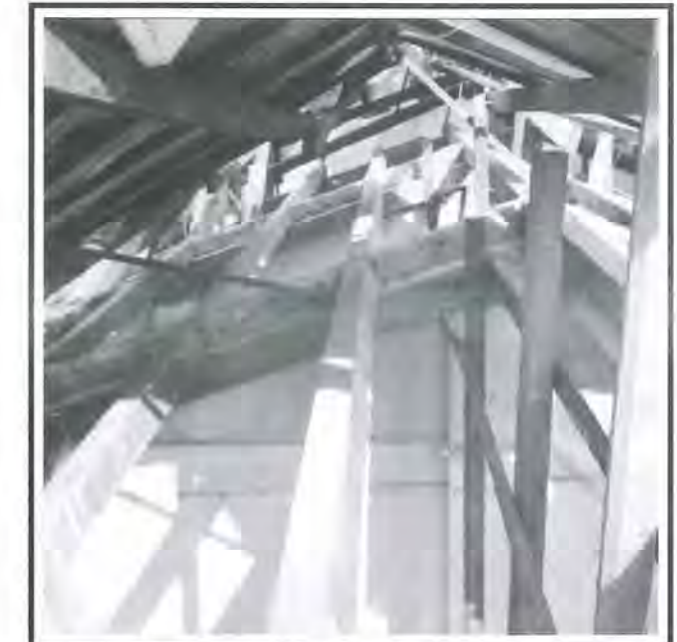
Fig 11: The replacement of the roof timber structure carried out under the temporary protective cover.

Retention of the existing timber may not always be possible as the condition of the element may indicate the need for replacement. The selection of appropriate replacements would depend on the durability, strength, availability and cost of the type of timber. The commonly used timber types would be kapur, chengal and balau. Replacement of the decayed members should be carried out on an elemental basis to ensure the structural stability of the roof during restoration. (See Fig 11)

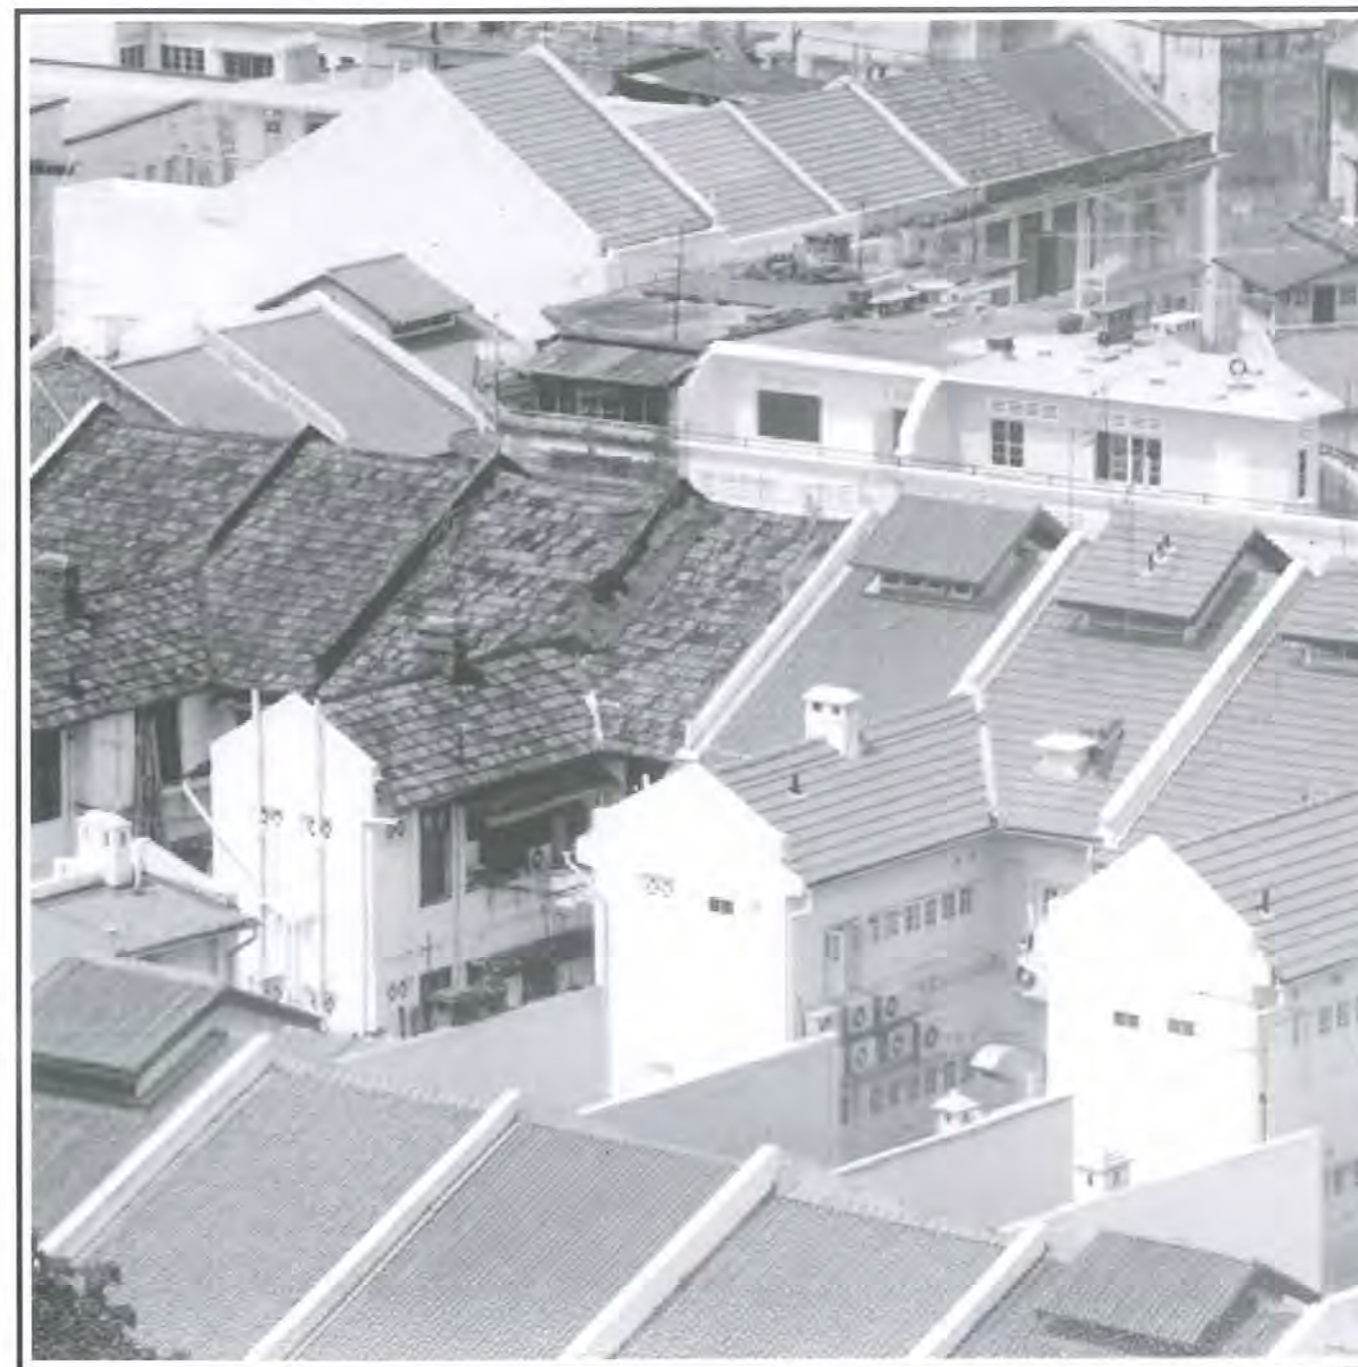
Fig 12: Old roof tiles and coverings are replaced with new small size V-profile or flat-interlocking unglazed terra-cotta clay tiles.

When retention of the existing tiles is not possible, replacement is usually required. It is important to ensure that the profile and dimension of the new tiles match those of the existing tiles. Damaged areas of the roof tiles should be replaced with similar profile tiles. (See Fig 12)

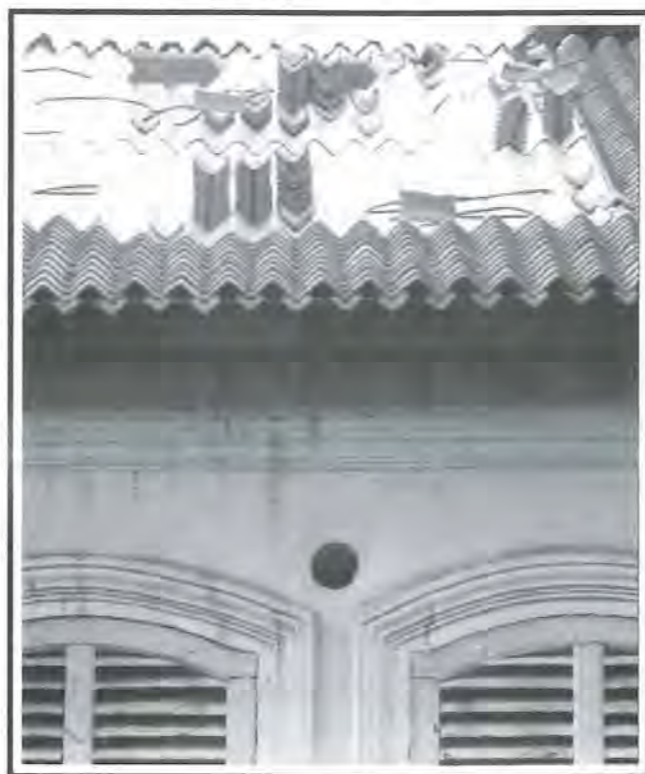
Fig 13: The laying of the tiles on the primary metal decking roof.

This new roofing system adopts a primary metal decking roof below, which helps to keep the roof leak-proof. The roof is also more structural as it is able to withstand additional loading. The metal deck follows the profile of the tiles, thereby creating a snug fit cradle for the tiles. The life of the galvaluminised steel decks can be increased through painting or by having proper metal coating of zinc or zincalume. (See Fig 13 - 15)

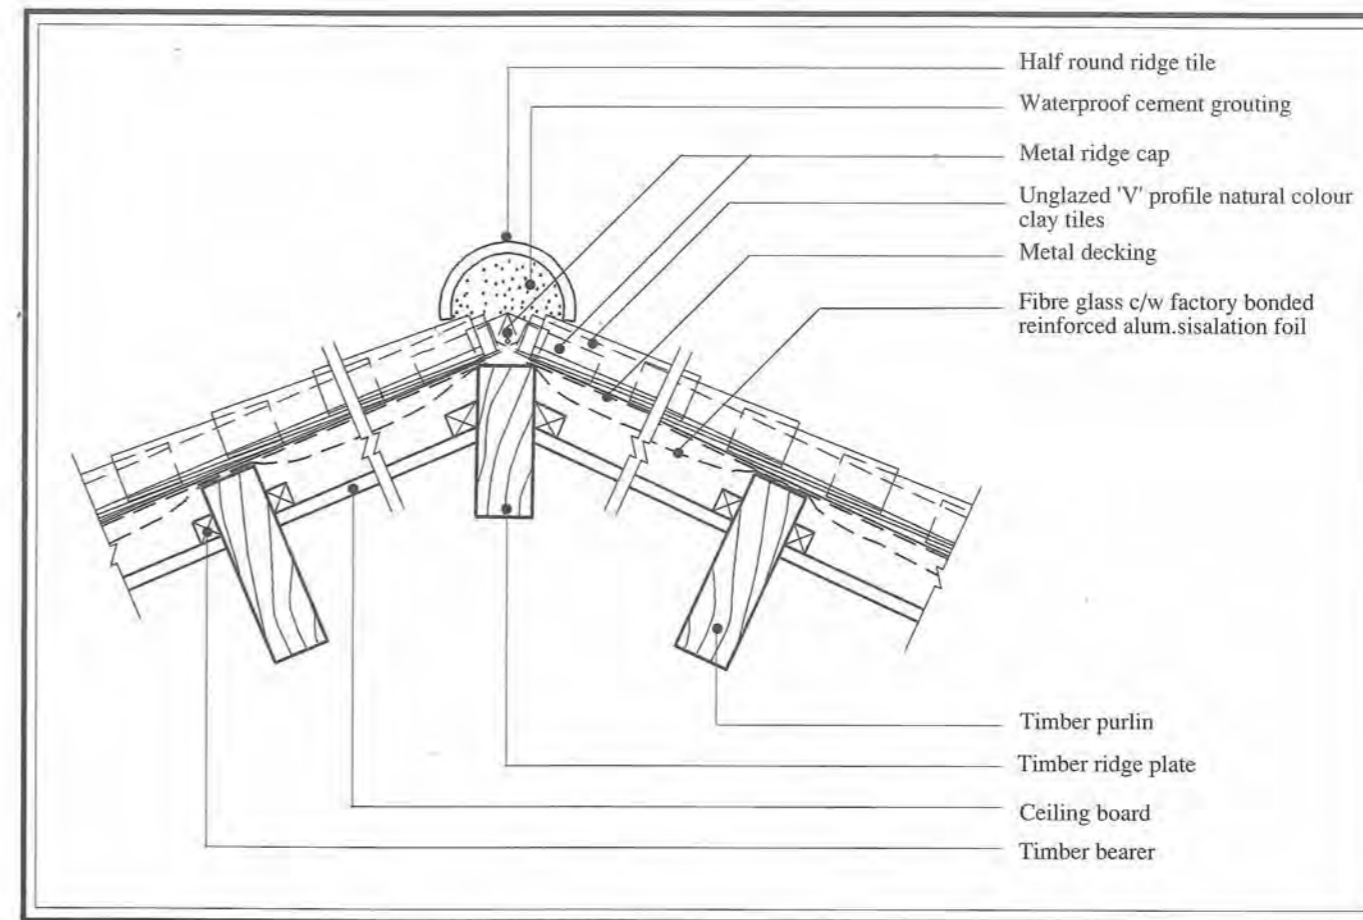
Fig 14: The use of the metal decking roof with insulation and ceiling board as a finish in a typical shophouse.

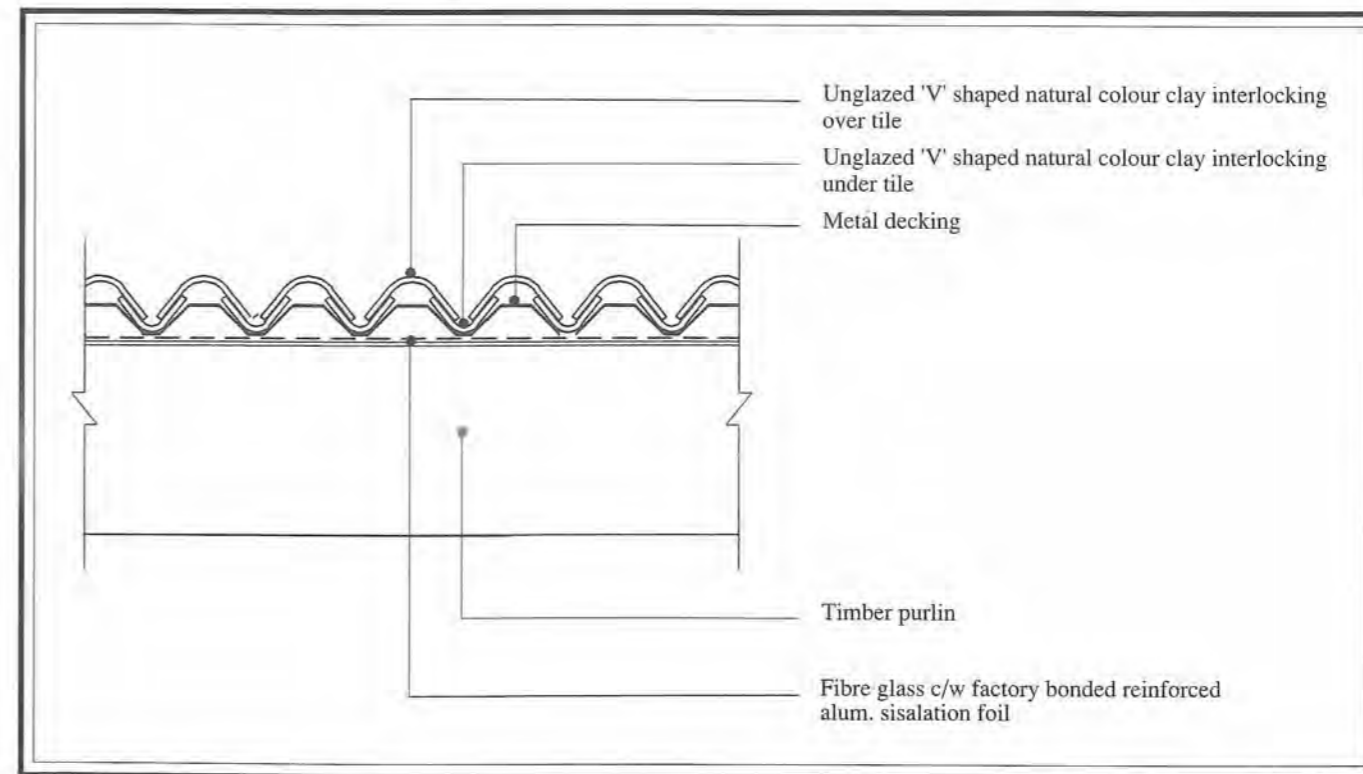
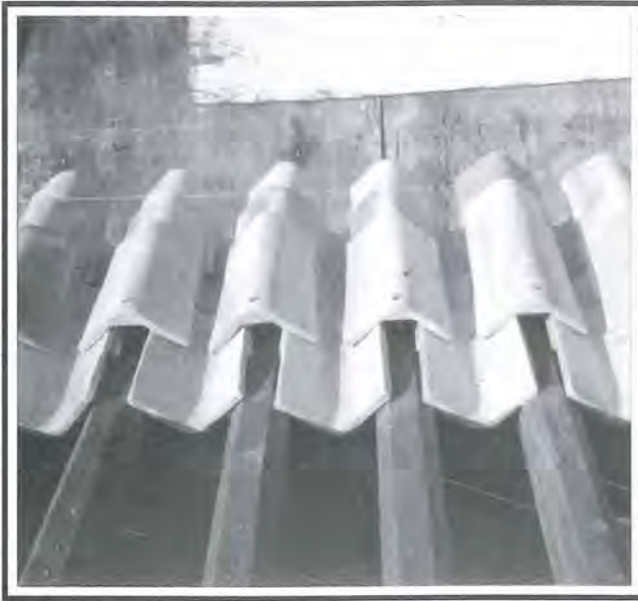
Fig 15: The metal deck provides a snug fit cradle for the tiles.

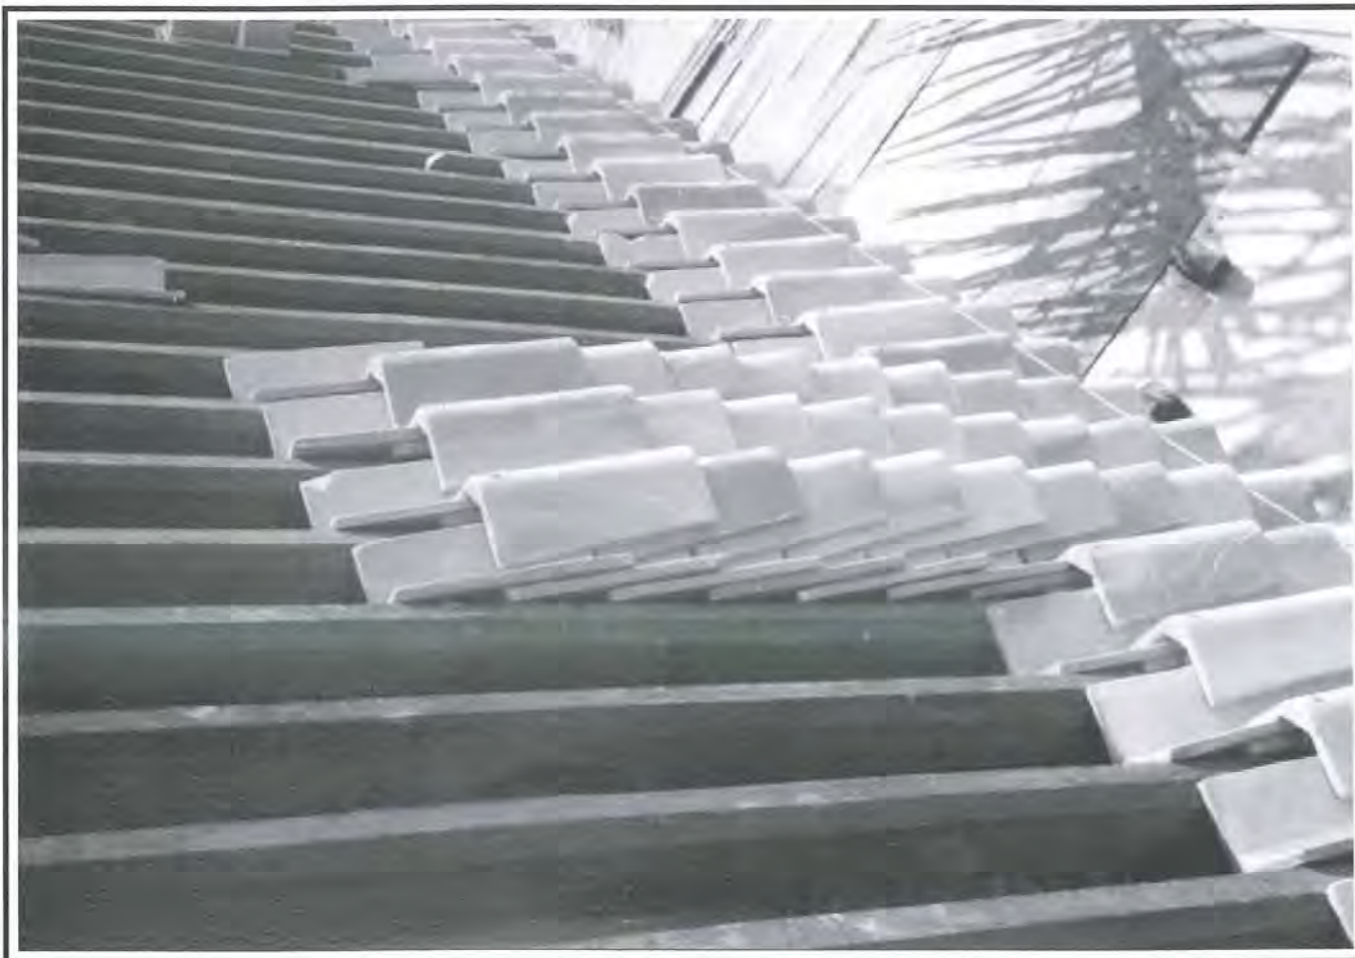
Fig 16: The use of galvanized nails properly sealed with silicon for fastening the tiles onto the trapezoidal battens.

The new construction method includes the use of trapezoidal battens, in place of the metal decking, which also provides a snug fit for the roof tiles. This method attempts to eliminate the increased cooling load of the building as a result of the use of metal decking, which results in heat retention. (See Fig 16 - 19)

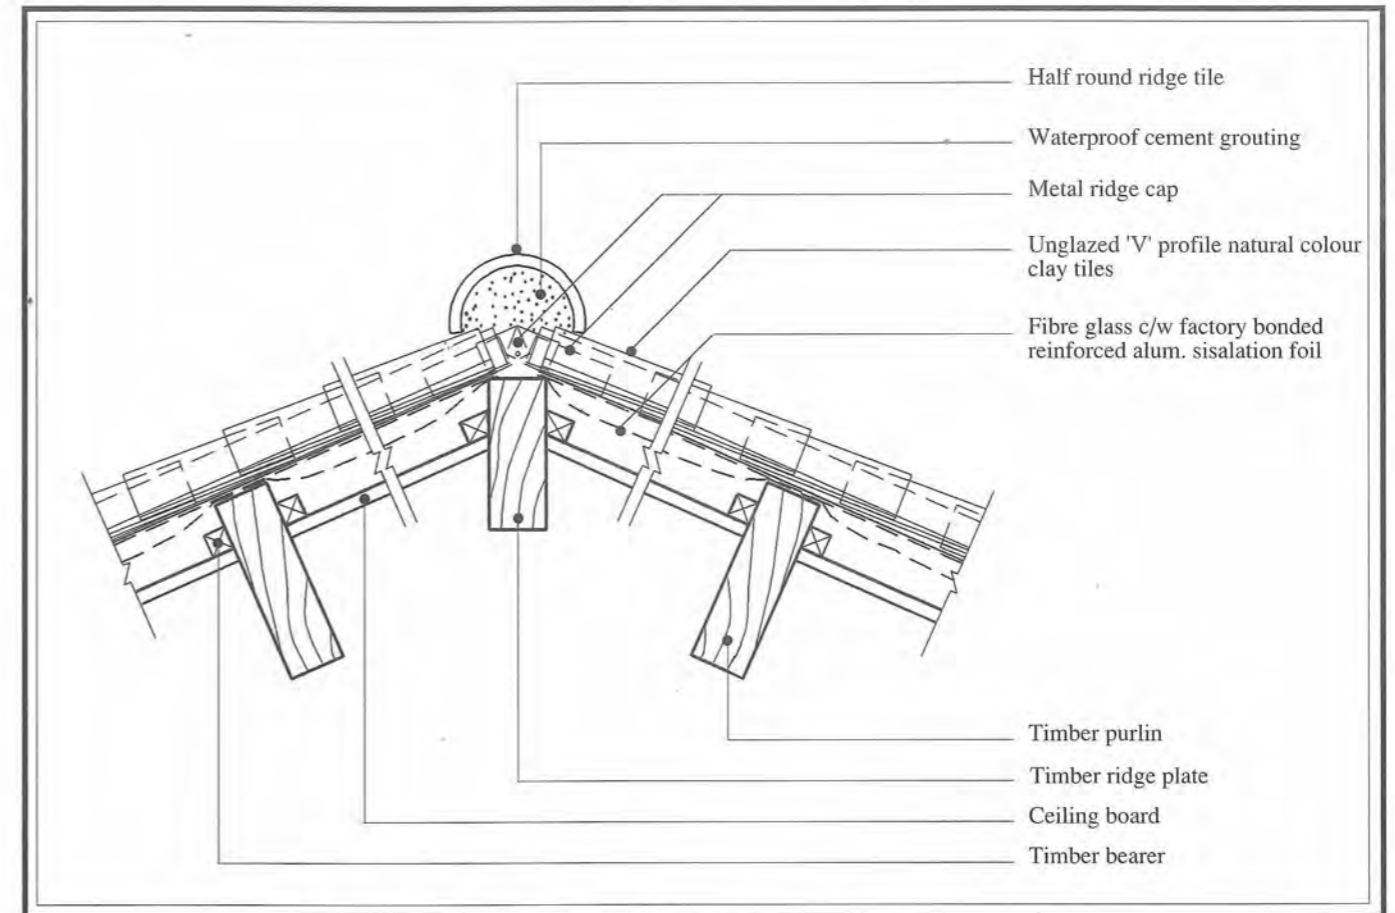
Fig 17: The use of trapezoidal battens and longer tiles for better overlap.

With improved technology, the traditional roof covering, without metal decking, has been re-adopted. This has also resulted in the improvements in the design of the new tiles. The tiles are now thicker so as to minimise breakage and longer to allow for larger overlaps, thus eliminating the problems of water penetration.

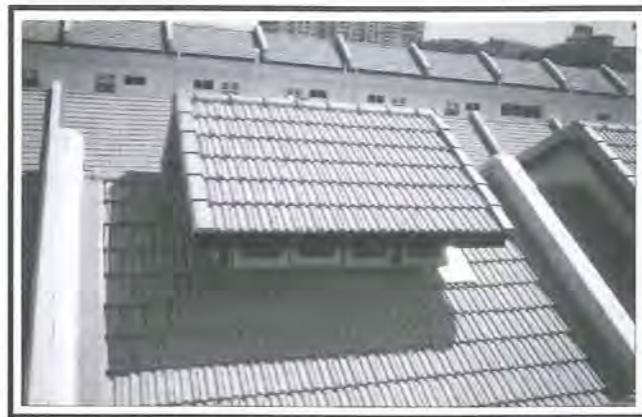
Fig 20: Extended partywalls above the roofs serve to prevent the spread of fire between shophouse units.

Fire safety measures include extending the firewalls (to a minimum requirement of 300 mm) on both sides of the shophouse to prevent the spread of fire to adjacent units. (See Fig 20 & 22)

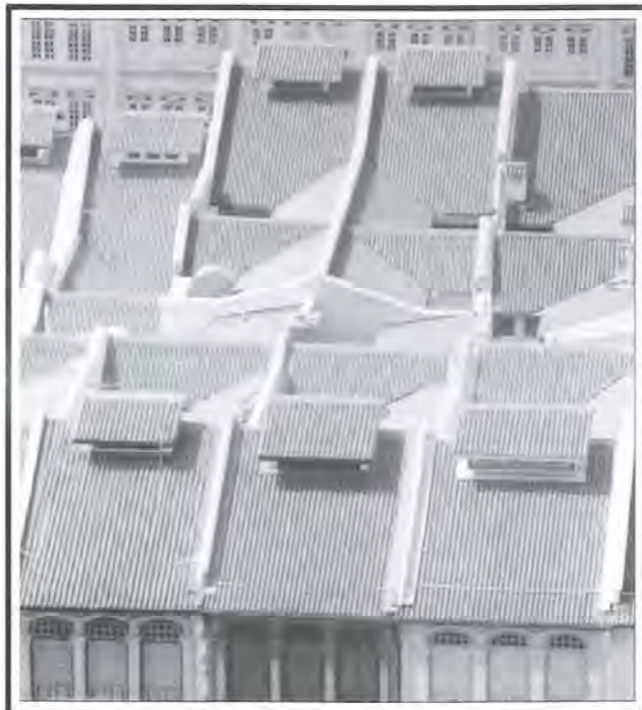
Fig 21: The firewalls also contribute to the scale and texture of the roofscape in conservation areas.

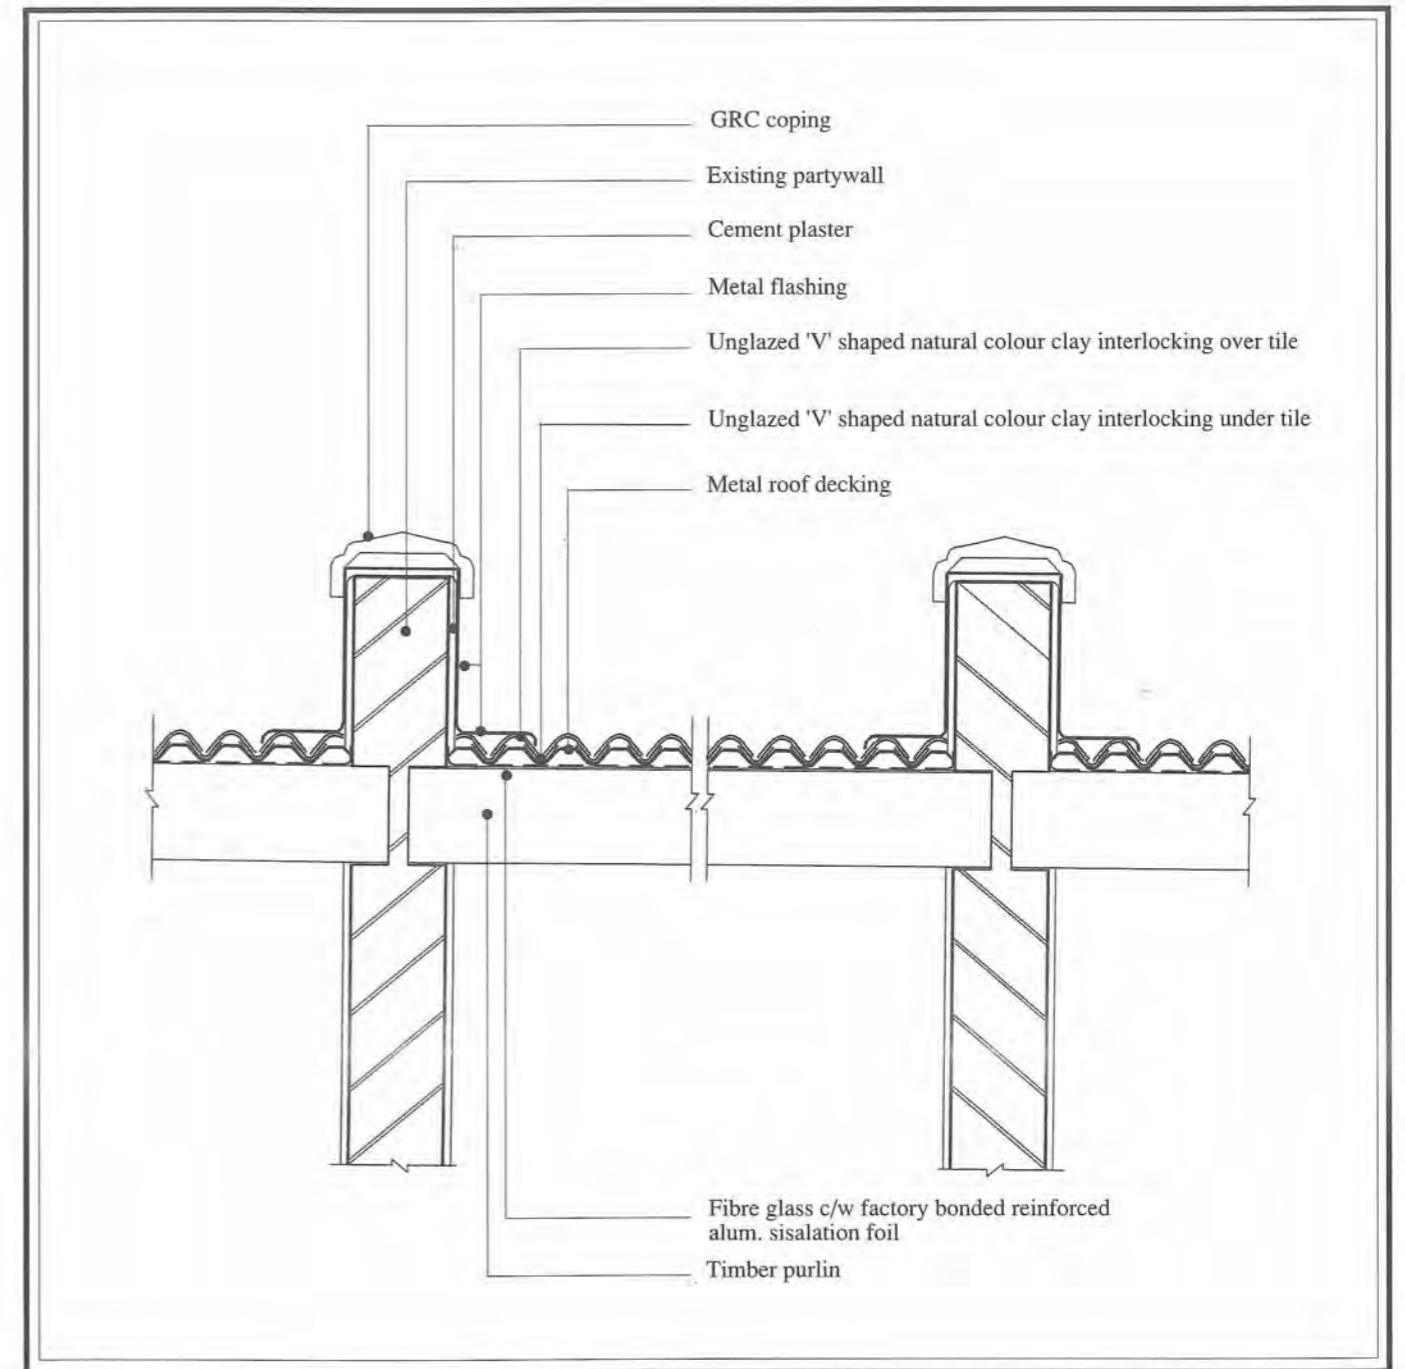
Fig 22: The extension of the partywalls on both sides of the roof acts as a fire-breaking device.

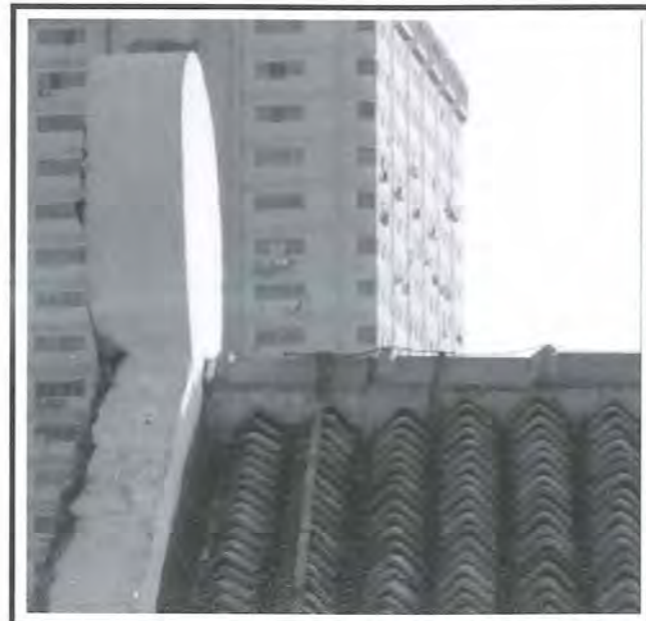
*Fig 23: The laying of the lightning conductor along the partywalls and on the ridge of the main roof.*

It is important to note that measures should be taken for workmen to step on proper supports during the installation of lightning conductors and antennae. This is necessary to avoid applying load at tile joints or the side of tiles as this will cause the tiles to break, thereby increasing the tendency for leakage problems to occur. Lightning conductors should be located along the partywalls and on the ridge of the main roof. During the installation, any puncture should be sealed for water tightness. (See Fig 23 - 24)

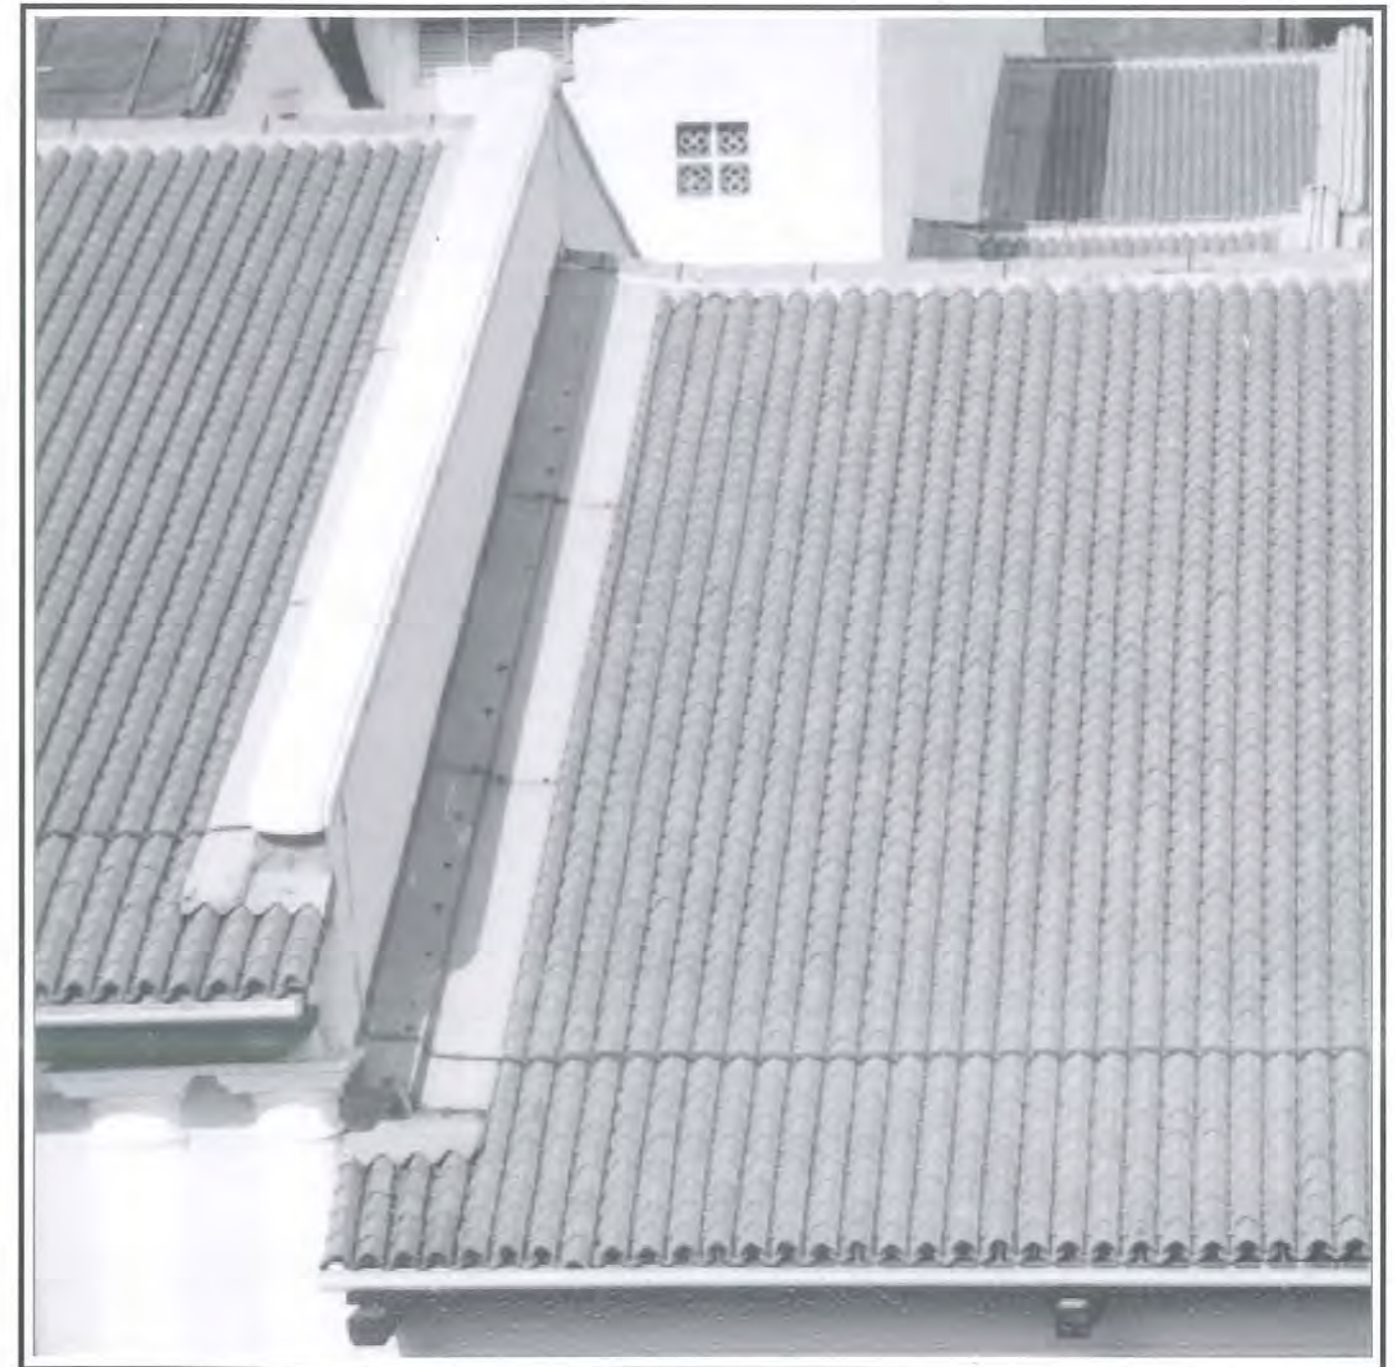
*Fig 24: The use of flashing at the connection between the roof and the partywalls serve to prevent water penetration of the roof. In cases where metal ridge cap is used for the main roof, the lightning conductors can be installed along the building line of the shophouse.*
