CONSERVATION GUIDELINES
TECHNICAL SUPPLEMENT

UNDERSTANDING
THE TIMBER FLOORS &
STAIRCASES

July 1997

SINGAPORE

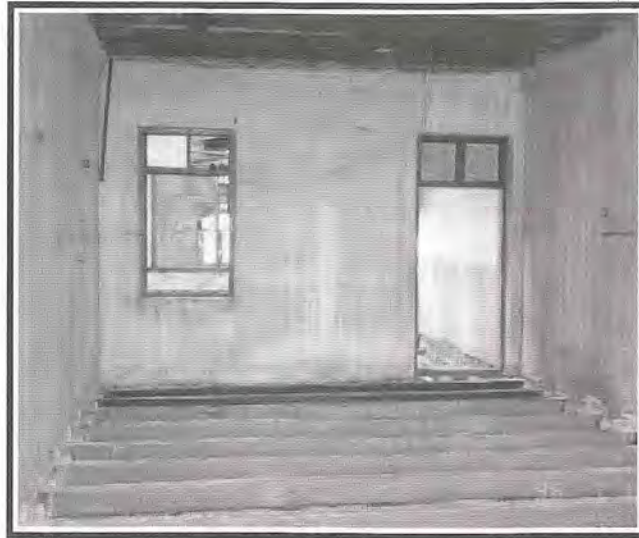
Fig 1: Timber floor joists spanning between the partywalls.

The upper floors of conservation buildings are usually constructed in timber. The structure consists of the timber joists which span between the party walls. (See Fig 1) The timber floor boards are then laid horizontally on the joists and are usually joined by the tongue and groove method. Being one of the key architectural elements which contributes to the internal spatial quality and original character of the shophouse, it is important that the timber floor should be retained.

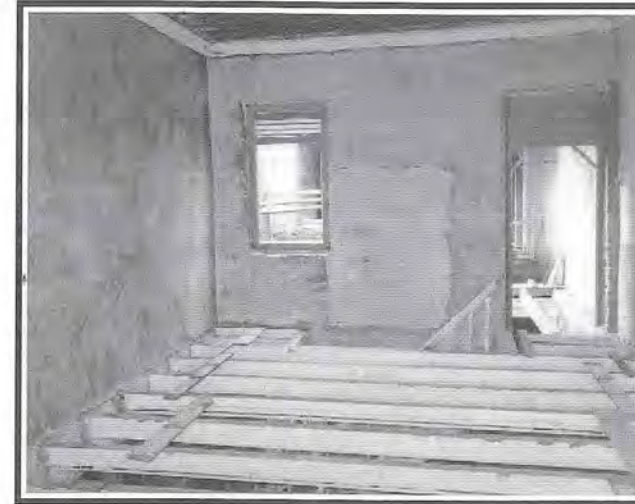
Fig 2: Location of existing staircase is tied in with the existing timber floor structure.

Ideally, the original internal layout of the conservation building should not be altered i.e. the staircase should be retained and restored in its original position. This is because any relocation of the staircase would mean a change in the structural layout and is tantamount to a reconstruction as the timber floor joists and floor boards would be affected. The original spatial quality of the building will also be altered. (See Fig 2 - 4)

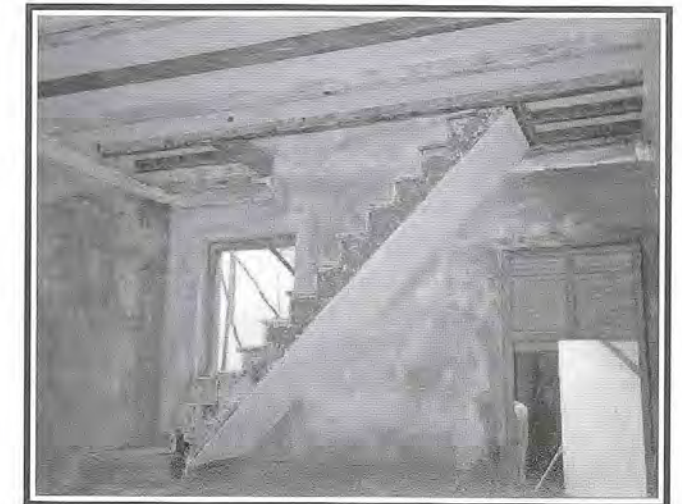
Fig 3: Timber floor and staircase in the process of being restored.

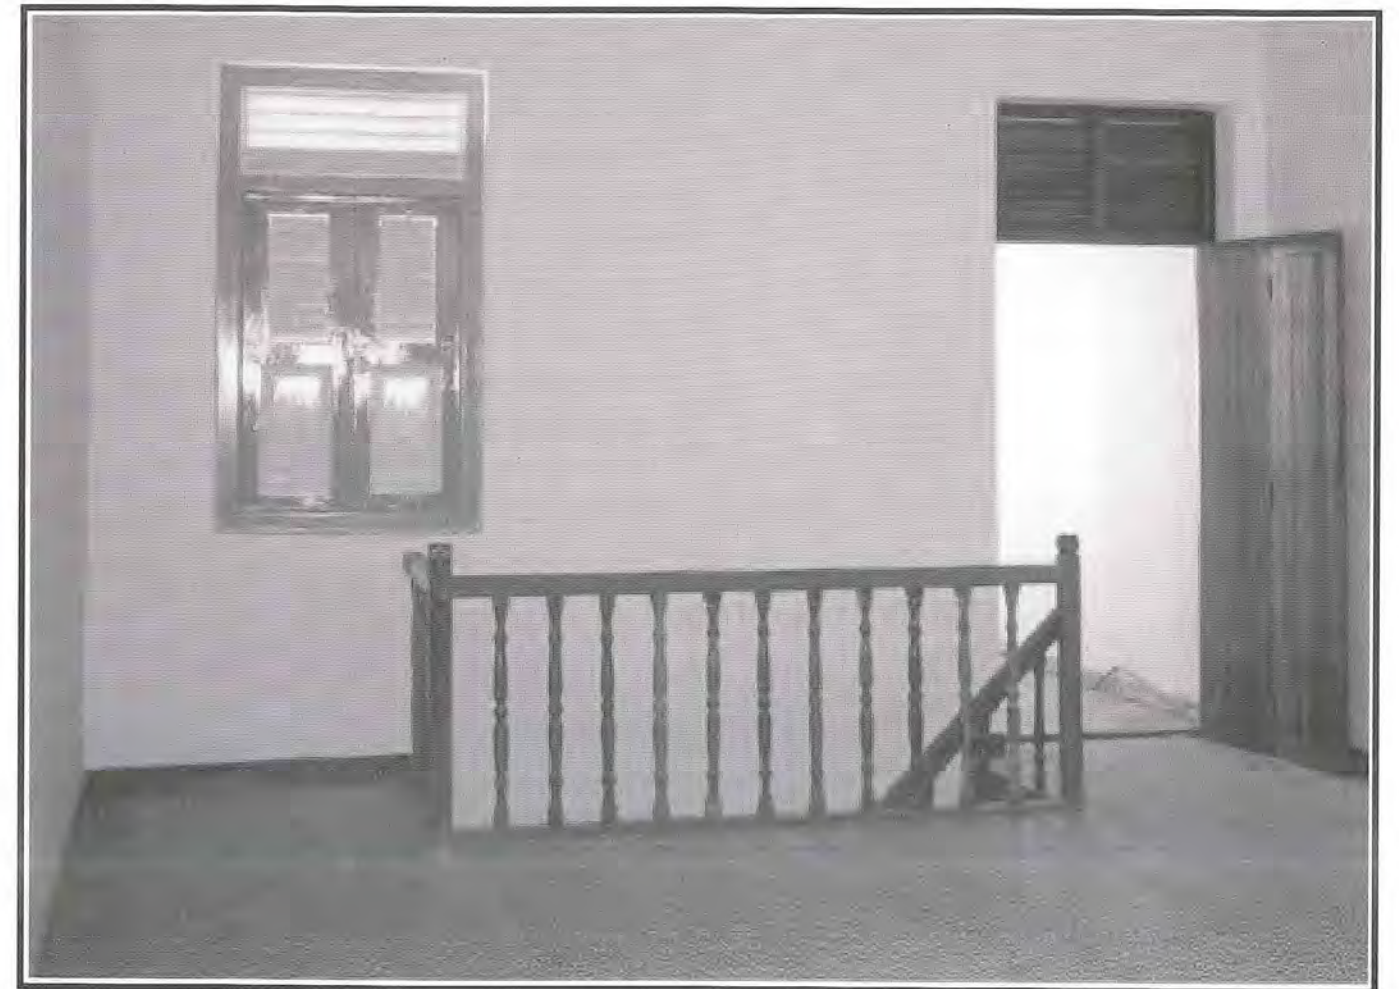
Fig 4: Existing location of staircase retained after restoration. Original spatial quality of shophouse is retained.

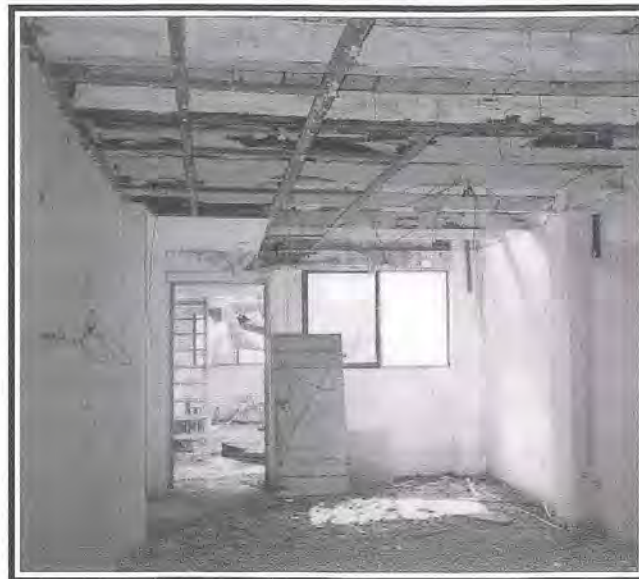
Fig 5: Visual inspection of the timber floor joists and boards should be carried out to determine the extent of decay and structural damage.

Before restoring the timber floor, a visual inspection should be carried out to detect decayed and termite infested joists and floor boards. The existing floor boards are usually removed so that the timber joists can be inspected. Such an inspection would determine the extent of retention, repair and replacement that is required. (See Fig 5 - 7)

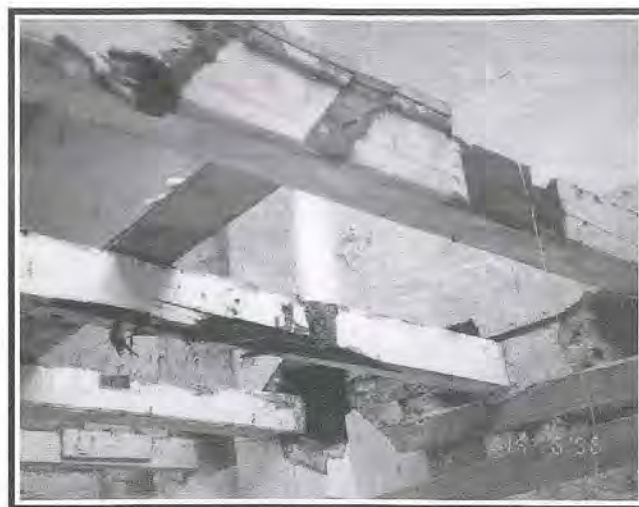
Fig 6: Badly deteriorated timber floor joists due to termite infestation, water penetration and fungal attack.

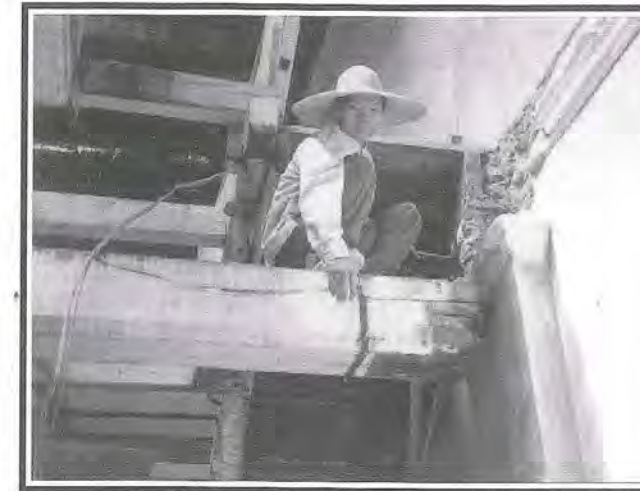
Fig 7: Areas of rot usually occur at the ends of the timber floor structural members.

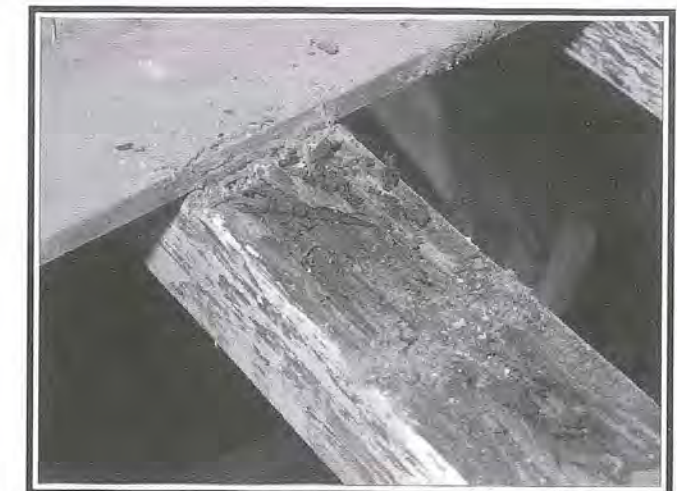
Fig 8: Timber splinters lifted up in short irregular pieces as a result of breakdown of the fibre strength due to timber decay.

Severe deterioration is usually apparent on visual inspection and by knocking. Other less severely deteriorated timber areas may be detected by jabbing a small screw driver into a wetted timber surface at an angle and prying up a small section of the timber. Sound wood will separate in long fibrous splinters, but decayed timber will lift up in short irregular pieces as a result of the breakdown of the fibre strength. (See Fig 8) Another method is to push the screw driver into the timber, perpendicular to the surface. If the core is badly decayed, pressure on the probe will force it through the apparently sound skin.

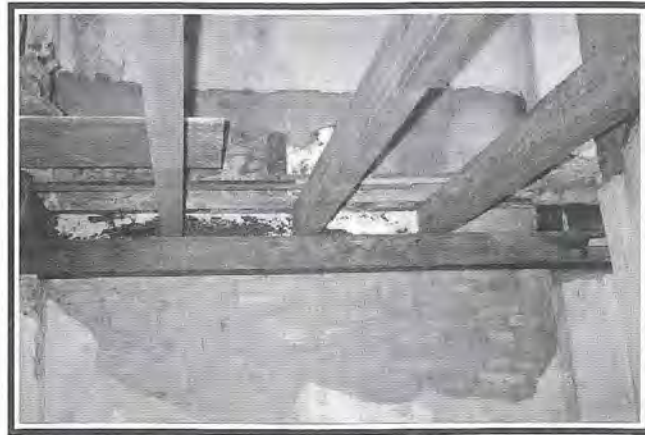
Fig 9: Repairs at the connections between timber joists and the partywall.

Any repair should be carried out using traditional jointing methods, such as scarfing, halving, mortice and tenon. Where this is not possible, modern jointing methods may be considered. Minor repairs can be done by epoxy-injection at the connection area between the timber joists and the partywall or by splicing. (See Fig 9, next page)

In the case of the epoxy resin, small holes are drilled at close intervals and the resin mixture is injected until the timber can absorb no more. The section is thus transformed into a resin composite.

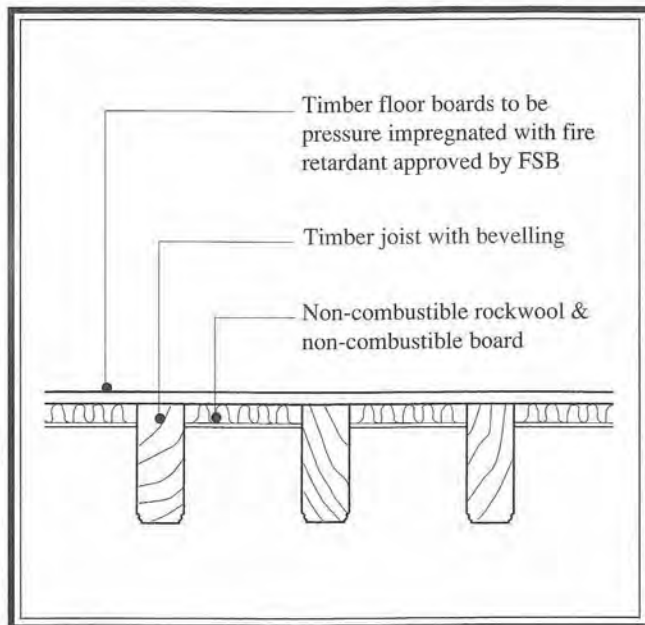
Fig 10: Use of bevelled timber floor joists as a form of architectural expression within the shophouse.

A bevelled edge can be introduced to the original floor joists by using a specific mould cutter on the underside of the joists, provided the structural strength of the timber members is not compromised. Alternatively, bevelled sections of timber could be added to the original floor joists to achieve the same ornamental effect. (See Fig 10)

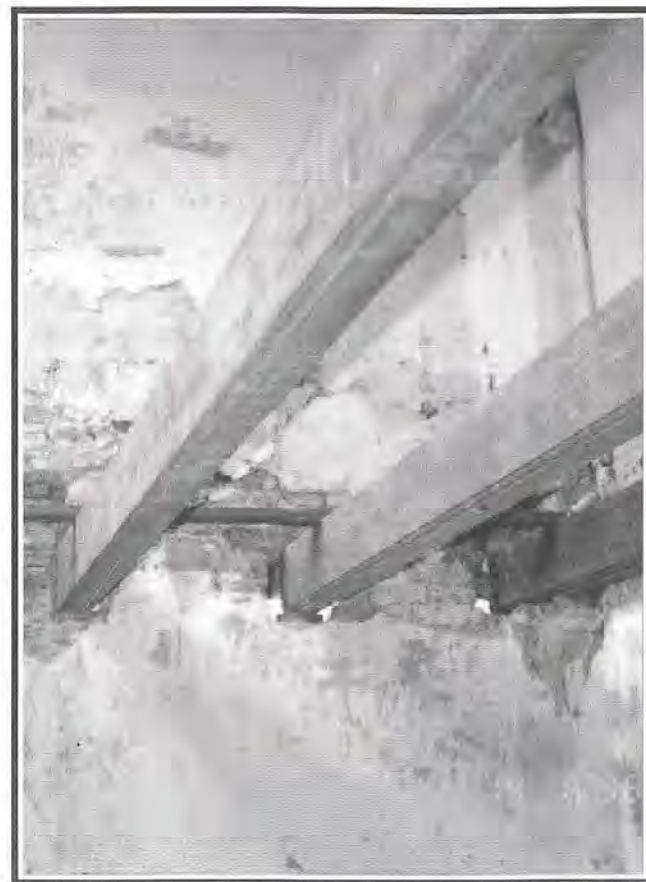
Fig 11: Insertion of additional timber floor joists between the existing joists to reduce the loading on the original members.

- a To increase the depth of the timber joists by adding timber sections to the bottom of the joists.
- b To insert additional joists between the existing joists to reduce the loading on the original members. (See Fig 11)

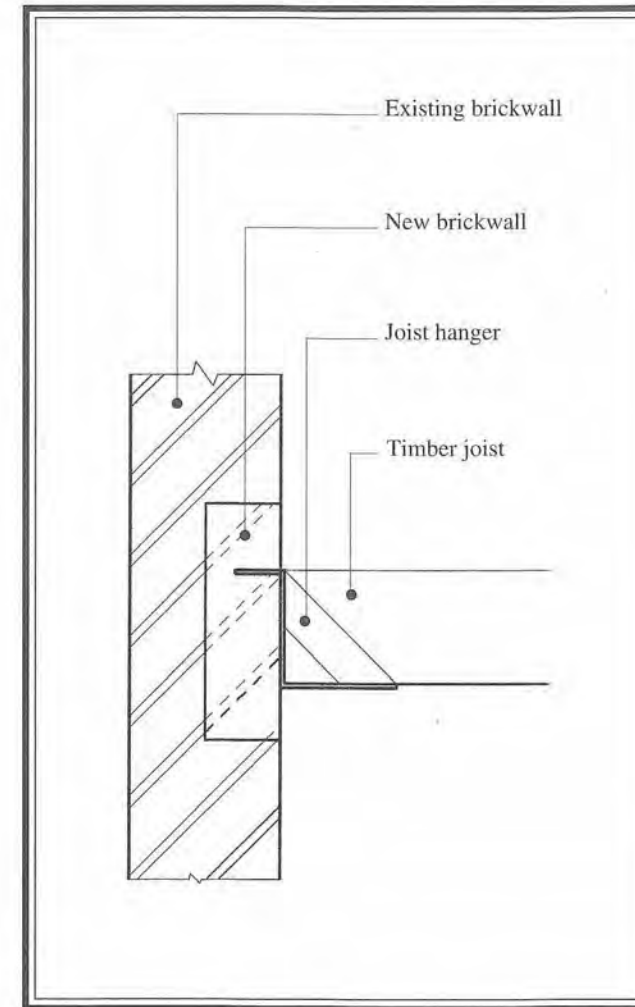
Fig 12: Use of repair joints at the areas of decay of the timber members.

Alternatively, the ends of weakened timber beams can be replaced with reinforced epoxy mortar. Where necessary steel reinforcement could be incorporated to achieve the necessary load bearing requirement. (See Fig 12 - 13)

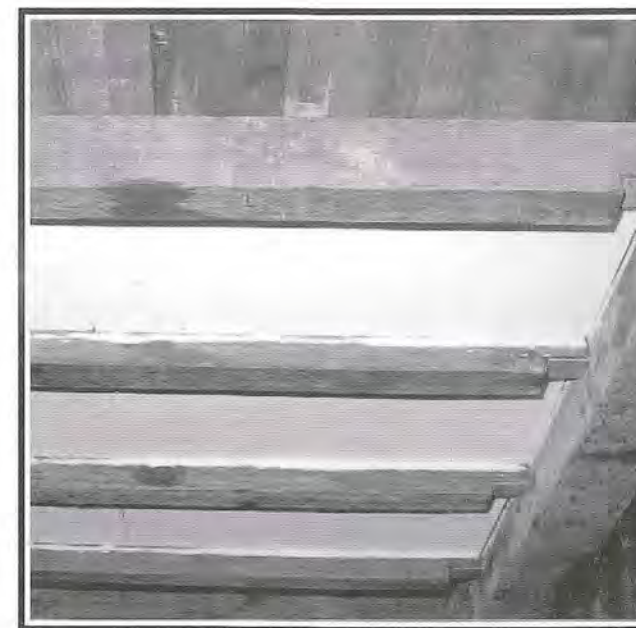
Fig 13: Use of galvanised steel brackets at the repair joints.

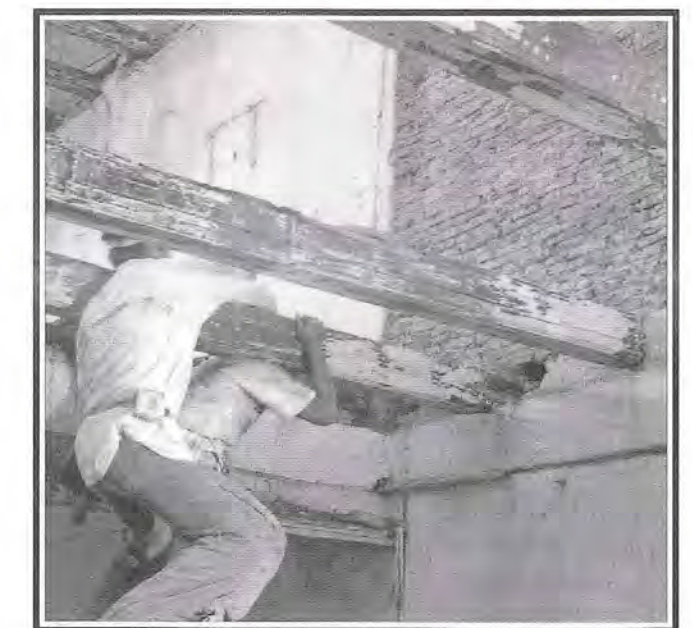
Fig 14: The replacement of the decayed timber floor joists.

Any repair or replacement of the timber joists should be carried out on an elemental basis i.e. replacing only one or two members at a time so as not to affect the lateral structural support stability of the building. Alternate beams are dislodged from the party walls and replaced immediately.

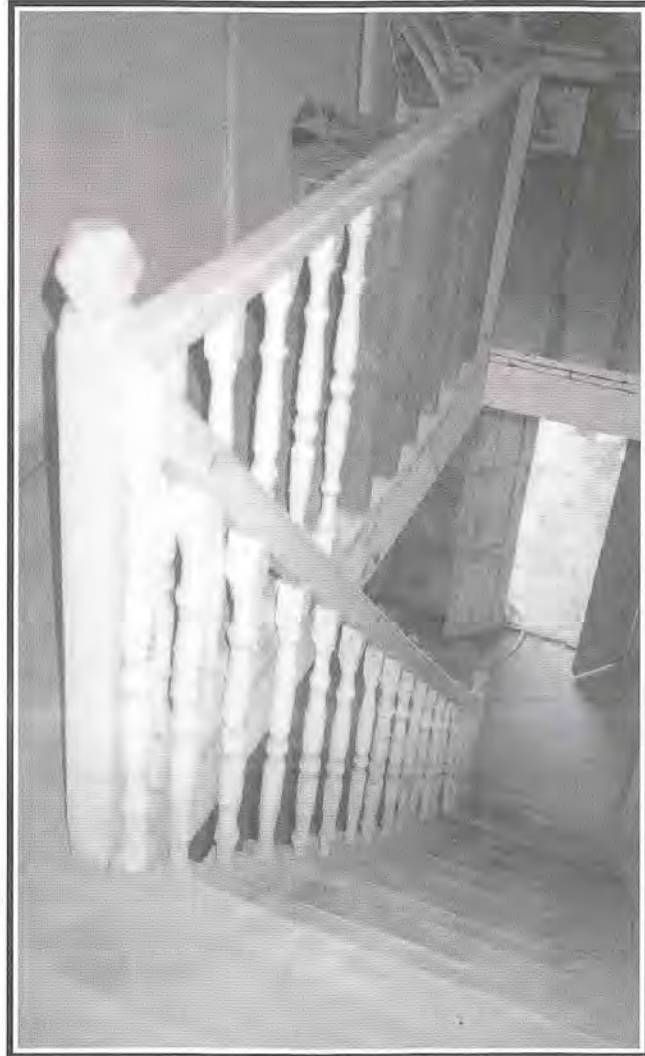
Fig 16: Mismatched balustrades before restoration.

Usually, the timber staircase elements are in acceptable condition and thus only minimal repair work needs to be done. Any minor replacement of the parts should match the original. For some staircases, the existing timber balustrades may have been replaced with mismatched designs. It is important to establish the original design of the timber balustrades to ensure that exact replicas of the ornately carved newels and handrails can be produced. In this way, the authenticity of the original material and

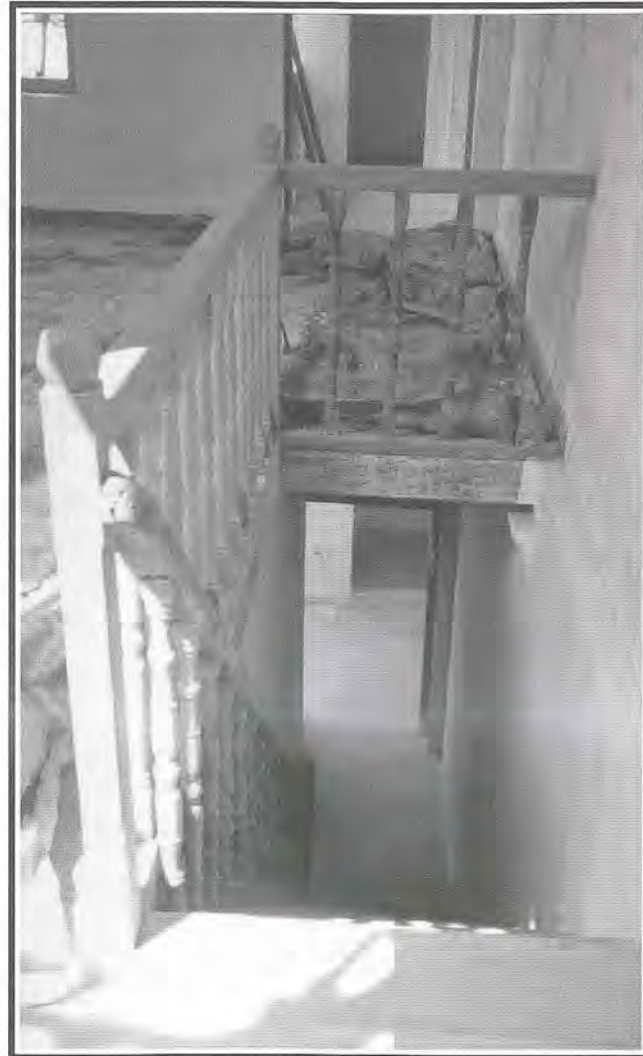
Fig 17: Restored staircase, using matching balustrades.

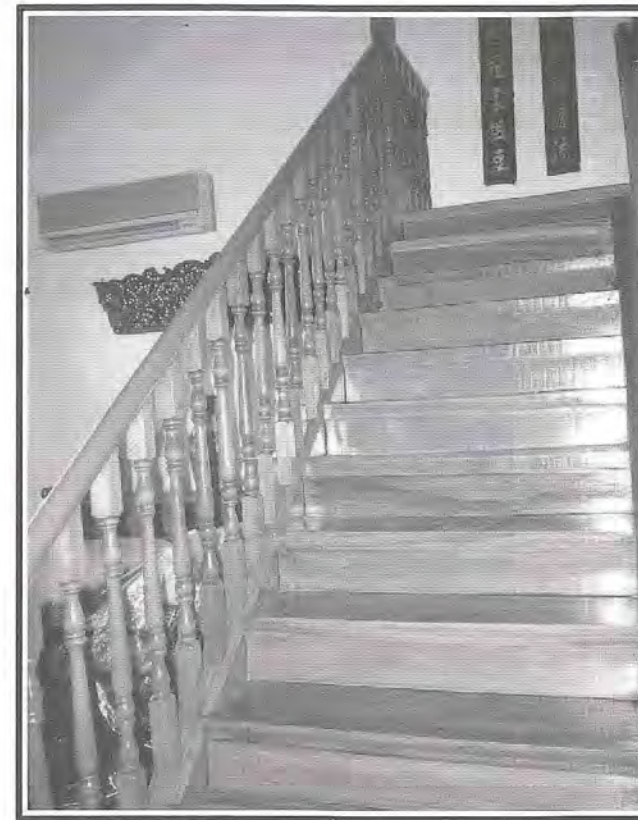
Fig 18: Timber staircase reconstructed to comply with current building codes.

Where the original staircase cannot comply with the current building codes or when there is a necessity to change the internal layout, the reconstructed staircase should try to reuse all the existing timber elements which are still in good condition. (See Fig 18 - 19)

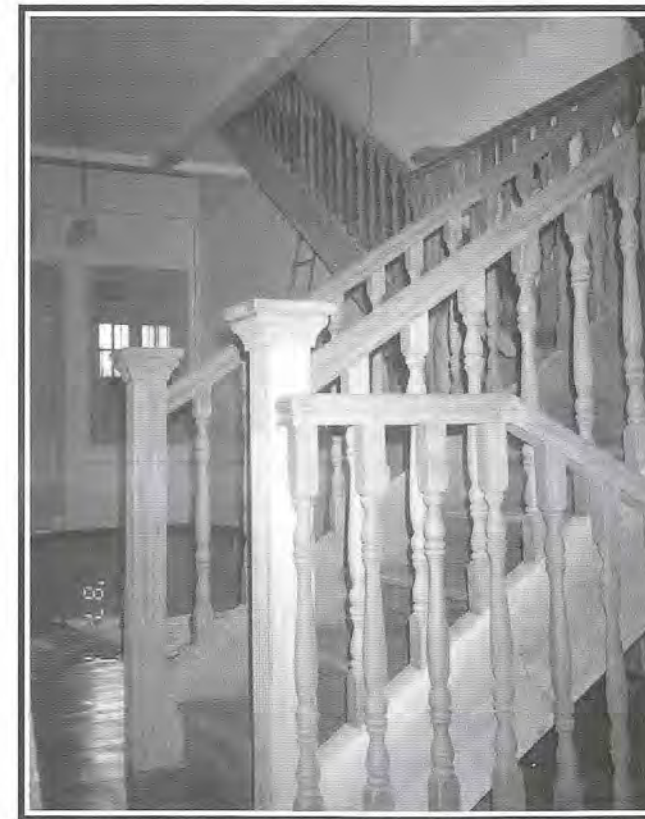
Fig 19: Reconstruction and reconfiguration due to changes in the internal layout of the shophouse.

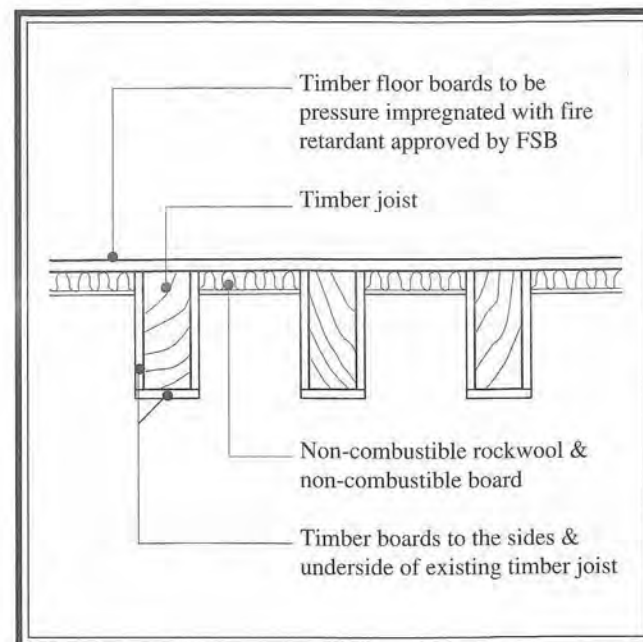
Fig 20: Timber floor joists covered with additional timber sections to achieve the required fire-rating.

In order to improve the fire resistance of timber floors, thereby minimising the possibility of a fire spreading from one floor to another, the principal approach is to use sacrificial timber. The cross section of existing timber joists is increased by covering with timber sections to achieve the required fire-rating while retaining the appearance of the exposed timber members. The existing timber joists, when retained, have to be pressure impregnated with fire-retardants upon reuse. The impregnation process is carried out in an off-site factory. However, if the existing timber floor joists can fulfill the fire-rating requirements, they need not be pressure impregnated. (See Fig 20)

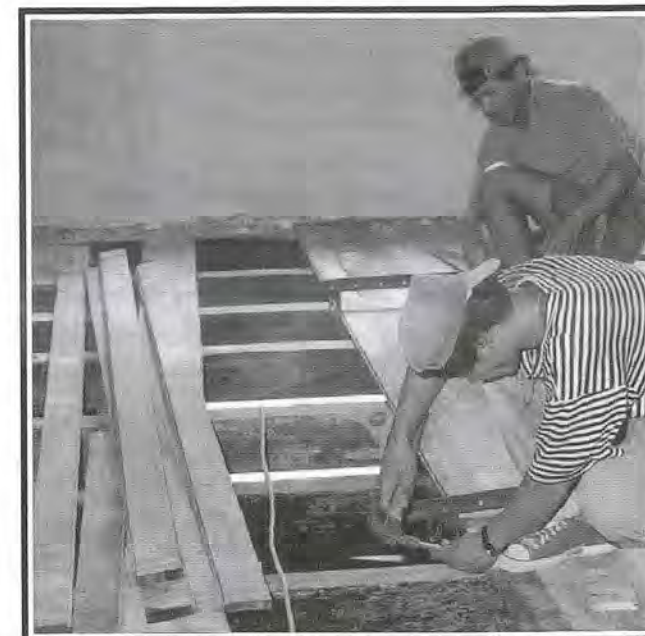
Fig 21: The use of tongue and groove joinery during restoration as a fire-safety measure.

Impregnation of the timber floor boards with fire retardants are normally carried out in the factory by pressure treatment. The impregnated original tongue and groove floor boards would usually require sanding-down to ensure that the joints fit properly. For residential use, pressure impregnation of the timber floor boards does not apply provided there is no increase in floor area or addition of a new roof mezzanine. (See Fig 21 - 23)

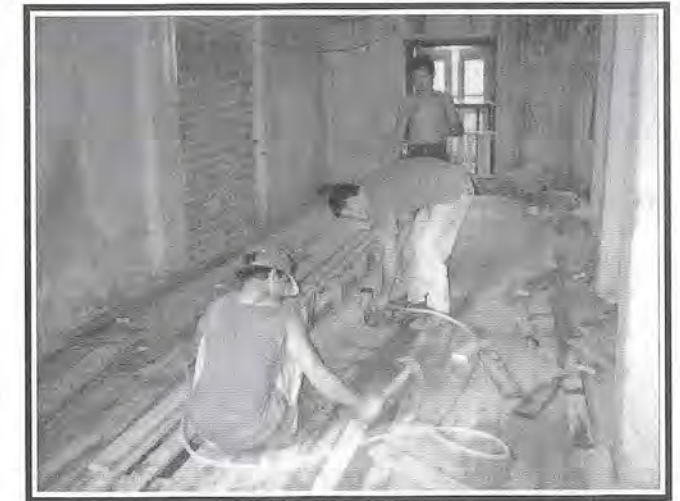
Fig 22: The laying of the new fire-retardant timber boards.

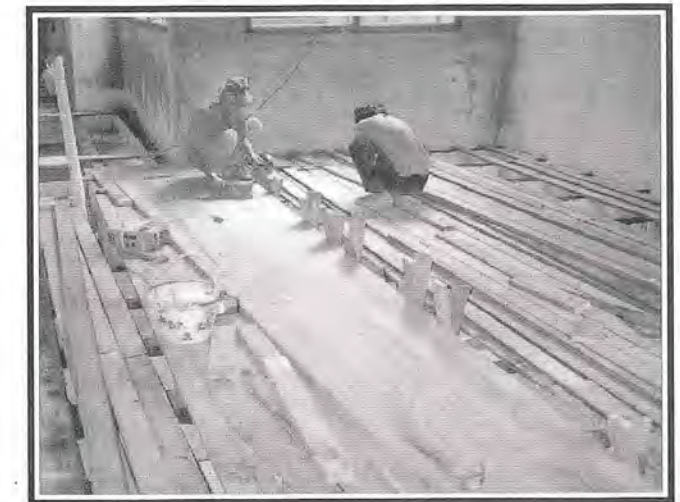
Fig 23: The timber floor being polished after laying and fastening to the timber joists.

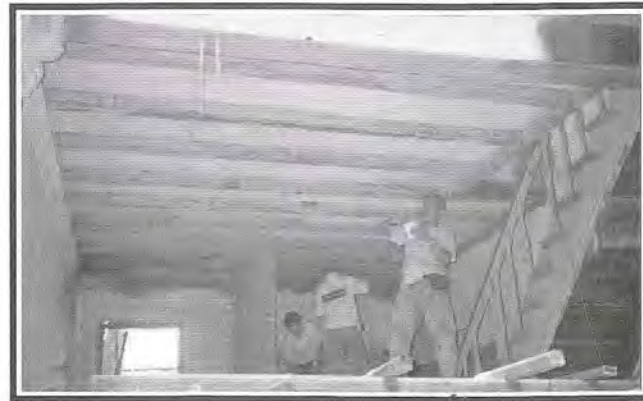
Fig 24: Use of non-combustible boards between timber floor joists to achieve the required fire-rating.

This is not recommended as it will not be possible to expose the timber floor joists and boards to retain the existing character of the building. However, for buildings with new roof mezzanines, the timber floor boards have to be lined on the underside between floor joists with non-combustible boards to achieve the required fire-rating as the pressure impregnation method is not acceptable. (See Fig 24)

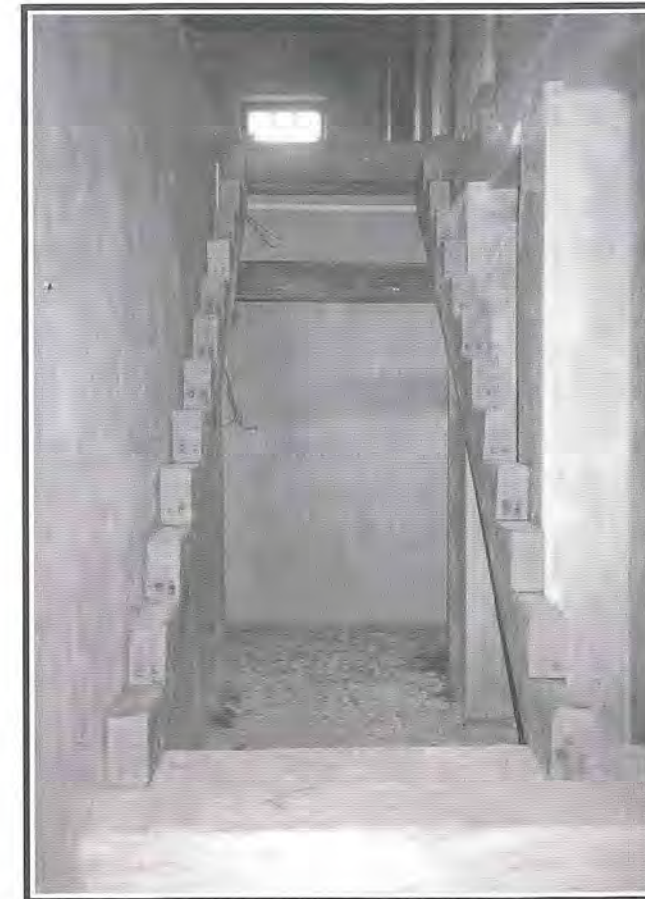
Fig 26: A compartmentalised staircase being constructed.

Protection of staircases is an important fire safety precaution as they serve as means of escape. For non-residential uses, staircases have to be compartmentalised and pressure impregnated with flame retardant chemicals to meet the relevant fire escape requirements. Fire-rated boards or brickwall partitions are used to compartmentalise the staircase in compliance with fire-safety requirements. Distance runs, manual call points and exit sign provisions, will have to comply with the current codes. (See Fig 26 - 28, opposite page)

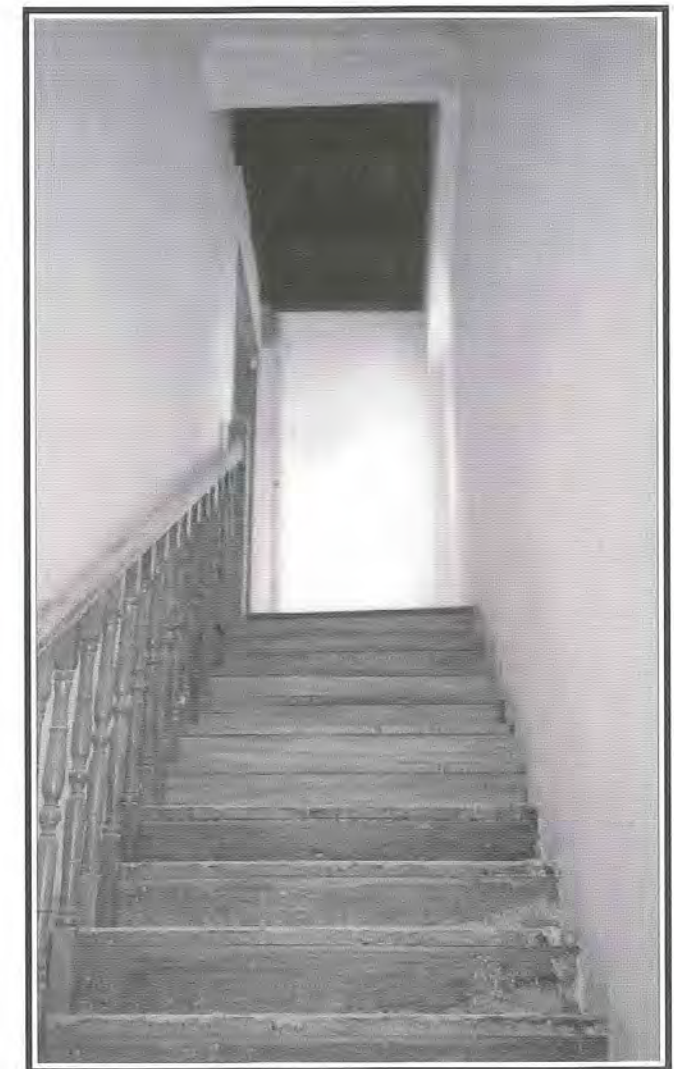
Fig 28: A completed compartmentalised staircase.

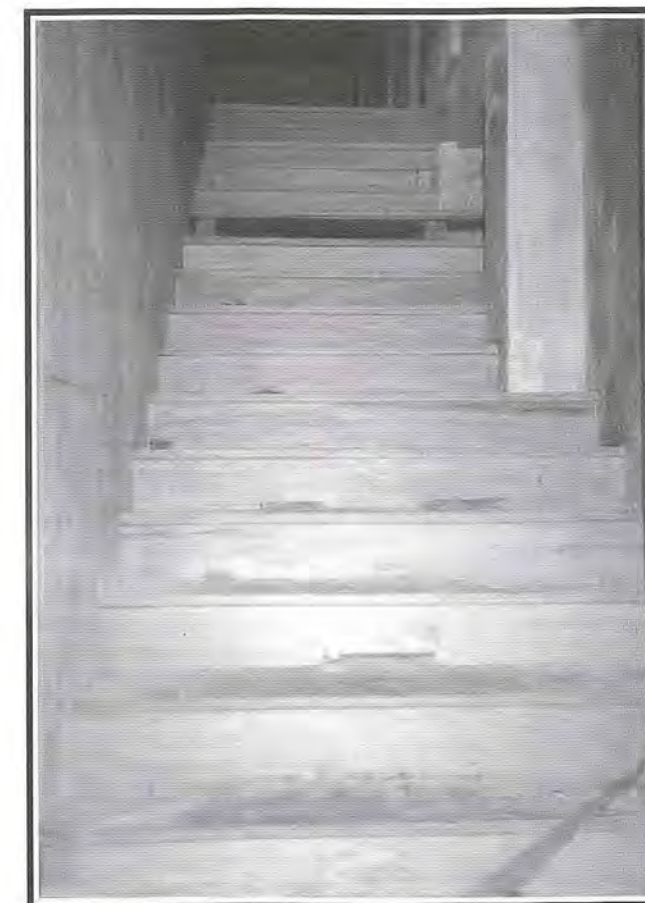
Fig 27: Laying of timber treads and risers.

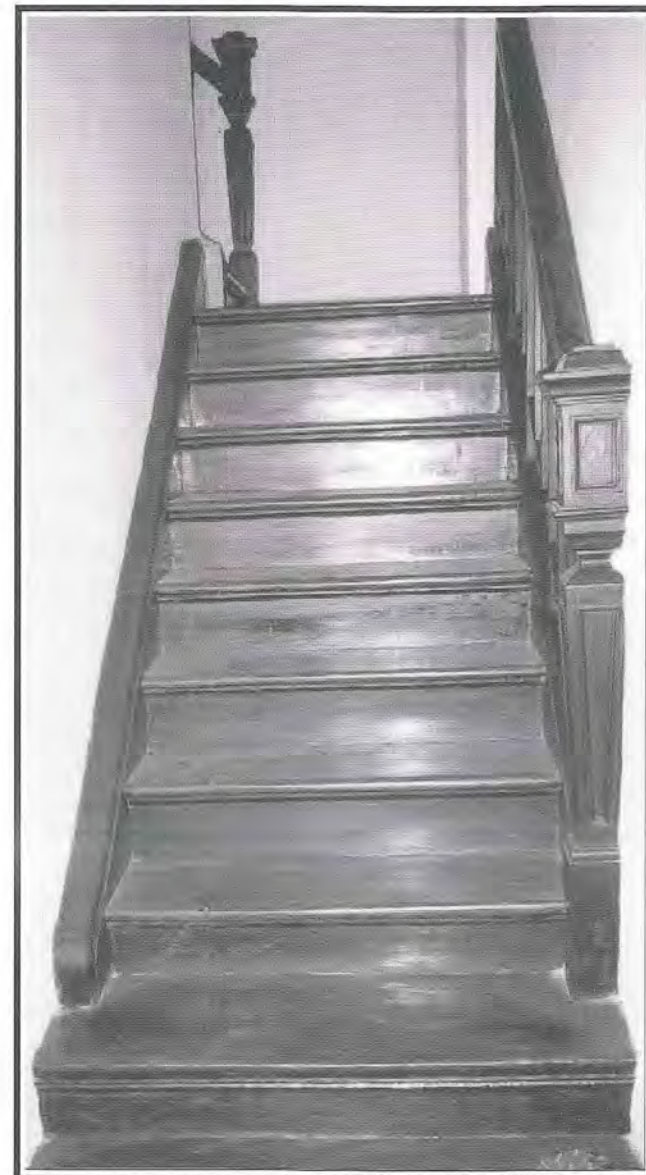
Fig 29: Restored timber staircase to be properly maintained to prevent deterioration due to water accumulation and termite infestation.

The restored timber floor joists and boards and staircases should be periodically examined to ensure that there is no water accumulation (particularly at the junctions between the partywall and the timber floor joists) which will cause timber deterioration. The termite resistant coating added to the timber members also has to be checked frequently to determine whether repainting is necessary, or if there is already an infestation, to localise the problem and repair the affected members. Early treatment would reduce costs. (See Fig 29 - 30)

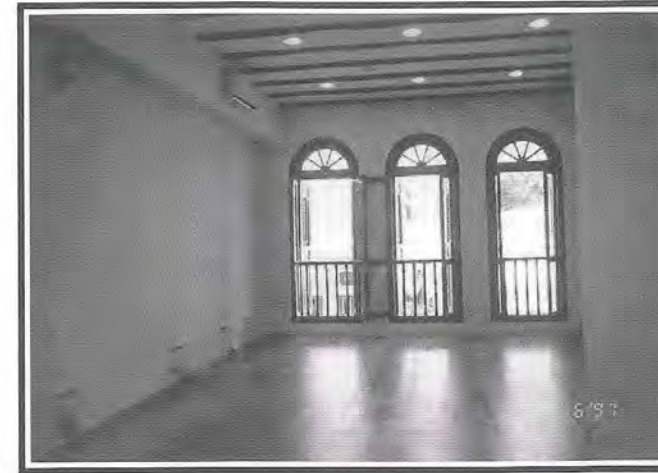
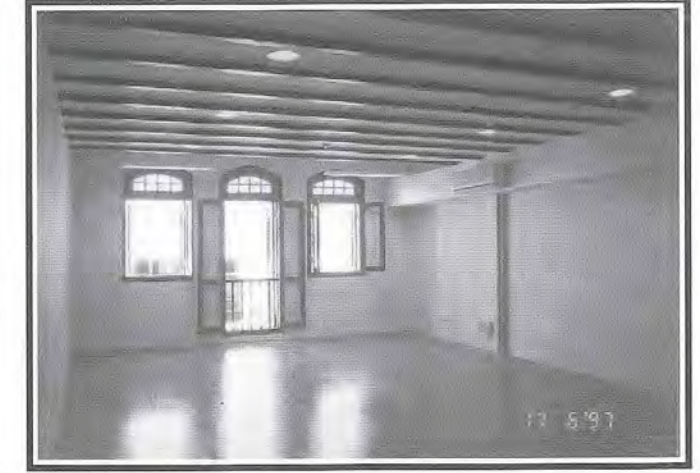
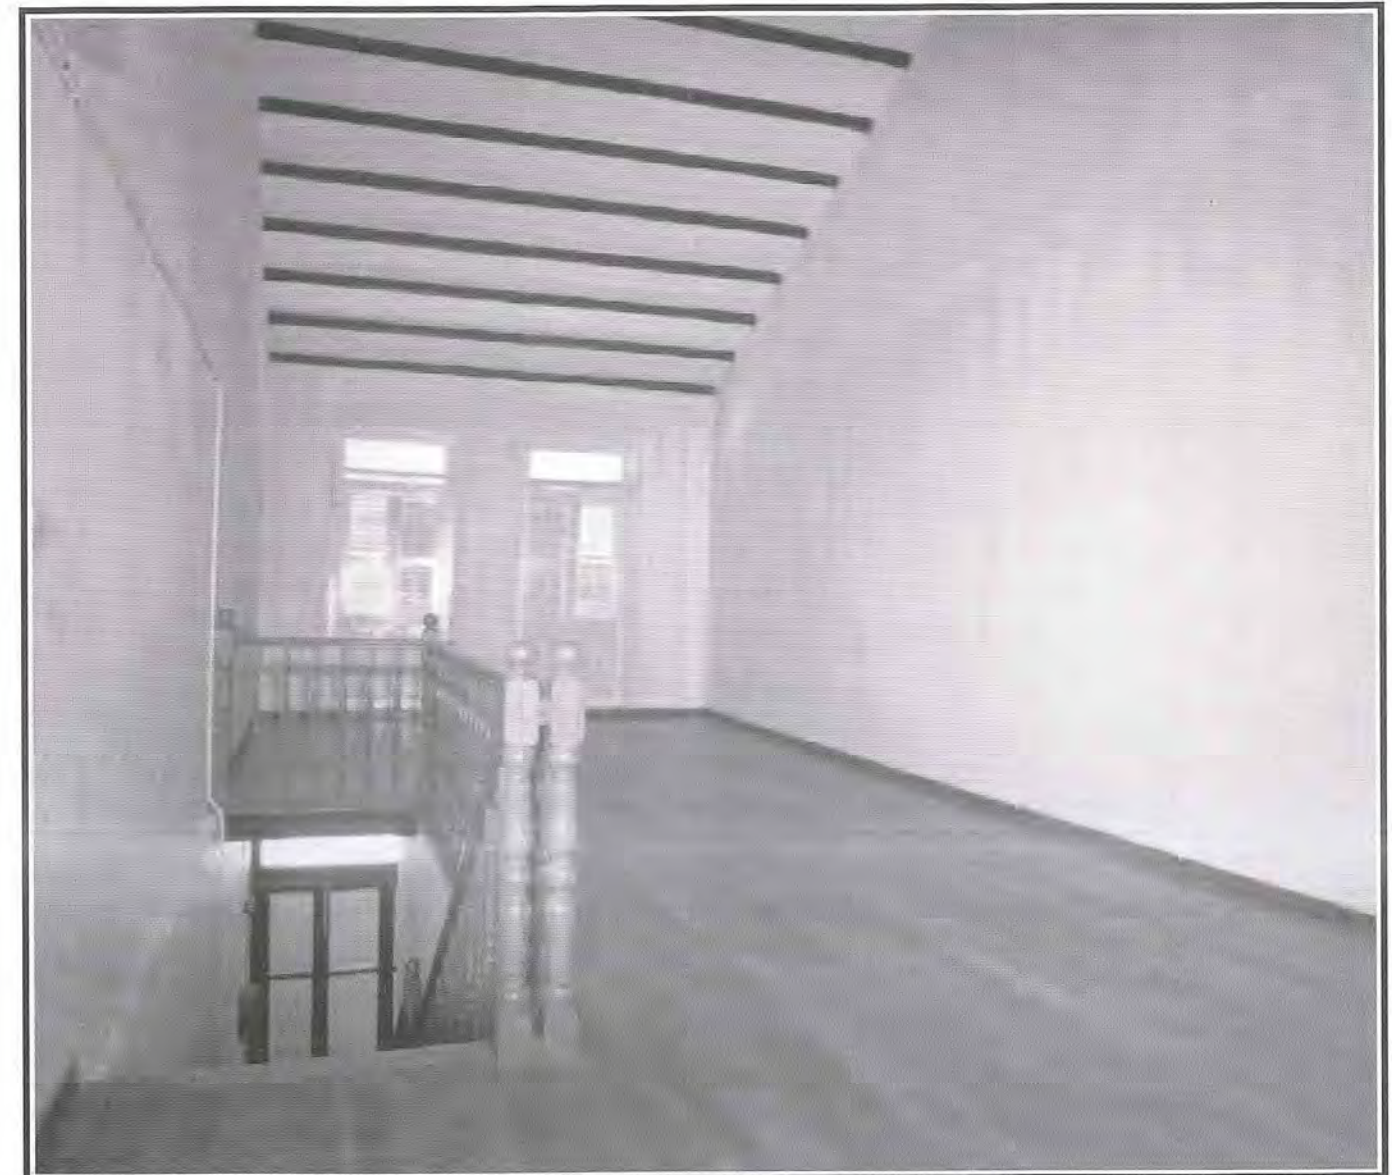
Fig 30: Timber floors after restoration.

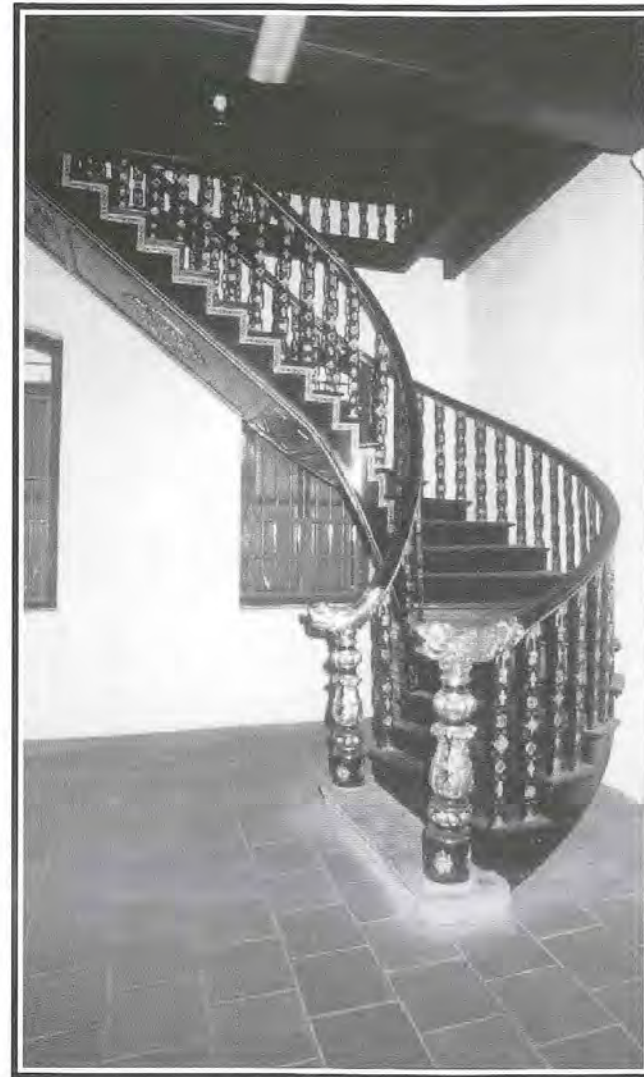
Fig 31: A restored ornate timber staircase.

As key elements of the shophouse, restoration of the upper storey timber floor and staircases have to be carefully considered. It is recommended that the essential form and integrity of the original structure be retained. This means supplementing damaged or inadequate structural members and replacing original structural elements only when it is absolutely essential. Where possible, repair of the existing timber floor and staircase should be all that is required. This will retain the original internal quality and appearance of the building.

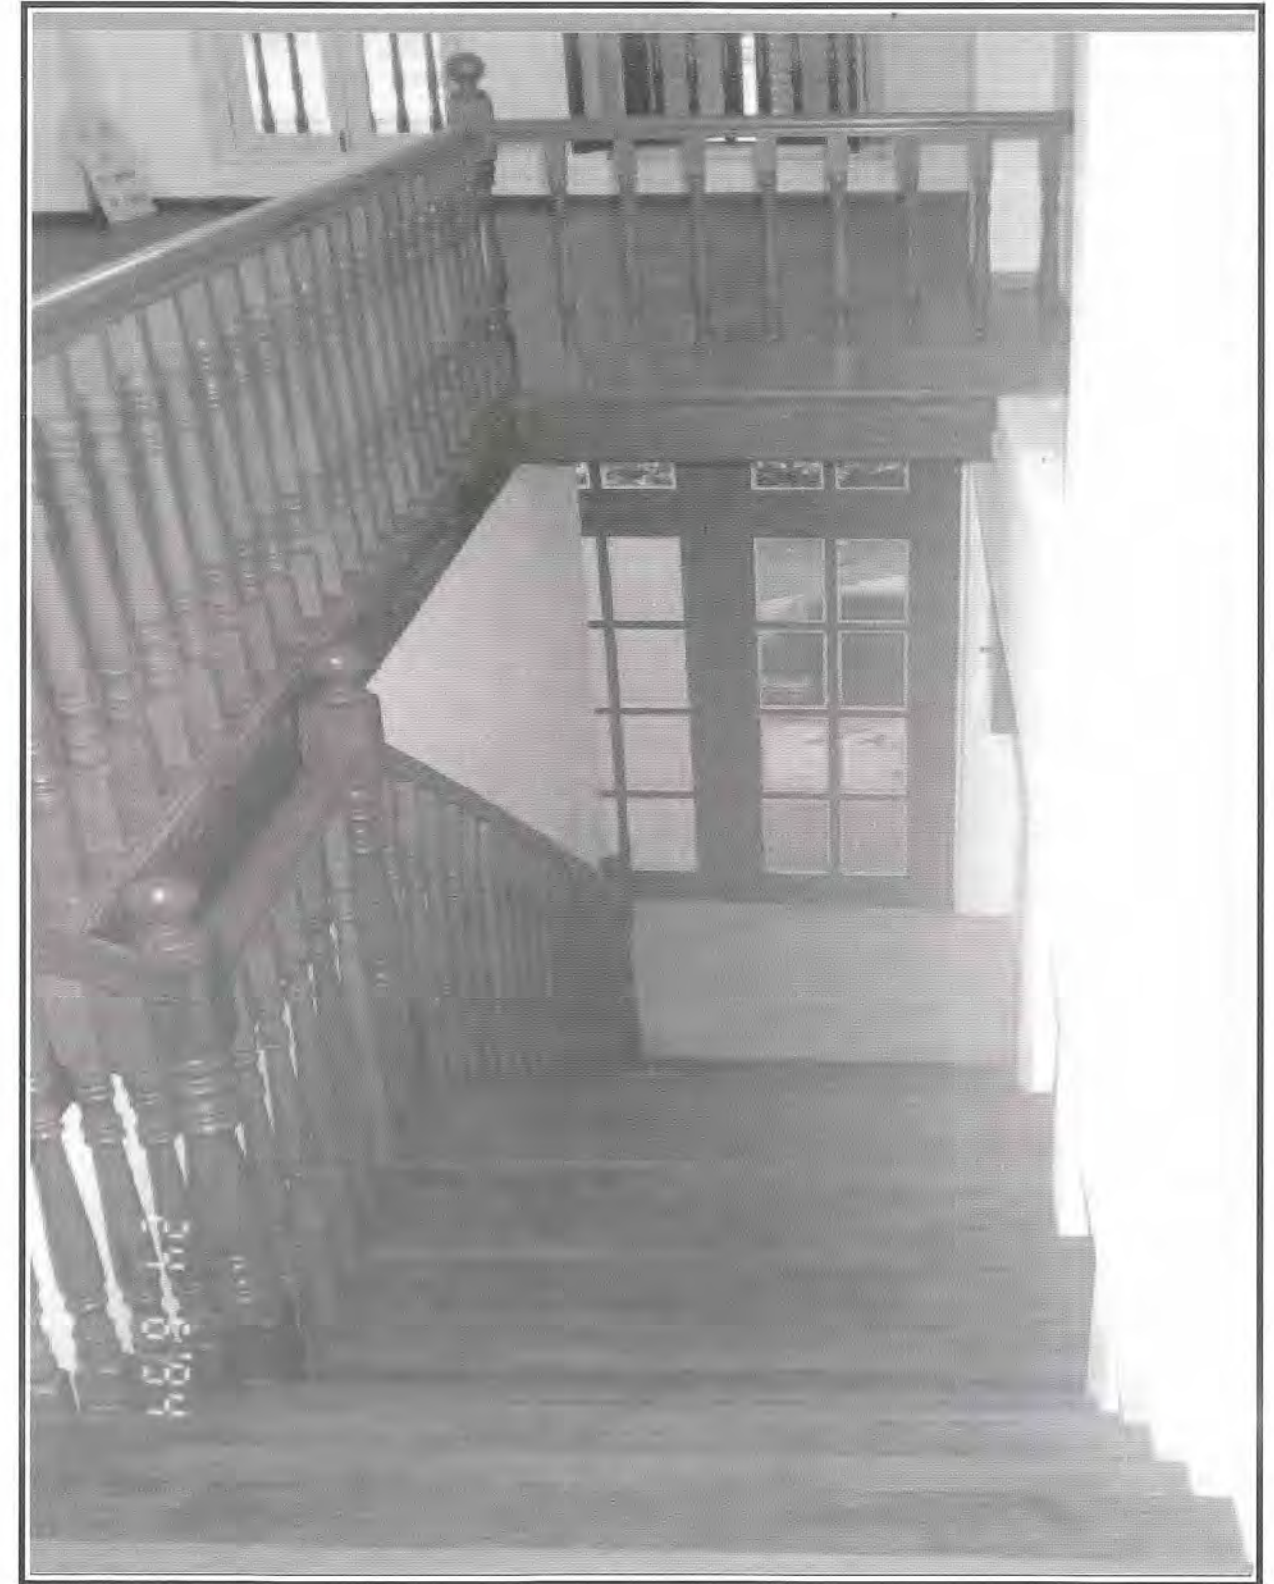
Fig 32: Timber floor and existing timber staircase retained and restored, thereby retaining the internal spatial quality and character of the shophouse.
