19 LORONG 24A GEYLANG

Artful Charmer

This early 1900s two-storey shophouse of the Late Style, characterised by an extensively ornamented façade, has been sensitively restored. Its revitalised interior with a new two-storey rear extension exudes the aura of a modern gallery-style home with vintage pedigree.

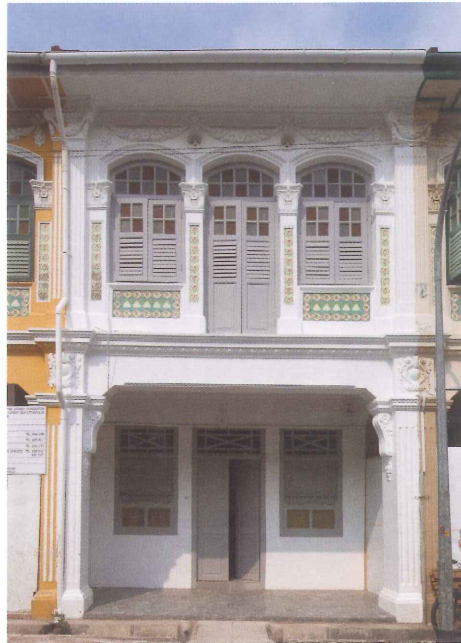
Late Style shophouse restored to a modern gallery-style home

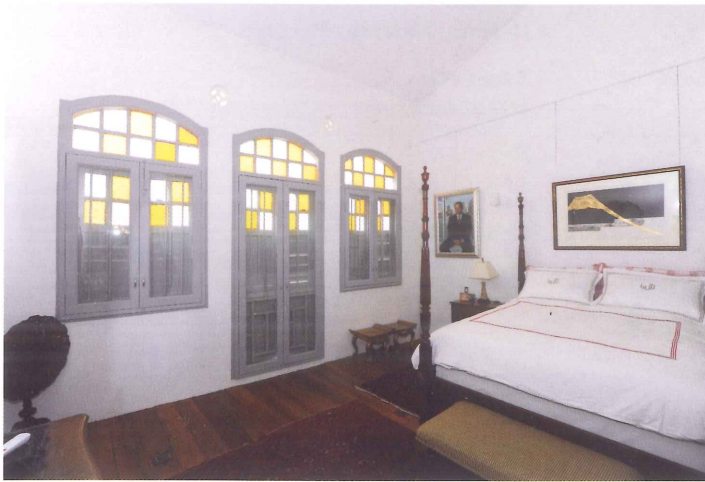
Bedroom at second storey with original timber floors, windows and door

Most of the first level floors and walls as well as the second level walls and timber floorboards, which had been certified to be in good structural condition, were conscientiously retained.

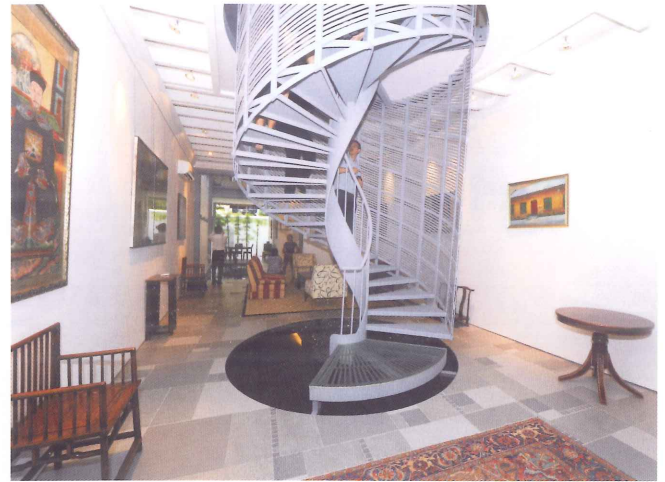
Central metal staircase expressed as an art sculpture

While the old has been given a new lease of life, the house has received a bold update with elements that tell of its past, but in a new language. The quirky skylight under the attic jack roof filters light down into the home's new stairway. Relocated and reconstructed, the original stairway has been replaced by a modish spiral version that is encased in a see-through weaving of steel bars. Conspicuous by design, this metal staircase lends itself almost as an art sculpture that is perhaps more in keeping with its new gallery-design intent than the traditional shophouse character.

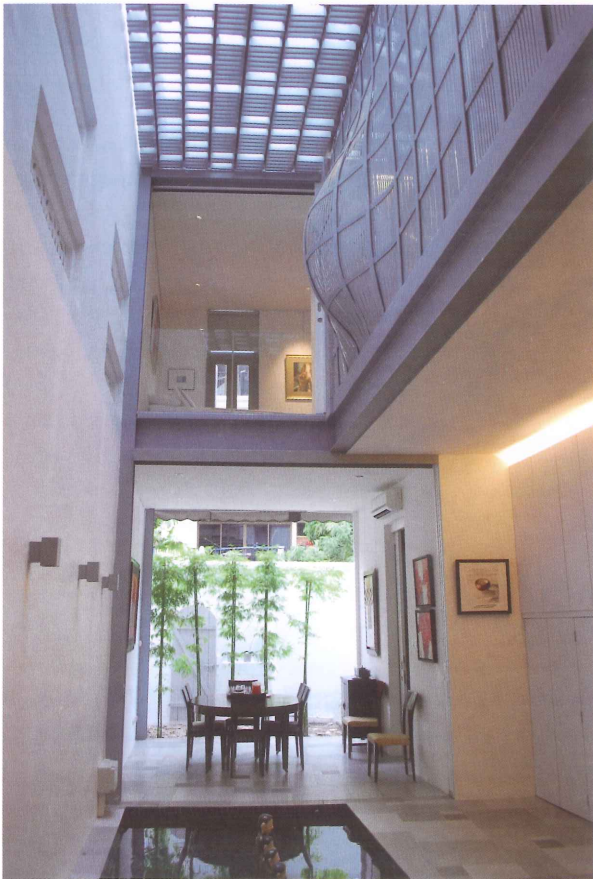
Central airwell with water feature as the new centre of the home

In adding the two-storey rear extension, the central airwell has become the new centre of the home, bathing internal spaces with much-needed natural light. The second storey plan, which includes the new rear wing, now accommodates three bedrooms, each of which has been cleverly engineered to receive natural light and ventilation from at least one elevation.

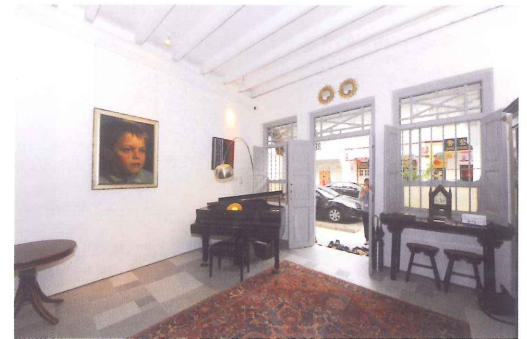
Original residential front kept

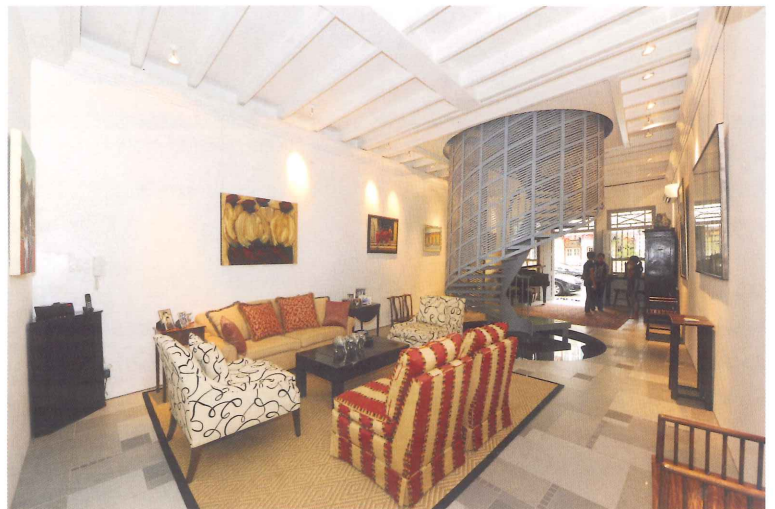
First storey space with original timber ceiling
