9 & 11 EMPRESS PLACE

A Timeless Encore

Owners:
National Arts Council &
Singapore Symphonia Company Limited

Architect:
W Architects Pte Ltd

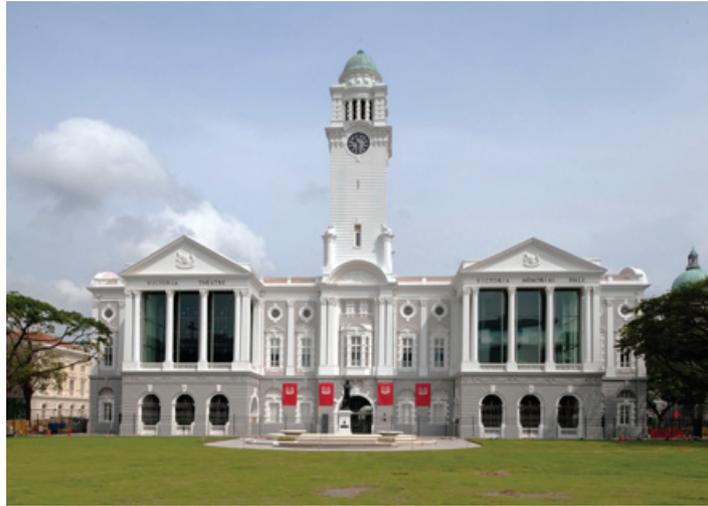
Victoria Theatre, Victoria Concert Hall and Clock Tower regained their prominence

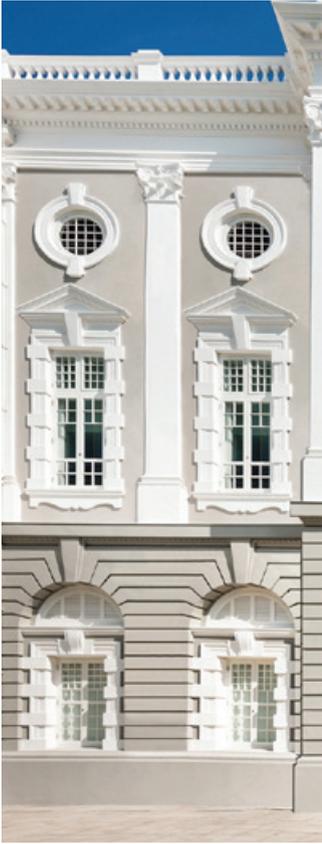
Crisply restored plaster-works on the façade

Throughout the restoration, the venerable structures were well protected with extensive shoring. The team commendably engaged conservation specialists for consultation on materials usage, and skilled craftsmen from India for the intricate plaster works. This further secures the

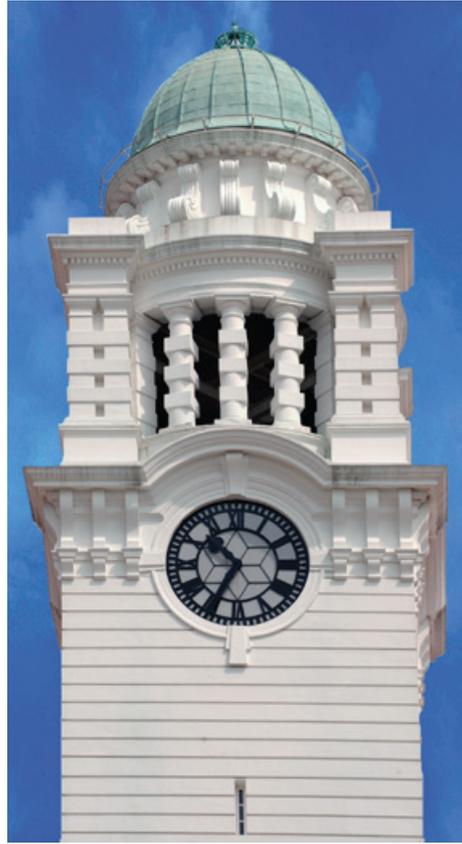
Crown modelled after original reinstated above copper dome

Noteworthy interventions at the Victoria Concert Hall include the refurbished balcony and mezzanine. Rebuilding them smarter and lighter allowed for the removal of intrusive support beams that had distorted the grand staircases below. Elegant new glazing for both porticos have given the facades a much lighter appearance. The extra effort to reinterpret the dome's missing crown, restore the clock mechanism, and reinstate the original 'City Crest' is laudable.

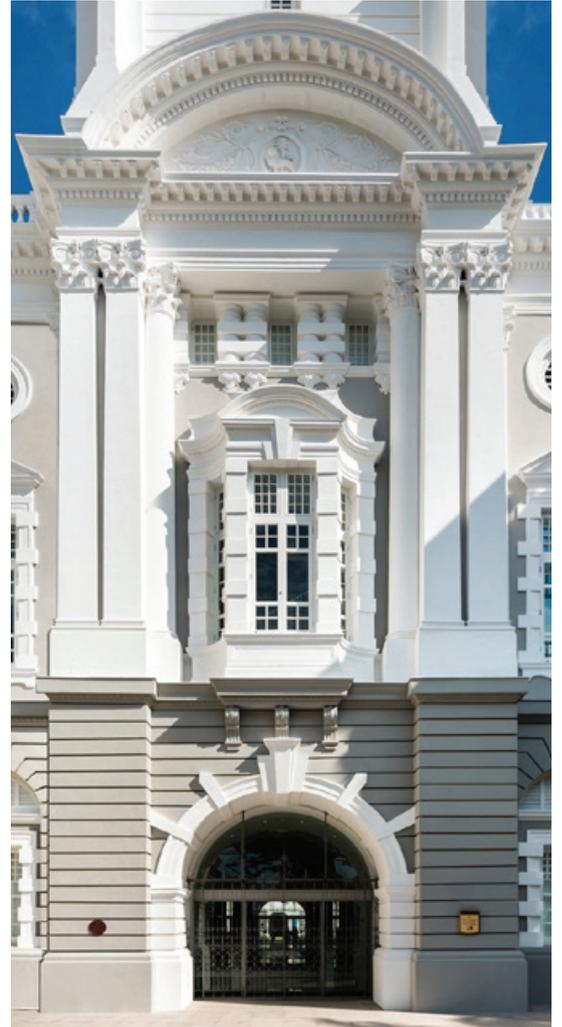
Main entrance to central atrium

In bringing history forward to embrace the buildings' new ambitions, the team introduced many sensitive interventions to dramatic effect. The recovery of the old open courtyard made way for a voluminous covered atrium with an ingenious skylight that visually connects the clock tower to the buildings. The lost internal façade was reinterpreted with such elegant restraint that

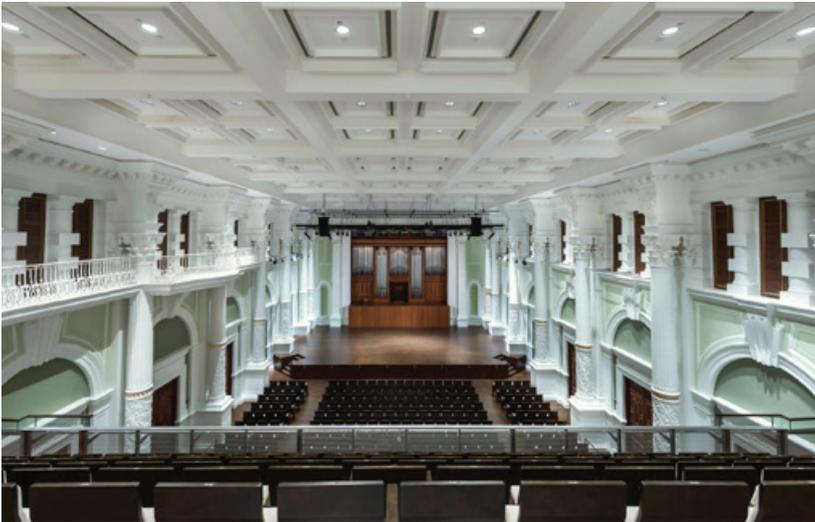
Restored and refreshed interior of Victoria Concert Hall

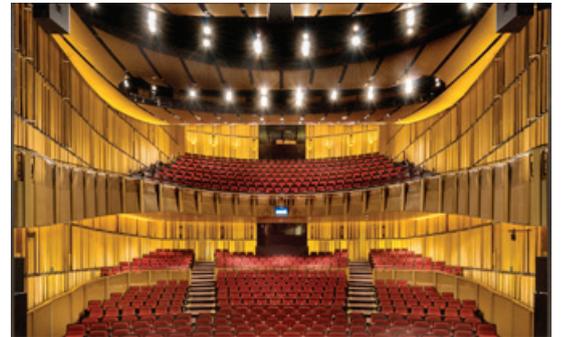
Reinterpreted interior of Victoria Theatre

While the new Victoria Theatre has a modernised interior, the past remain everywhere and in delightfully unexpected ways. Timber seat backings have been repurposed as sculptural pieces and metal chair components, redirected to serve as a support for the timber wall claddings.

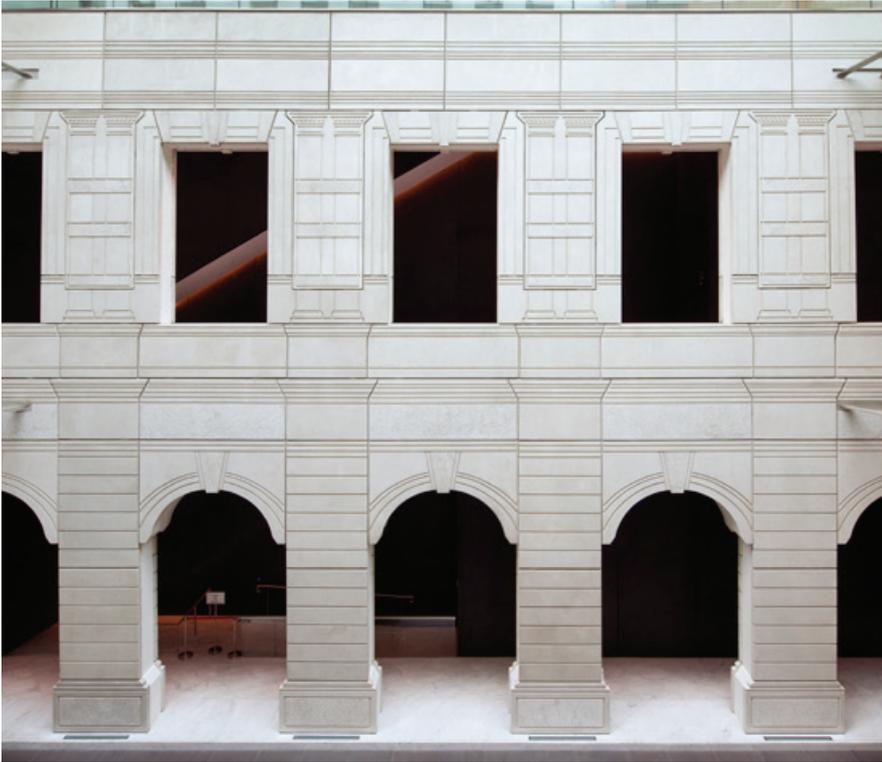
Sensitive reinterpretation of Victoria Theatre's atrium façade

the new wall stands with great confidence in contrast with the old.

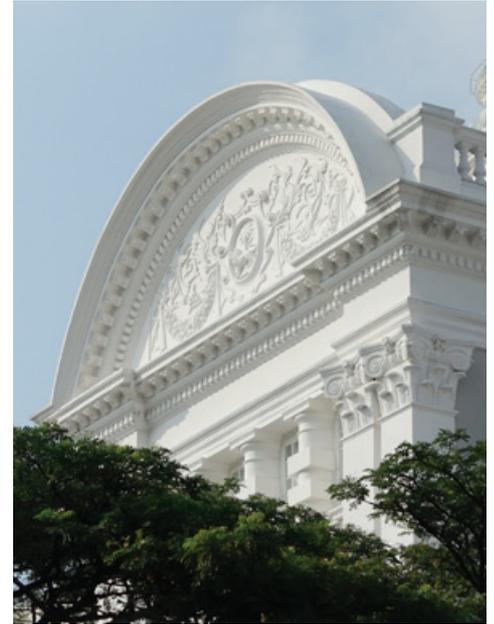
Tympanum with elaborate plaster-work wreaths and crest of the Colony of Singapore

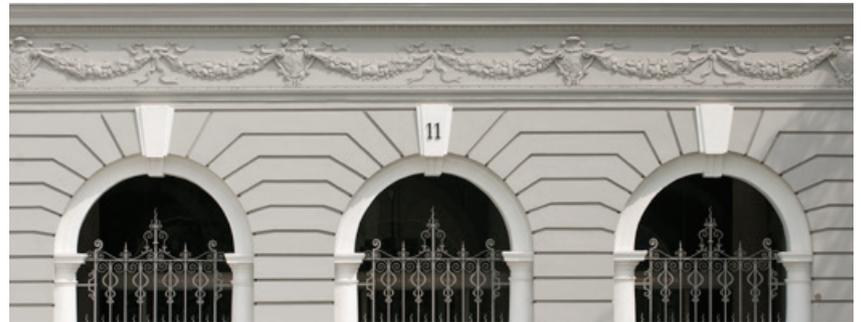
Festoons, plaster and wrought iron-work at front porch

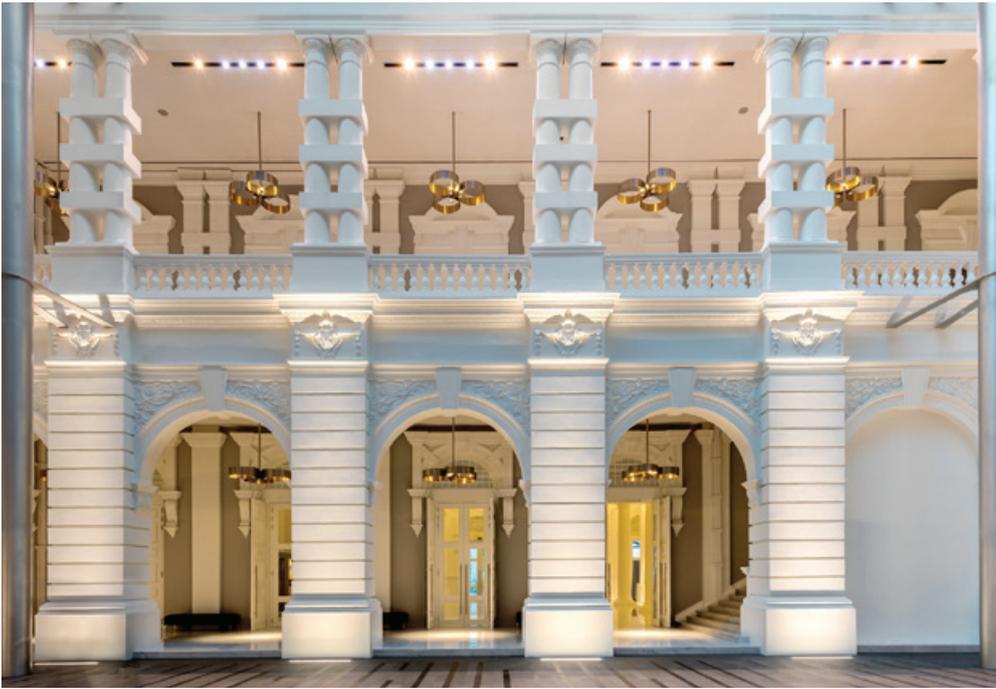
Victoria Concert Hall's atrium façade

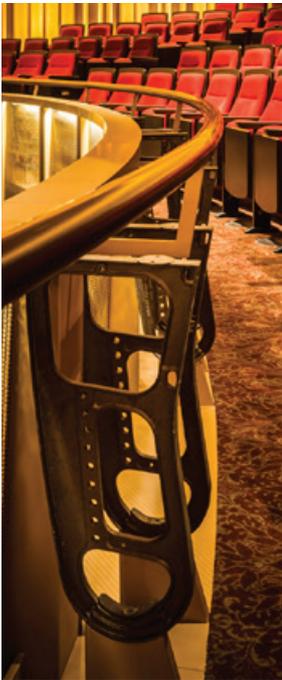
Old chair frames used as balustrades at Victoria Theatre

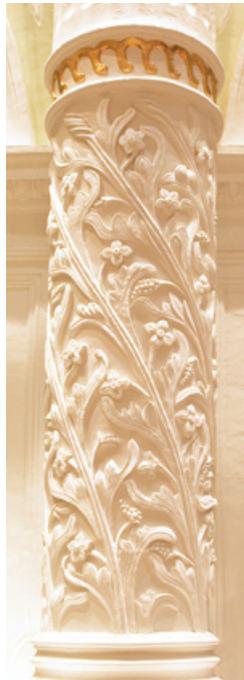
Column of Victoria Concert Hall

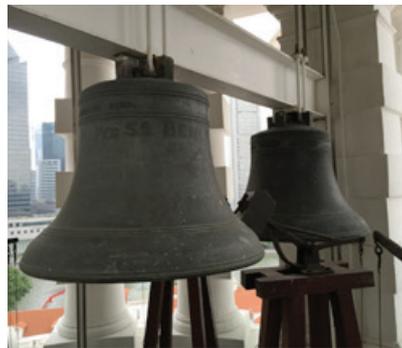
Restored clock tower bells
