## 3 Chatsworth Park

**1997 AWARD**

The two-storey Art Deco bungalow, located in the Chatsworth Good Class Bungalow Area, was designed by Frank Brewer and built in 1923. Over the years, several additions and alterations were made to the bungalow.

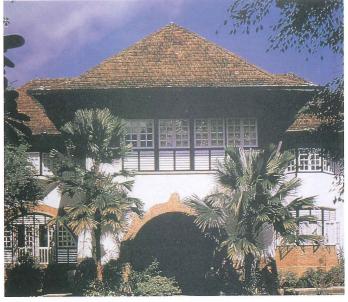
Two-storey Art Deco bungalow designed by Frank Brewer
